**PHASE I
ENVIRONMENTAL SITE ASSESSMENT
FORMER HEALDSBURG ARMORY
900 POWELL AVENUE
HEALDSBURG, CALIFORNIA**

Prepared for:
CALIFORNIA DEPARTMENT OF GENERAL SERVICES

March 2014
Fugro Project No. 04.72120008, Phase 15

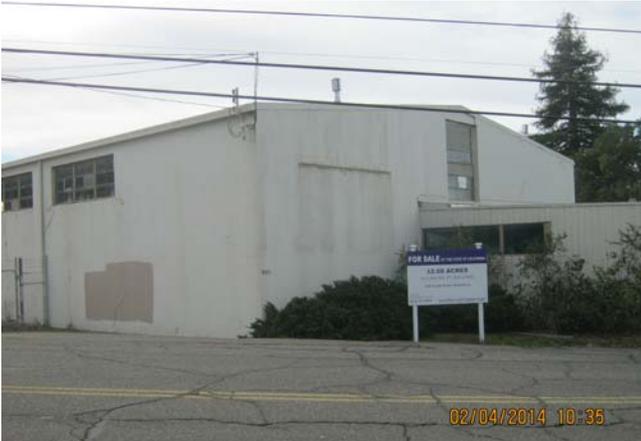
Photo 1: View of the north-facing portion of the Site building, looking south.

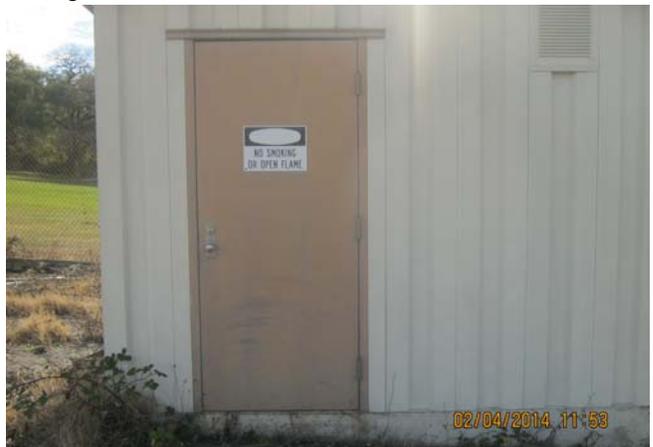
A small metal storage shed is located to along the south property line. This shed, which was used to store small volumes of hazardous materials and petroleum products, was locked and inaccessible at the time of the site reconnaissance. However, based on verbal information obtained from Mr. Bob Swift, the shed is currently empty. No staining was noted around the shed.

Photo 6: View of the locked storage shed located southwest of the Site building.

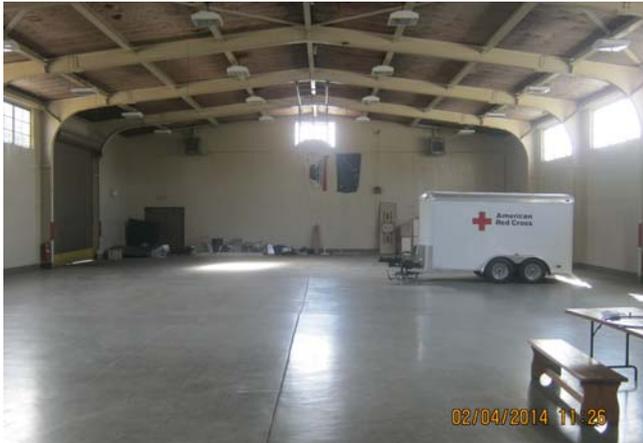
The existing Site building is a vacant one-story structure situated on the northwestern portion of the Site. The interior of the building is comprised of a large open area (assembly area) which makes up the majority of building's net area. Fugro observed an American Red Cross trailer, a couple of tables, several metal toilet fixtures, and other miscellaneous building equipment in the assembly area. The presence of the trailer and other equipment/materials

Photo 7: Interior view of the open floor space inside the Site building.

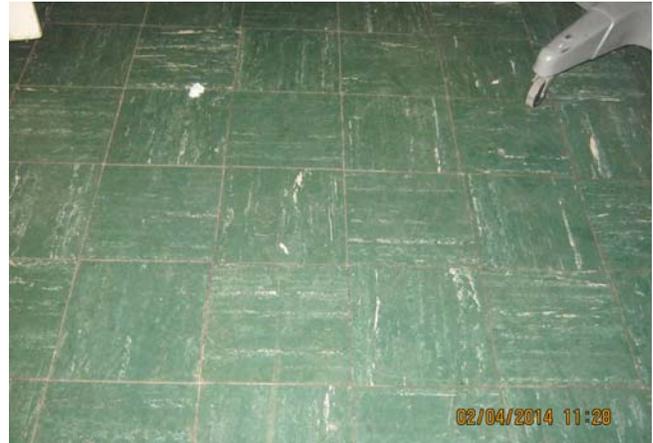
- The Site building was constructed in approximately 1950. Based on the construction date of the building, there is a potential that the building contains asbestos containing materials (ACMs) and lead-based paint (LBP). During the site reconnaissance, 9" x 9" floor tile was observed in the kitchen and the classroom portion of the building; this type of floor tile commonly contains asbestos. The observed exterior paint of the building was observed in poor condition, with large areas of flaking and cracked paint. Flaked paint was observed on the ground surface at the base of some of the building walls. Fugro recommends that a demolition asbestos survey and an LBP survey, including the testing of the paints used on building surfaces, be conducted prior to any future demolition or renovation work of the existing building.

Photo 14: View of some of the 9" x 9" floor tile in the building. This tile typically contains asbestos.

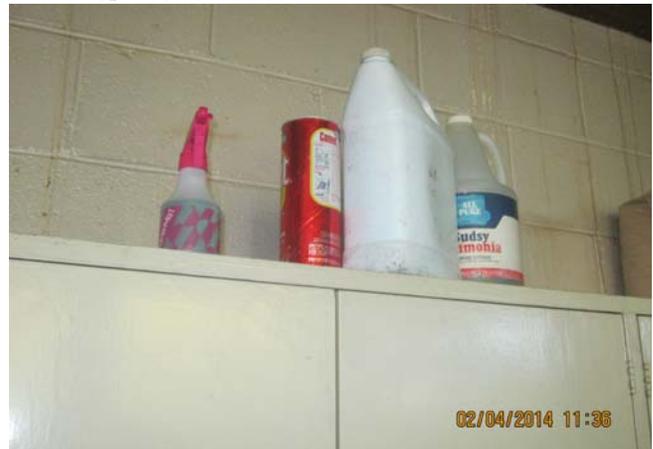
The northern and western sides of the building are subdivided into several small rooms. An administrative (manger's) office, which was locked and inaccessible during the site reconnaissance, a custodian room, and a kitchen, were observed along the northern portion of the building. The custodian room contained some toiletry items, a ladder, and some recreational equipment (football shoulder pads). A few small containers of household janitorial cleaners were noted in the kitchen.

Photo 16: View of the janitorial cleaners found in the kitchen.

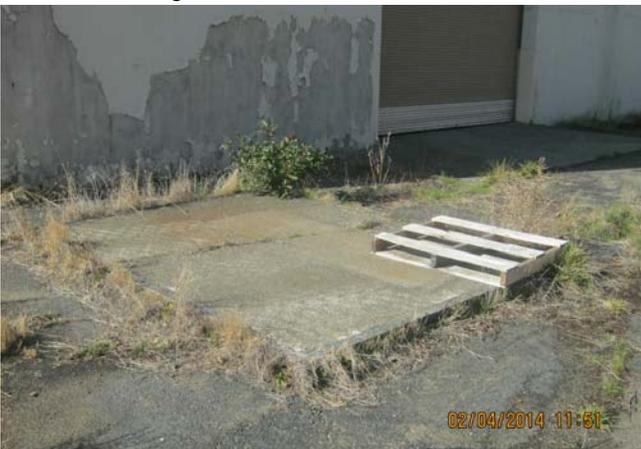
Surrounding the building is an old asphalt-paved parking lot. The parking lot was observed in very poor condition, with large cracks and holes in the pavement. A small raised concrete pad was noted near the southeastern portion of the building. As noted earlier, this was the area of a former trash enclosure. No stained pavement was noted around this pad.

Photo 17: View of the raised concrete pad located adjacent to the southeastern end of the Site building.

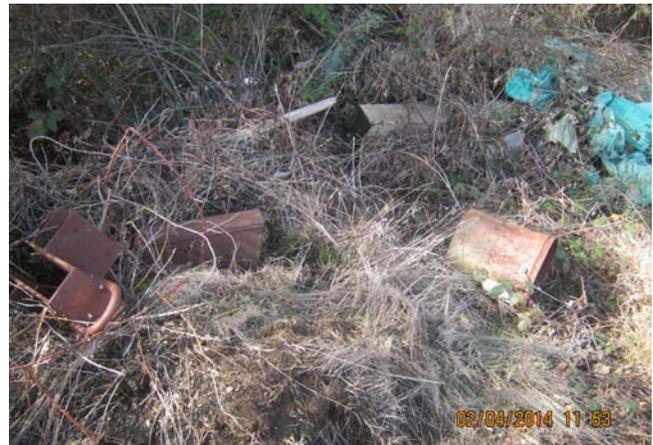
The eastern portion of the Site is an open field that is covered with native grasses/weeds and a few trees and shrubs. Fugro observed one small debris pile containing an empty paint can, trash, and soil. The debris pile did not appear to contain hazardous materials/wastes, but should be properly removed from the Site.

Photo 20: View of some debris/trash found on the Site.

- A small a pile of debris/trash was noted on the Site. This debris/trash should be properly removed and disposed of.

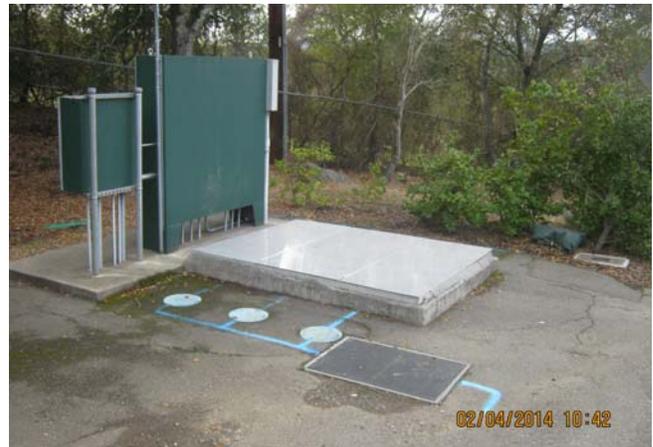
Photo 22: View of well/water pump station located adjacent to the northeastern corner of the Site.
