May 15, 2014

Re: San Marcos Fire Station Demolition

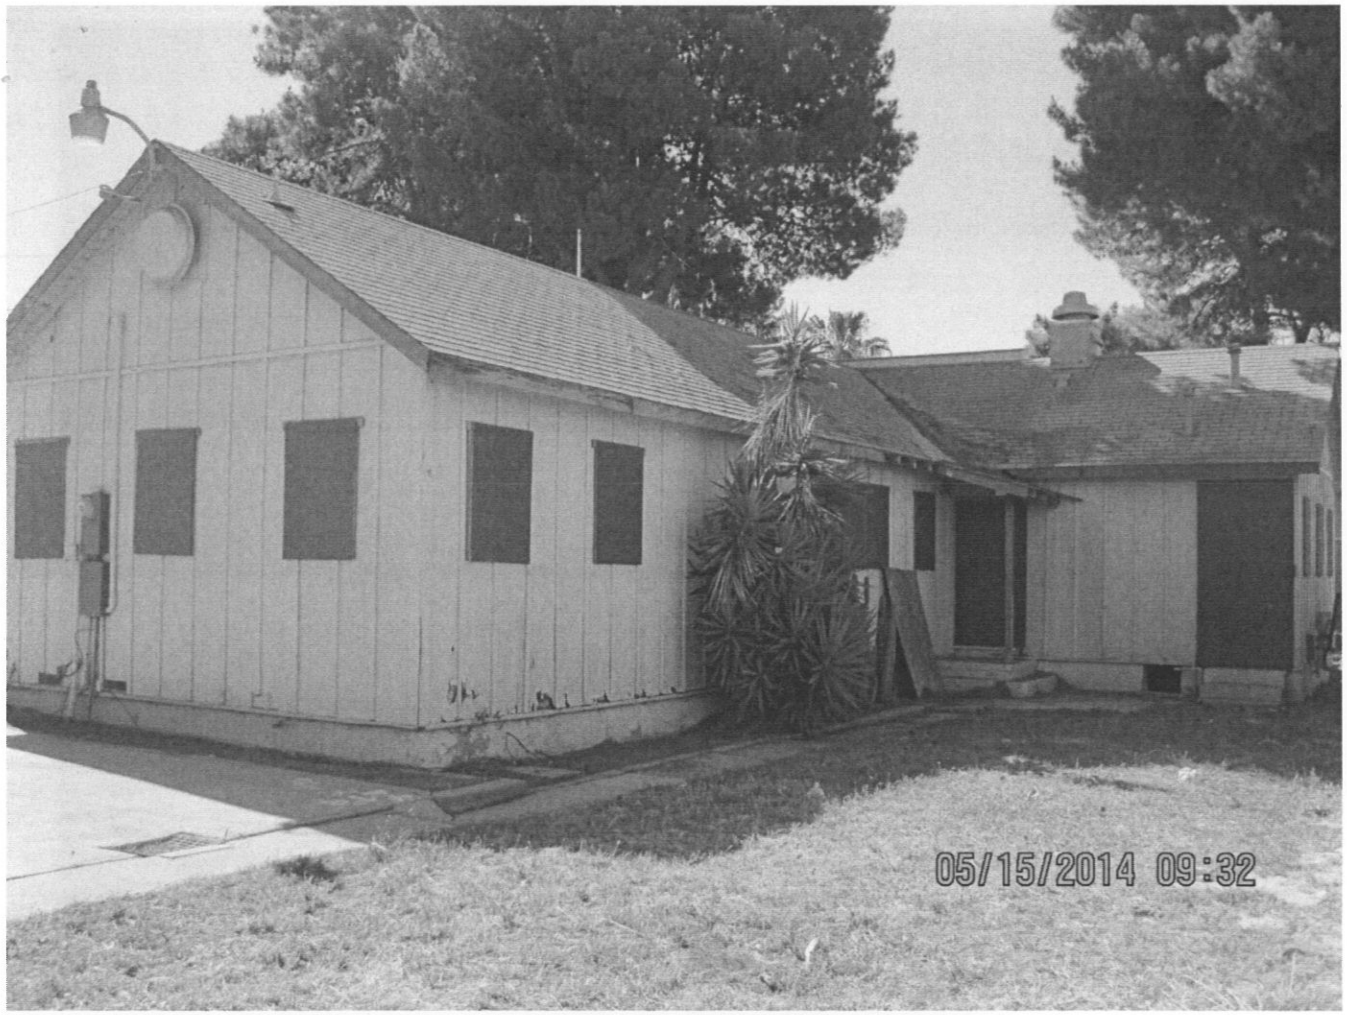
I examined the subject properties and they have degraded even further since their abandonment. The siding is deteriorated. The roof joists are termite infested and deteriorating. The roof is deteriorating. The fascia boards are almost completely deteriorated. I have included some photos as evidence of this fact. I am sending the photos in a separate email.

Note deterioration of board and batten siding and roof on back of Barracks building.

It is my professional opinion, that we should allow DGS to go ahead with their planned demolition of these structures following our approved management plan. Since these buildings have been replaced for their planned function, it is OK for DGS to proceed with the demolition of the two structures and the eventual sale of the surplus property.

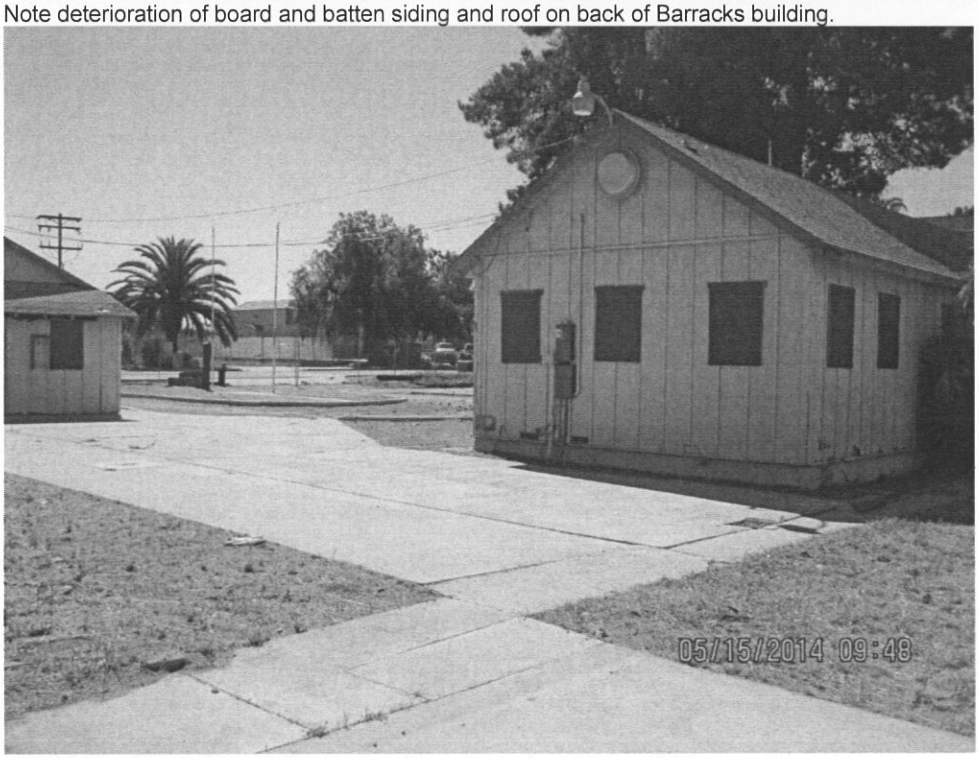
Same look of barracks on left, entrance in center and garage on right.

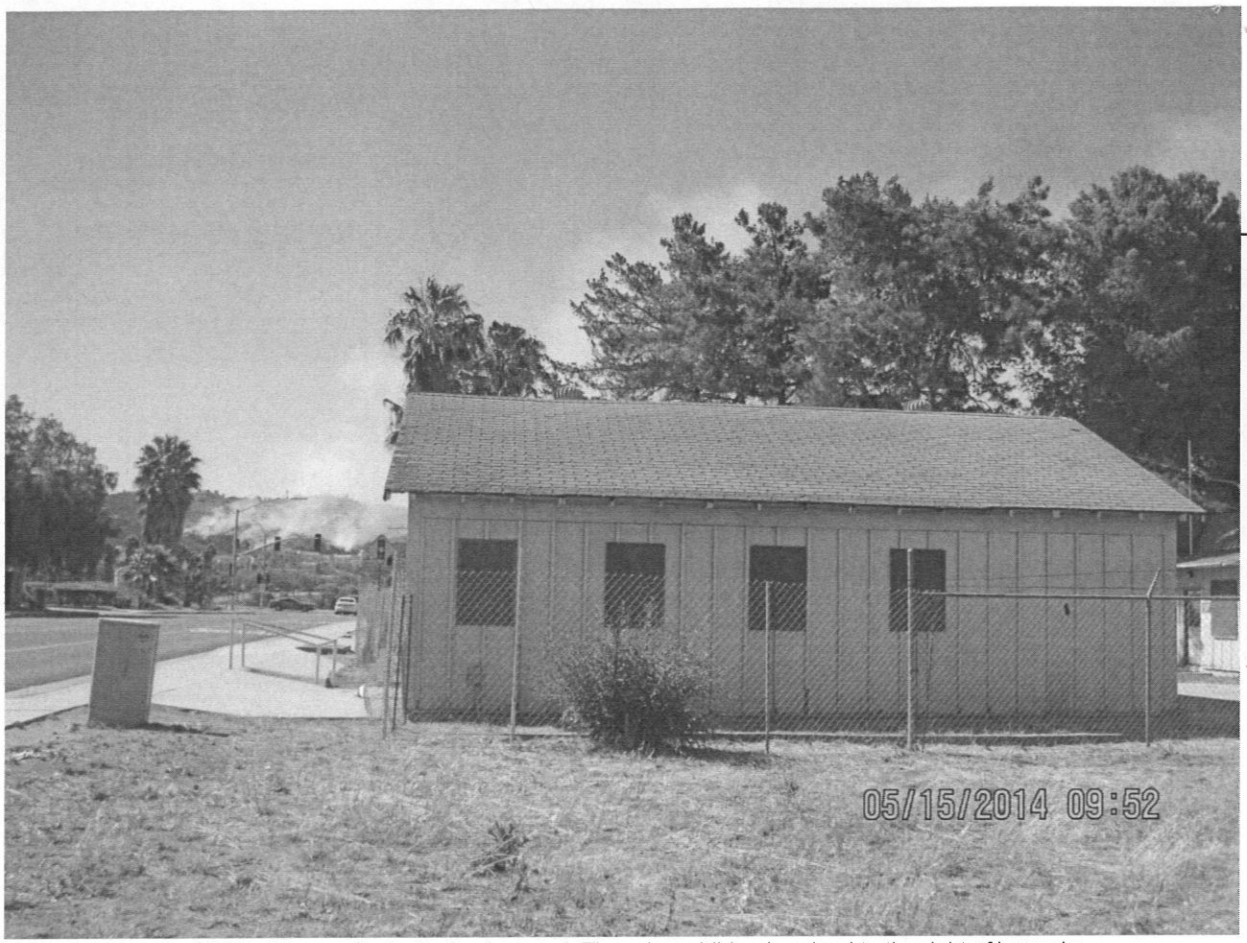
Picture of garage with San Marcos fire in the background. There is a children's school to the right of barracks.

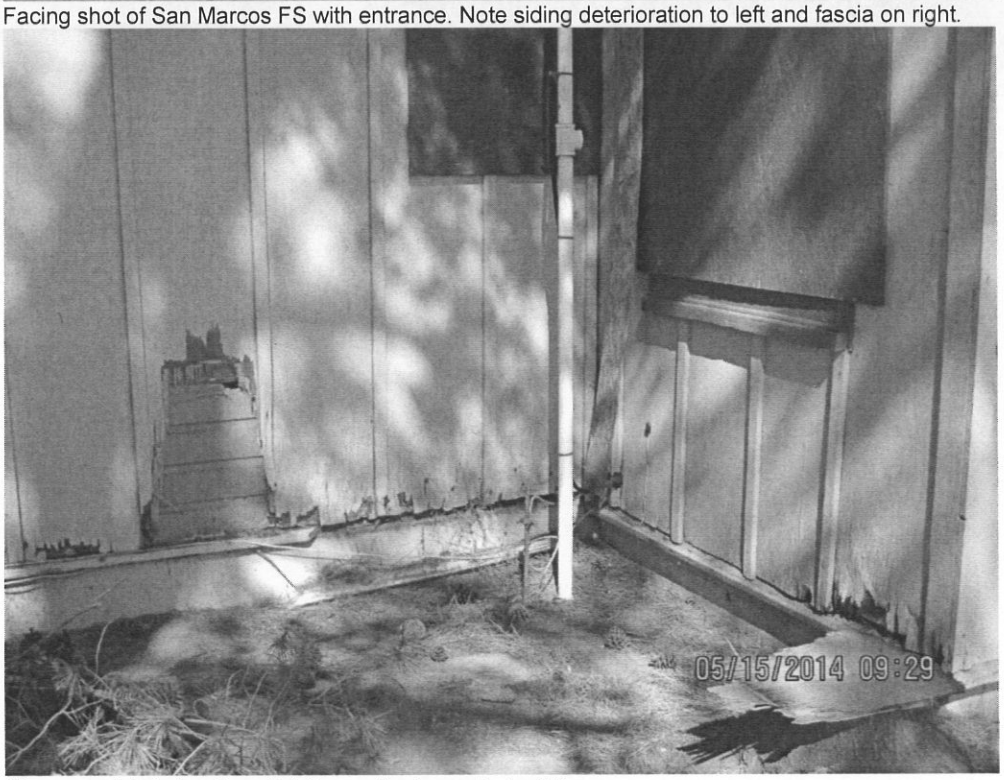
Facing shot of San Marcos FS with entrance. Note siding deterioration to left and fascia on right.

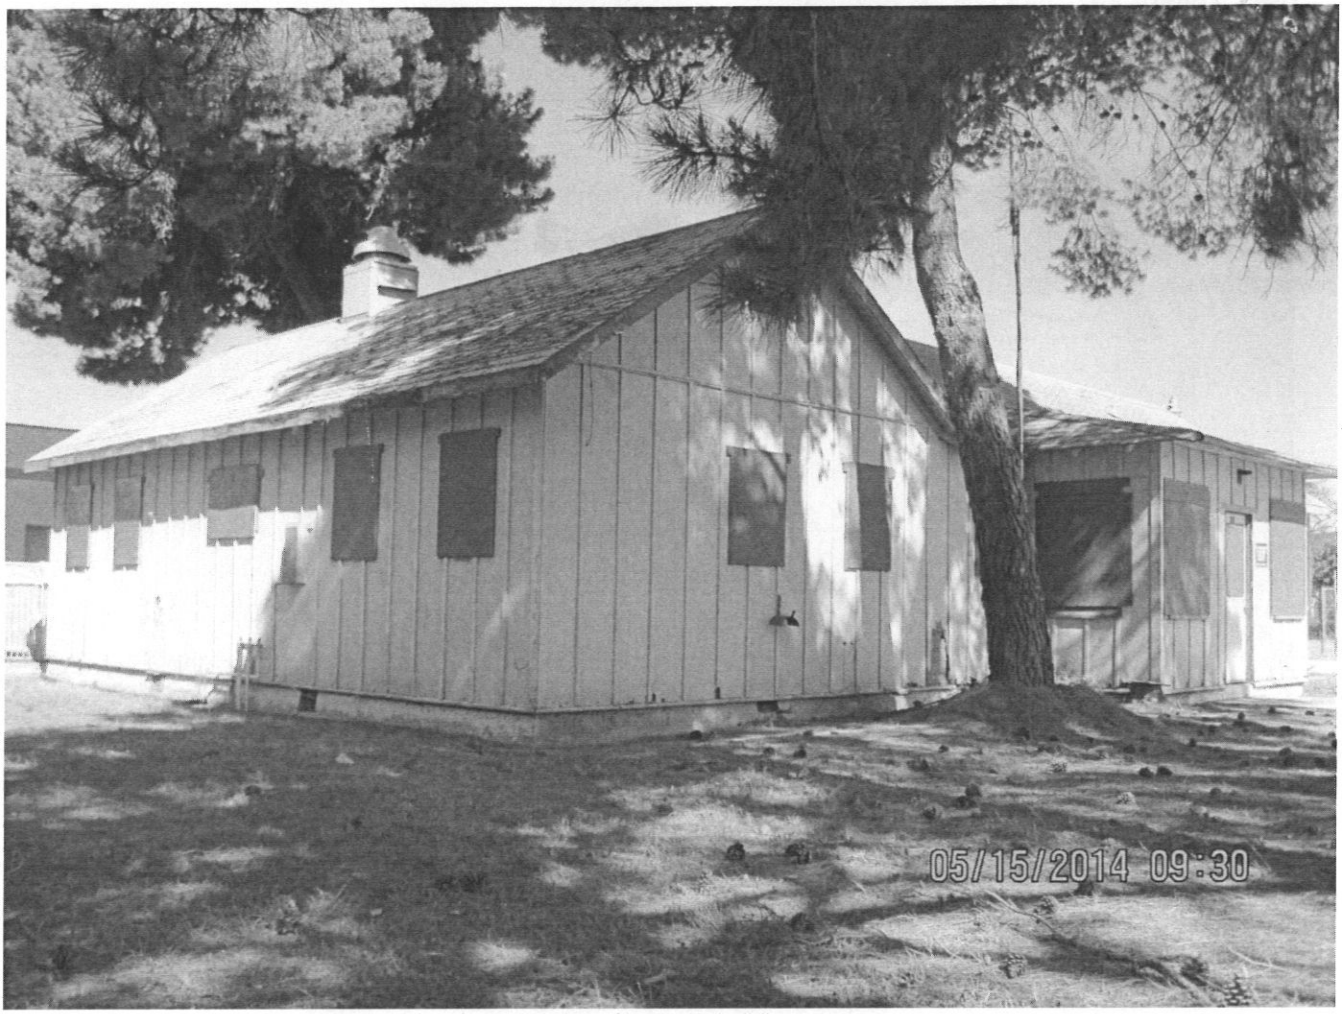
Close up of deterioration of siding on the barracks building.
