OFFICE OF THE STATE ARCHITECT
ASBESTOS PROGRAM
HOMOGENEOUS MATERIAL SURVEY REPORT

OSA#	BUILDING NAME	FACILITY	ADDRESS	CITY	ZIP	COUNTY
30691	MEMORIAL GARDEN BUILDING	32ND DISTRICT AGRICULTURAL ASSOCIATION	88 FAIR DR	COSTA MESA	92626	ORANGE

OSA#	BUILDING NAME	FACILITY	ADDRESS	CITY	ZIP	COUNTY
30690	BUILDING #16	32ND DISTRICT AGRICULTURAL ASSOCIATION	88 FAIR DR	COSTA MESA	92626	ORANGE

OSA#	BUILDING NAME	FACILITY	ADDRESS	CITY	ZIP	COUNTY
30689	BUILDING #10	32ND DISTRICT AGRICULTURAL ASSOCIATION	88 FAIR DR	COSTA MESA	92626	ORANGE

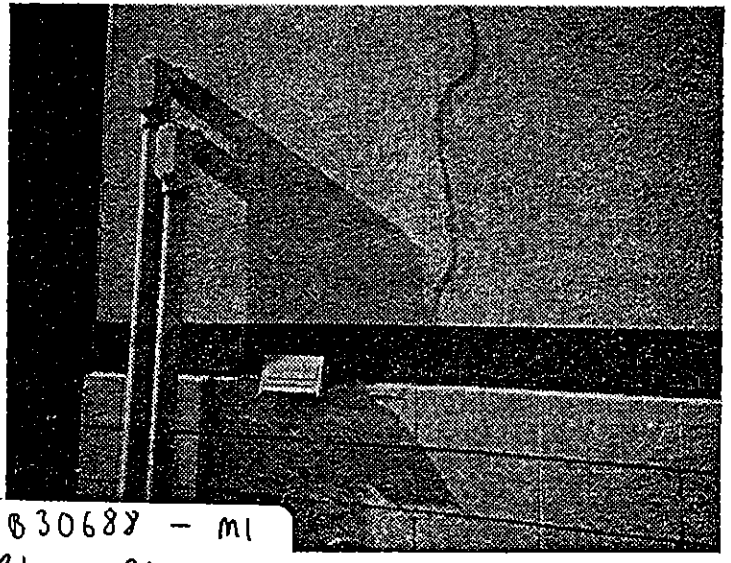
B30688 - M1
R1 - P1

ROOM NAME/ FUNCTIONAL AREA	FLOOR#	MATERIAL LOCATION IN ROOM	QTY	UNITS	ALGORITHM SCORE	PRIORITY	ASSUMED / CONCEALED	** SAMPLE RESULTS ** PERCENTAGE RANGE	ASBESTOS TYPES
M1 FINISH PLASTER BEIGE (PAINTED), STUCCO MATERIAL								NONE DETECTED - 1	CHR
R1 EXTERIOR OF BUILDING	1	EXTERIOR OF BUILDING (ALL WALLS)	390	SY	18	L			
M2 FIREPROOFING (SPRAYED) GREY, FLUFFY MATERIAL								**NONE DETECTED**	
R9 MAIN EXHIBITION AREA	1	ON METAL CEILING PAN, THROUGHOUT ROOM	12,000	SF

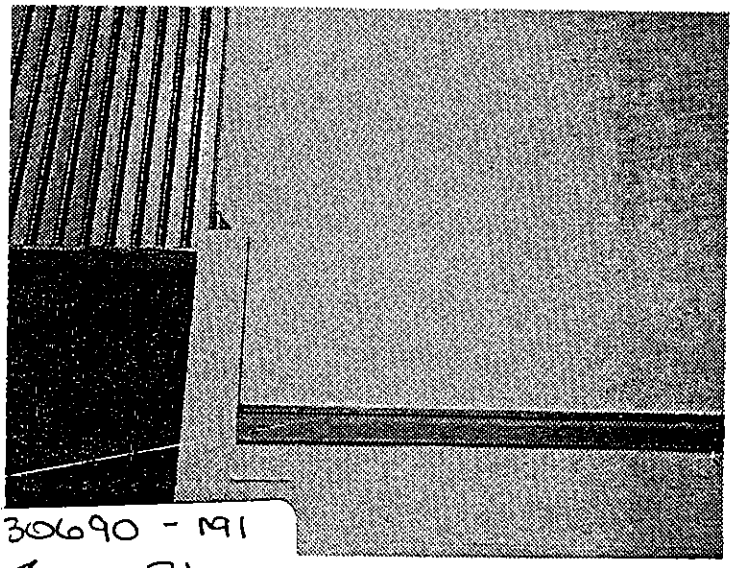
B30690 - M1
R1 - P1

ROOM NAME/ FUNCTIONAL AREA	FLOOR#	MATERIAL LOCATION IN ROOM	QTY	UNITS	ALGORITHM SCORE	PRIORITY	ASSUMED / CONCEALED	** SAMPLE RESULTS ** PERCENTAGE RANGE	ASBESTOS TYPES
M1 FINISH PLASTER BEIGE, HARD STUCCO								NONE DETECTED	
R1 BUILDING EXTERIOR		EXTERIOR OF BUILDING	500	SY					
								NONE DETECTED	
M2 FIREPROOFING (SPRAYED) GREY, FLUFFY, SOFT									
R9 MAIN EXHIBITION AREA	1	SPRAYED ON METAL PAN	20,000	SF					
								NONE DETECTED	
M3 BUILTUP ROOFING BLACK AND WHITE TAR AND GRAVEL									
R10 BUILDING EXTERIOR	1	LOW ROOF ON NORTH SIDE	3,700	SQ
