Plastic Failure Labs

Why Do CPVC Pipes Fail?

By Dr. Duane Priddy, Plastic Failure Labs, Midland, MI

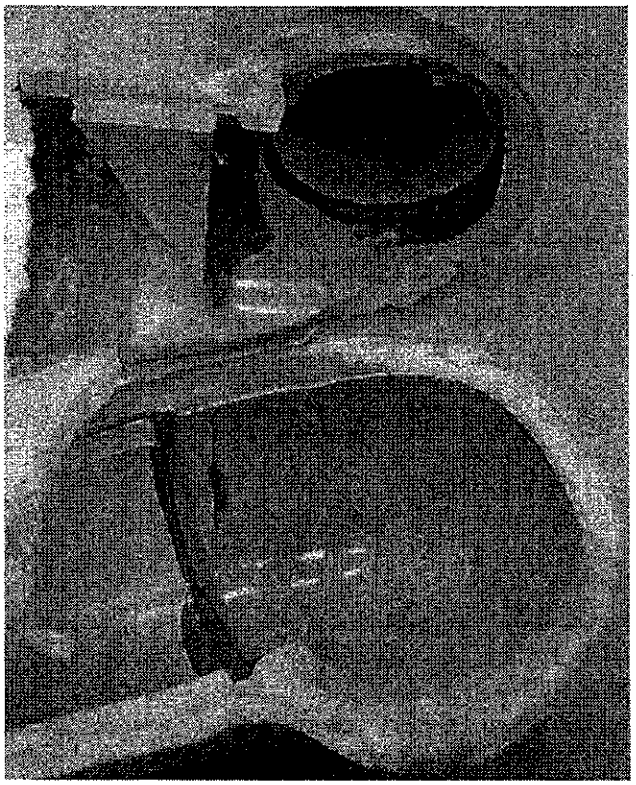
Figure 2. Disintegrated CPVC elbow caused by over-pressurization.

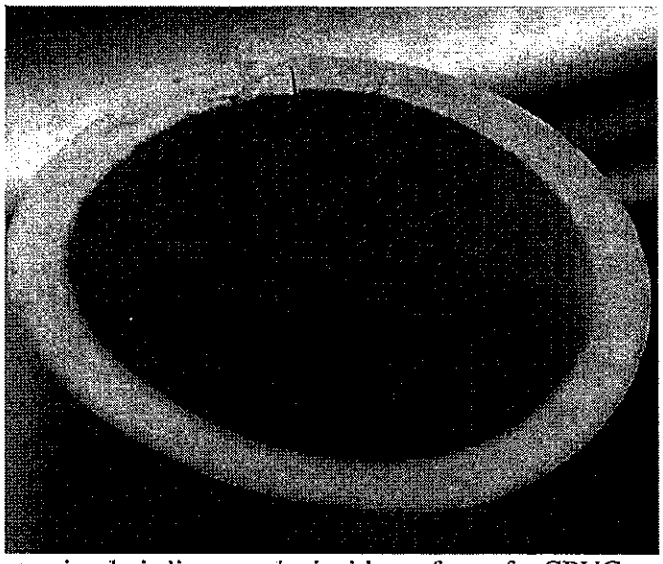
environmental stress cracking (ESC). Cracks originating from the knit lines appear as straight-line cracks running longitudinally and parallel down the pipe (Figure 3) and they display no single initiation point.

Figure 3. Weak extrusion knit-lines on the inside surface of a CPVC sprinkler system pipe resulting in the formation of perfectly parallel straight line cracks upon exposure to contaminants

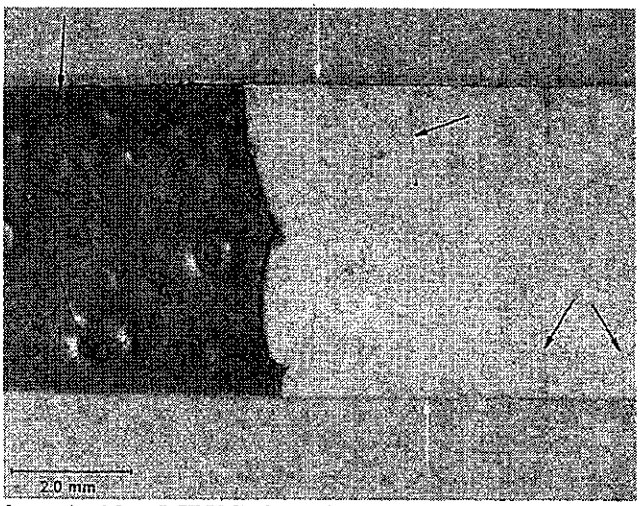
dribble is a spongy material and it serves as a place where contaminants can be absorbed and trapped underneath. Peeling back the glue often reveals hairline cracks underneath (Figure 4).

When excessive glue is used on the outside of pipe it is not as much of a problem as on the inside. This is because, on the outside, the organic solvents quickly evaporate. However, on the inside of the pipe, the organic solvents are trapped allowing more exposure time of the plastic to the solvent. Also, the glue dribble is porous and acts like a sponge providing a place where trace hydrocarbon contaminants can be absorbed from the water inside the pipes. The hydrocarbon laden glue dribble is in constant contact with the inside pipe surface providing the perfect site for crack initiation (Figure 4).

Figure 4. Glue dribble on inside of CPVC pipe with hairline cracks found underneath the dribble.

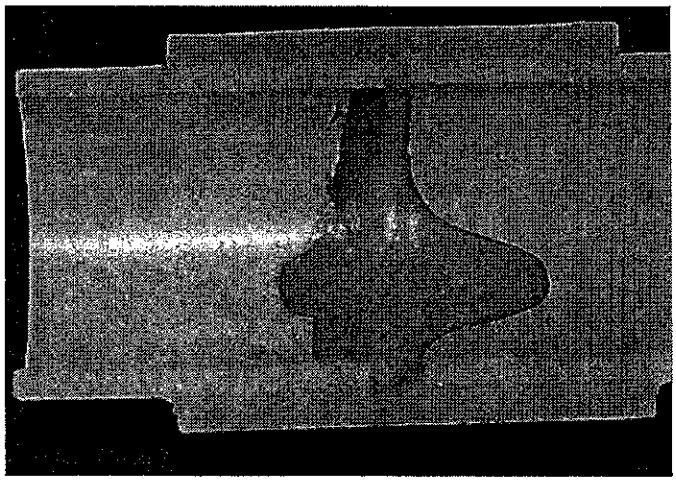
Figure 5. Pooling of excess glue inside of fitting. Notice mud cracking of the inside surface to left of glue.

It is alright to end up with excess glue on the outside of a pipe/fitting but it is not alright to end up with excess glue on the inside of the pipe/fitting. By applying the excess glue to the end of the pipe, but not the fitting, when the pipe is inserted into the fitting, the excess glue is pushed down the outside of the pipe. If excess glue is applied to the inside of the fitting, the excess ends up remaining in the fitting and either pools inside the fitting (Figure 5) or else runs down the pipe (Figure 4). It is generally quite easy to spot whether a fitting was assembled using sufficient glue versus an insufficient amount of glue as shown in Figure 6.

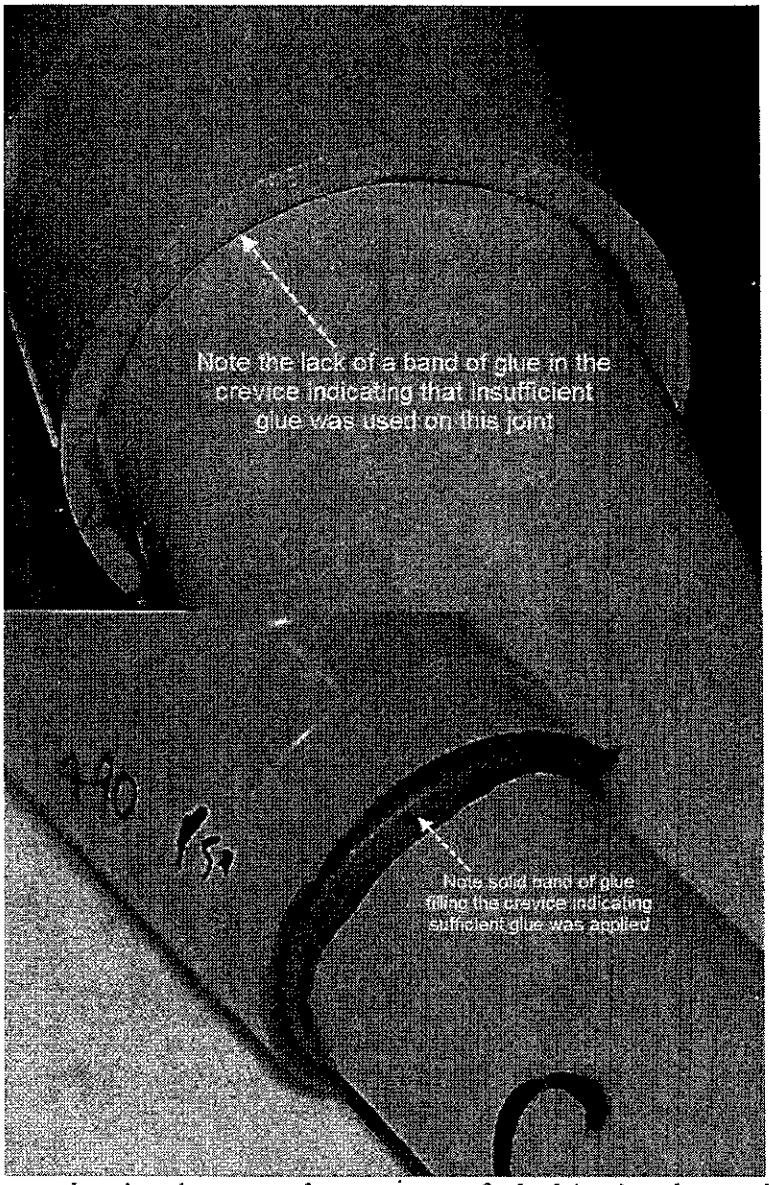
Figure 6. Photos showing the external appearance of a bad (top) and a good (bottom) joints.

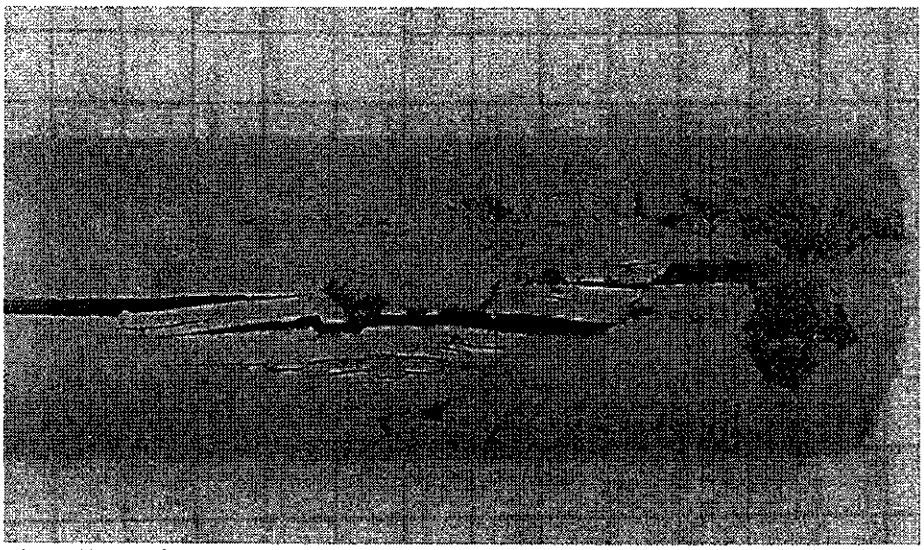
Contamination - Exterior: Care must be taken not to allow CPVC pipes to contact other non-metallic materials. Figures 7 and 8 show examples of failure due to contact of CPVC with other materials that contain plasticizers. Figure 7 was a condominium where a worker sealed all of the openings in walls using a fire caulk. A drop of excess fire caulk fell down onto a CPVC fire sprinkler pipe resulting in failure of the pipe underneath the fire caulk.

Figure 7. Failure of CPVC fire sprinkler pipe due to fire caulk contamination on the exterior surface of the pipe. The fire caulk contained phthalates and phosphate esters which migrated from the caulk and into the CPVC.

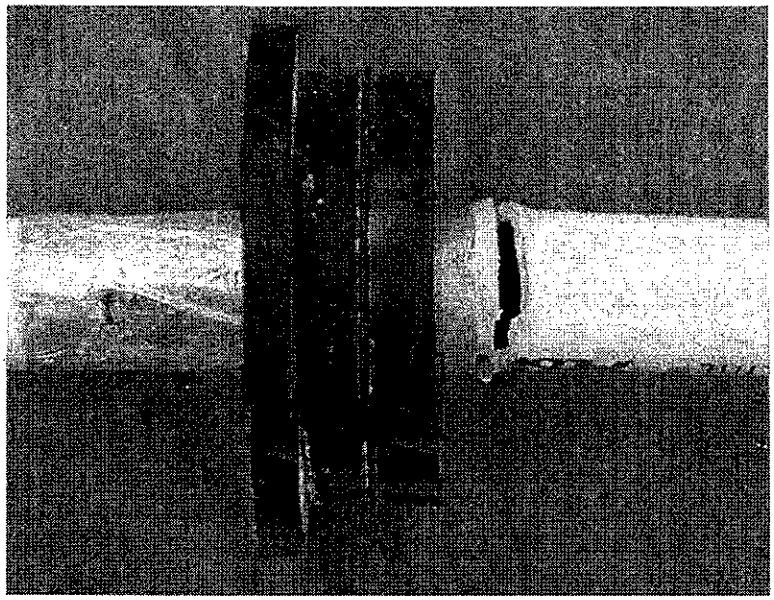
Figure 8 shows an example where a black grommet was used to seal the hole in the concrete floor through which a CPVC pipe ran. It was known that black grommets are not compatible with CPVC so metal foil tape was applied to the pipe to isolate the grommet from contacting the pipe surface. However, the phthalate plasticizers in the grommet migrated from the grommet down the tape and into the pipe resulting in softening of the pipe wall.

Figure 8. Failure of CPVC pipe due to migration of phthalate plasticizer from Proset grommet down metal foil tape used to isolate pipe. Phthalates were absorbed into the pipe resulting in softening and failure of the pipe wall.

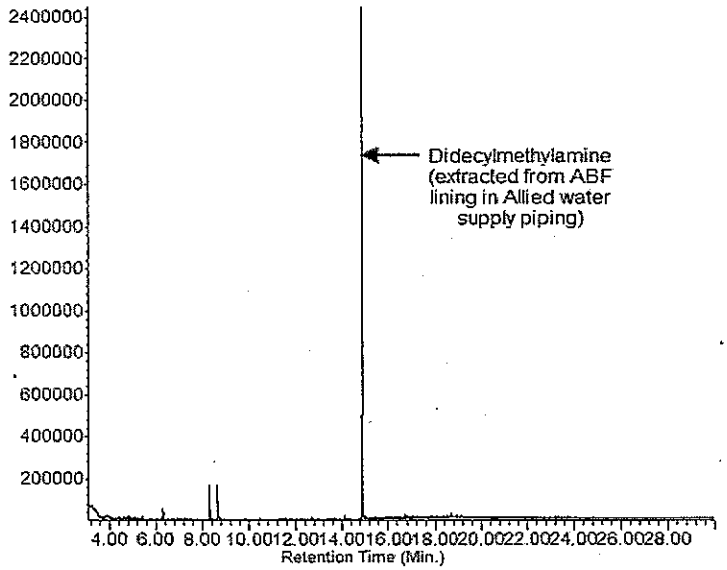
Figure 9 shows an example of a GC-MS analysis of a CPVC sprinkler pipe sample removed from a condominium. The pipe sample was found to contain didecylmethylamine. The amine was also identified in the hexane wash of the Allied ABF lined metal pipe that supplied the water to the CPVC sprinkler piping system.

Figure 9. GC-MS analysis of contaminants identified inside of a failed CPVC pipe. The contaminant found in highest concentration was didecylmethylamine which was extracted from the ABF lining in Allied pipe and deposited into the CPVC sprinkler pipe.

Metal pipes that are connected to CPVC pipes should be thoroughly cleaned before they are connected to the CPVC piping system. Unfortunately most of the contaminants are hydrophobic (water hating) and are repelled by water. Thus flushing plain water through metal pipes is not very effective for contaminant removal. Removal of hydrocarbons generally requires that a surfactant (soap) be added to the water being flushed through the metal pipes. Surfactants compatibilize the hydrophobic oils with the water allowing the oil to become emulsified so that it can be flushed from the metal pipe surfaces. After the soapy water flush, the metal pipes should be thoroughly rinsed with pure water to remove all of the soap residues from the metal pipes as some concerns have been expressed about
