Library and Courts II Building (038)

900 "N" Street, Sacramento, CA 95814

Facility Condition Assessment

June 2015

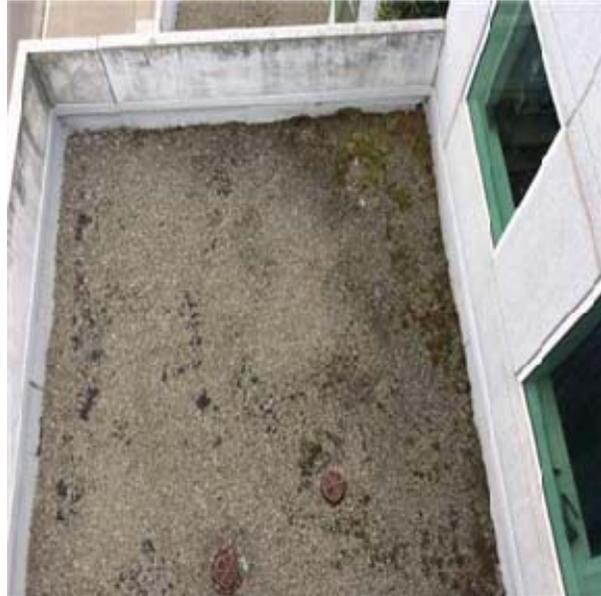
B3011 Built-up Roof

- There is moisture intrusion in the basement, and a new waterproof coating should be applied to the exterior surface of the basement wall.
- Built-up roofing replacement, including new flashings and ballast, is recommended.
- Interior finish replacements, including painting and new flooring, are recommended.

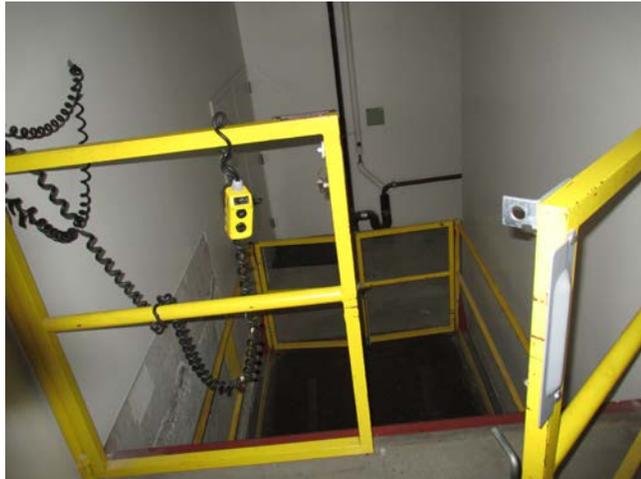
Dock Lift:

The building has a 6,000 lbs dock lift for moving freight. Access should be limited to authorized personnel that have been trained on the lift operation.

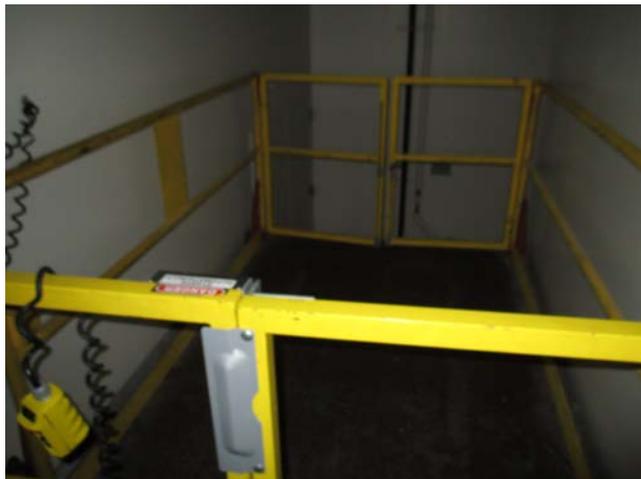
Dock Lift:

Dock lift with lift at upper landing.
