East End Complex Block 171 (051)

1501 Capitol Avenue, Sacramento, CA 95814

Facility Condition Assessment

June 2015

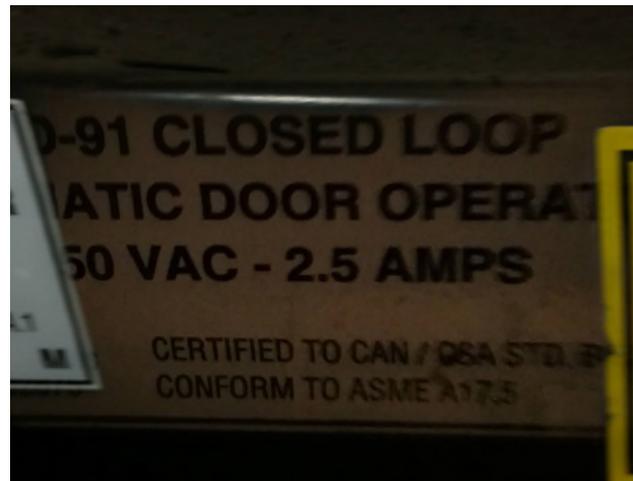
Door Operator:

The door operators are TKE's HD-91 which are known to be reliable and closed loop.

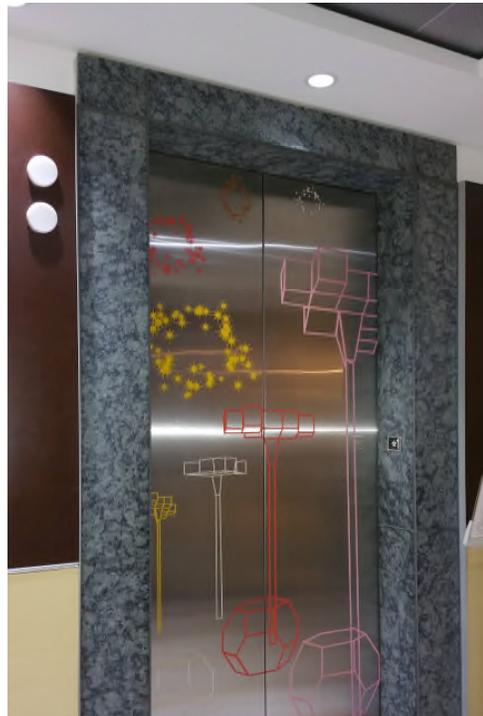
Hall Lanterns:

Hall lanterns inform persons waiting in the hall of which direction the elevator is about to travel in next. ADA requires that the hall lanterns illuminate and sound for the waiting passengers. The existing passenger elevators have hall lanterns for each car. The lanterns have the proper gong for up and down.

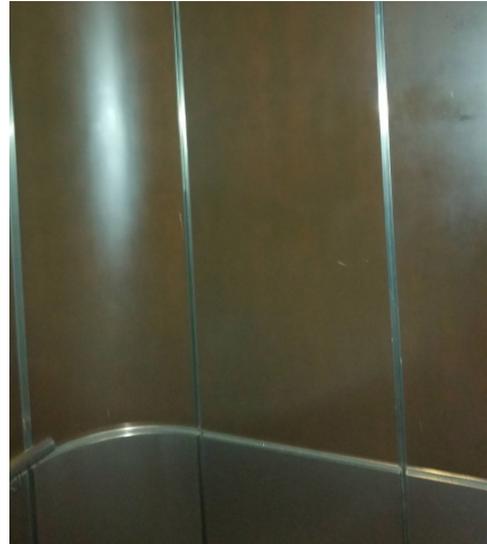
Wall Finish:

The existing cab interiors are in good condition and have the code required handrails. The service cars in each building have stainless steel cabs which are desired for service cars.
