## Junipero Serra Office Building (512)

320 West Fourth Street, Los Angeles, CA 90013

### Facility Condition Assessment

September 2015

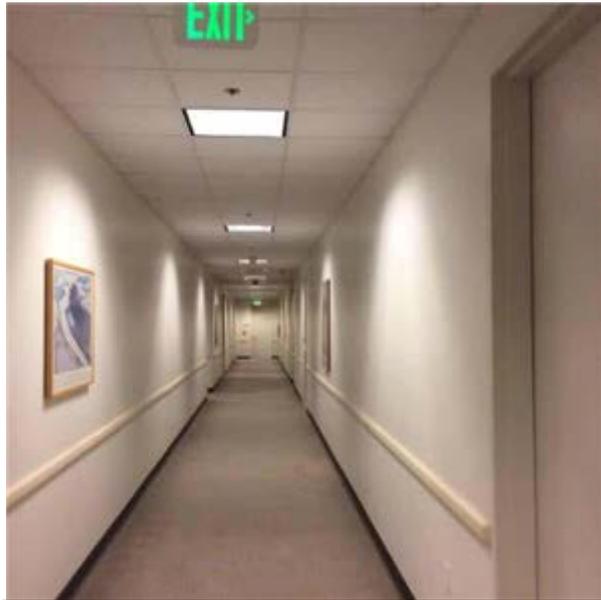
C3012 Wall Finishes, Interior Painting

- Interior gypsum wallboard repainting throughout
- Central heating boiler with heat exchanger replacement
- Asphalt driveway and parking lot replacement
