**PHASE I ENVIRONMENTAL SITE
ASSESSMENT AND PHASE II LIMITED
GROUNDWATER ASSESSMENT REPORT**

**Proposed City of Escondido Fire Station
2315-2319 Felicita Road
Escondido, California 92029
SECOR Job No. 80005-013-01**

for
**City of Escondido Public Works Department
201 N. Broadway
Escondido, California 92025**

June 19, 1997

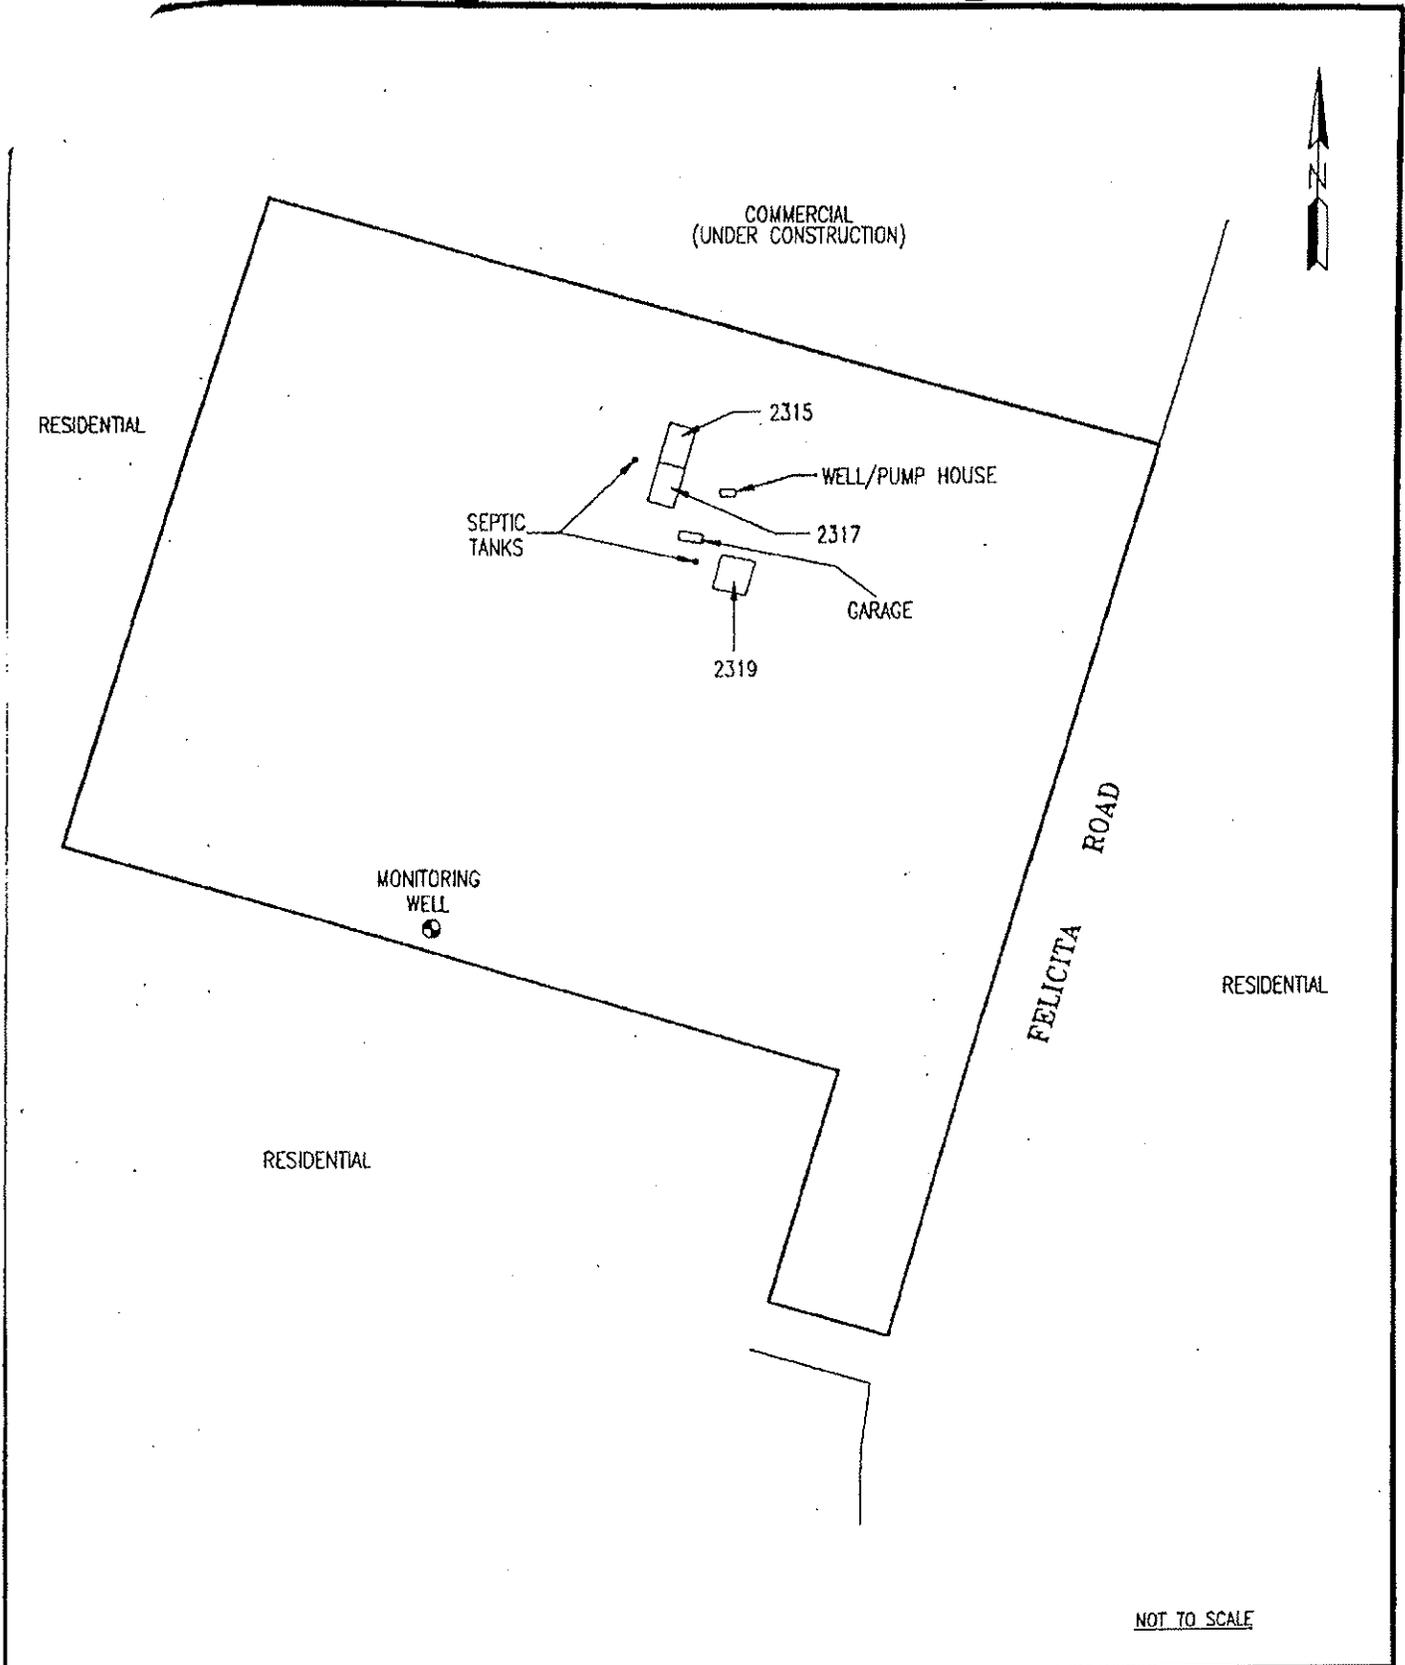
The subject property consists of approximately 7.32 acres of land comprised of Assessor Parcel Numbers 238-101-12, 17, & 18, occupied by three residences and various out-buildings. A Site Plan/Adjacent Property Map is presented in Figure 2.

As previously discussed, there are two septic tanks, one water well, and a monitoring well (Photograph 6) located on the subject property. The location of these structures is presented on Figure 2. No other evidence of water wells, septic tanks or floor drains was observed on the subject property.

The subject property bordered on the north, south, and west by residential properties. A commercial building is under construction to the east of the subject property. An adjacent property map is presented as Figure 2.

On June 4, 1997, *SECOR* conducted limited groundwater sampling on the subject property. The purpose of the limited sampling activities was to assess the potential presence/absence of petroleum and halogenated hydrocarbons from two specific locations on the subject property (Figure 2). A summary of the sampling activities and the analytical results is presented below.
