JANA LABORATORIES INC.

CHLORINE RESISTANCE TESTING OF CROSS-LINKED POLYETHYLENE PIPING MATERIALS

*P. Vibien, J. Couch and K. Oliphant, Jana Laboratories Inc., Aurora, ON
W. Zhou, B. Zhang and A. Chudnowsky, University of Illinois at Chicago, Chicago, IL,
USA, 60607*

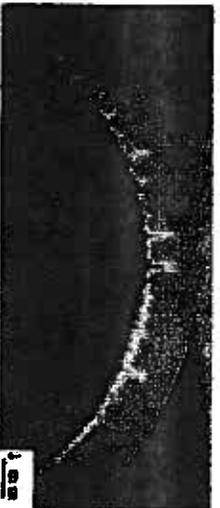
Figure 3: Radial Crack Growth in a PEX Pipe Material.

Figure 3 shows another view of the propagation of the micro-cracks through the pipe wall. Several large cracks are observed, distributed randomly around the circumference of the pipe. In Figure 4, the axial cross section of the same pipe material is shown. The sample was cut along one of the large longitudinal cracks. The advancing crack front is clearly seen in this view. Regions where multiple small cracks have coalesced to form a larger crack are also visible.

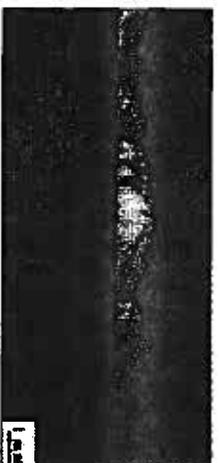
Figure 4: Axial Cross-section of PEX Pipe Material.

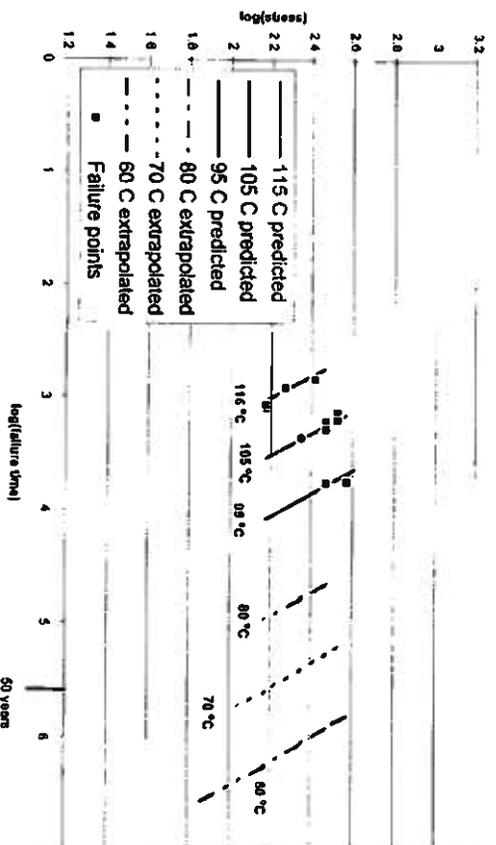
Figure 5: Failure Times for a PEX Pipe Material Exposed to Chlorinated Potable Water.

Figure 5 shows a plot of the experimental failure points and the predicted failure times from the Rate Process Model. From the data it is seen that the Rate Process Model provides a good fit to the experimental data. The R² for the regression was 0.98. Also shown in Figure 5 are the extrapolated test lifetimes at lower temperatures.
