## ***Background Of The Field Act***

This report evaluates the effectiveness of the Field Act, how it is administered, and the advisability for community college construction oversight to come under the jurisdiction of local building departments under AB 127.

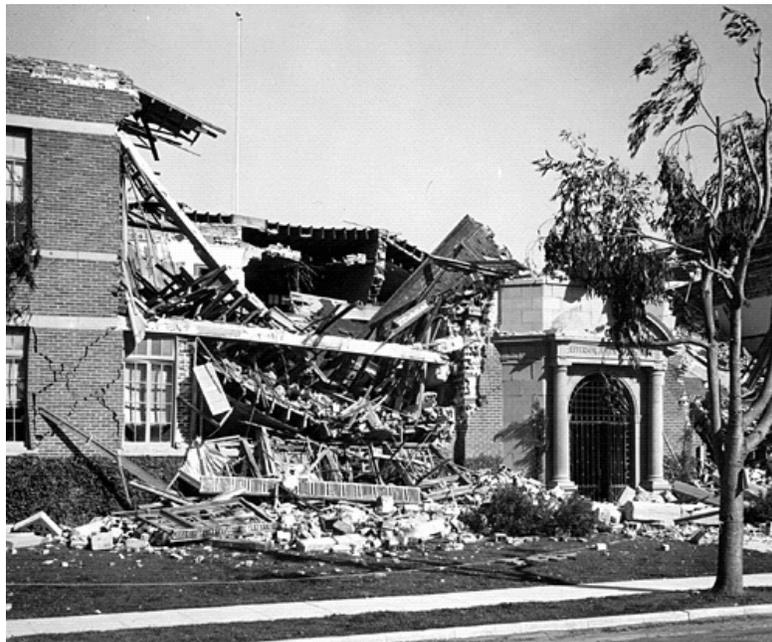
**Figure 1** Jefferson Junior High School damage after the 6.4 magnitude 1933 Long Beach earthquake.

The Field Act has its genesis in the 6.3 magnitude Long Beach earthquake of March 10, 1933. In that earthquake, more than 230 school buildings were either destroyed, suffered major damage, or were judged unsafe to occupy. The buildings had been poorly designed and were not constructed to resist earthquake forces. Fortunately, it was 5:55 a.m. on a Friday evening, and schools were closed. It was lost on no one that a disaster had been averted by fewer than four hours.

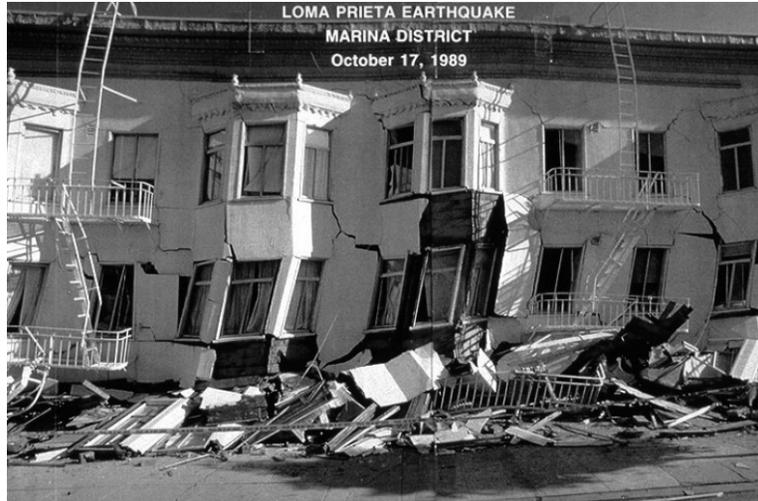
**Figure 2** Marina District Apartment building damage during the 6.9 magnitude 1989 Loma Prieta earthquake. Two nearby public schools were not damaged and were used as emergency shelters.

Nearby, however, commercial buildings suffered collapse and heavy damage. For example after the 1989 Loma Prieta earthquake the Marina Middle and John Swett schools, both located in San Francisco's heavily damaged Marina District, were used as emergency shelters and disaster assistance centers.

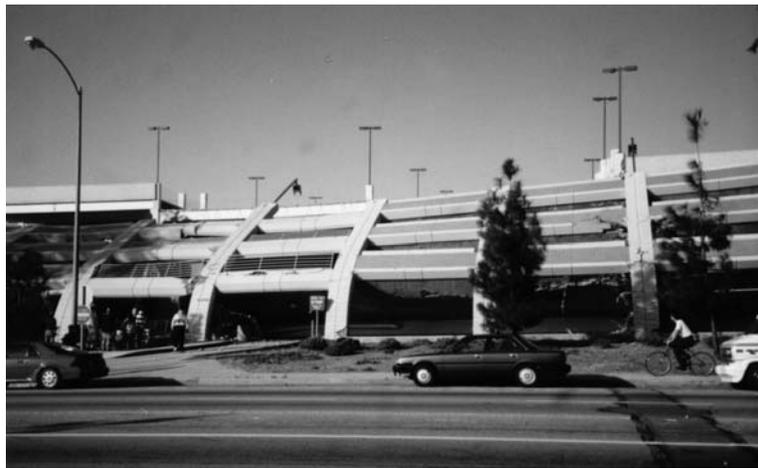
**Figure 3** California State University Northridge parking structure built in the early 1990s collapsed after the 6.7 magnitude 1994 Northridge earthquake.

The Northridge earthquake (1994) caused the California State University System's (CSUS) Northridge campus to suffer an estimated \$750 million in damage, and needed rebuilding. Two community colleges in the San Fernando Valley, Pierce and Mission Colleges, of similar age and type of construction to the Northridge campus, were subject to very similar shaking in that earthquake, but had only \$5 million and no damage respectively. In addition **there was no partial or complete collapse of any public school in this event.**

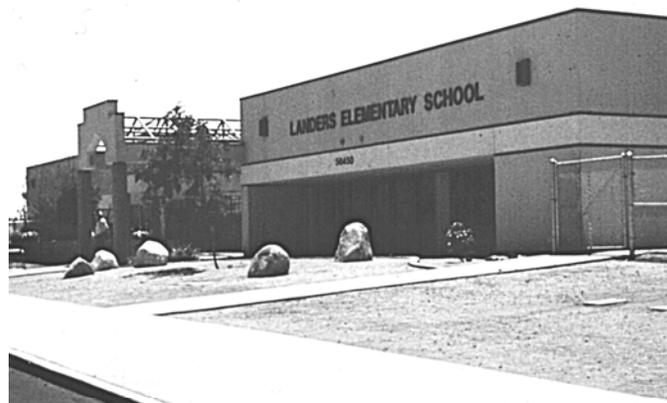
**Figure 4** Landers Elementary School with minor non-structural damage and immediate reuse after the 7.3 magnitude 1992 Landers earthquake. There has been no partial or full collapse of any public school building constructed to the requirements of the Field Act since 1933.

Similarly, the Landers Elementary School experienced only minor damage during the Landers earthquake (1992) and was capable for reuse almost immediately while several homes nearby were greatly damaged. It should be noted that Landers Elementary School is located less than one-half mile from the fault that generated the major (7.3 magnitude) earthquake that resulted in 12 feet of horizontal surface rupture that continued for about 45 miles.
