SEISMIC SAFETY INVENTORY OF CALIFORNIA PUBLIC SCHOOLS

(A Report to the Governor of California and the
California State Legislature)

Prepared by the Department of General Services
(November 15, 2002)

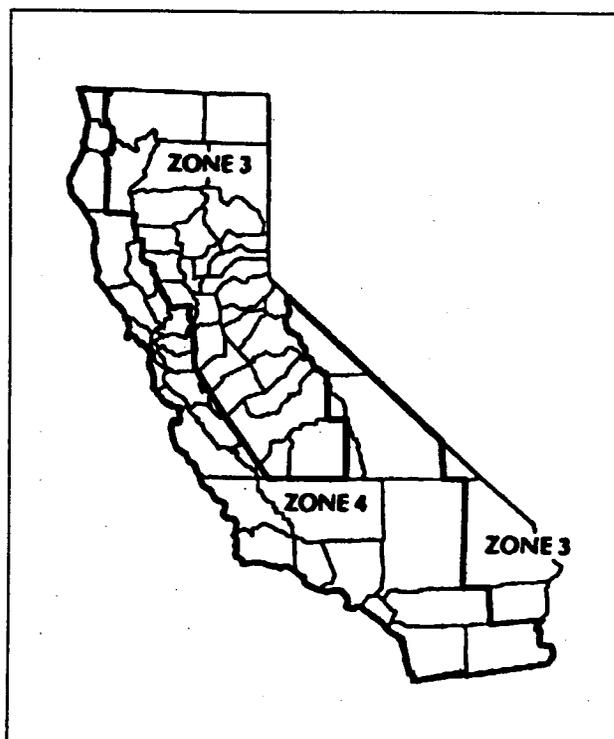
Figure 2. Map of California showing Title 24 Seismic zones.

A summary of California public schools in Seismic Zone 3 and Zone 4 (Figure 2), as specified by the 1997 UBC, is provided in Table 4. Zone 4 specifies the region of highest expected ground shaking. Zone 3 ground motions are expected to be less severe than Zone 4, and the equivalent static force level for design is $\frac{3}{4}$ of that for Zone 4. Within Zone 4, which contains 79 percent of the school buildings in the seismic-safety inventory, there are 1,596 public school buildings in seismic vulnerability Category 1 and 6,061 public school buildings in seismic vulnerability Category 2. In Zone 3, which contains 21 percent of the school buildings in the seismic-safety inventory, there are 526 public school buildings in seismic vulnerability Category 1 and 1,476 public school buildings in seismic vulnerability Category 2.
