Employment Development Department Annex (013)

751"N" Street, Sacramento, CA 95814

Facility Condition Assessment

June 2015

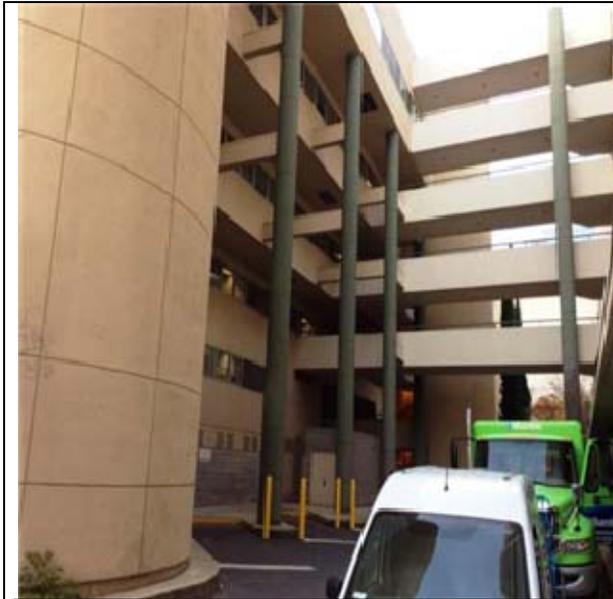
:- Front elevation

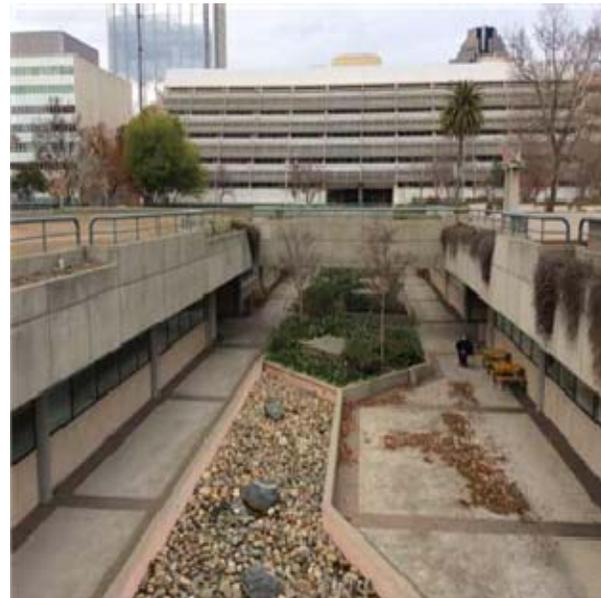
B1020 Seal concrete at outdoor park

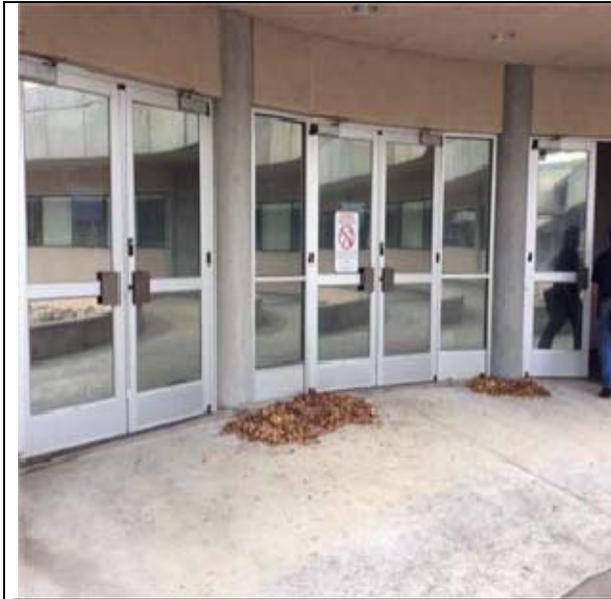
B2031 Alumium 1/4" Tempered Glass

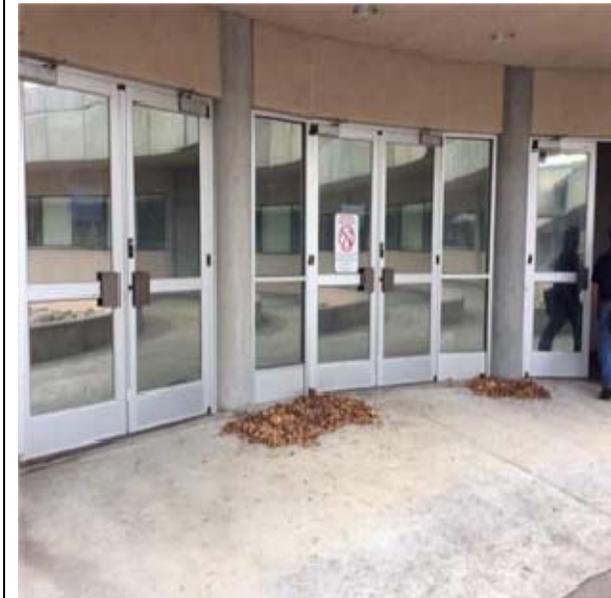
B2031 Glazed Double Doors

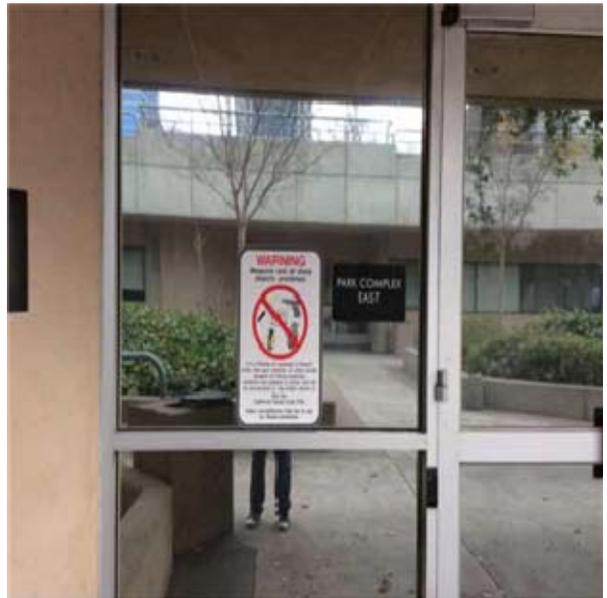
B2031 Glazed Double Doors

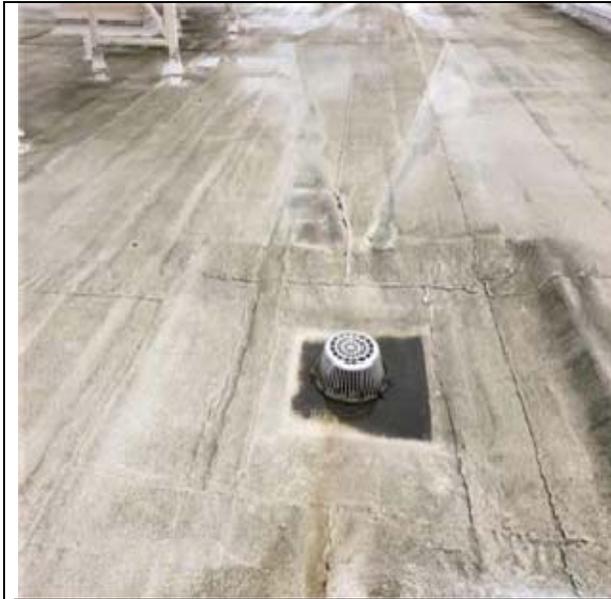
- The roof membrane is old and there are areas with ponding water. Roof replacement is recommended.
- Interior finish replacements are recommended, including painting, new flooring, and acoustic ceiling tiles.
- Replacements for heating, ventilation, and air conditioning (HVAC), including air distribution ducting and HVAC controls, are required.
- Installation of a wet-pipe fire sprinkler system for life safety is recommended.

B301 | Built-up Roof :- Built-up roofing

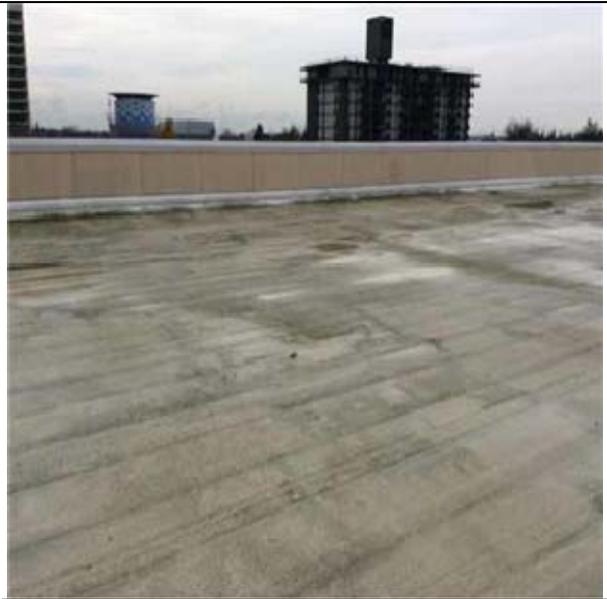
B301 | Built-up Roof:- Parapet wall

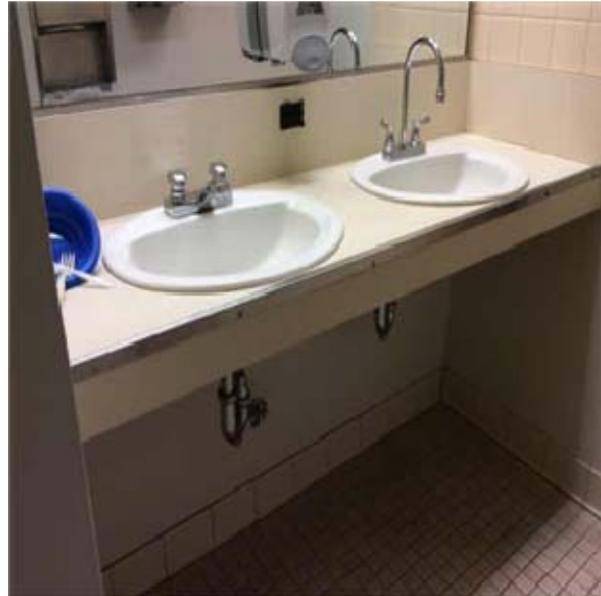
C3005 ADA Restroom Renovations

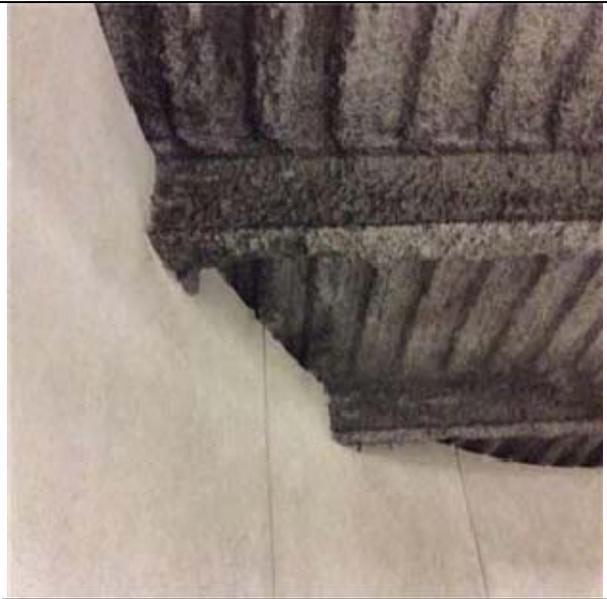
C3012 Mechanical Room

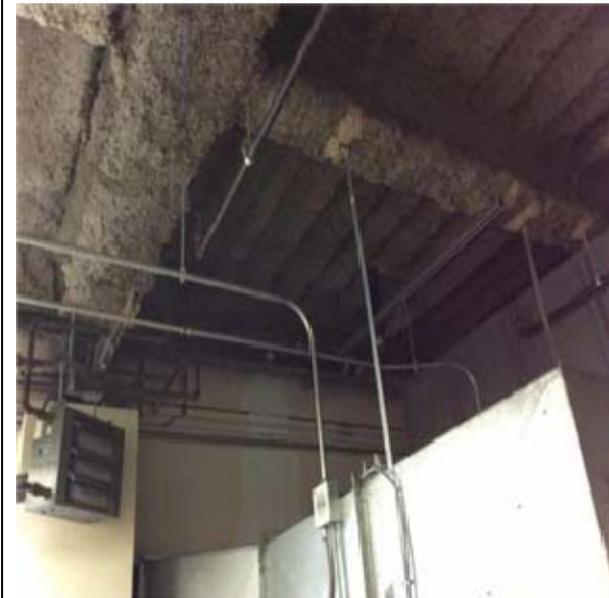
C3012 Mechanical Room

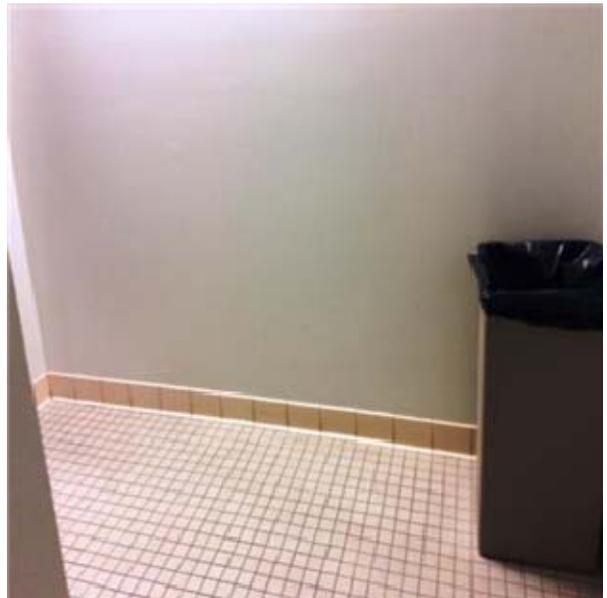
C3012 Drywall, Painted Walls

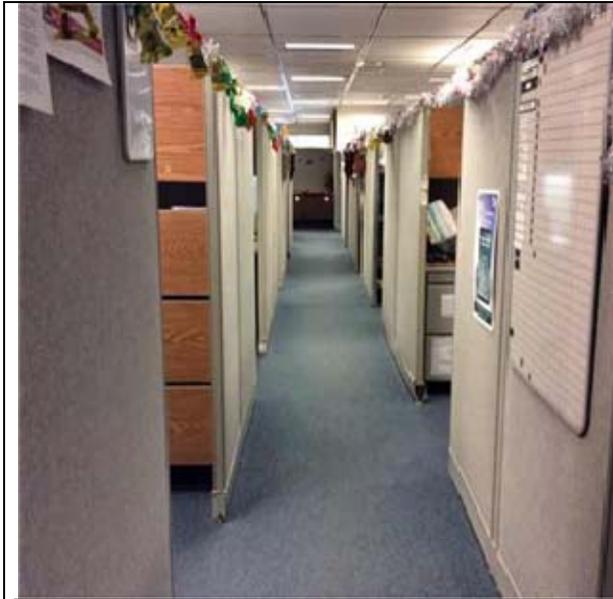
C3025 Carpet flooring

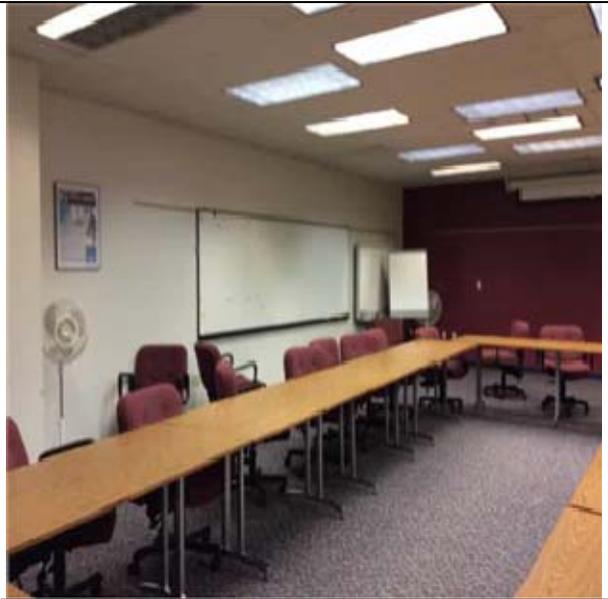
C3032 Suspended Ceilings

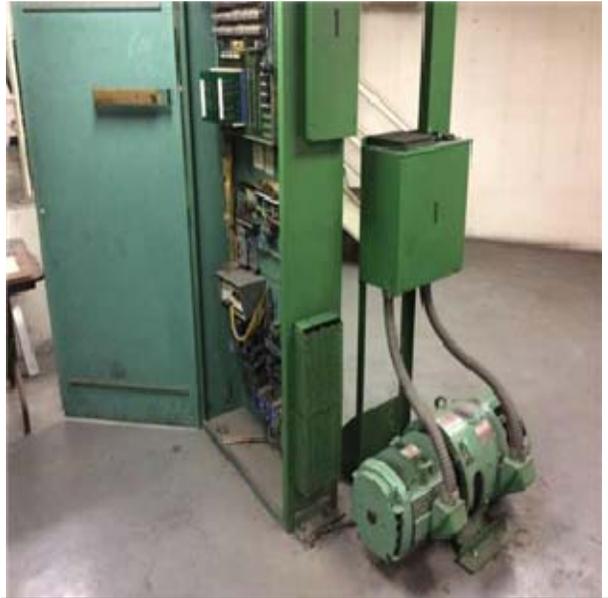
D1011 Overhead Traction Elevators, 2500 LB:- Elevator controls

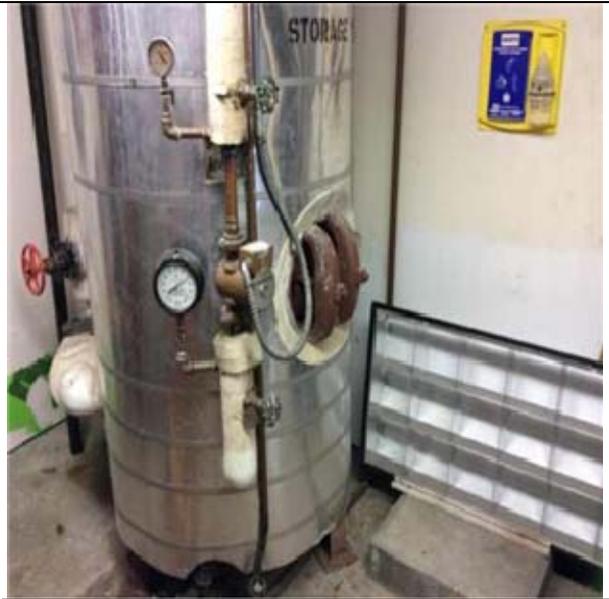
D2023 Domestic Water Storage Tank 425 Gallons:-
Storage tank

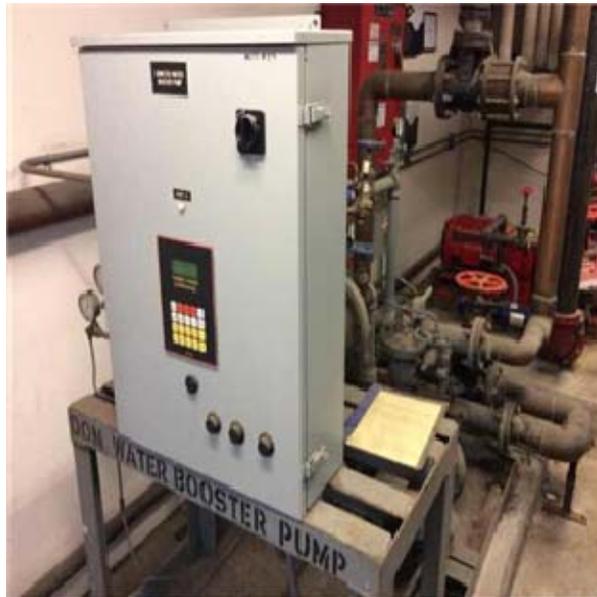
D2023 Domestic Water Booster Pump Station :-
Domestic water booster pumps

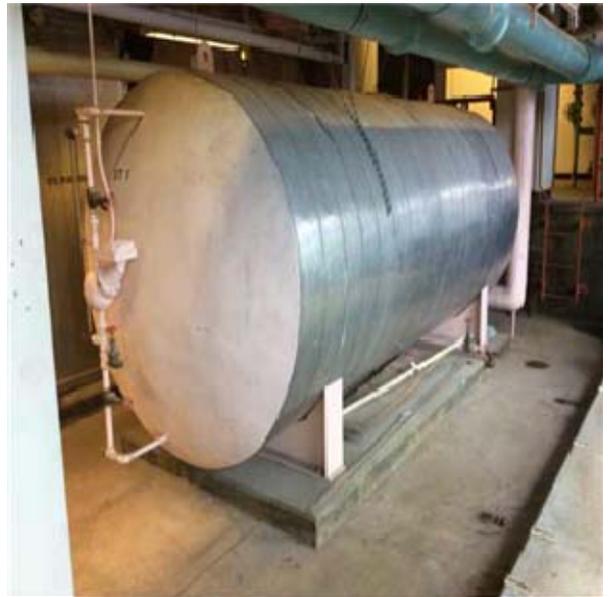
D2023 Solar and Chiller Equipment (Abandoned):-
Abandoned solar and chiller plant equipment

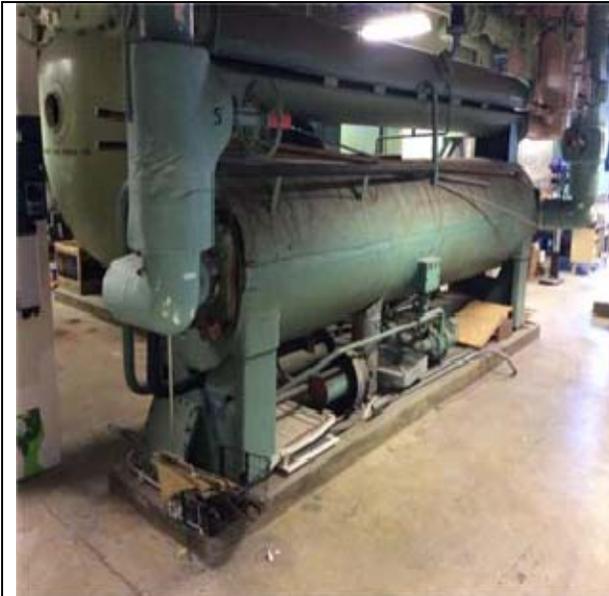
D2023 Solar and Chiller Equipment (Abandoned) :-
Abandoned absorption chiller

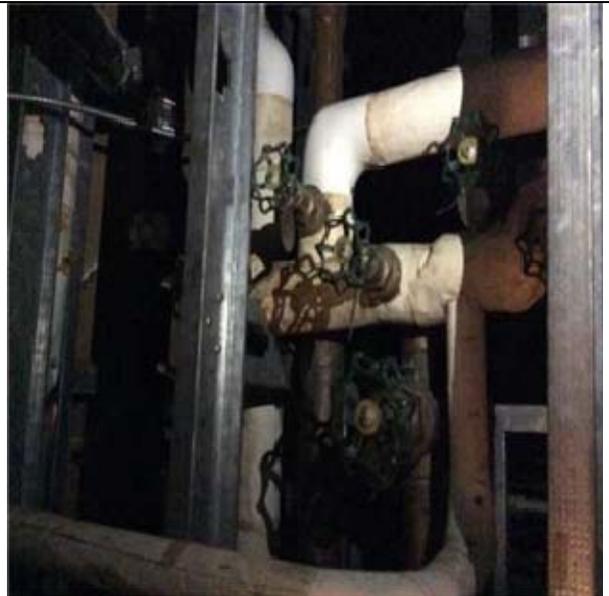
D2031 Restroom Floor Drains:- Piping above restroom
ceiling

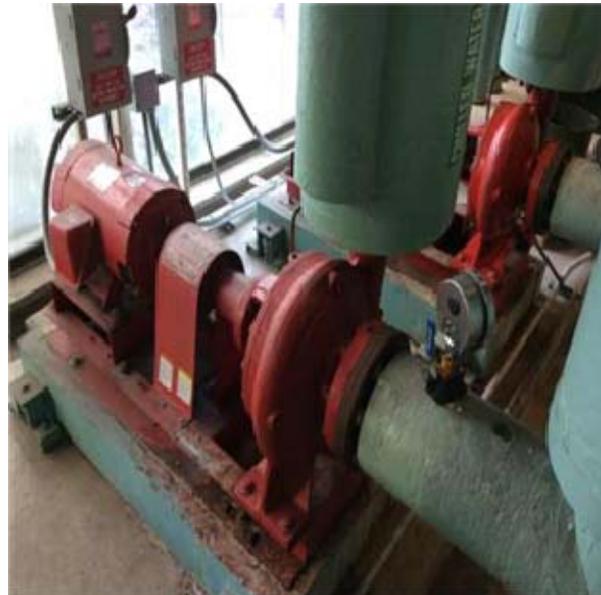
D3022 HVAC Chilled Water Pumps 15 HP :- Chilled
water pumps

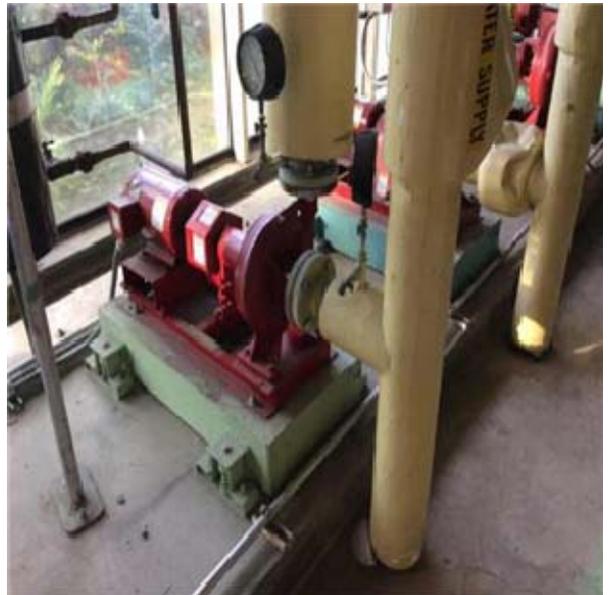
D3022 HVAC Heating Water Pumps 3-5 HP:- Heating
water pumps

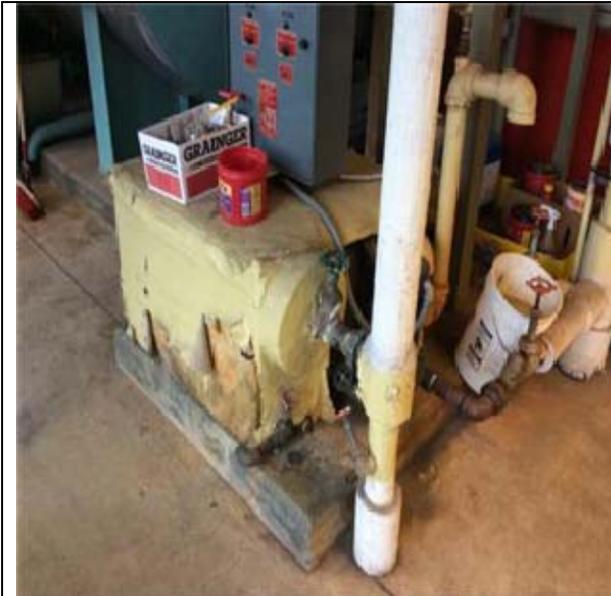
D3023 Condensate Return System :- Condensate return system

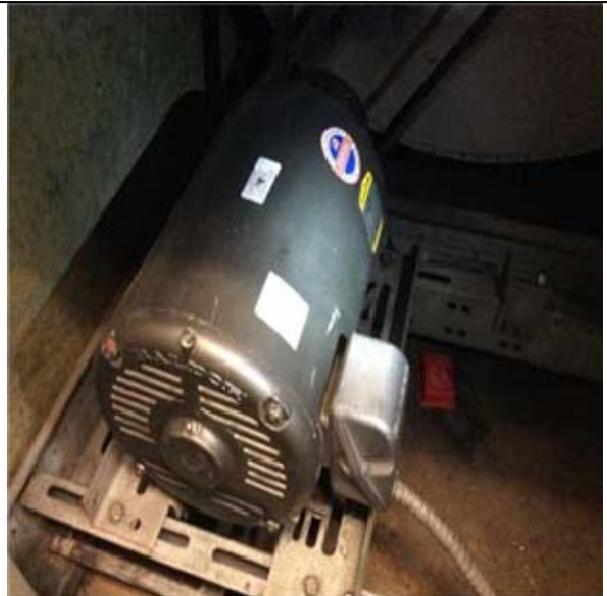
D3041 Air Handler 10,000 to 13,000 CFM:- AHU fan motor

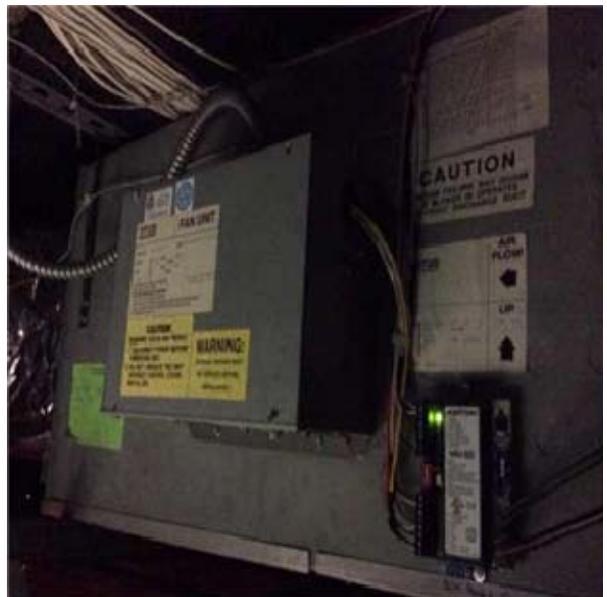
D3041 VAV Boxes:- VAV box

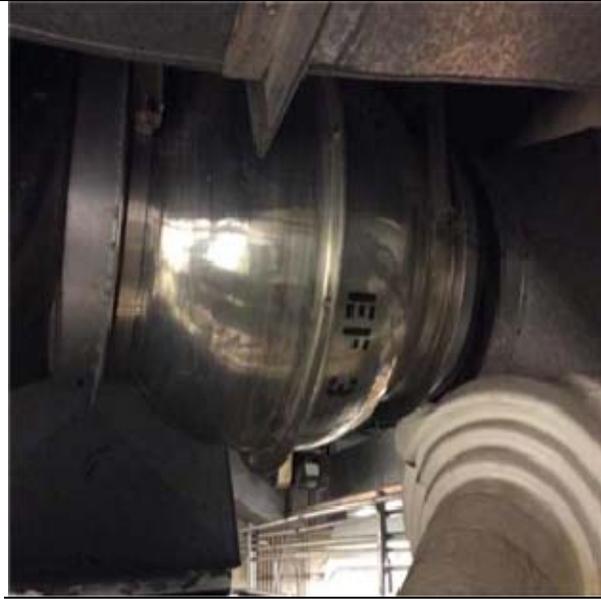
D3042 Exhaust Fan 4500 CFM :- Exhaust fan

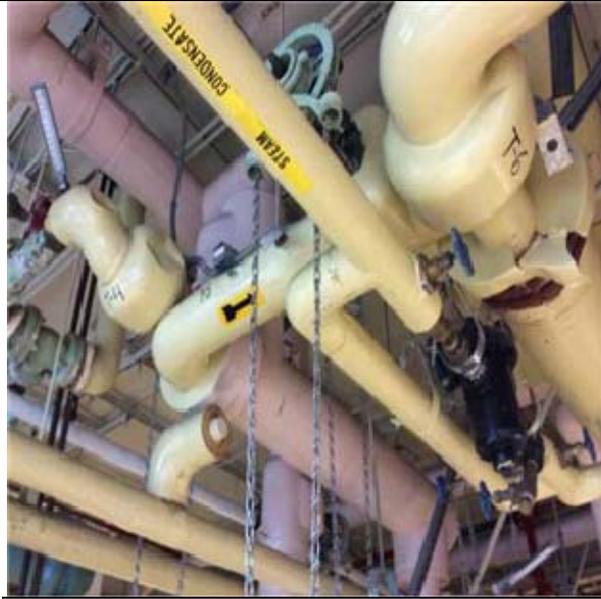
D3043 HVAC Heating Water Heat Exchanger:- Heat exchangers overhead

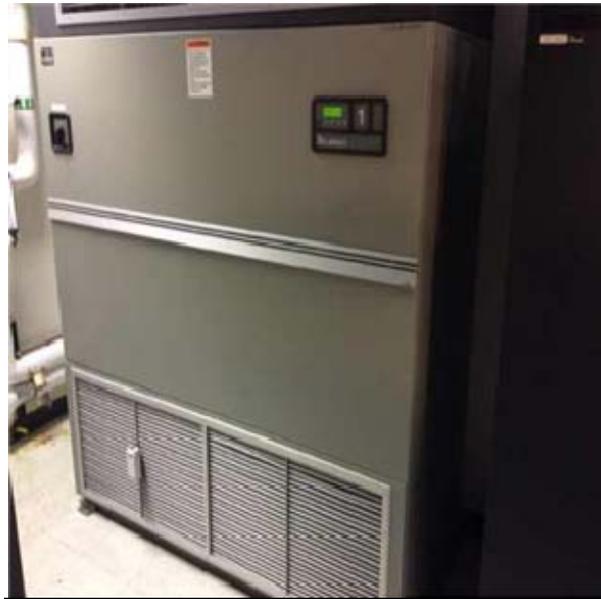
D3052 Computer Room A/C Unit, Chilled Water, 10-Ton :- Subterranean server room unit

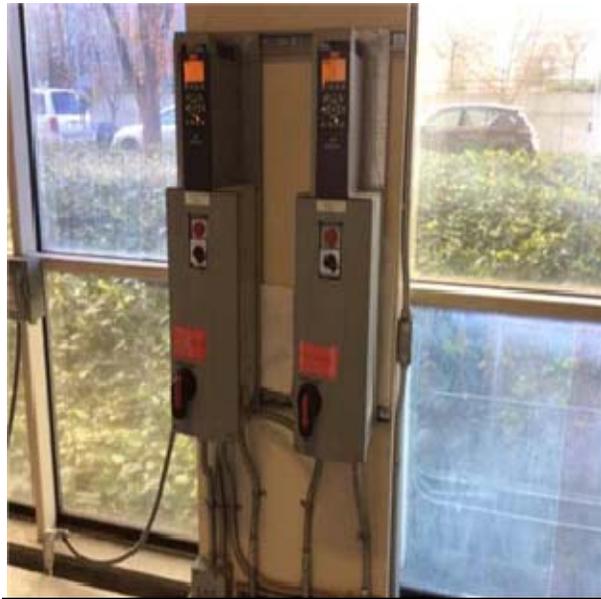
D3063 Variable Frequency Drives:- Older VFD's

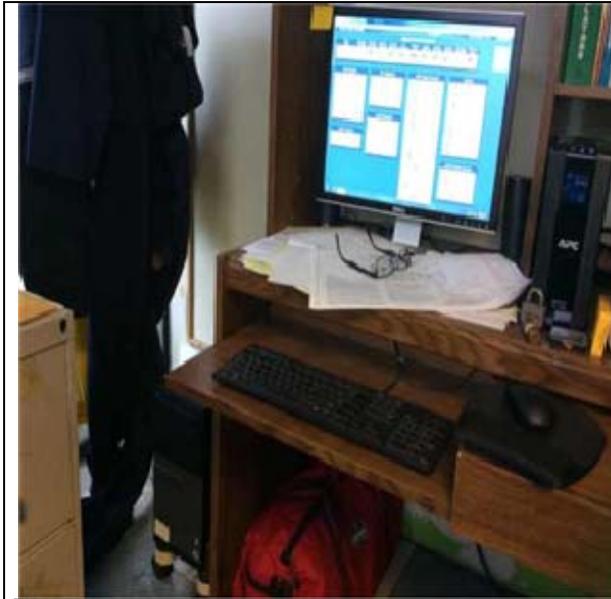
D3068 Direct Digital Controls (DDC) :- Desktop computer with HVAC controls software

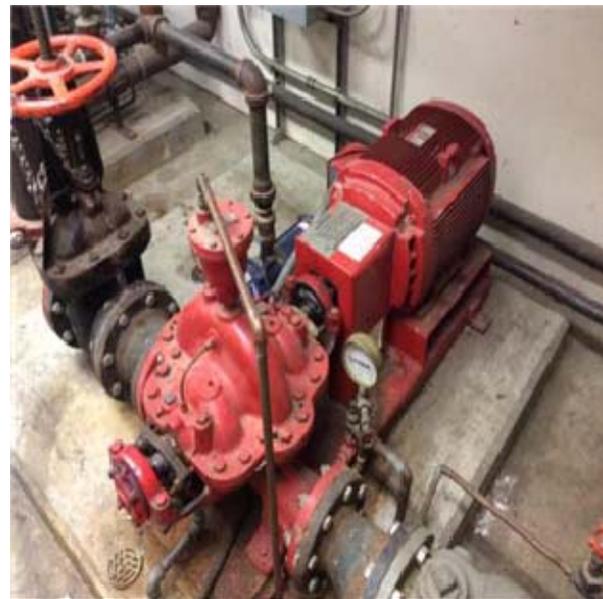
D4012 Electric Fire Pump, 500 GPM :- Fire pump

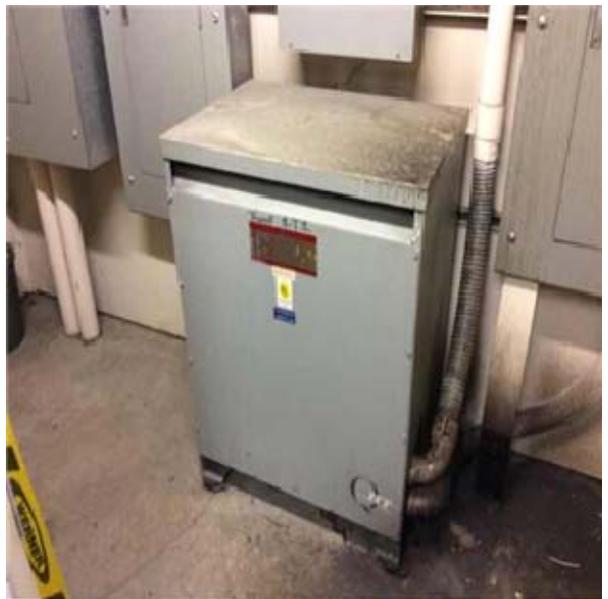
D5012 Secondary Dry Transformer 15 kVA:- Step-down transformers

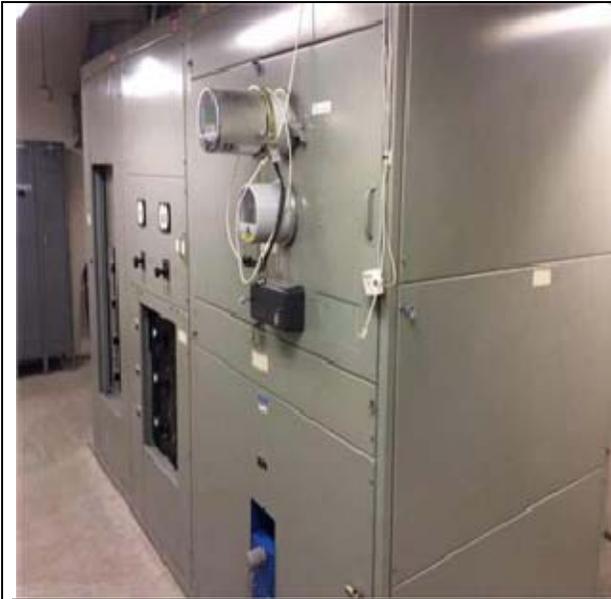
D5010 Switchgear, Mainframe, 4000 Amps :- Main electrical switchgear

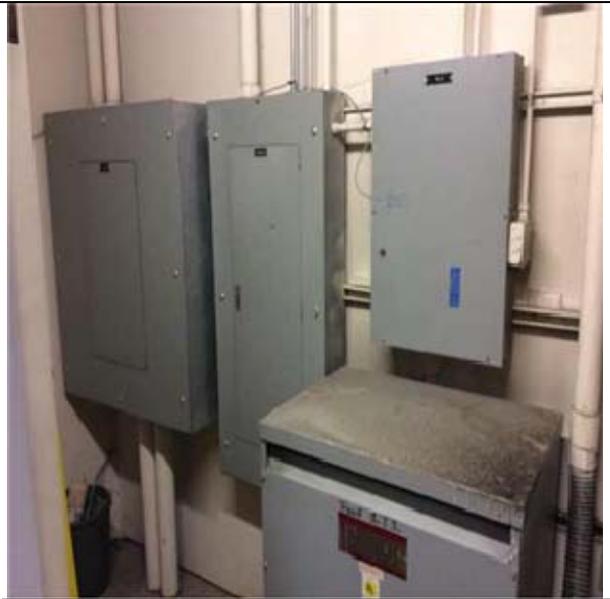
D5012 Breaker Panel 225 Amps, 30 Circuits:- Electrical panels

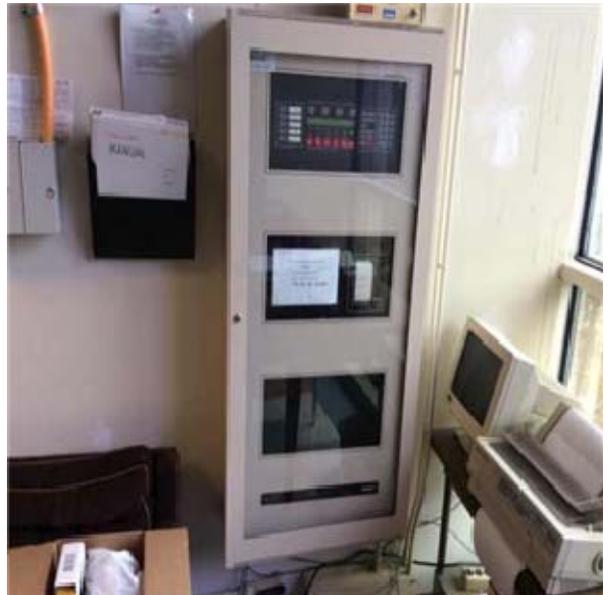
D5037 Fire Alarm Panel:- Fire alarm panel

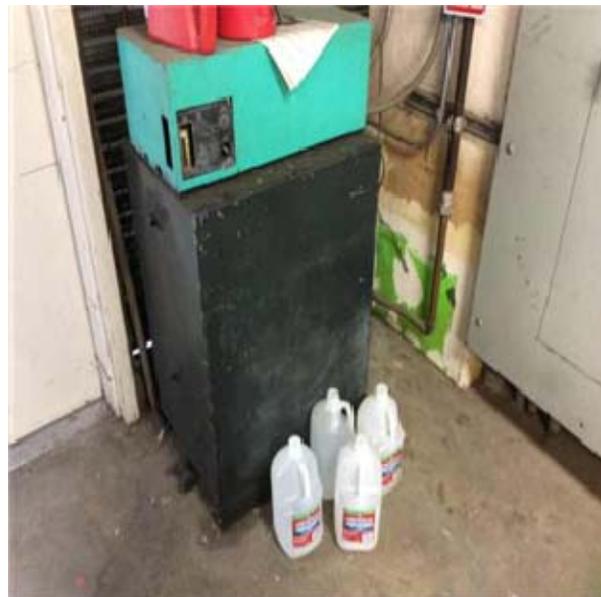
D5092 Diesel Generator 125 kW :- Diesel day tank lacking secondary containment

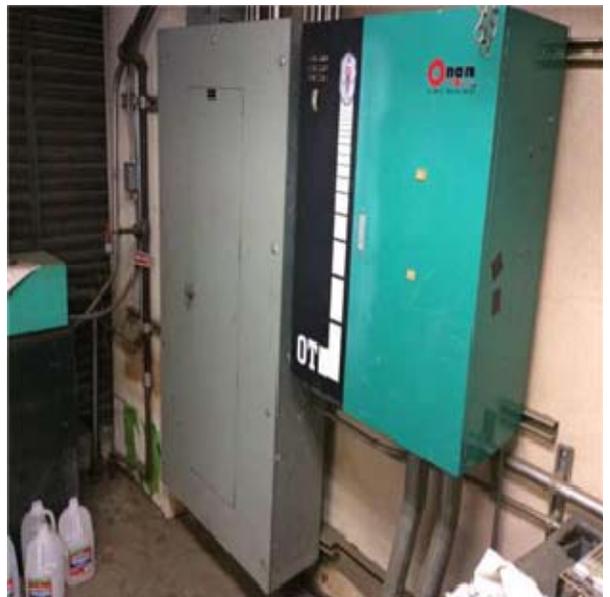
D5092 Emergency Transfer Switch:- Transfer switch and adjacent panel

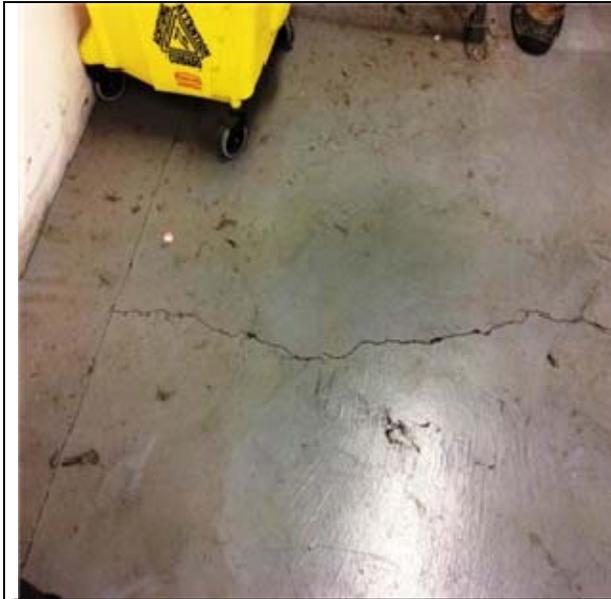
G2022 Concrete Walks :- Mechanical Room Floor

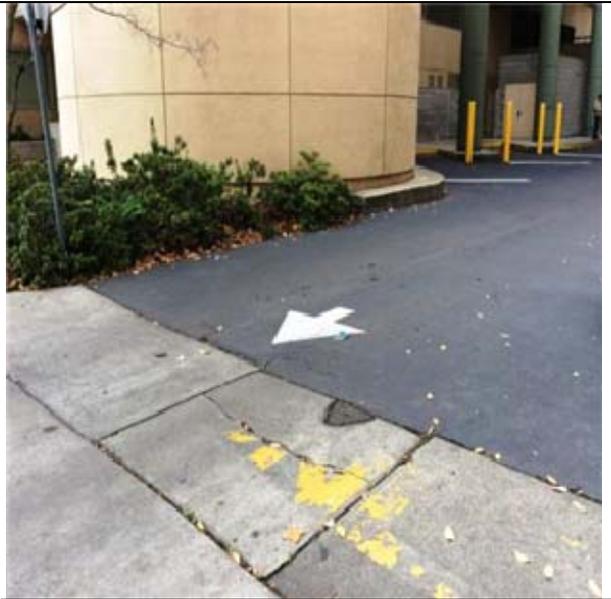
G2022 Concrete Walks:- Northeast side

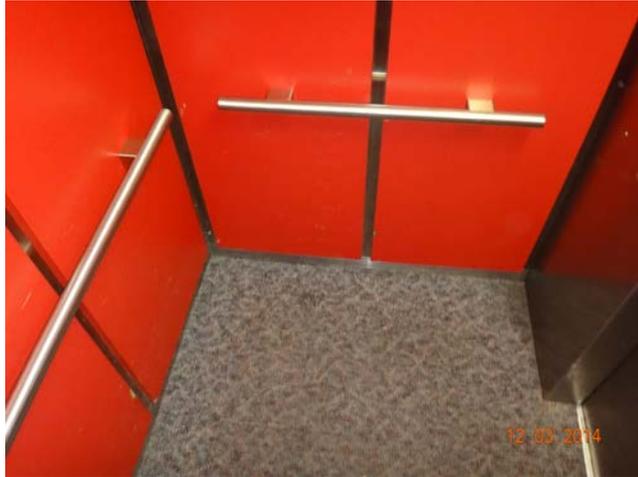
Wall Finish:

The existing cab interiors are likely original and look very dated. The side and back wall have code required handrails that are in compliance with Title 24 California code.

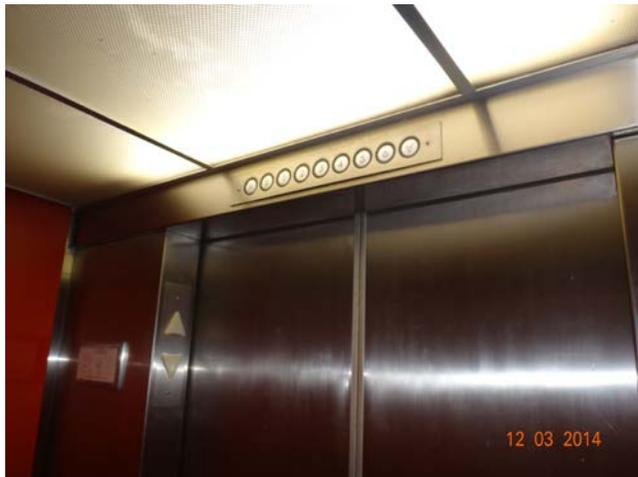
Ceilings:

The cabs have T frames with translucent panels. The light fixtures should be updated down light ceilings with energy efficient LED's to improve aesthetics and save energy.
