Employment Development Department Headquarters (025)

722/800 Capitol Mall, Sacramento, CA 95814

Facility Condition Assessment

June 2015

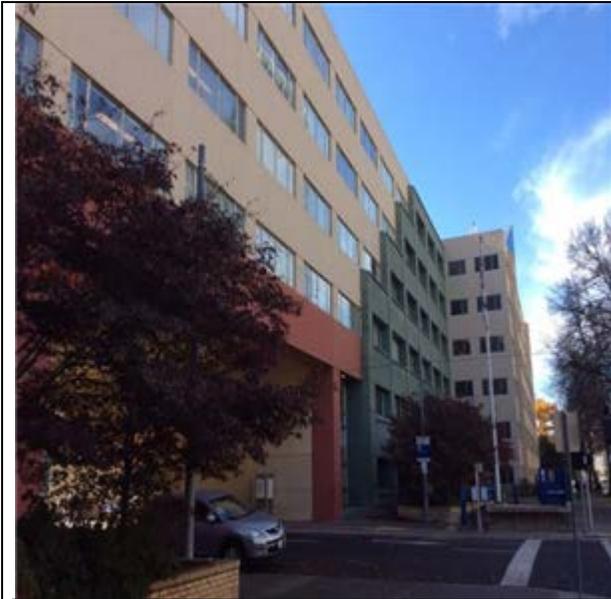
:- Front elevation

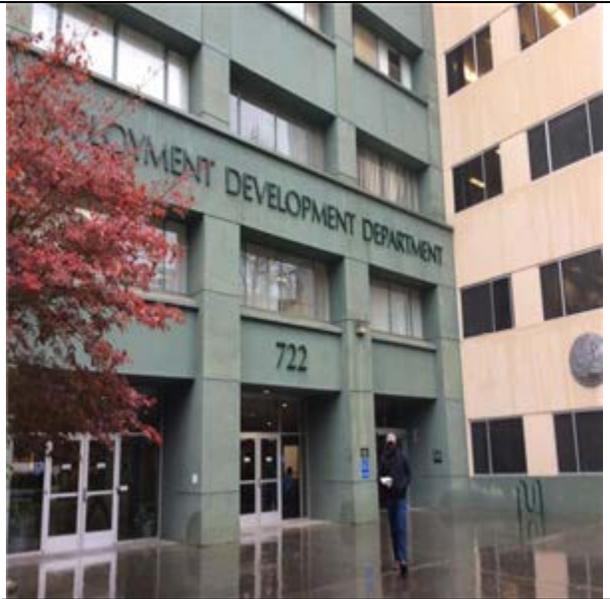
:- Front entrance

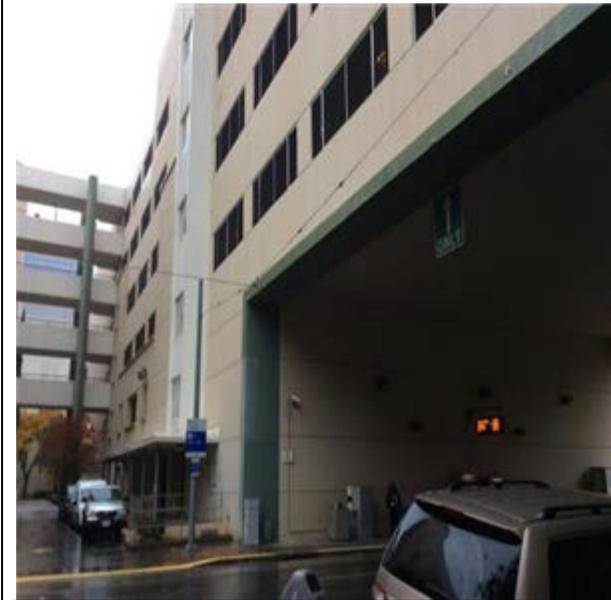
:- Partial rear elevation

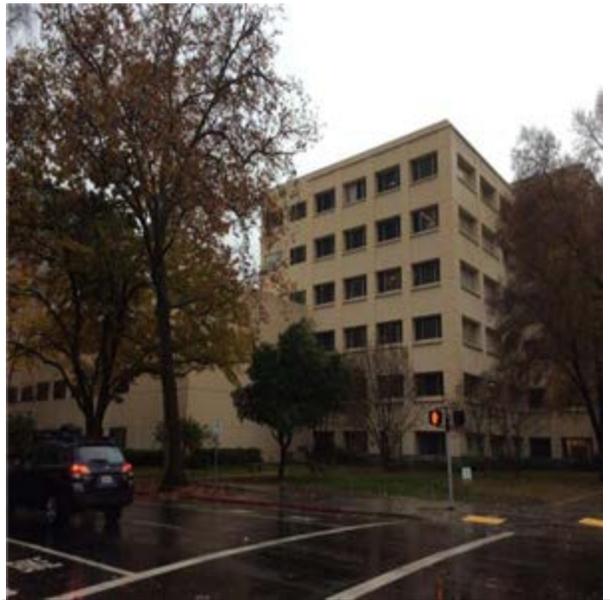
:- Partial west side elevation

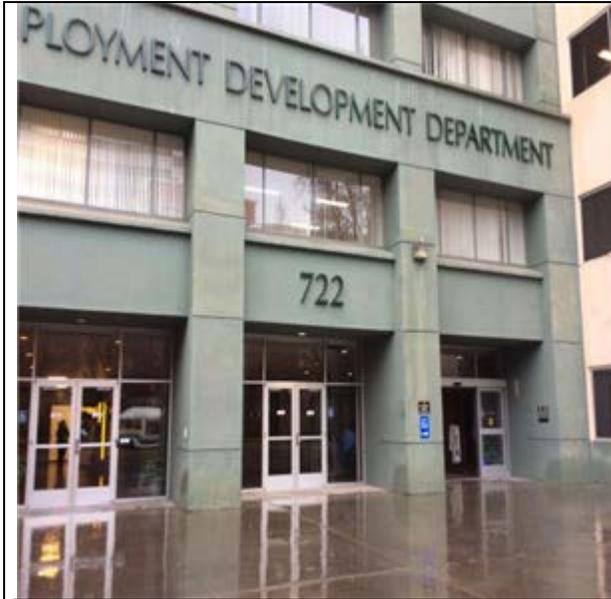
B2030 Aluminum Glazed Doors :- Full vision storefronts

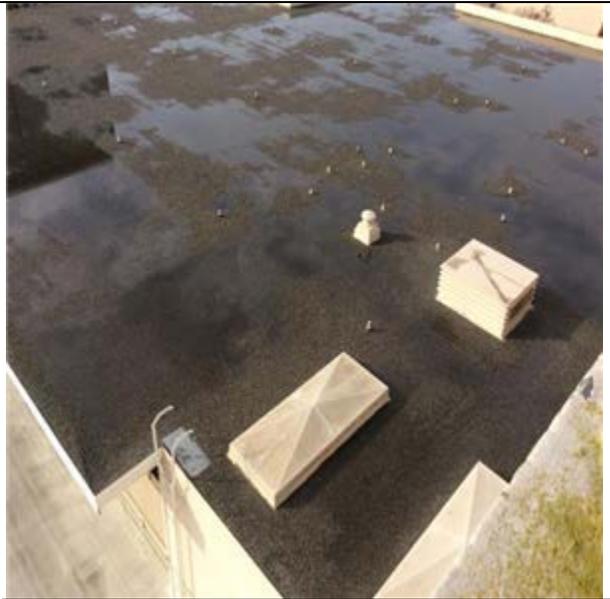
B3010 Built-Up Roofing:- Roof over 4th floor cafeteria

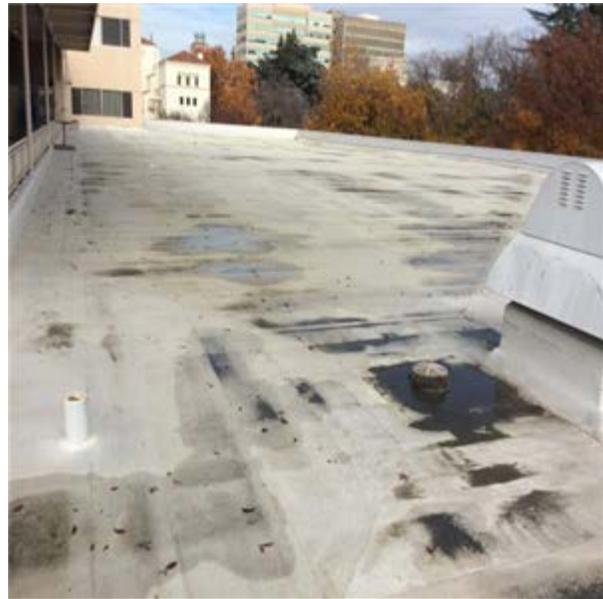
B3011 TPO, Roof 45 Mills, Full Adhered :- Third floor roof adjacent to cafeteria

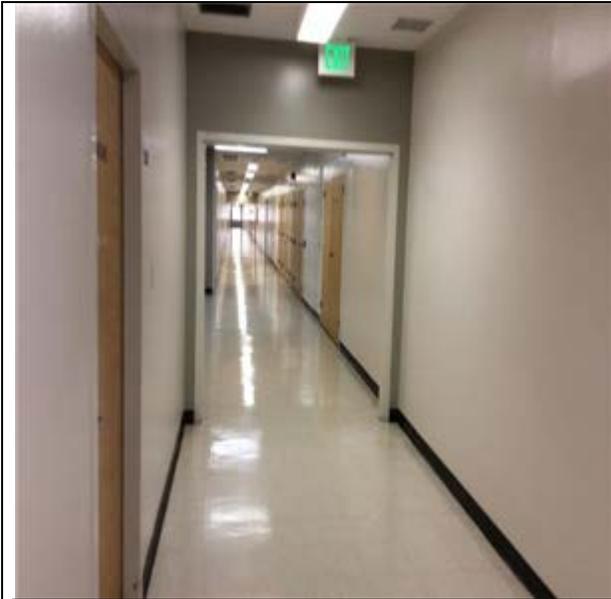
C1021 Interior Doors :- Corridor doors

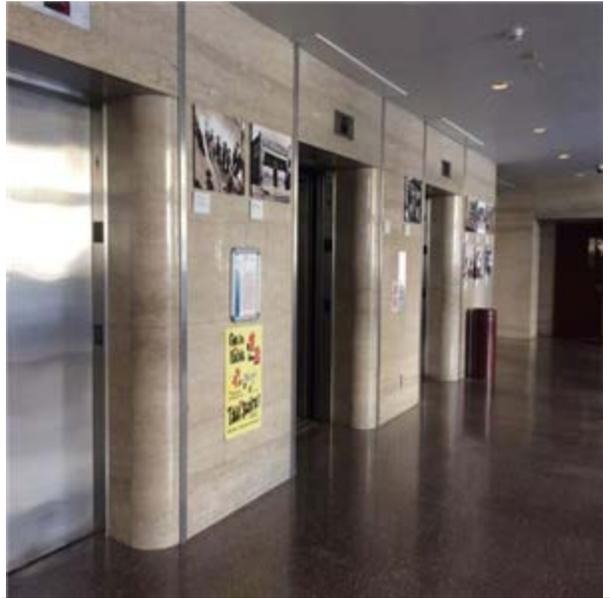
C3020 Terrazzo Flooring:- Entrance lobby

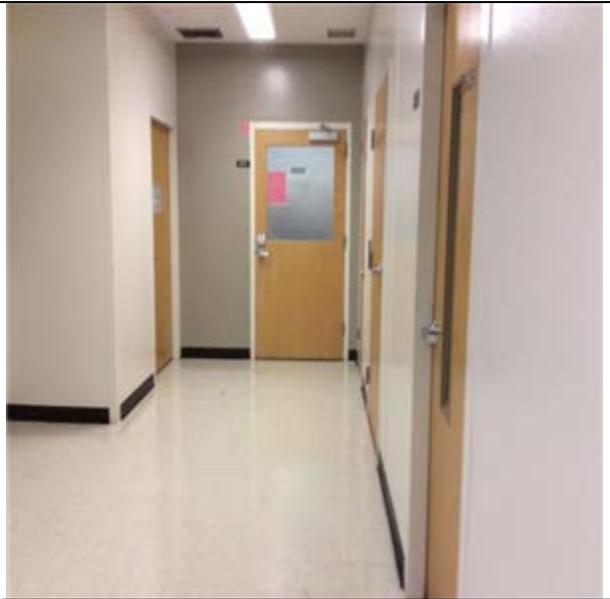
C3020 Vinyl Tile:- Corridor finishes

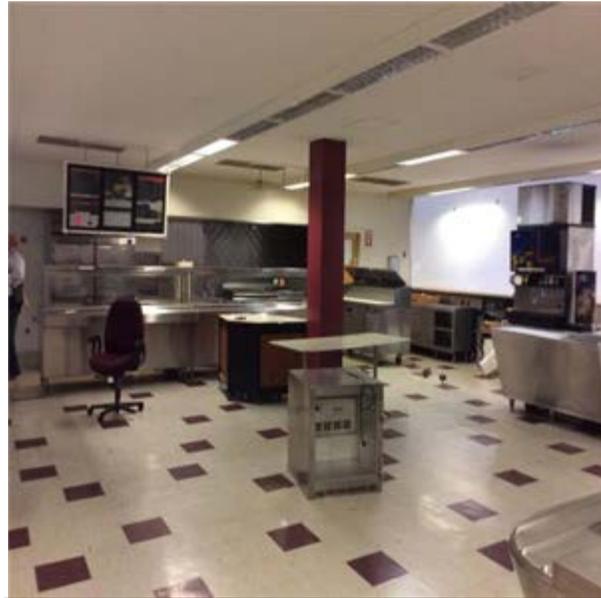
C3020 Vinyl Tile :- Cafeteria

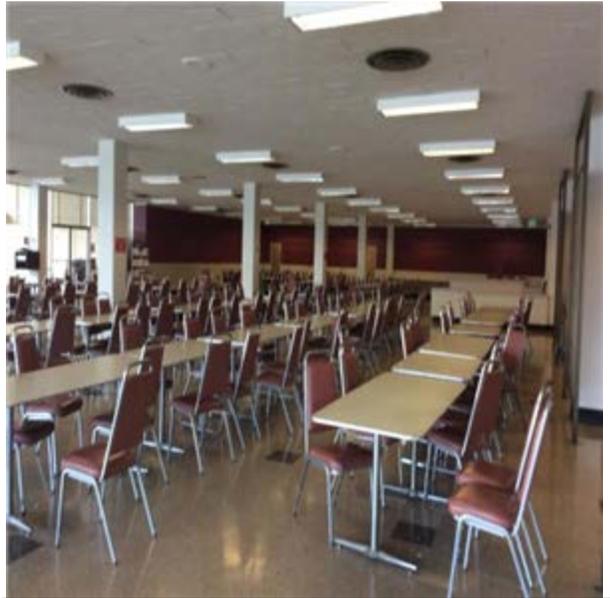
C3020 Vinyl Tile:- Cafeteria

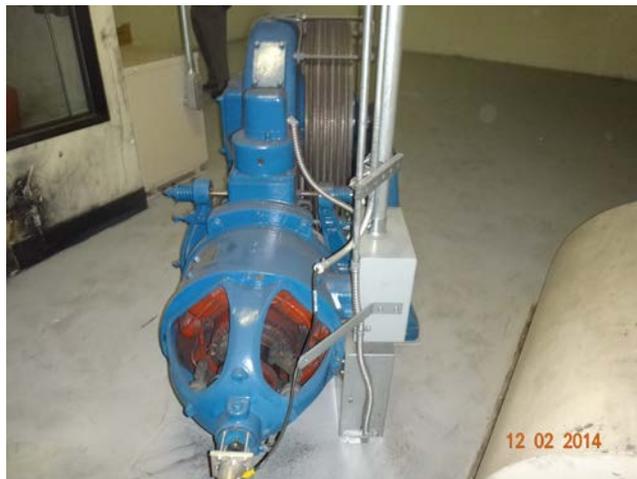
Service/Freight Machines:

Service Car 7 and Freight Car 8 have the original Westinghouse geared machines. The machines have the original D.C. hoist motors. Both the machines were found to be in good condition.

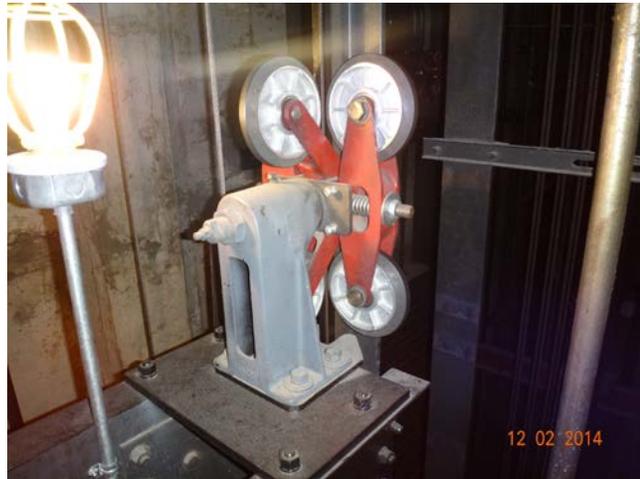
Car Roller/Slide Guides:

On both sides of the elevators and on the top and bottom roller guides keep the elevators riding up and down the steel guide rails. The existing ride quality was noted to be good. High quality ELSCO roller guides appeared to be new from the last modernization. No work is anticipated on the roller guides.

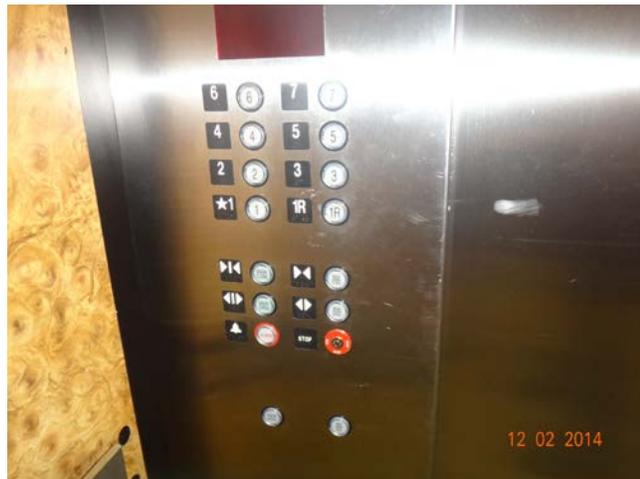
Car Operating Panels:

All the elevators have the newer Car Operating Panels (COP's) installed during the recent elevator modernization. The panels are in good condition meet ADA and T24 and do not need any work at this time.

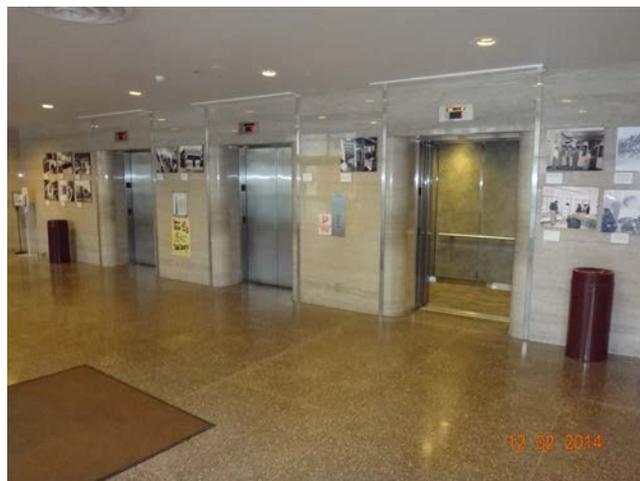
Hall Lanterns:

Hall lanterns inform persons waiting in the hall of which direction the elevator is about to travel in next. ADA requires that the hall lanterns illuminate and sound for the waiting passengers. The existing elevators have hall lanterns for each car. The lanterns have the proper gong for up and down.

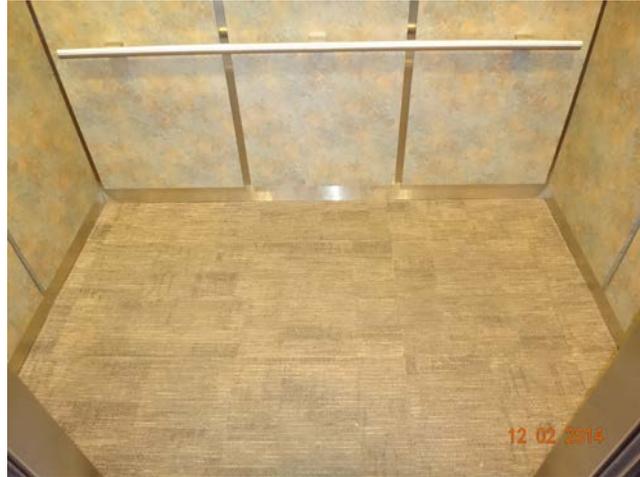
Wall Finish:

The existing cab interiors are likely original and are in fair condition. The back wall has the code required handrail. The railing heights are in compliance with Title 24 California code.

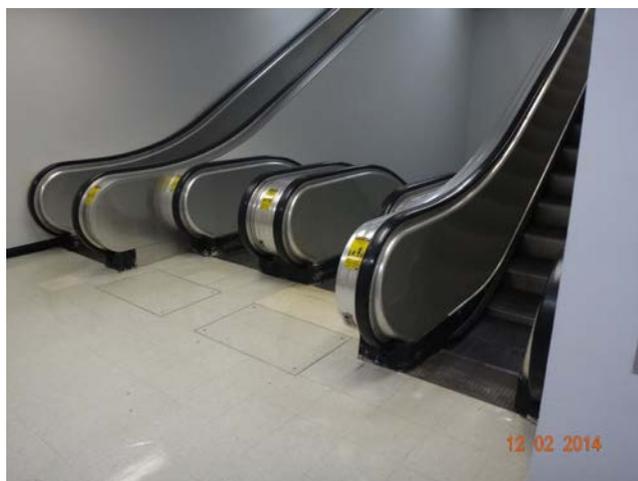
Middle Section:

View of escalators at 2nd floor with two center escalators coming up from first floor and the outer escalators providing service from the 2nd to the 3rd floor.

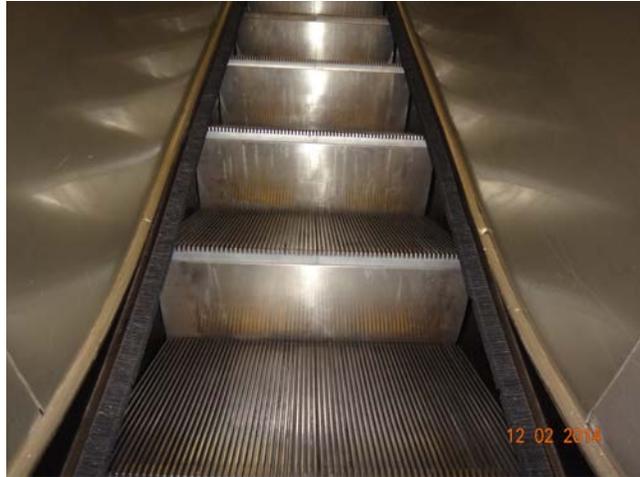
Typical Escalator:

View of escalator looking up with smooth risers visible and skirt brushes installed.

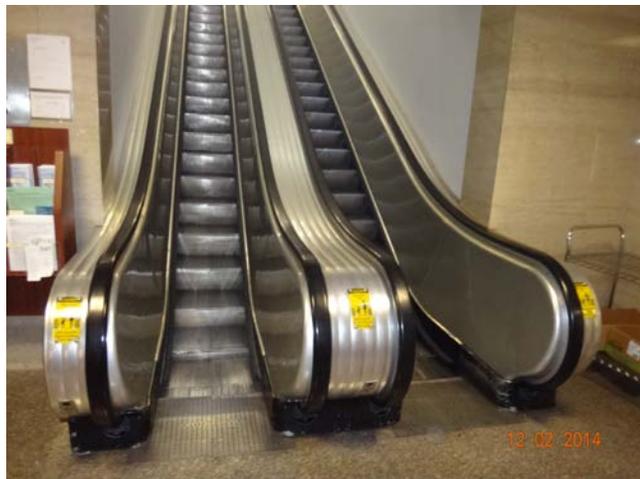
Terminal:

View of terminal landing with combplates that are not contrasting color.
