# Gregory Bateson Building (011)

1600 Ninth Street, Sacramento, CA 95814

## Facility Condition Assessment

June 2015

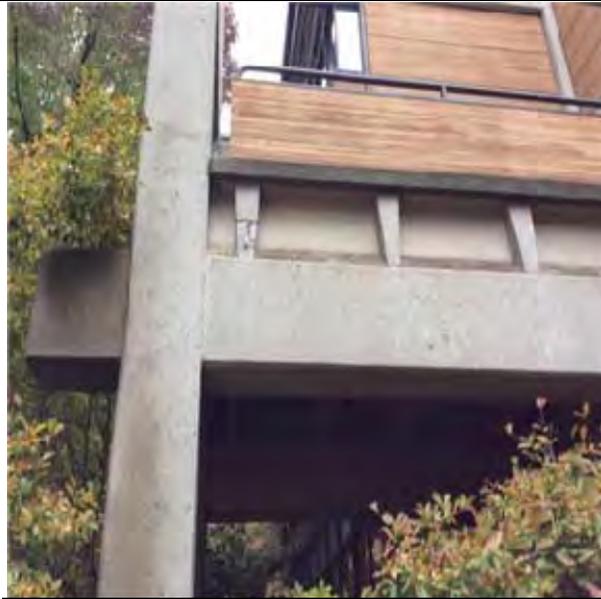
B1010 Floor Construction

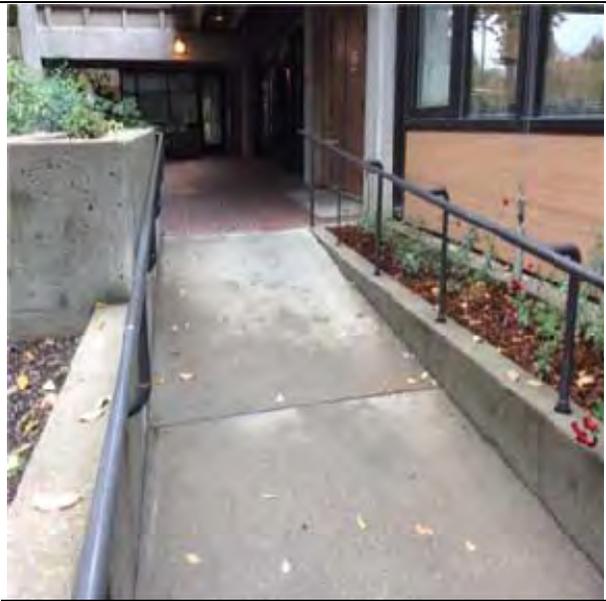
B1010 Ramps:- 9th street Ramp

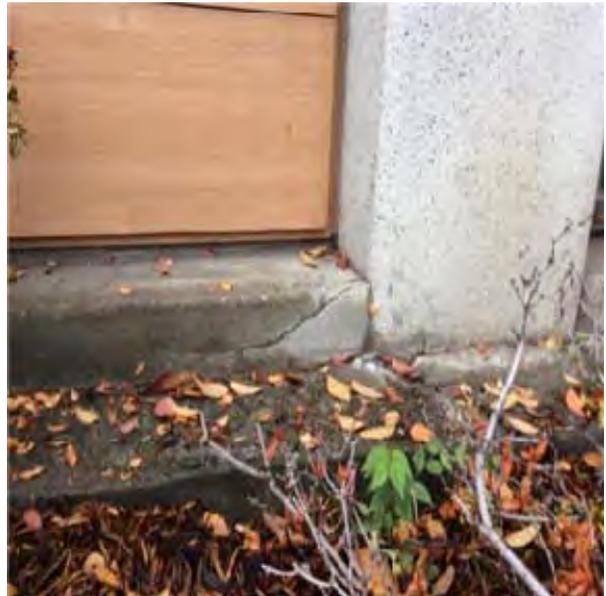
B2010 Glue-lam beam at walls and railings

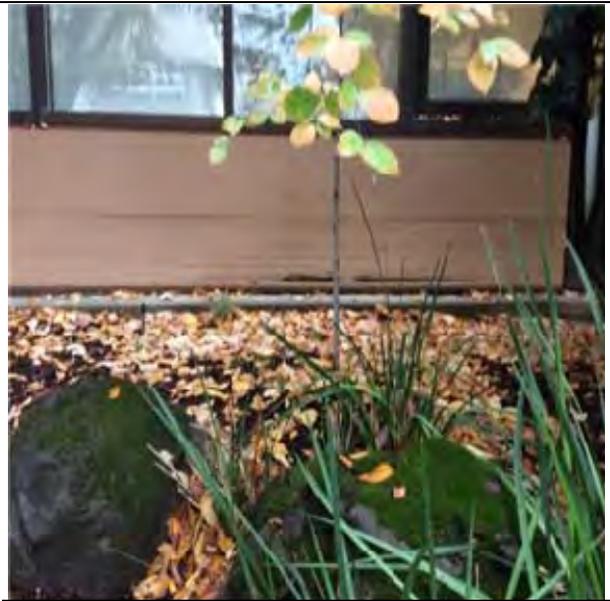
B2010 Glue-lam beam at walls and railings

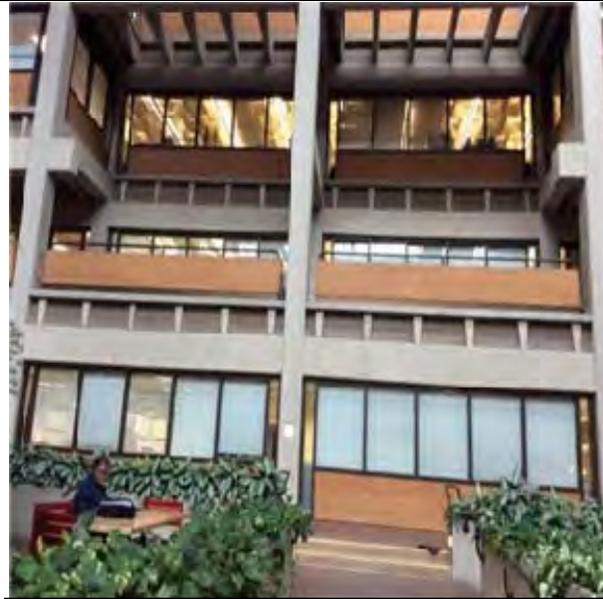
B2020 Exterior aluminum windows

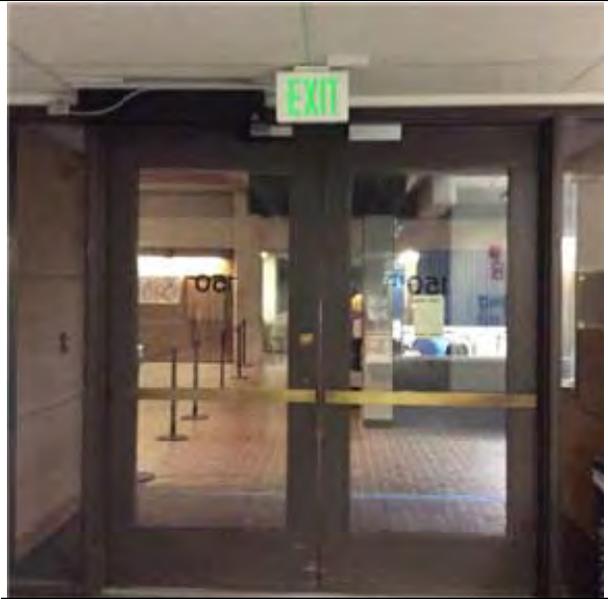
B2030 Exterior Doors

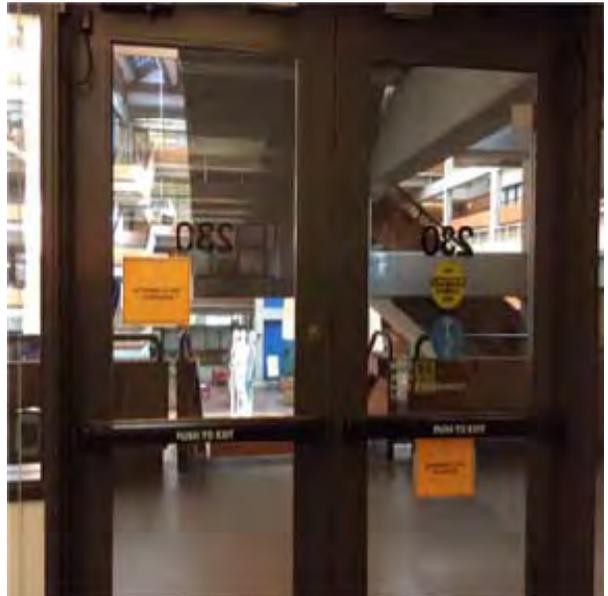
B2030 Exterior Doors:- Room 230

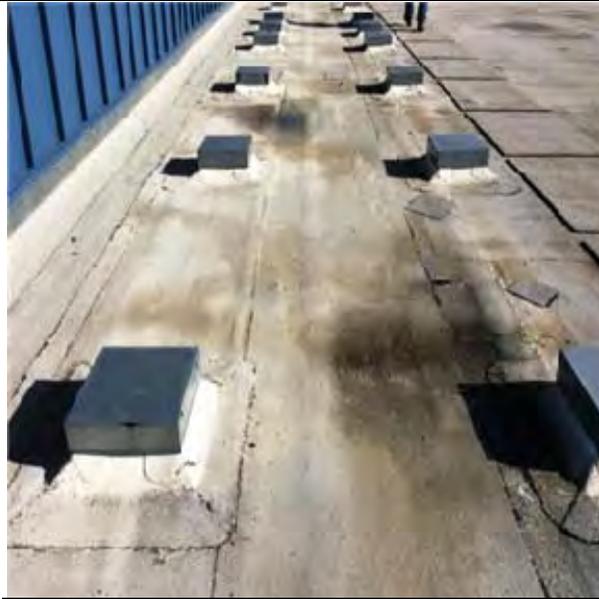
B3010 Built-Up Roofing, Total Roof :- Support brackets from original solar system

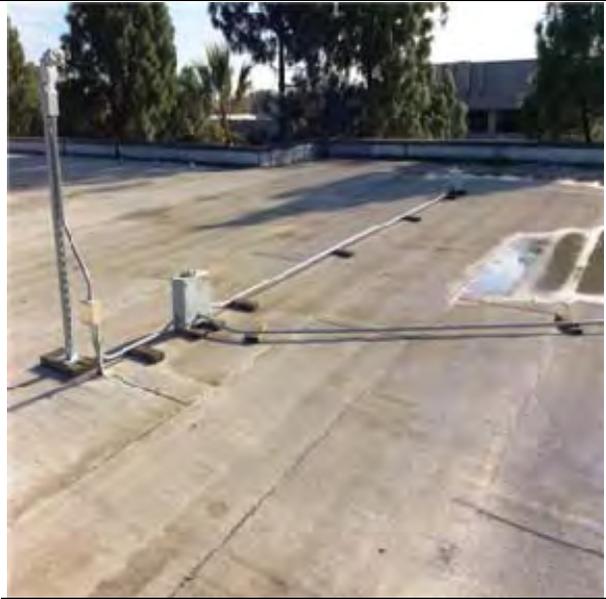
B3010 Built-Up Roofing, Total Roof

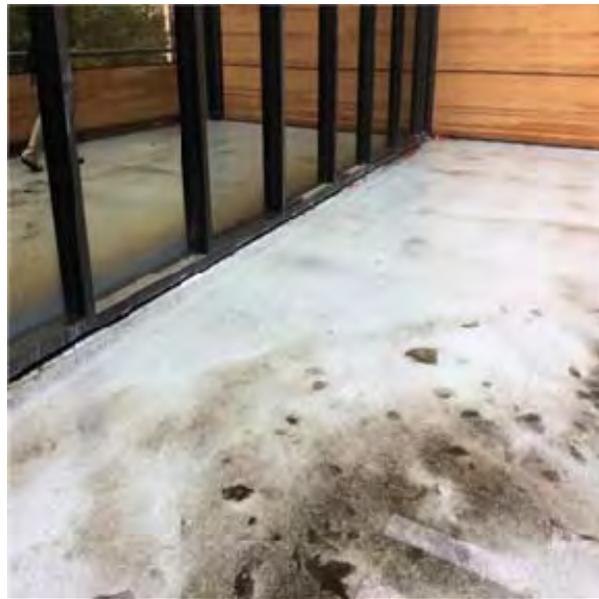
B3011 Balcony Coatings

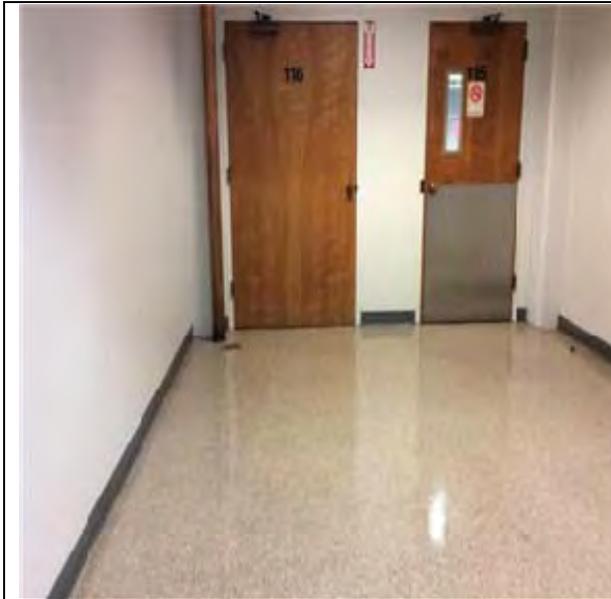
C1020 Door :- next to loading duck

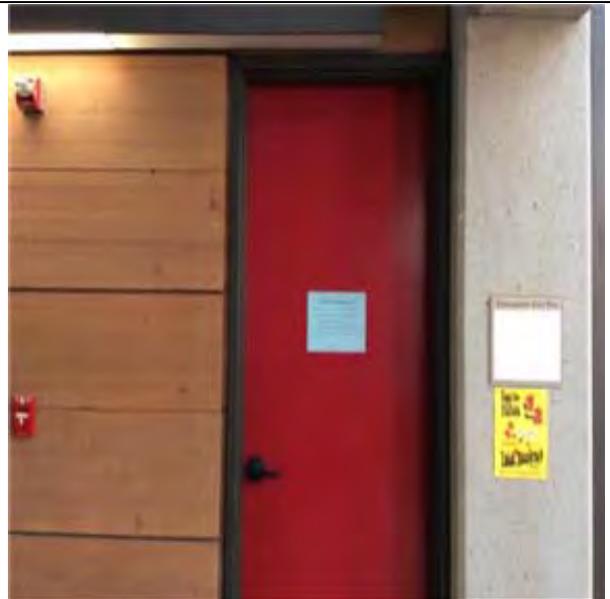
C1020 Fire Door, metal with wire glass:- door to roof

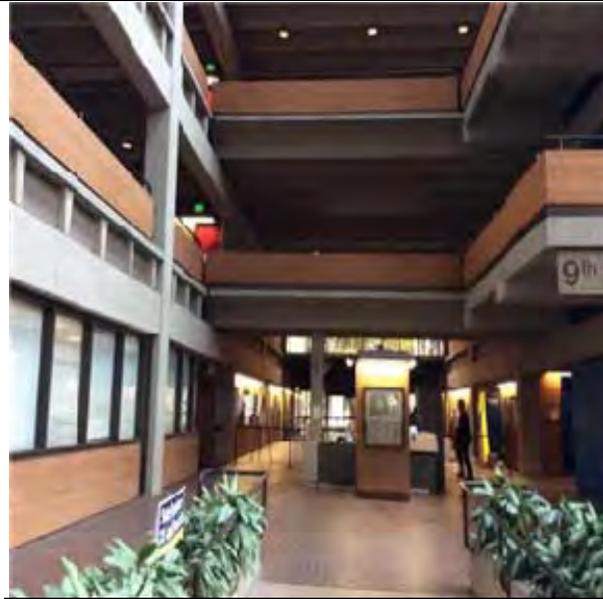
C3010 Wood Paneling

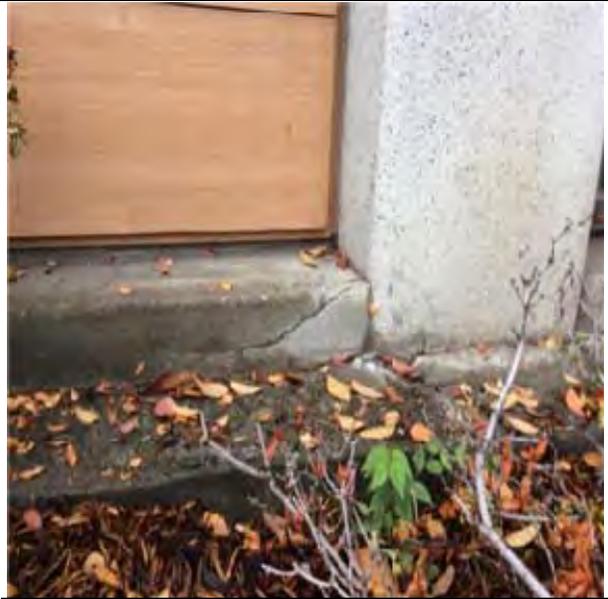
C3010 Wood Paneling

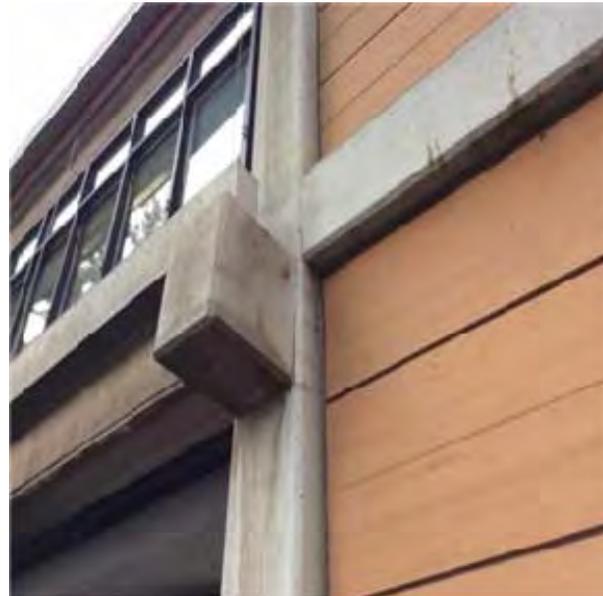
C3010 Wood Paneling

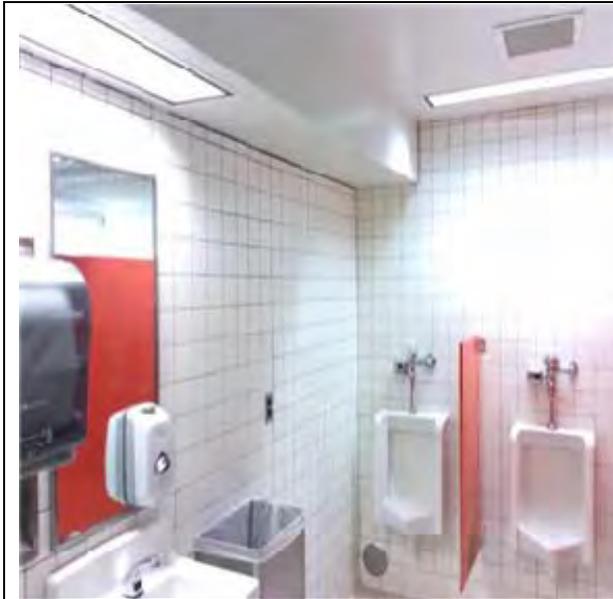
C3012 4X4 Ceramic Tile

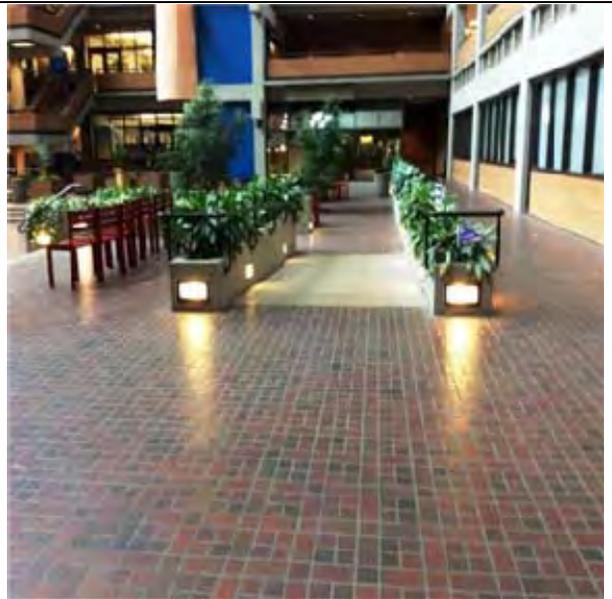
C3020 Brick flooring at atrium

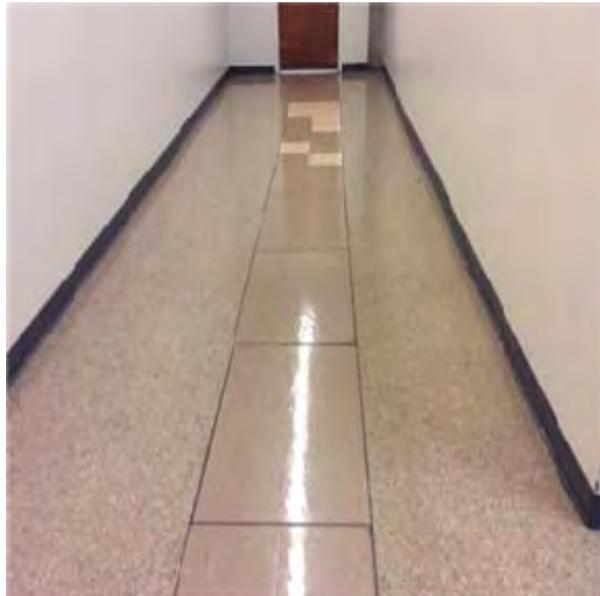
C3020 Sheet Vinyl

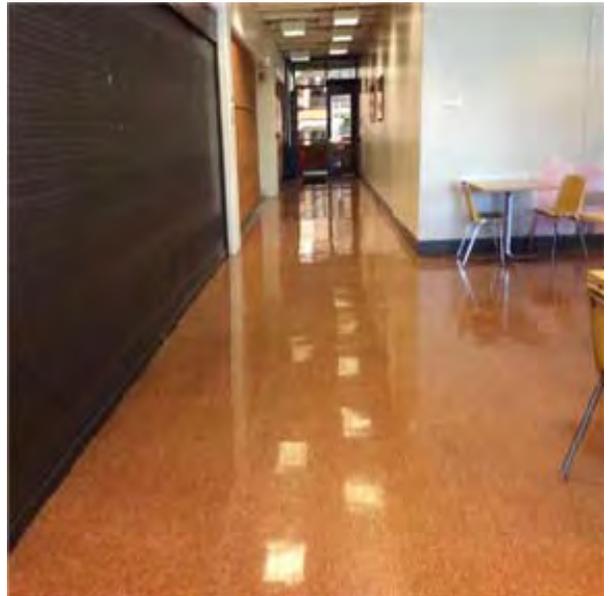
C3020 Sheet Vinyl:- Hallway to kitchen

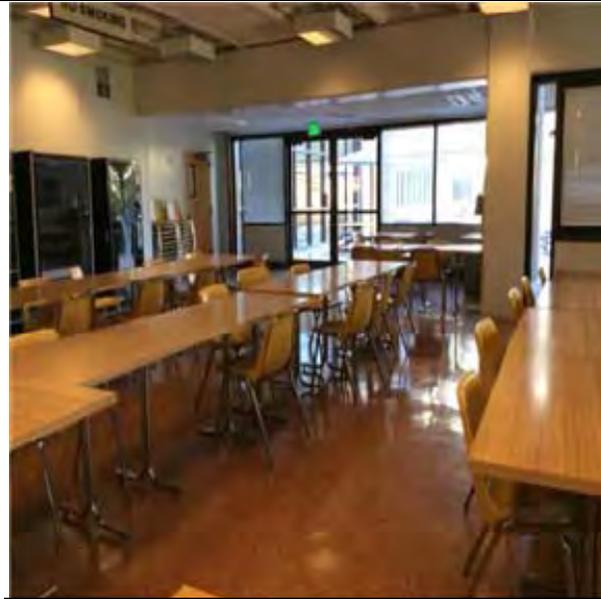
C3020 Sheet Vinyl

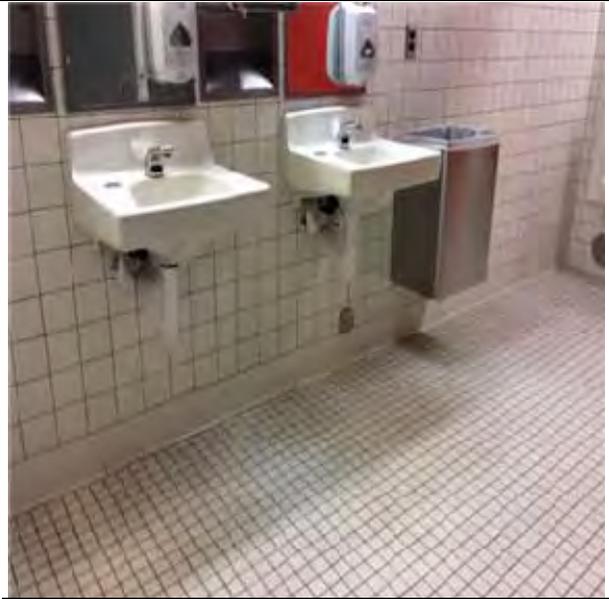
C3020 2X2 Ceramic Tile:- Floor of men Restroom

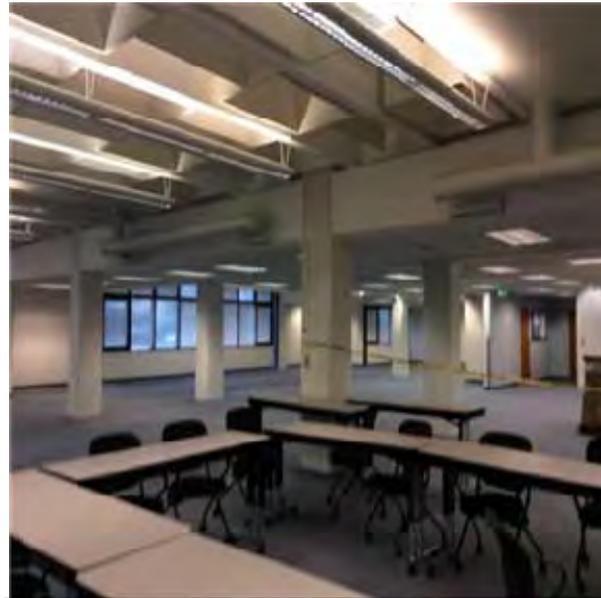
C3030 Acoustical Tile With Exposed Grid System

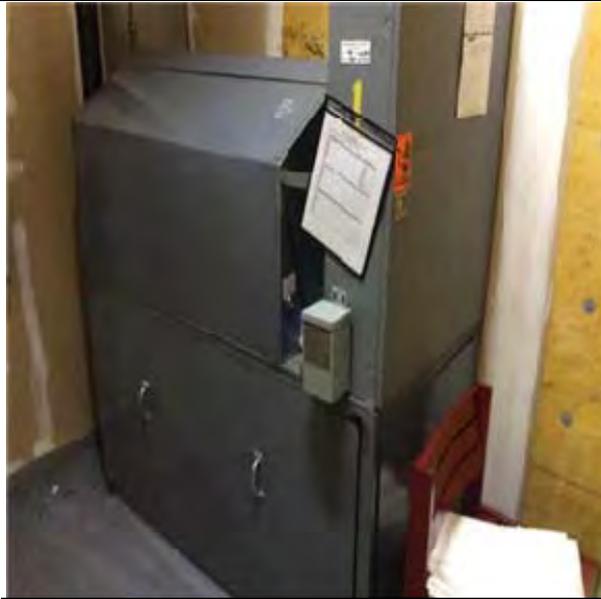
D1010 Elevator Hydraulic System, 3,500 Lb Capacity

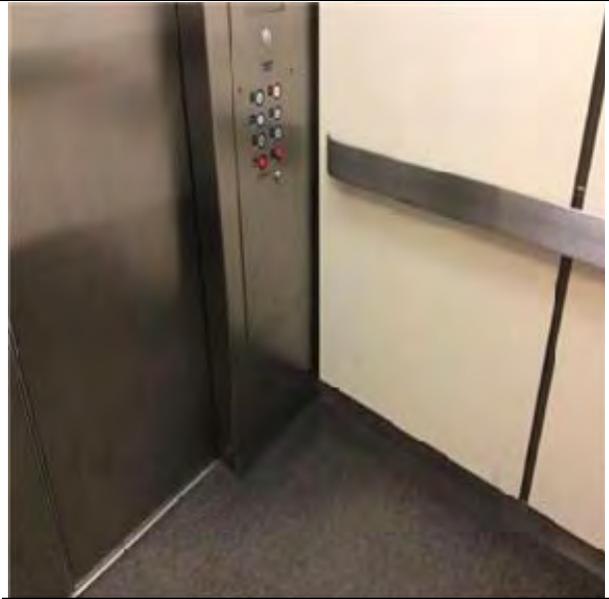
D1010 Elevator Hydraulic System, 3,500 Lb Capacity:-  
Elevator cab

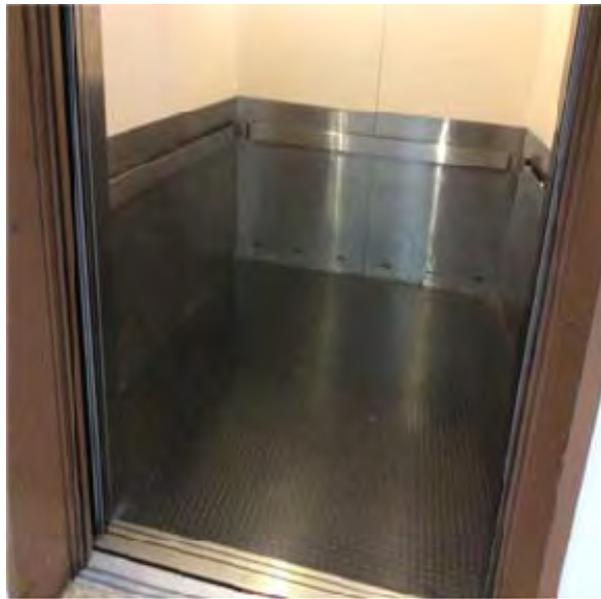
D1010 Freight Elevator, Hydraulic Equipment, 7,500 Lb

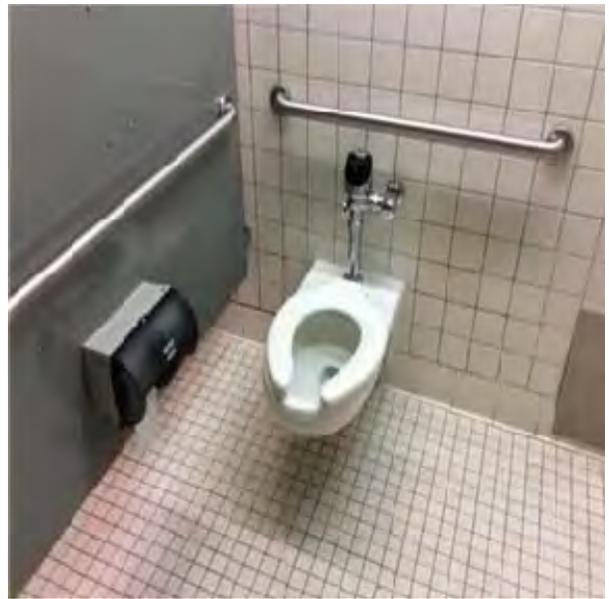
D2010 Commercial Grade Water Closet With 1.6 Gpf  
Unit

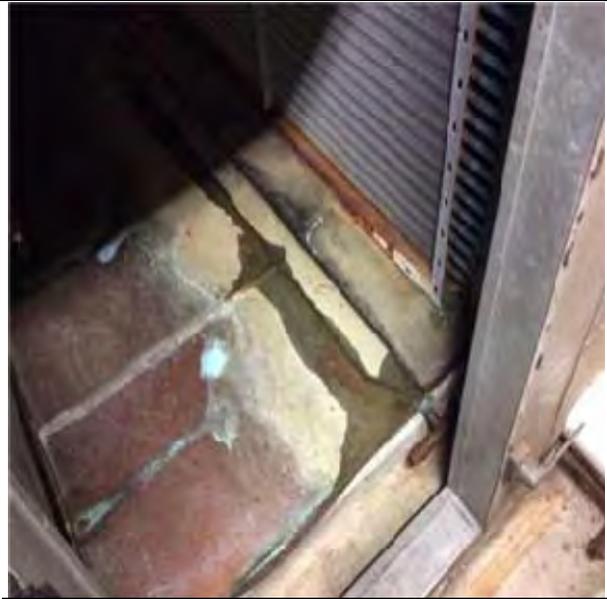
D3040 Air Handler 18,000-20,000 CFM :- Fan motor
