Resources Building (018)

1416 Ninth Street, Sacramento, CA 95814

Facility Condition Assessment

June 2015

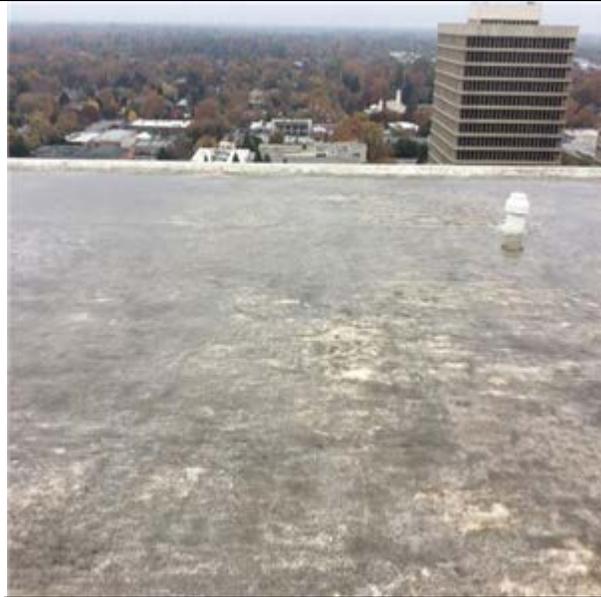
B1029 Guard rail at roof edge :- No railing

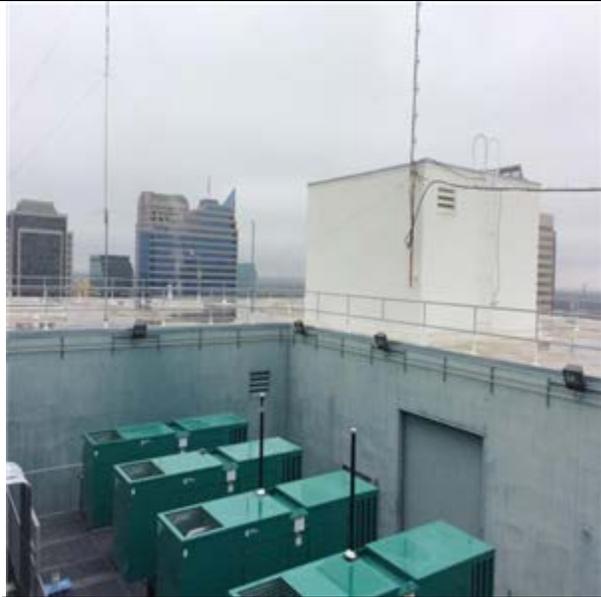
B1029 Guard rail at roof edge:- Should be brought up to code

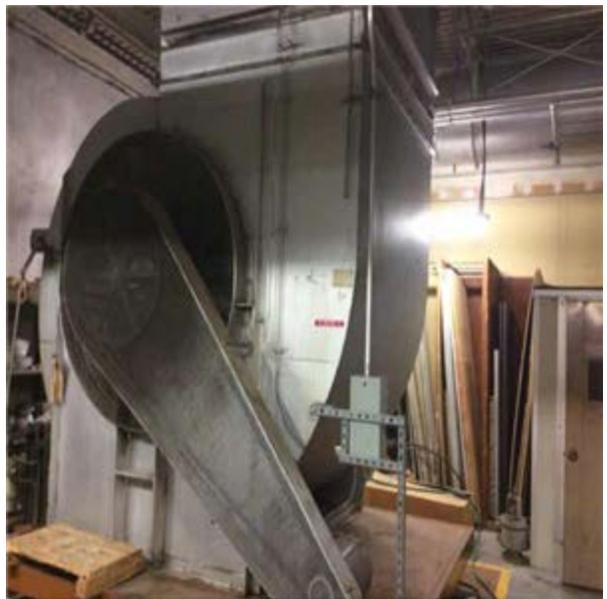
D3042 Exhaust fans central west:- West side exhaust fan

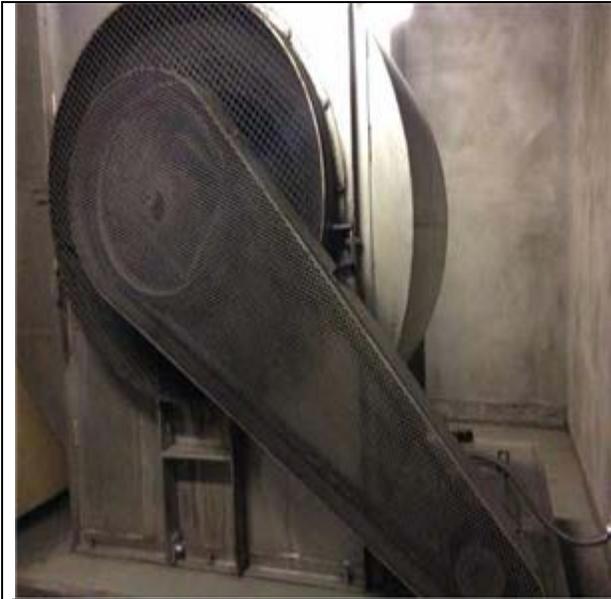
D3042 Exhaust fan restroom (15 hp) :- Central exhaust fan for bathrooms

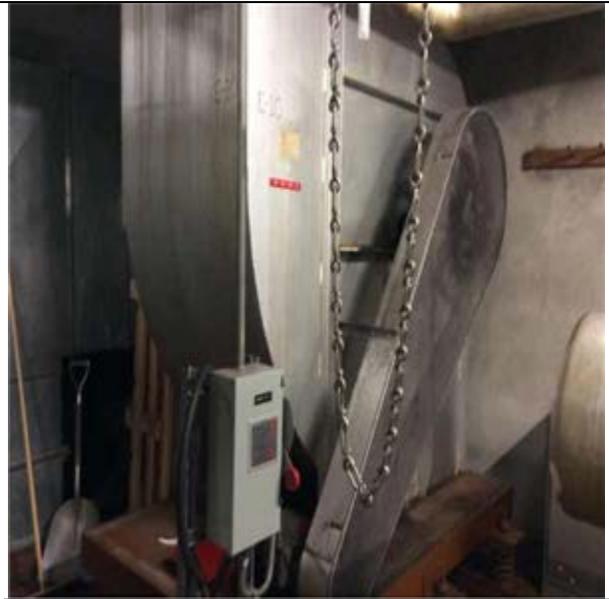
D3042 Exhaust fan kitchen west (15 hp):- Kitchen exhaust fan - west side

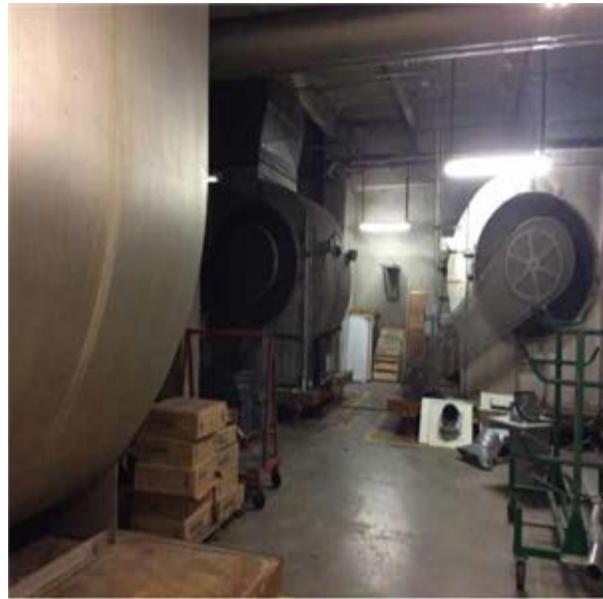
D3042 Exhaust fans east central (15 hp) :- Central exhaust fan - east side

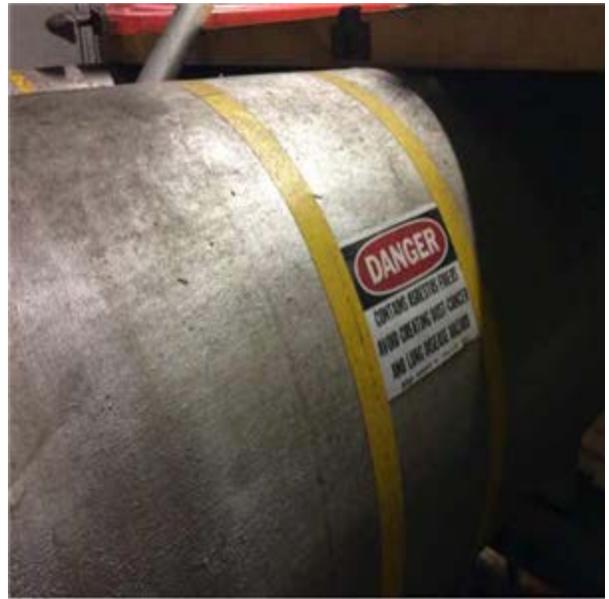
D3043 Heat Exchanger for DHW:- Hot water heat exchanger

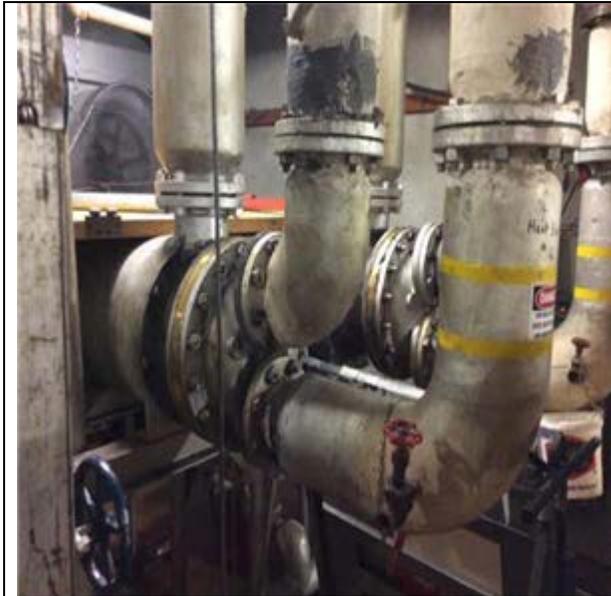
D3043 Heat Exchanger for Heating :- Heat exchanger

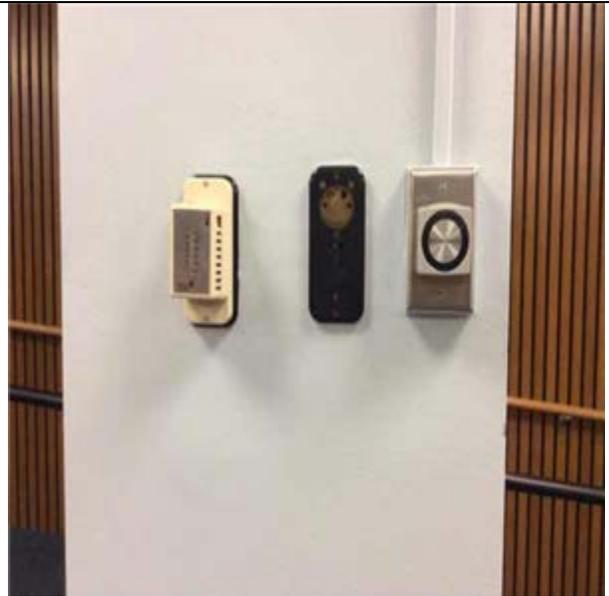
D3068 Direct Digital Controls (DDC) Pneumatic System:- Direct digital controllers (DDC) for pneumatic system

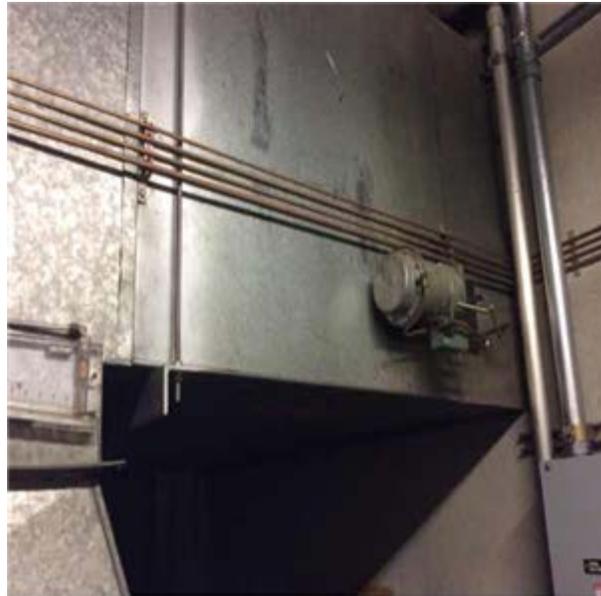
D3068 Direct Digital Controls (DDC) Pneumatic System :- Pneumatic controller on VAV

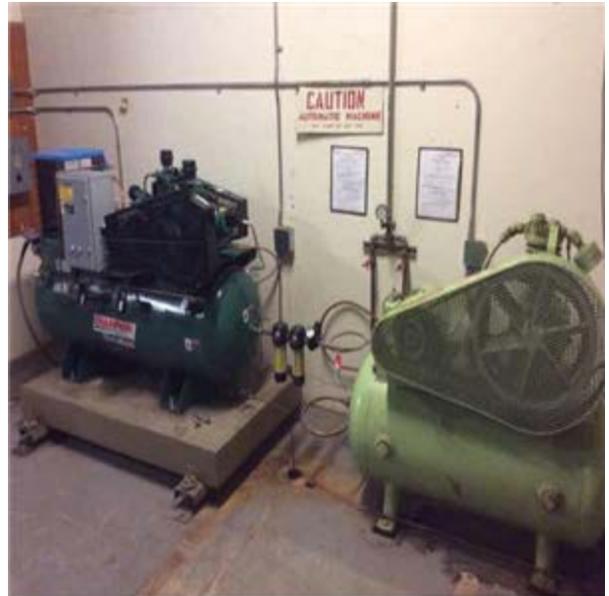
D3069 Air compressor:- Auxiliary air compressors

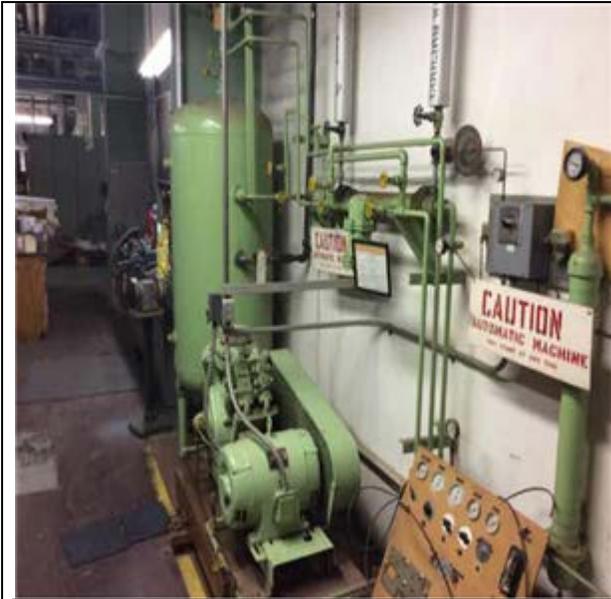
D3069 Air compressor for all district air pneumatics :-
Air compressor for pneumatic controllers

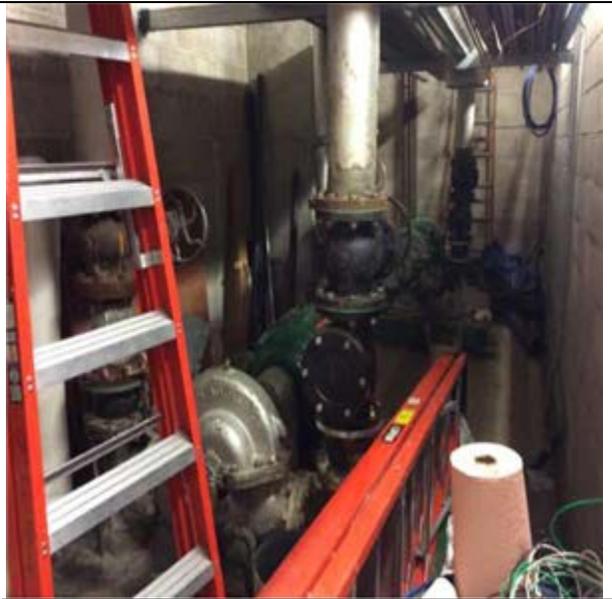
D4012 Fire Pump Electric 500 Gpm 27 HP:- Pump with
stand pipe visible

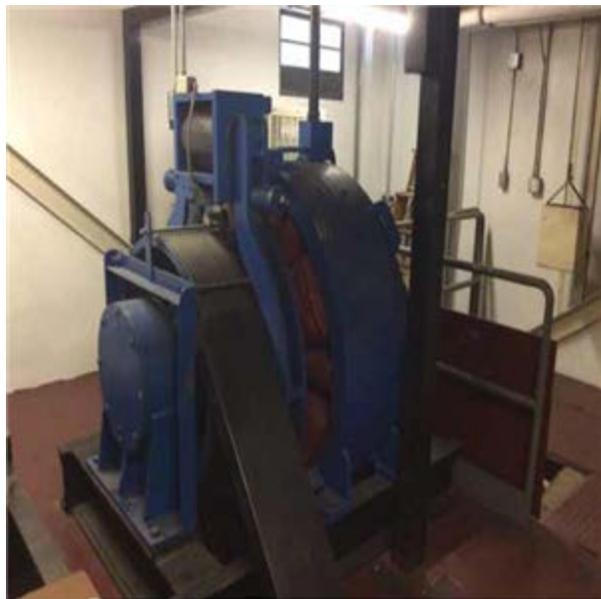
D5012 Freight elevator mechanical room breaker
panel:- Freight elevator motor

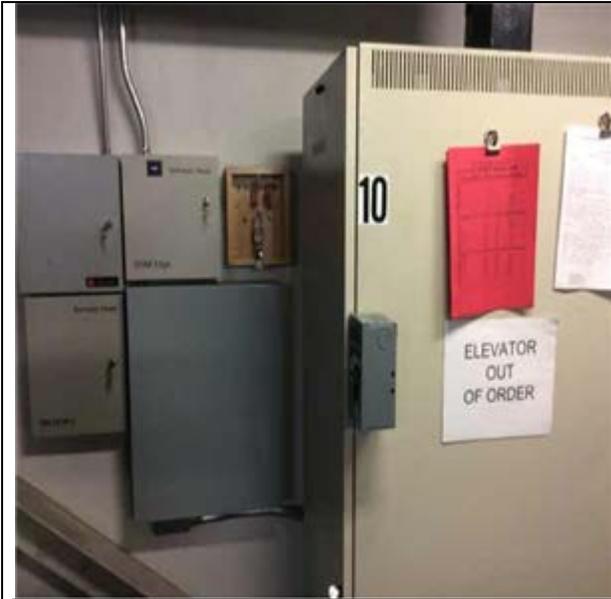
D5012 Freight elevator mechanical room breaker panel :- Freight elevator controller cabinet

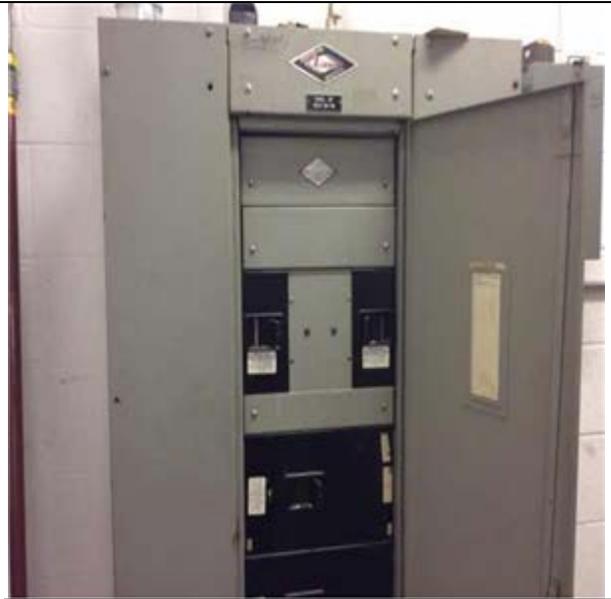
D5012 Electrical Distribution Panel, 1200 Amp:- 1200 amp

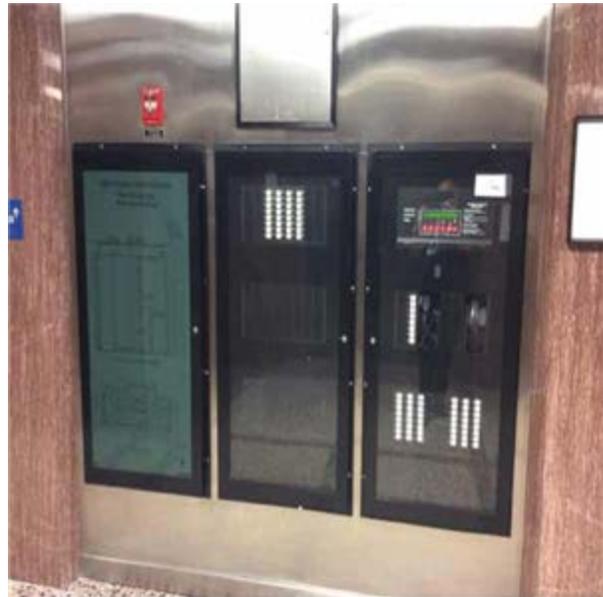
D5037 Fire Alarm System:- Main fire control panel

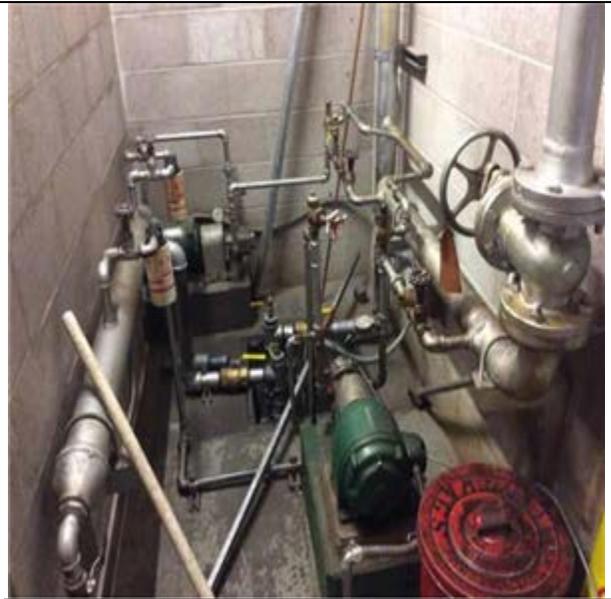
D3022.1 Circulation Pump 1.5 HP to Supply Emergency Generator Diesel Fuel:- Diesel

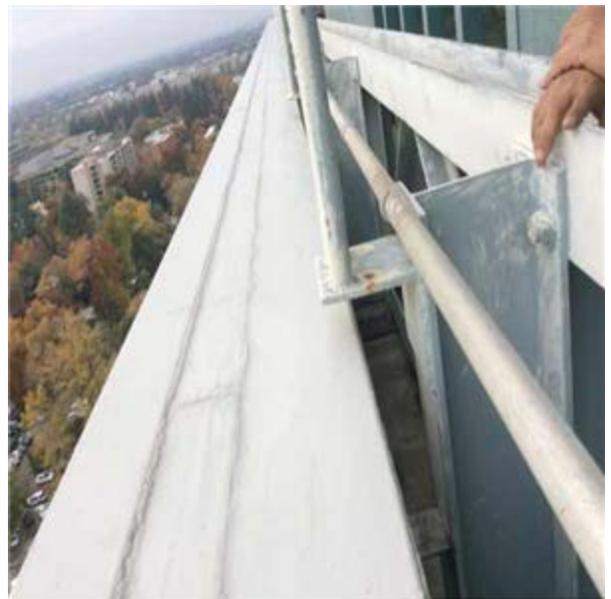
E1097 Roof Carriage track:- window washing track

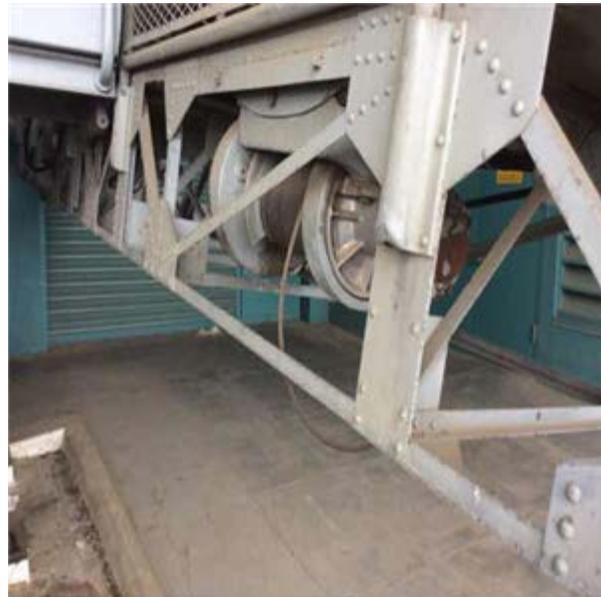
E1097 Roof carriage with suspended scaffold :- existing equipment

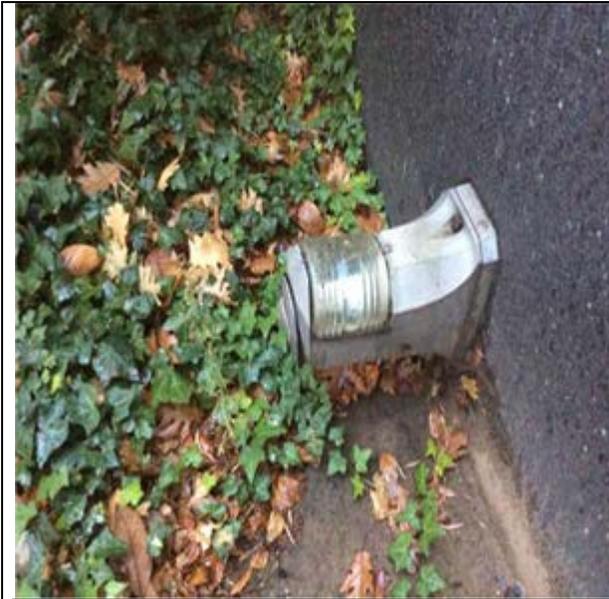
G4021 Landscape Ground Mounted Uplight Fixture Only :- Ground mounted upward illumination fixture

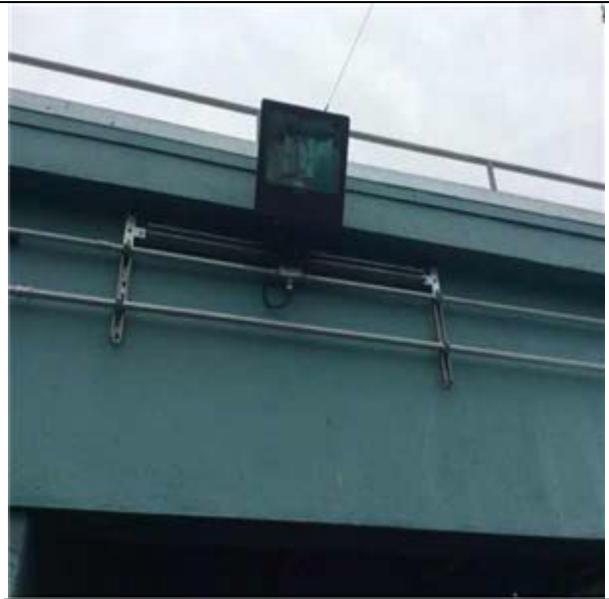
G4022 400 W HPS Fixtures:- Wall mounted HPS fixture

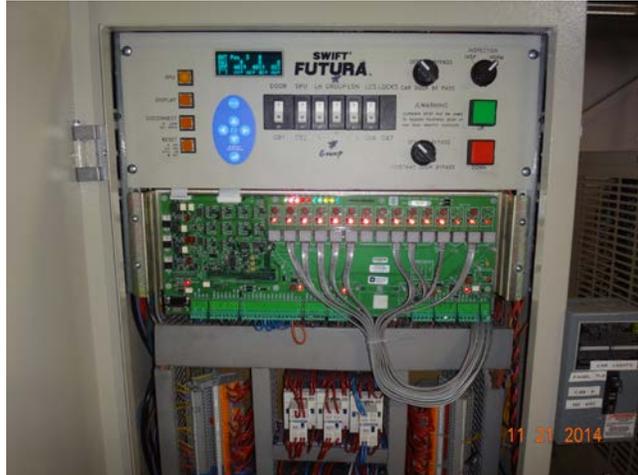
Controllers:

The controllers were manufactured by CEC/Swift and installed locally by TKE when the elevators were modernized in 2009. The controllers have energy efficient SCR drives made by Magnetec, the world's leading supplier of SCR drives.

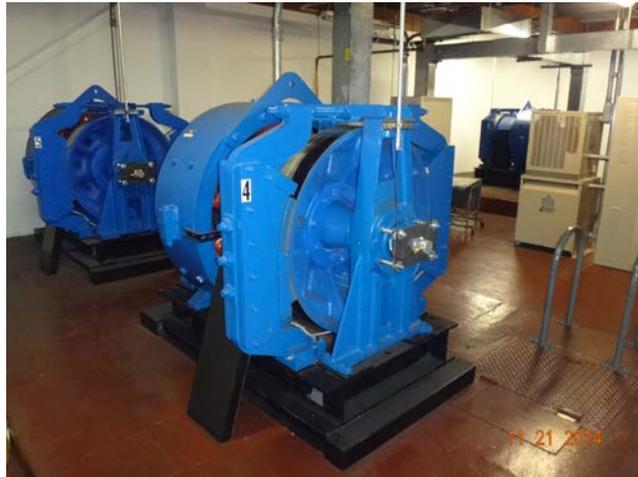
High-rise Machines:

All the high-rise elevators have Schindler Haughton gearless machines that were installed when the elevators were first modernized in 1987/88. The machines have D.C. hoist motors and appear to have been refurbished when modernized in 2009. All the machines were found to be in good condition.

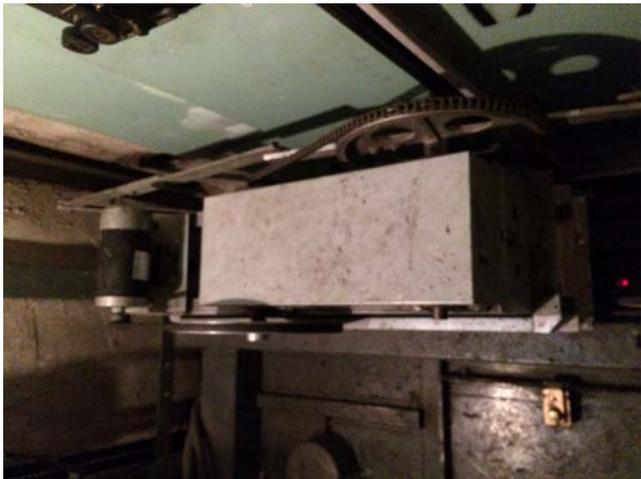
Door Operator:

The door operators for the passenger elevators were made by GAL and are closed loop and known to be of high quality. The door operator for the service car was made by Elevator Solutions and designed to replace MAC door operators. The door operation was noted to be fair with room for improvement. All of the cars are equipped with door restrictors.

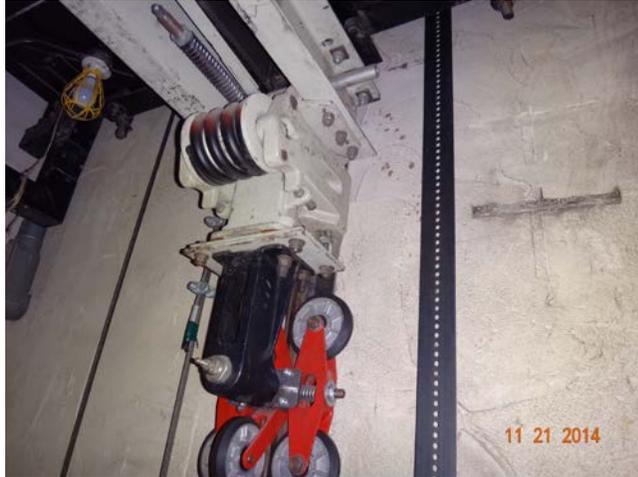
Car Roller/Slide Guides:

On both sides of the elevators and on the top and bottom roller guides keep the elevators riding up and down the steel guide rails. The existing ride quality was noted to be good. These are newer ELSCO rollers installed with seismic retainer plates. No work is anticipated on the roller guides.

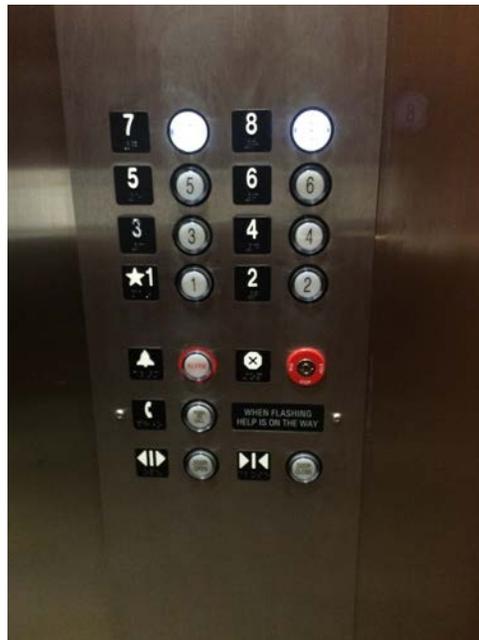
Car Operating Panels:

All the elevators have newer Car Operating Panels (COP's) that were installed during the recent elevator modernizations. The panels are in good condition meet ADA and T24 and do not need any work at this time.

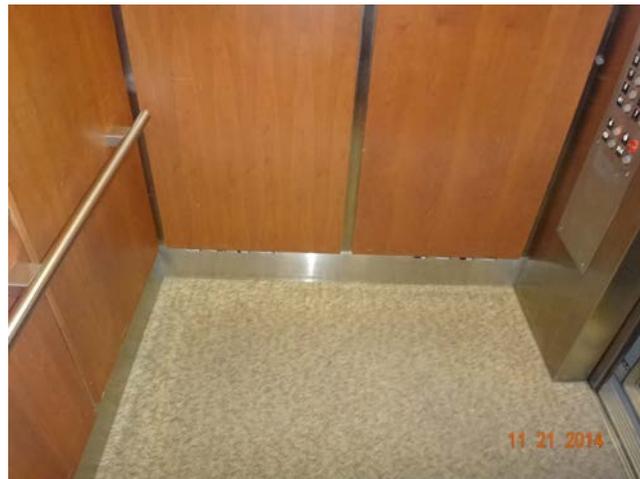
Wall Finish:

The existing cab interiors are likely original and are in fair condition. The back wall has the code required handrail. The railing heights are in compliance with Title 24 California code.
