## Agriculture Building (006)

1220 "N" Street, Sacramento, CA 95814

### Facility Condition Assessment

June 2015

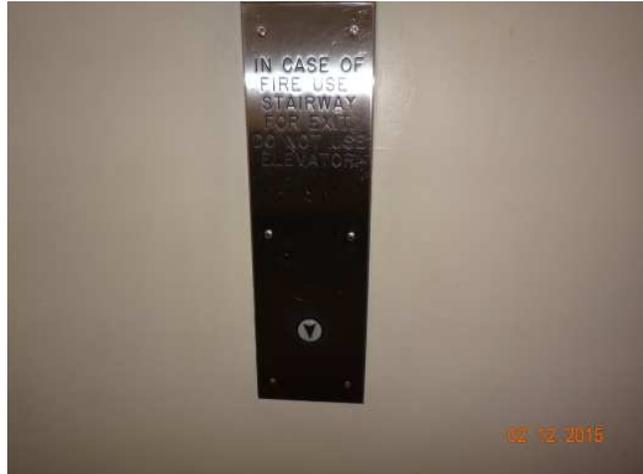
**Hall Call Pushbuttons:**

At each floor hall call push buttons are located so that users can call the elevator. The hall call stations have raised operation buttons which meet ADA and California Title 24.

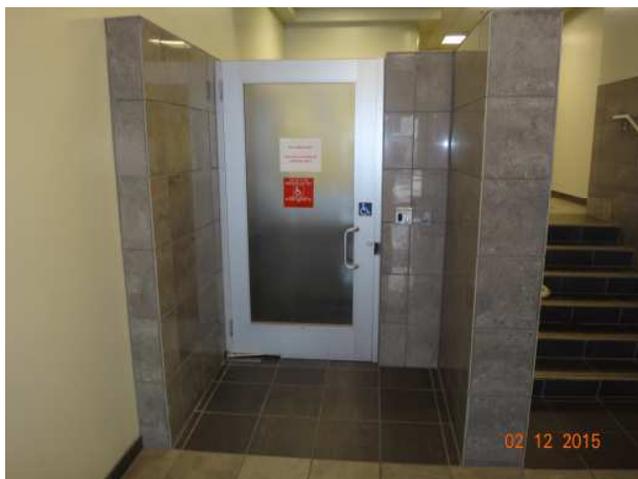
**Platform Lift:**

A platform lift with semi-automatic doors was installed in 2004 to provide access to the main lobby from the street.
