## Franchise Tax Board Los Angeles Building (084)

9645 Butterfield Way, Rancho Cordova, CA 95827

### Facility Condition Assessment

June 2015

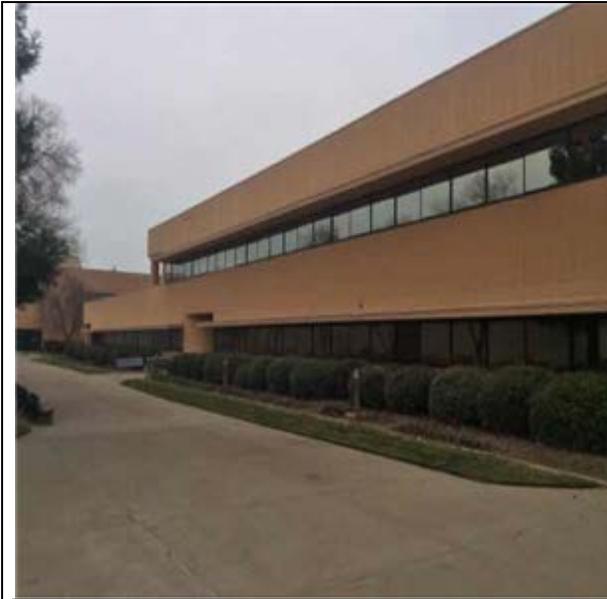
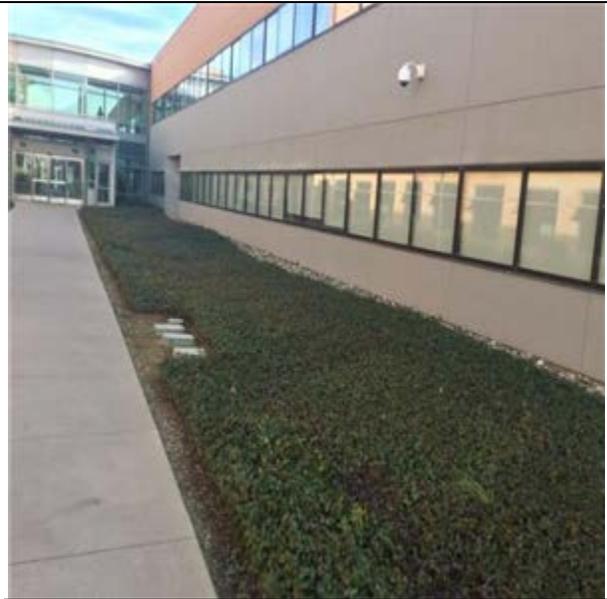
:- Front elevation

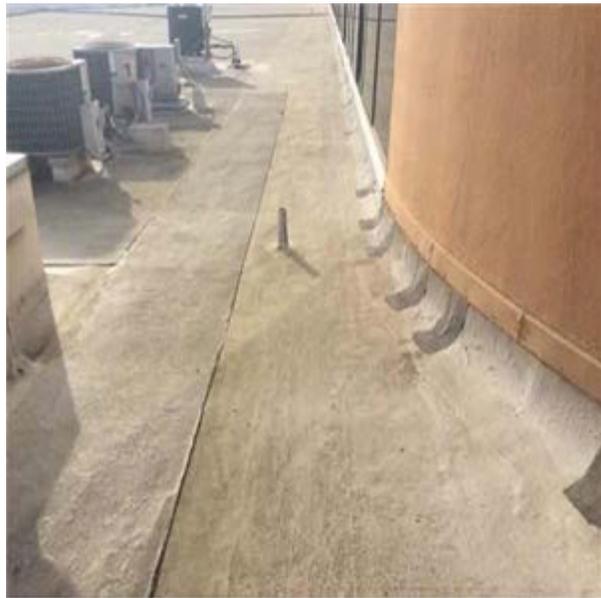
B3011 Built-Up Roofing

- The roof has a history of leaks throughout the building. Built-up roof replacement is recommended.
- There is a mixture of new and old carpet in the building. Replacement of the older carpet is recommended.
- The cooling units for the computer/data rooms are original to the building. Replacement is recommended.
- The building is using a mixture of original pneumatic and newer digital controls as part of the energy management system. Pneumatic systems are prone to leakage issues, and are antiquated. Replacement with digital controls is recommended.

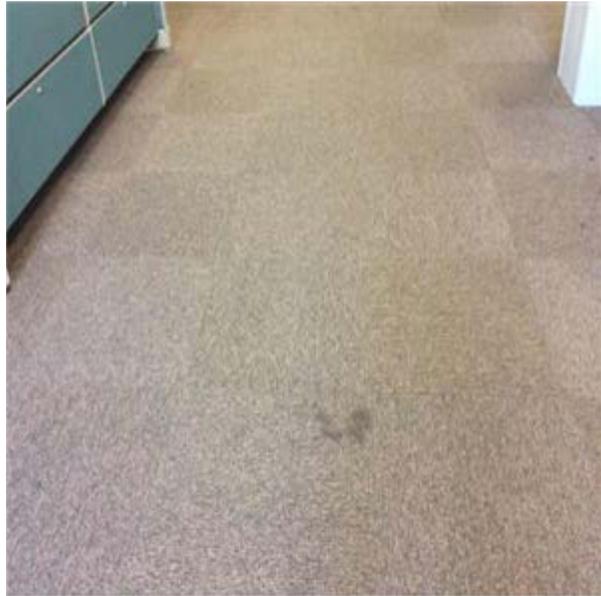
C3025 Carpet Tiles - Older
