Jesse M. Unruh Building (002)

915 Capitol Mall, Sacramento, CA 95814

Facility Condition Assessment

June 2015

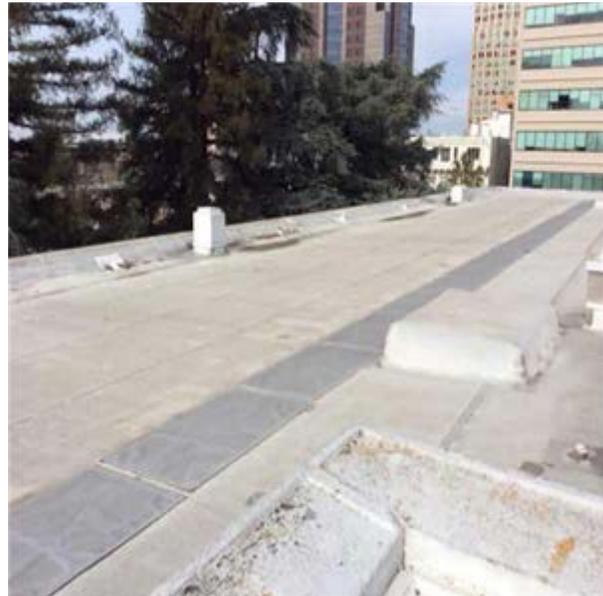
B1029 Cable Unistrut Fall Protection

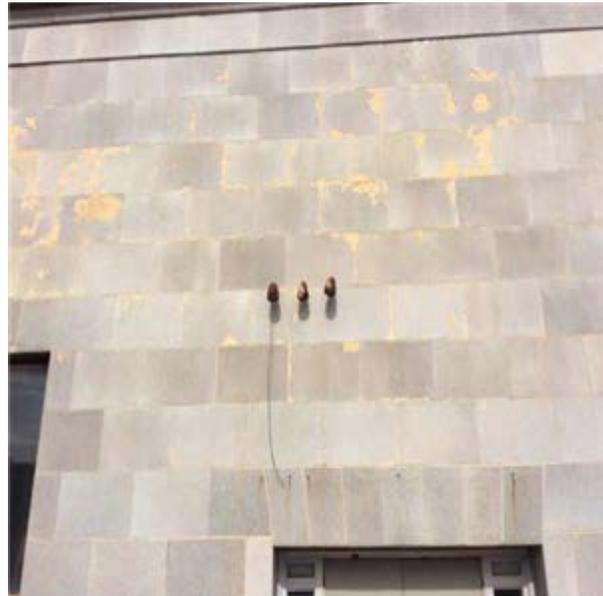
B2011 Terra Cotta Block Masonry

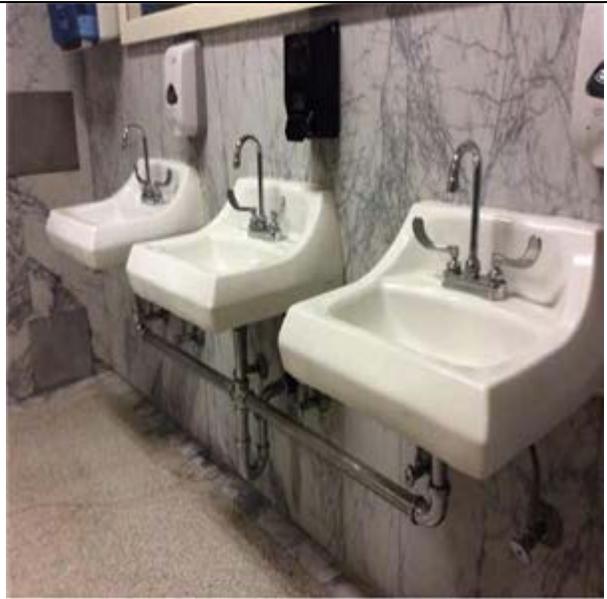
C3005 ADA Renovations

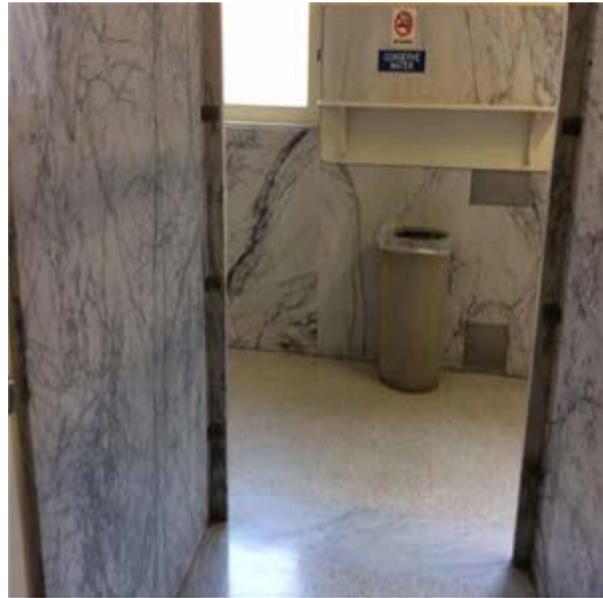
C3005 ADA Renovations

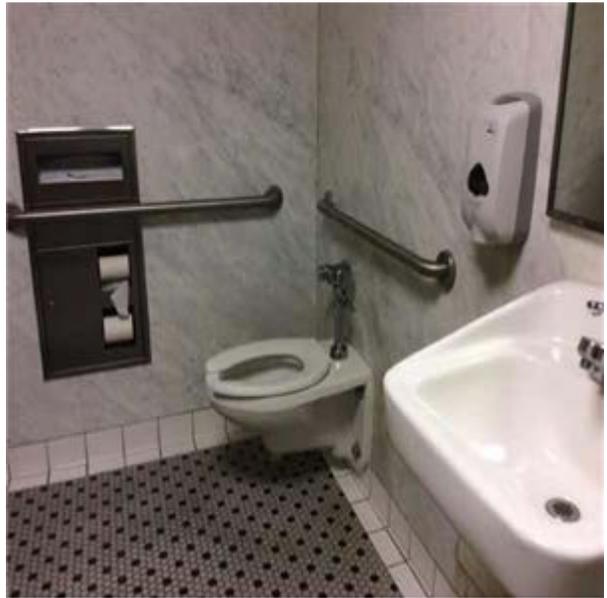
C3005 ADA Renovations

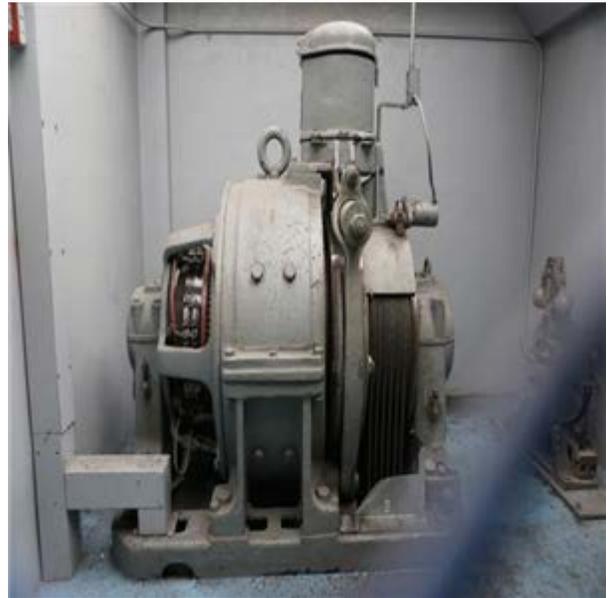
D1011 Modernize Traction Elevator:- Original 1929 equipment

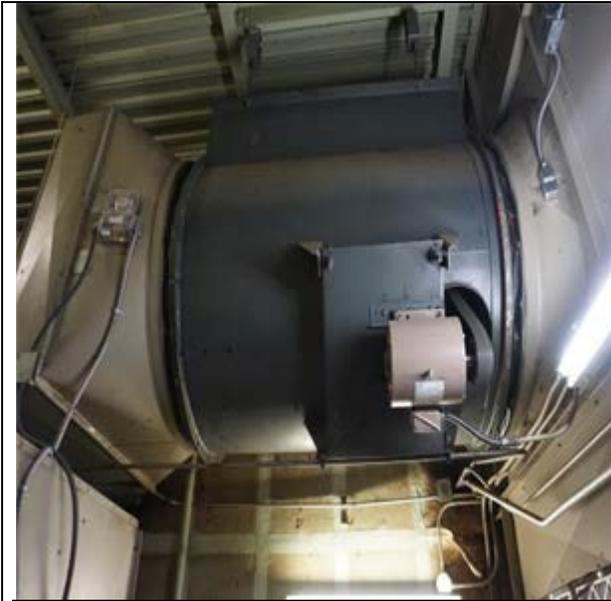
D3042 Exhaust Fan 2 hp

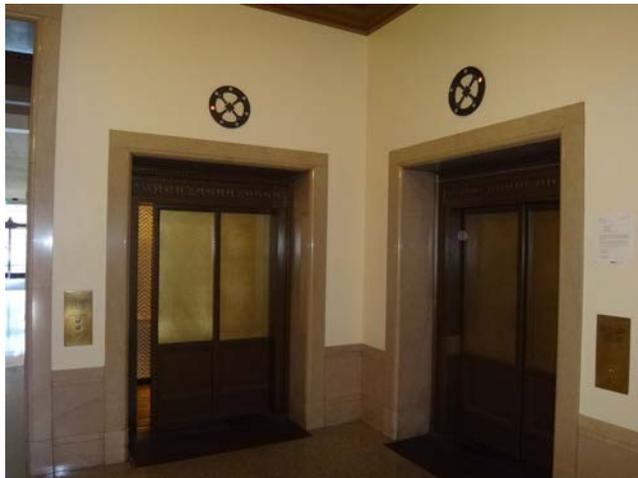
Hall Call Pushbuttons:

At each floor hall call push buttons are located so that users can call the elevator. The hall call stations have raised operation buttons which meet ADA and California Title 24. These were all noted to be in good condition.

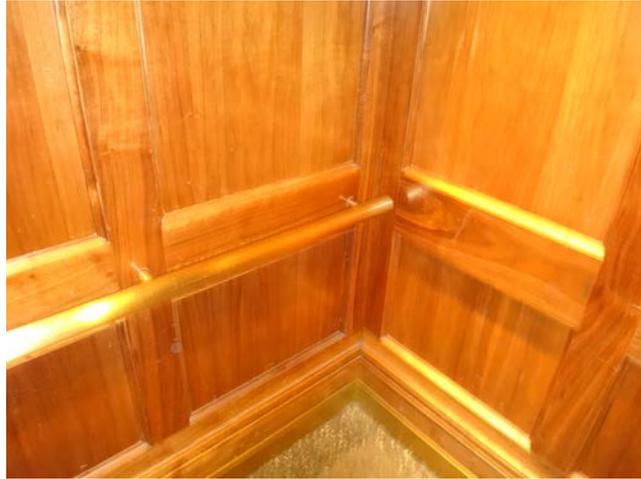
Wall Finish:

The existing cab interiors have high-end wood finishes that match the historical décor of the building. No work is anticipated on the cab interiors.

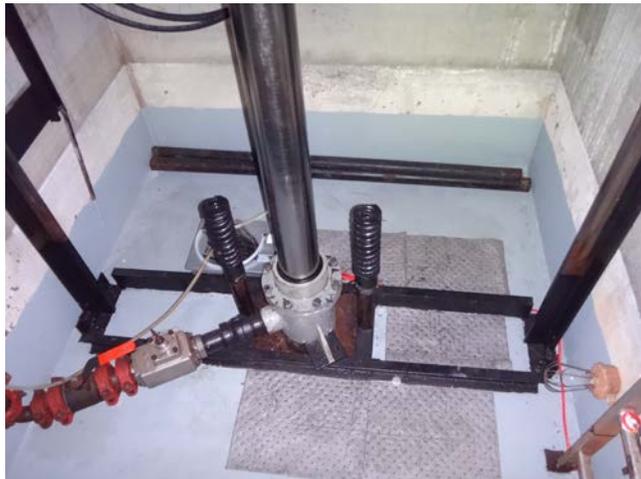
Hydraulic Pit:

Elevator 4 has an in-ground jack and seismic rupture valve. The pit was noted to be clean and in good condition.

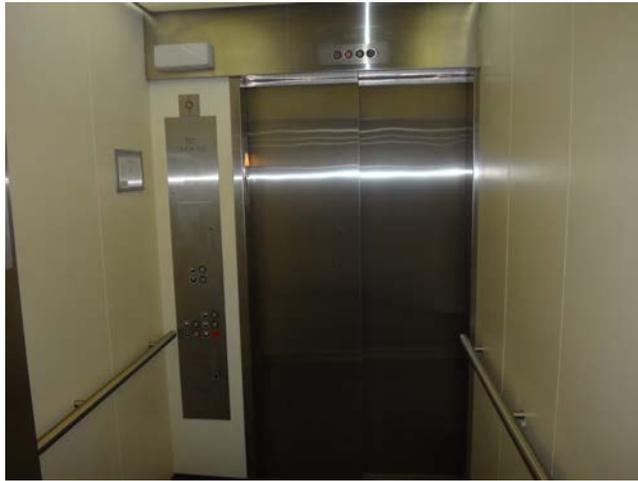
Car 4 Cab:

Passenger elevator, Car 4 is in good condition as it appears to be very lightly used. This is an important elevator for the vault, but because it is lightly used the modernization is not as urgent as for Cars 1-3.

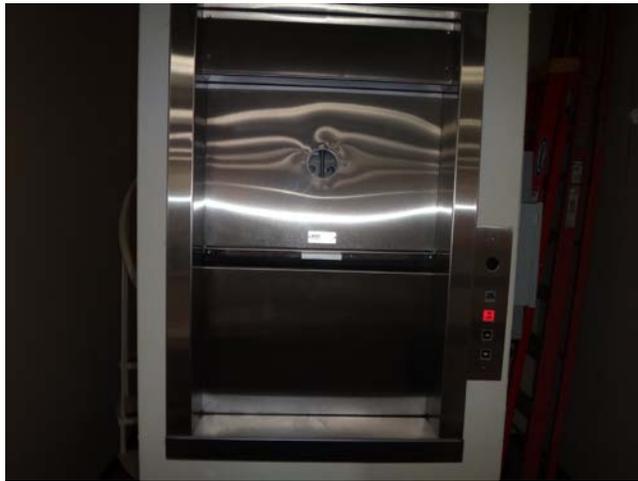
Dumbwaiter:

The dumbwaiter is adjacent to the vault elevator, Car 4 and is in great condition. No work is needed at this time nor recommended.
