Paul Bonderson Building (016)

901 "P" Street, Sacramento, CA 95814

Facility Condition Assessment

June 2015

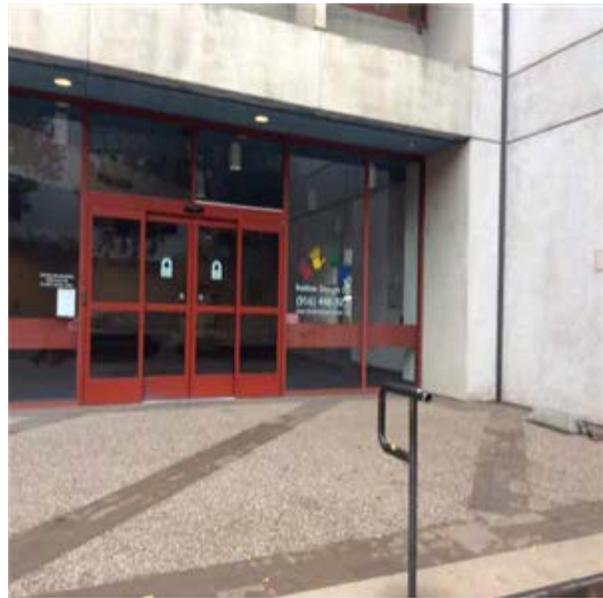
B2031 Glazed Entrance Doors :- Northwest entrance

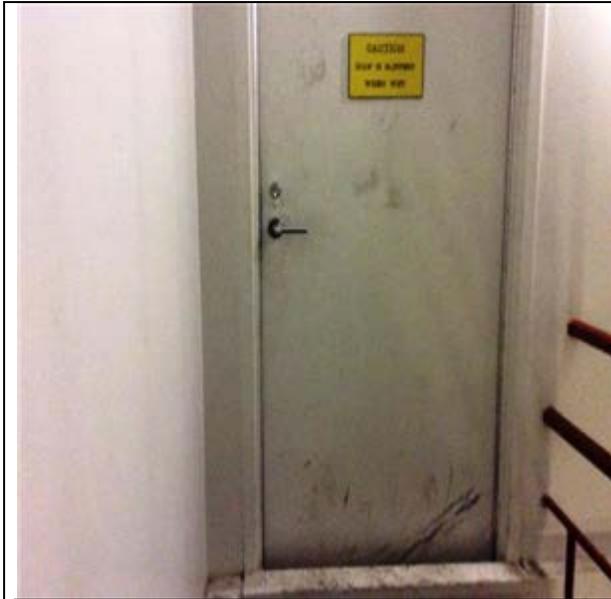
B2032 Steel, Insulated Core, Ptd. Door :- Upper level roof access

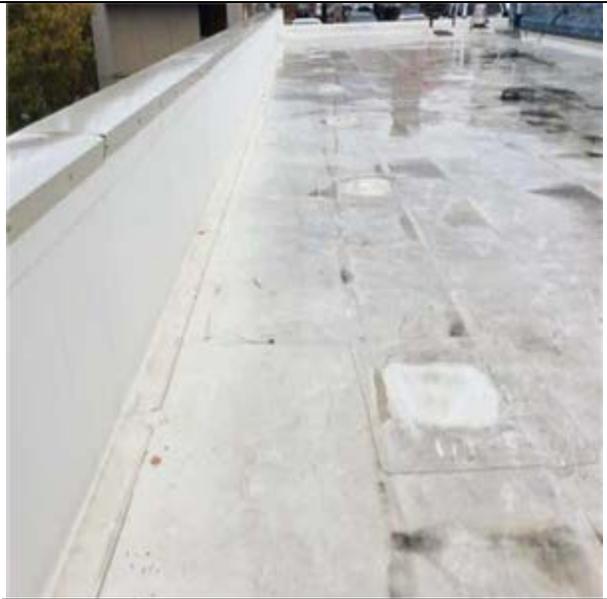
B3011 Single Ply PVC Membrane Roofing:- lower roof

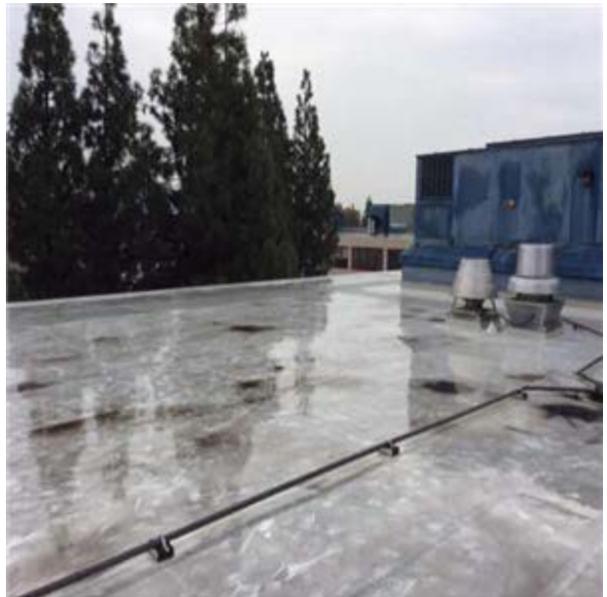
B3011 Single Ply PVC Membrane Roofing:- upper roof without parapet

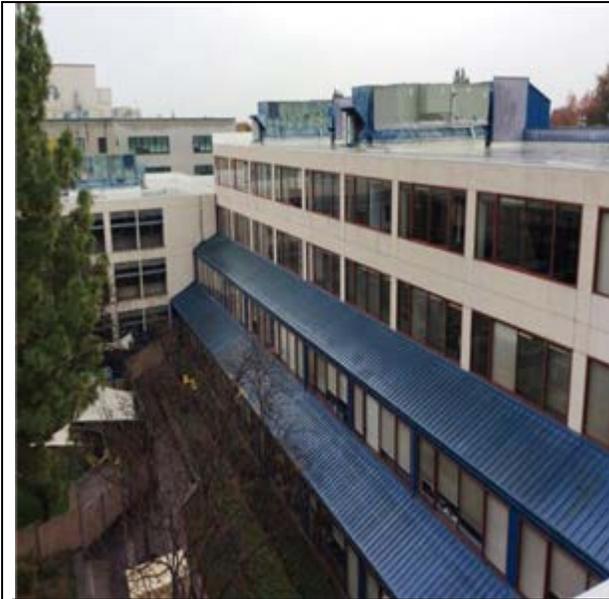
B3011 Metal Steep Roofing, Metal Panel :- West side

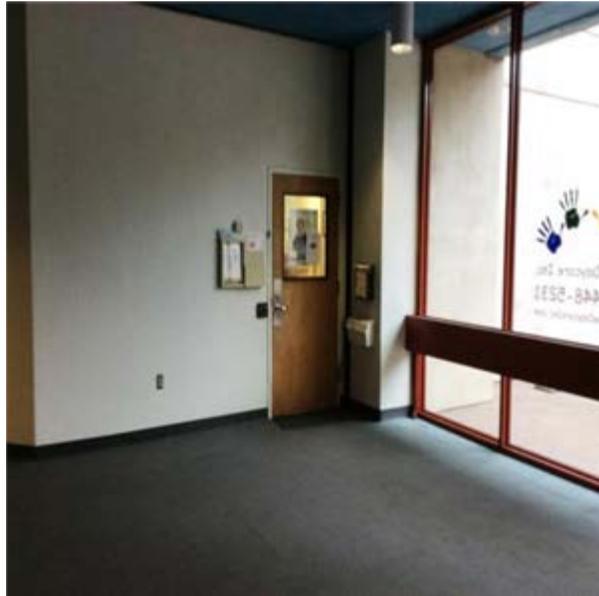
C3012 Paint Interior Walls, Drywall :- Vacant Area

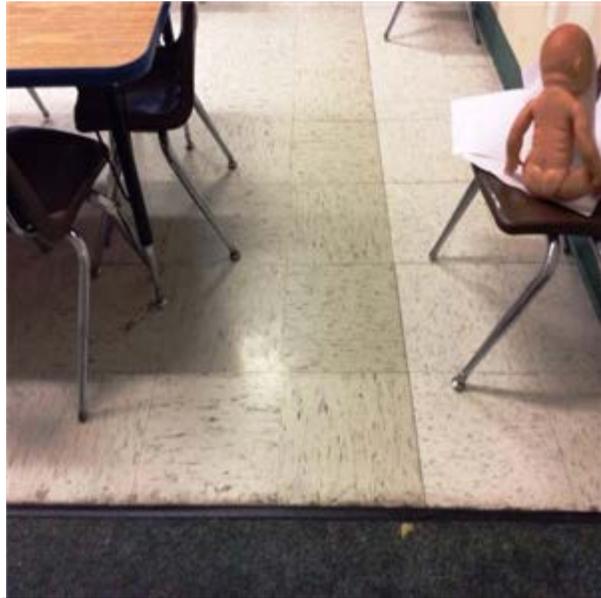
C3024 Vinyl Tile :- Child Care Center

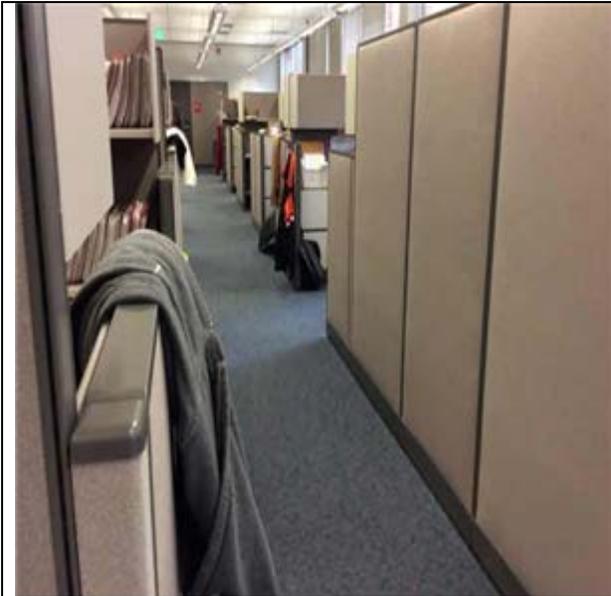
C3025 Carpet, Standard Commercial, Medium Traffic :-
Office area Carpet

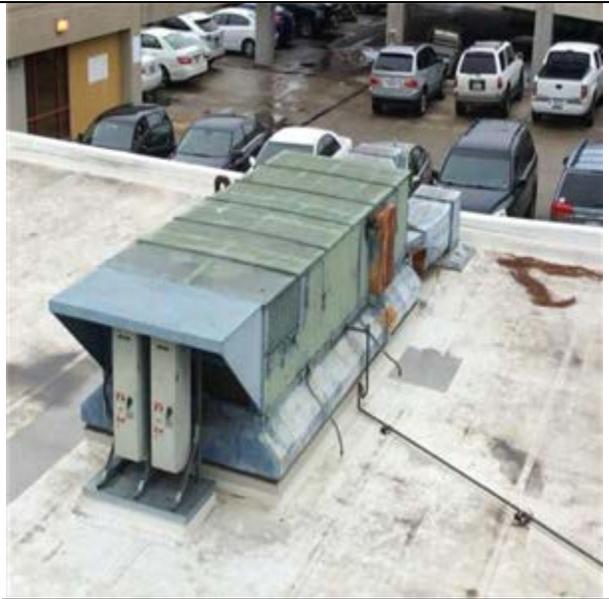
D3041 Air Handler 18,000-20,000 CFM (Original)

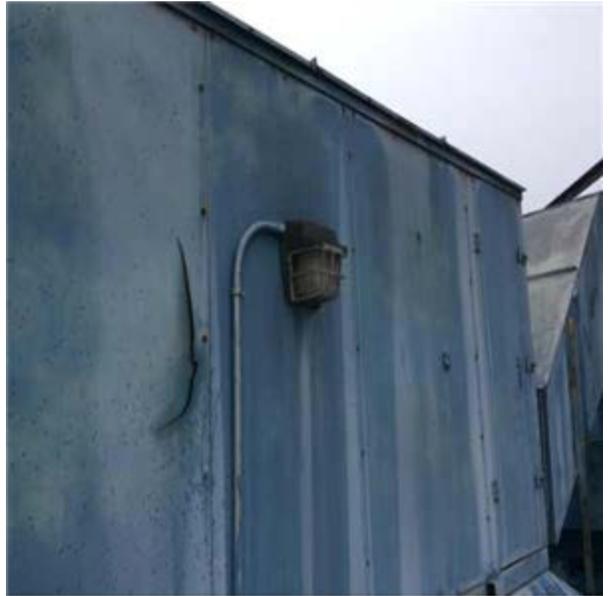
D3041 Air Handler 18,000-20,000 CFM (Original)

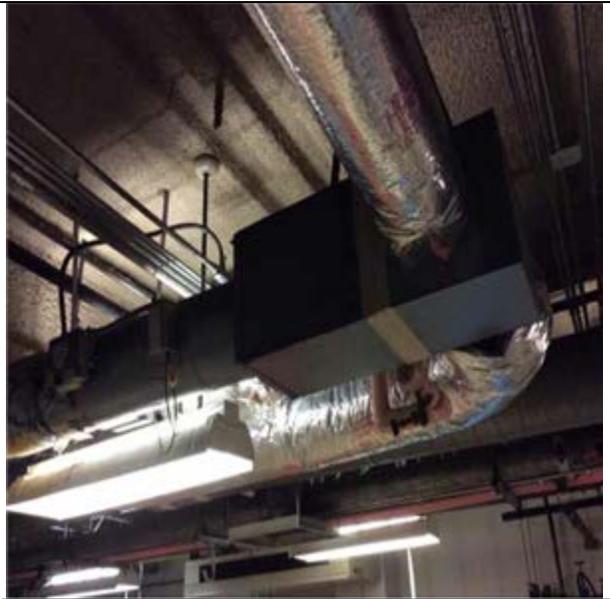
D3041 VAV Boxes:- VAV box

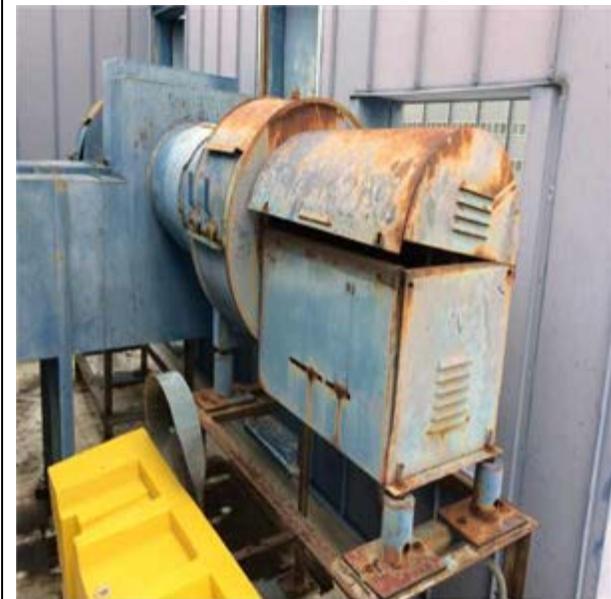
D3042 Kitchen / Print Shop Make Up Air Unit 5000 CFM :- Kitchen area exhaust fan

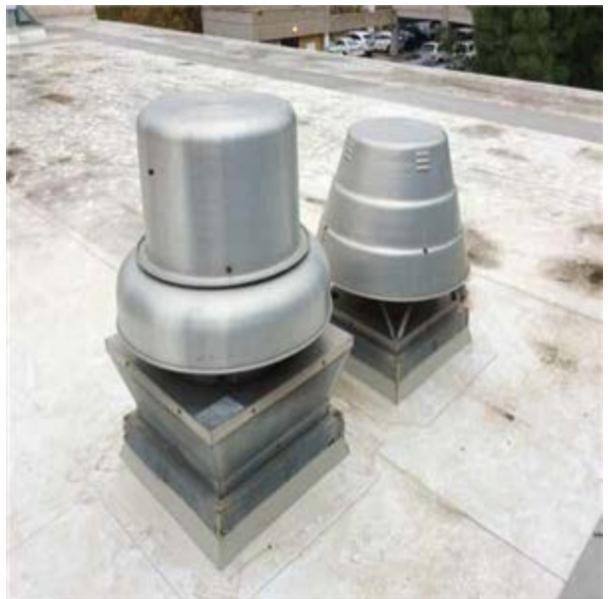
D3042 Exhaust Fan 2000 CFM:- Exhaust fans

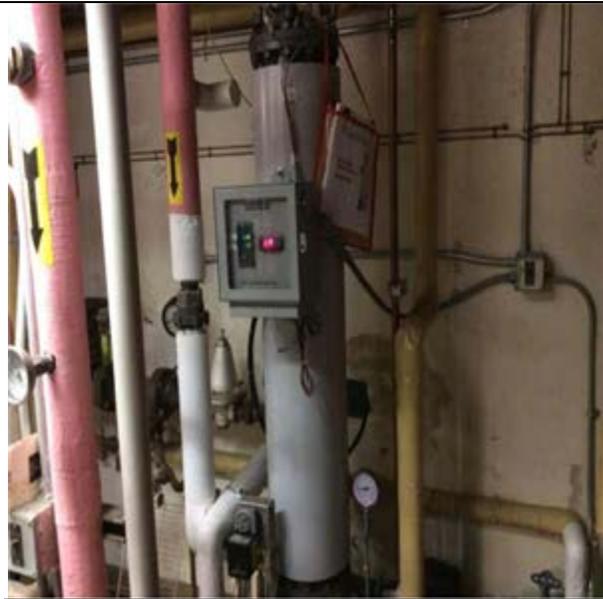
D3043 Domestic Hot Water Heat Exchanger:- New domestic water heat exchanger

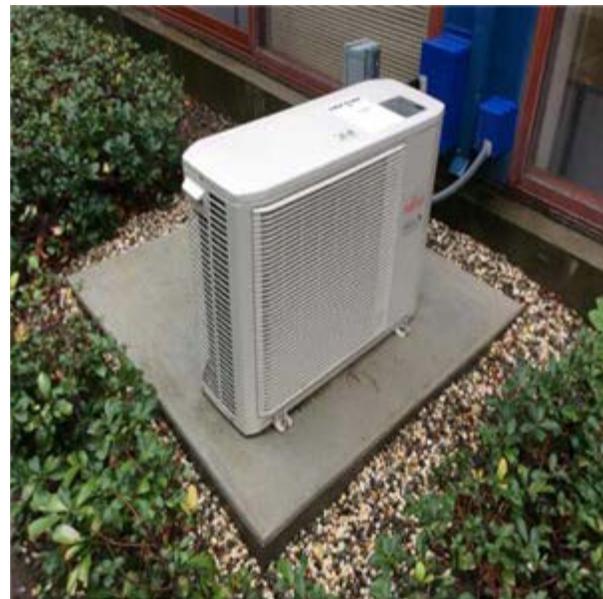
D3052 Computer Room 2-Ton Split Ductless System, Cooling Only :- Split system heat pump for server room

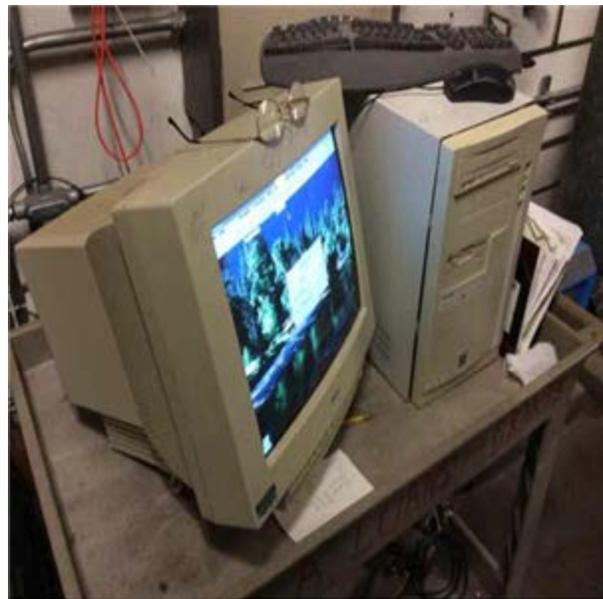
D3068 Pneumatic HVAC Controls:- PC with HVAC control software

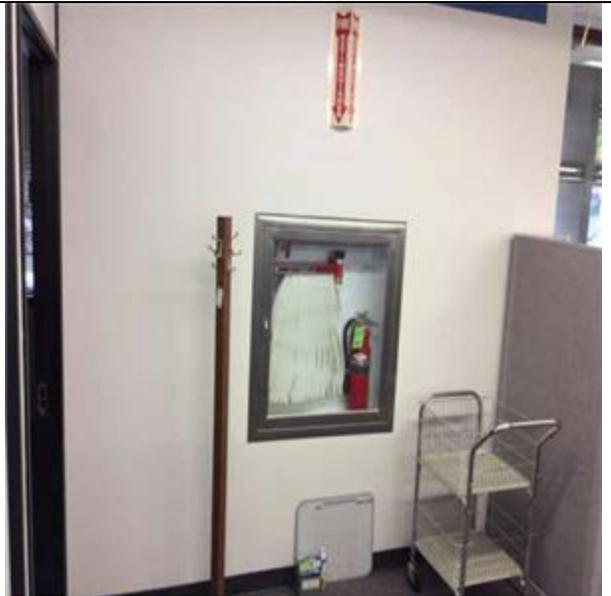
D4011 Wet Pipe Sprinkler System:- Fire hose cabinet

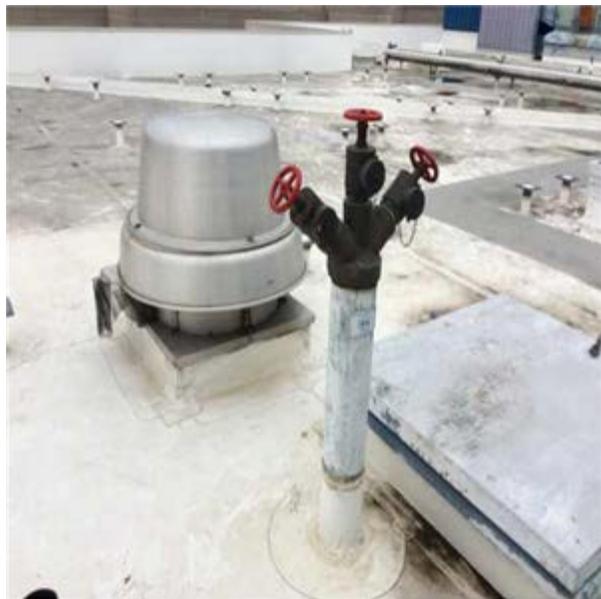
D4011 Wet Pipe Sprinkler System :- Dry standpipe connection on roof

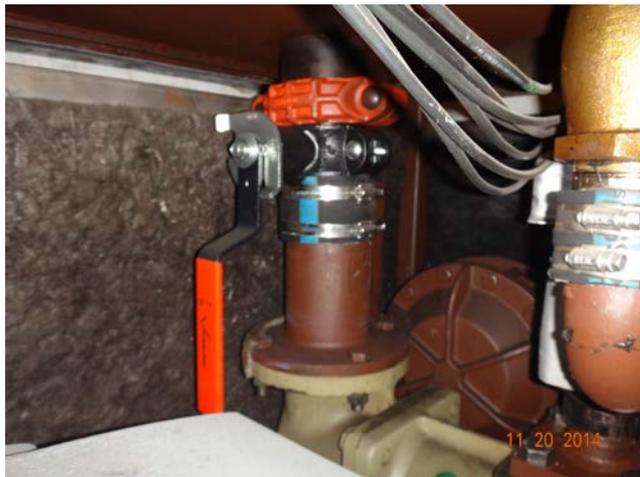
The power units are equipped with Maxton control valves, IMO pumps, and AC electric motors. None of the units have shut off valves in the machine rooms except Car 1 which is equipped with a suction line shut off valve.

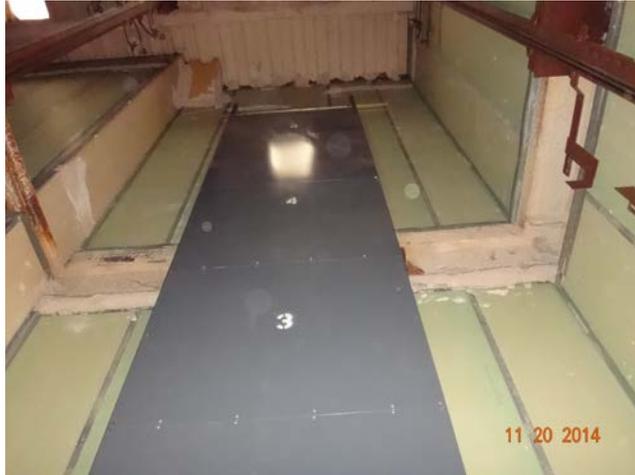
The hoistway (elevator shaft) is the main area where the elevators go up and down. The hoistways are mostly built of drywall and some concrete beams. The vents at the top of the shafts are fixed open. These could be replaced with motorized vents that are normally closed to reduce energy loss.

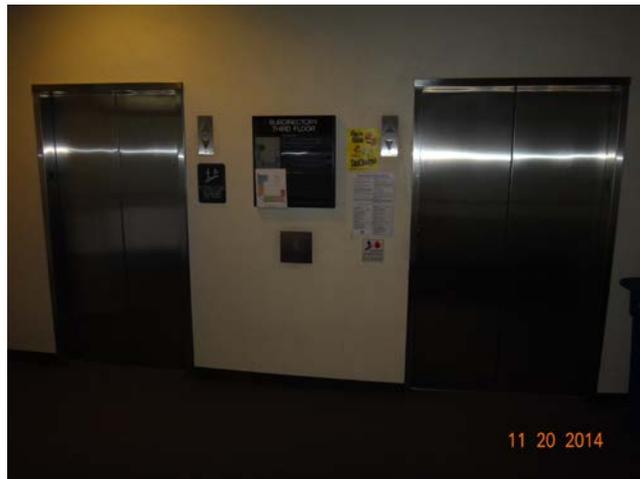
At each floor hall call push buttons are located so that users can call the elevator. The hall call stations have raised operation buttons which are ADA and T24 compliant. During a modernization the fixture and fire exit sign will be replaced.
