Personnel Building (021)

801 Capitol Mall, Sacramento, CA 95814

Facility Condition Assessment

June 2015

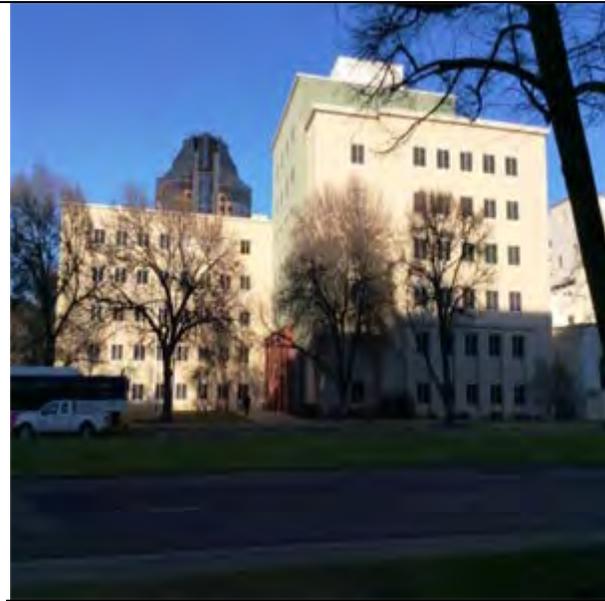
:- Front elevation

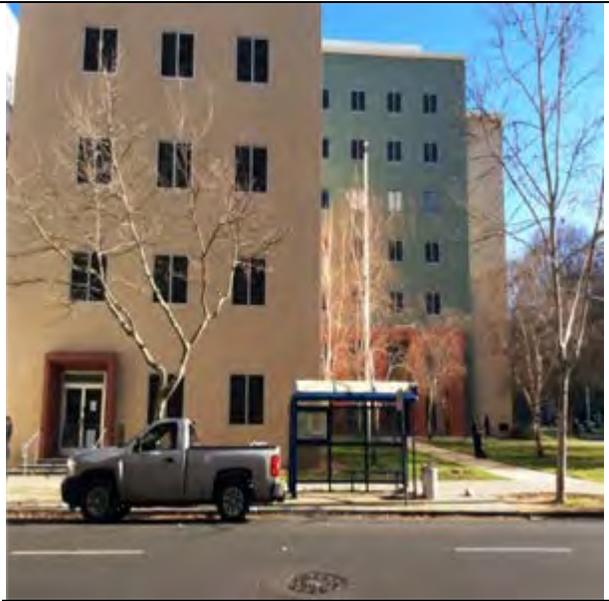
:- West elevation

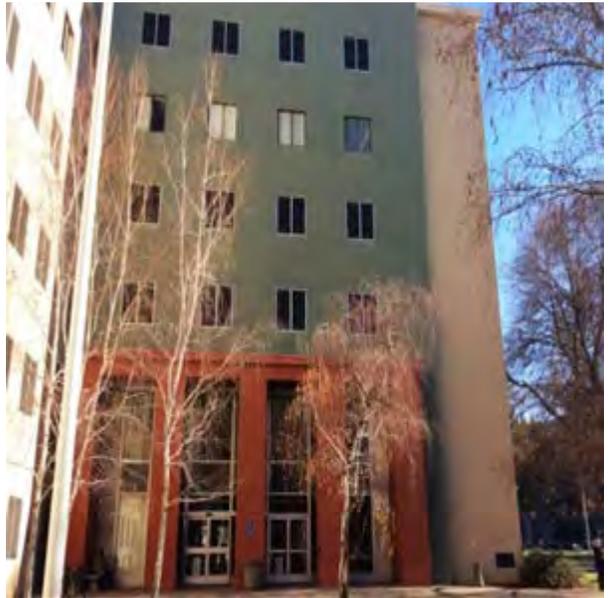
:- Front entrance

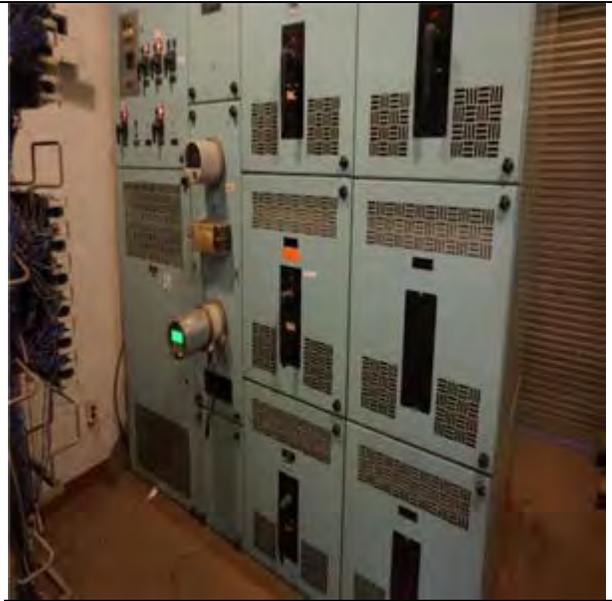
D5010 Switchgear, Mainframe, 3000 Amps

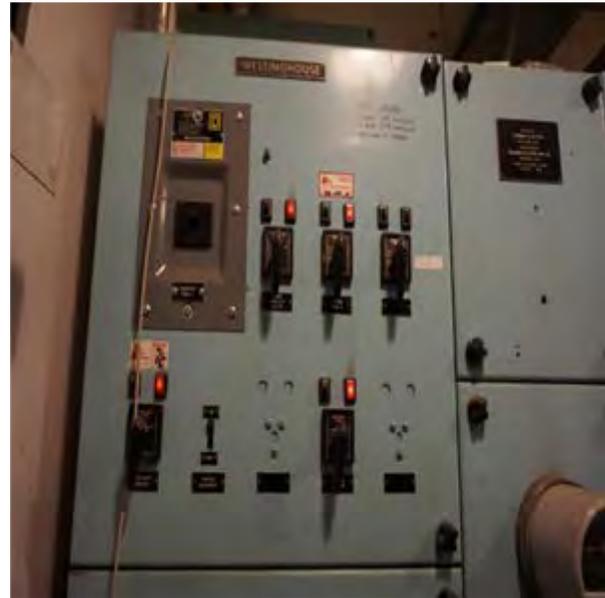
D5010 Switchgear, Mainframe, 3000 Amps

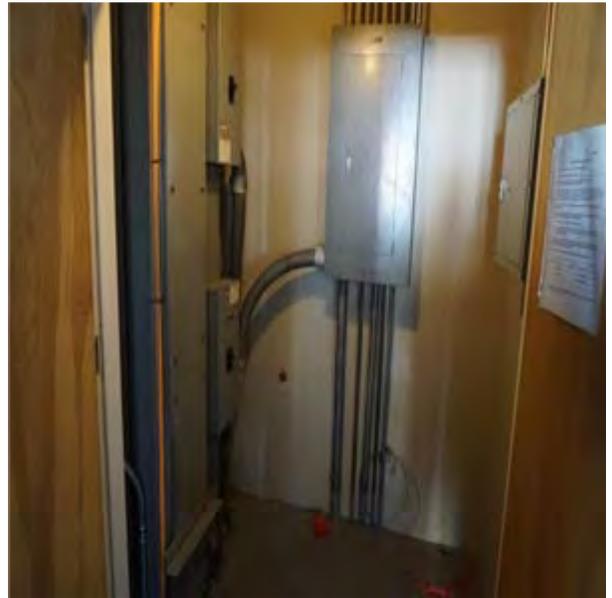
D5012 Breaker Panel 225 Amps, 30 Circuits

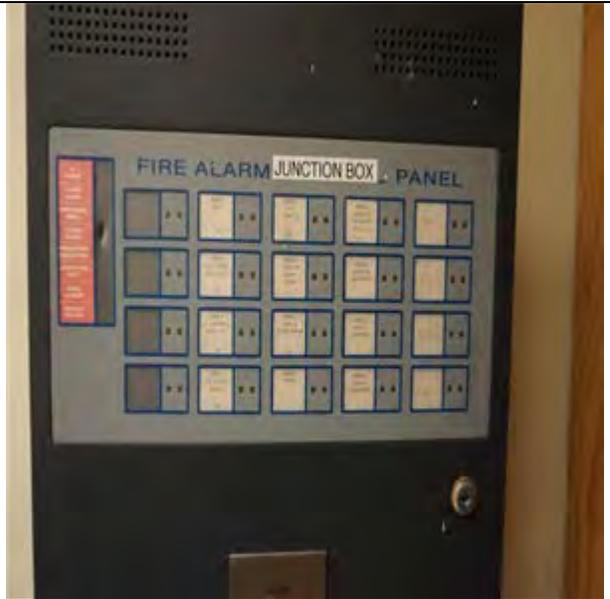
D5037 Fire Alarm Panel

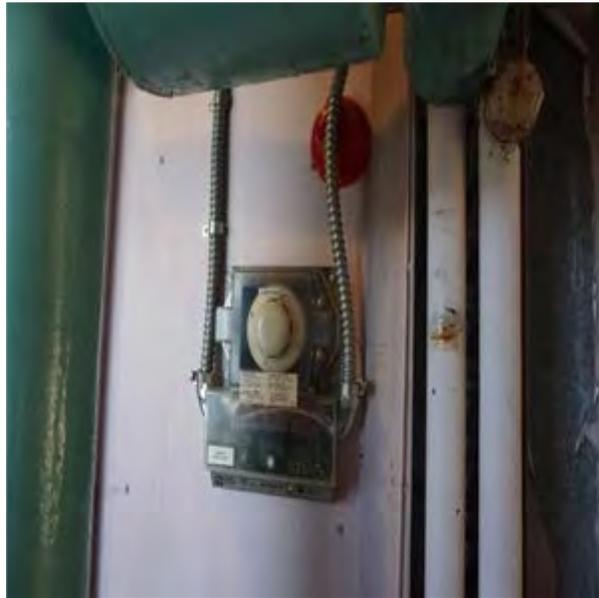
D5037 Fire Alarm System

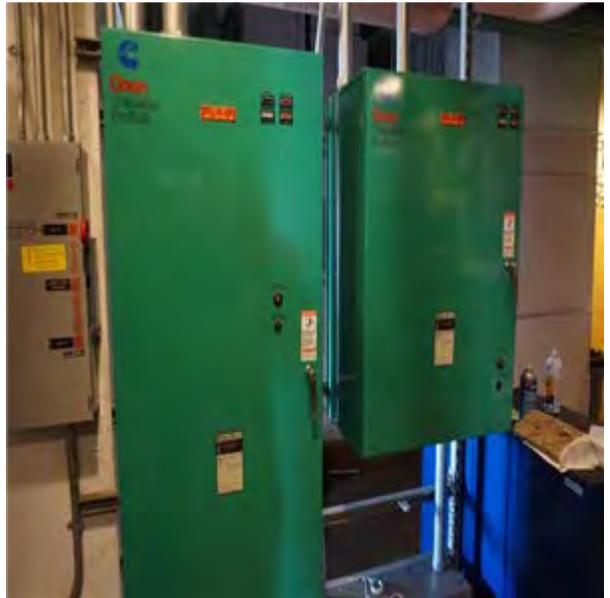
D5092 Emergency Transfer Switch

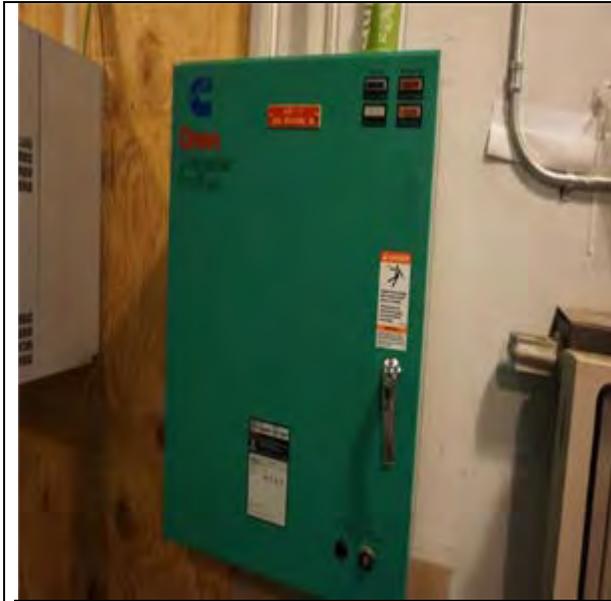
D5092 Emergency Transfer Switch

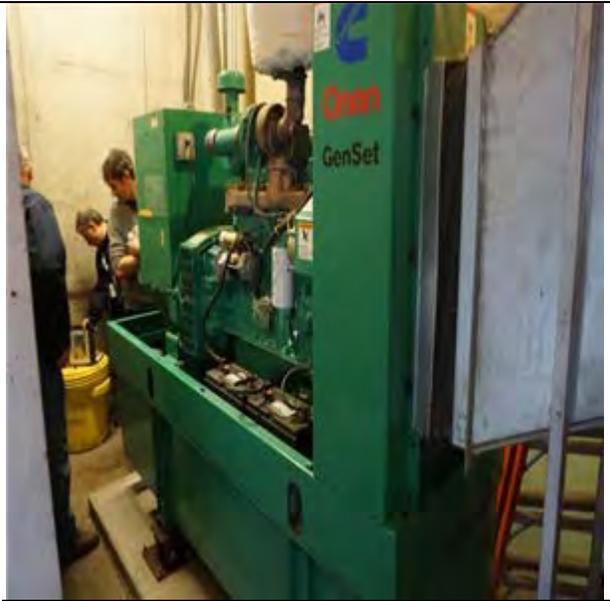
D5092 Emergency Generator 100 kW

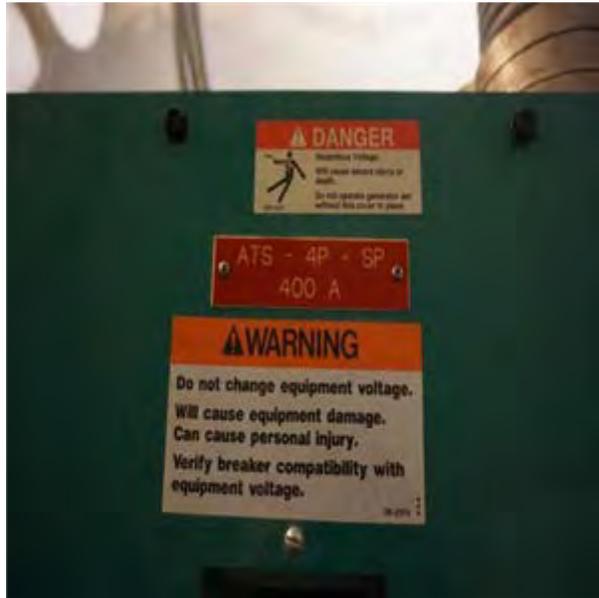
D5092 Emergency Generator 100 kW

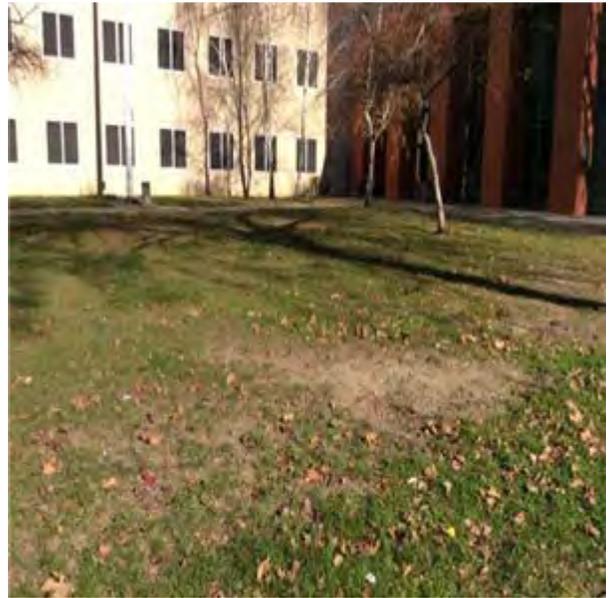
G2053 Landscaping
