Secretary of State / Archives Building (036)

1500 11th Street, Sacramento, CA 95814

Facility Condition Assessment

June 2015

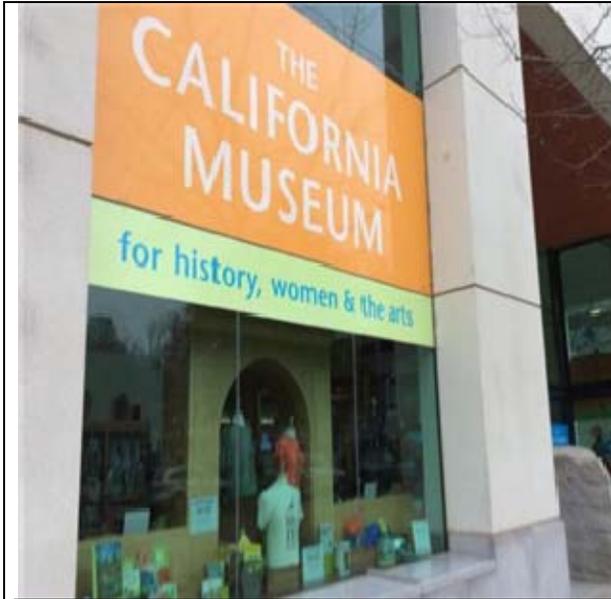
:- Museum entry

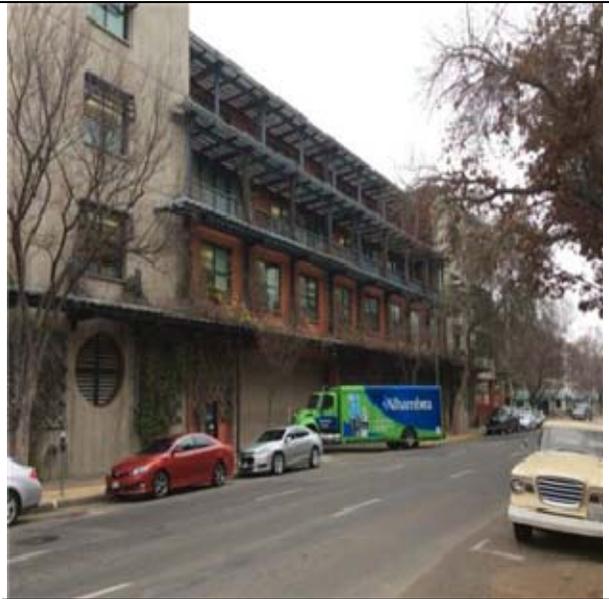
:- Street view

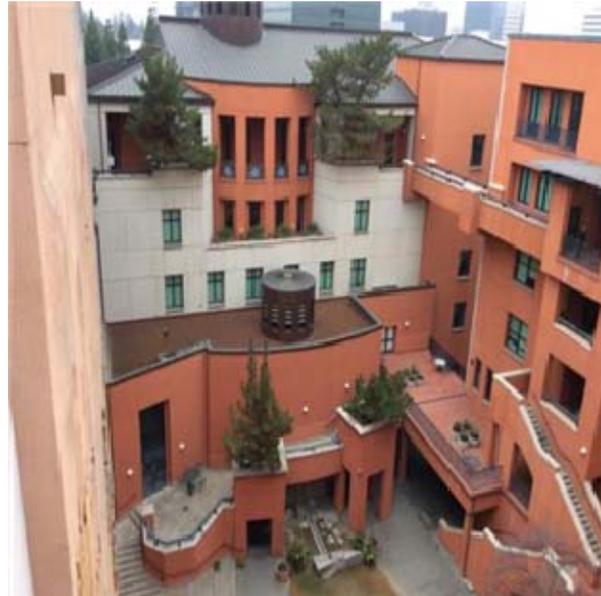
:- Courtyard view from roof

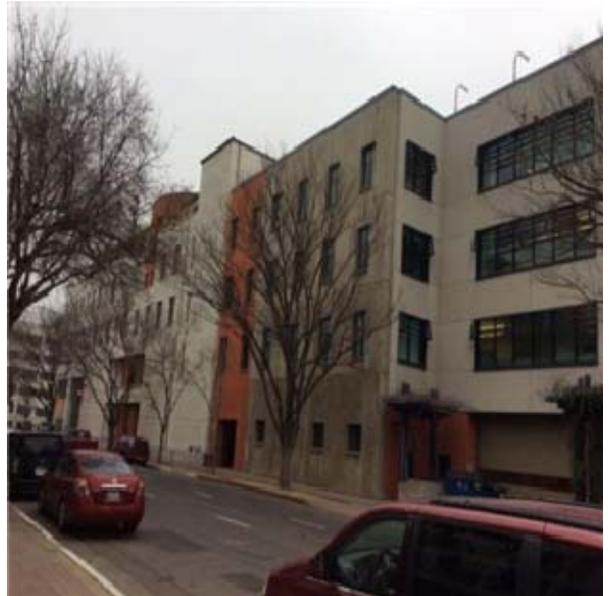
:- Street view

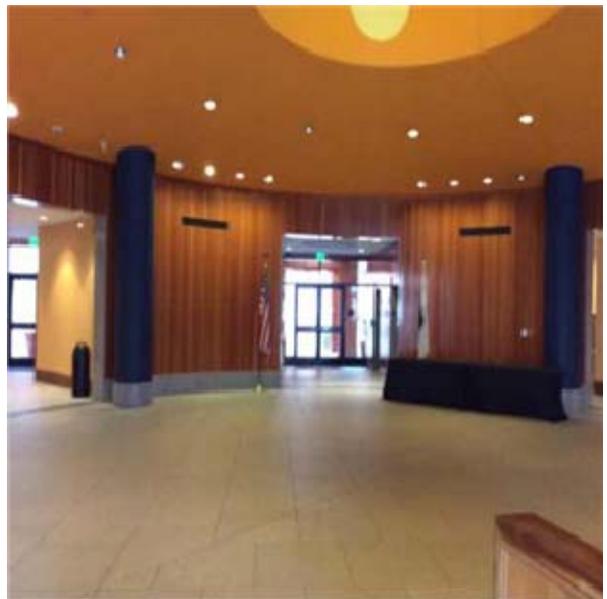
C3012 Paint Interior Walls, Drywall

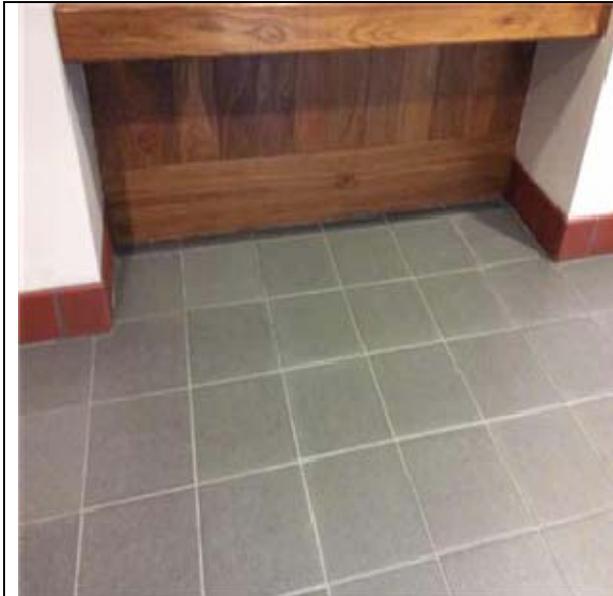
C3024 Granite Flooring

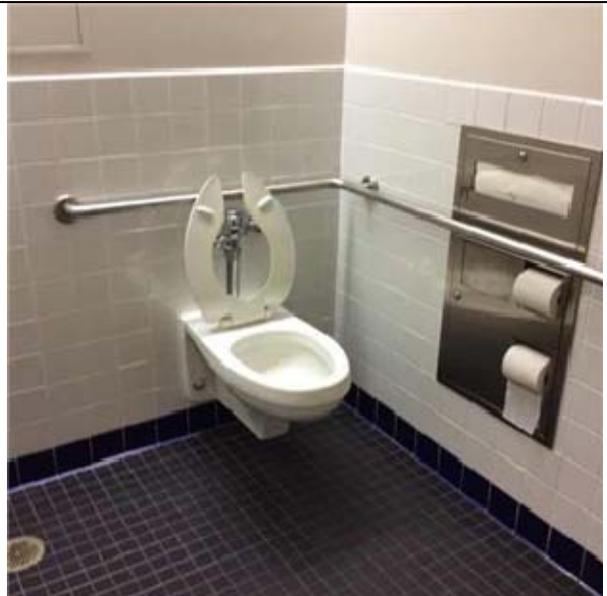
C3024 12 x 12 Ceramic Tile

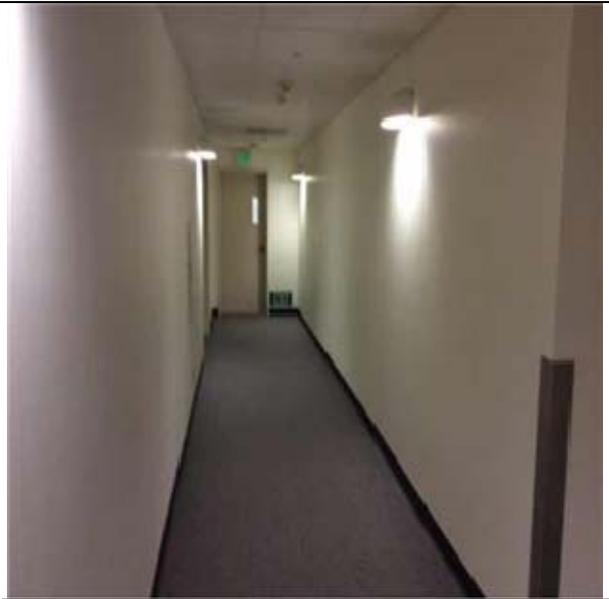
C3032 Acoustical Ceiling Tile

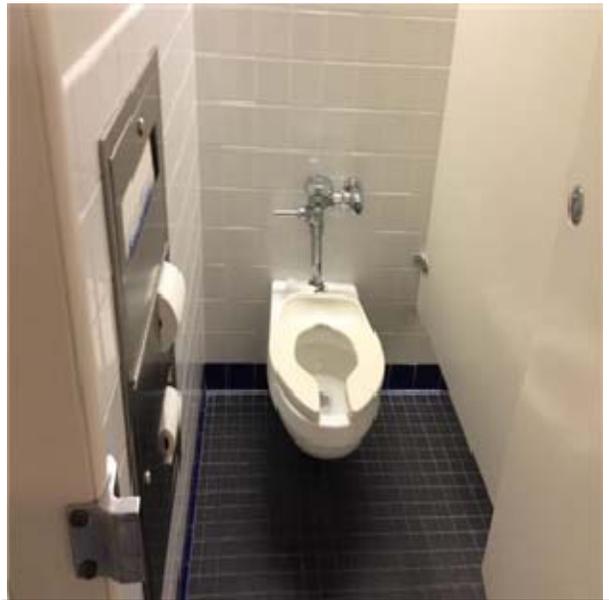
D2011 Commercial Water Closet - 1.6 GPF

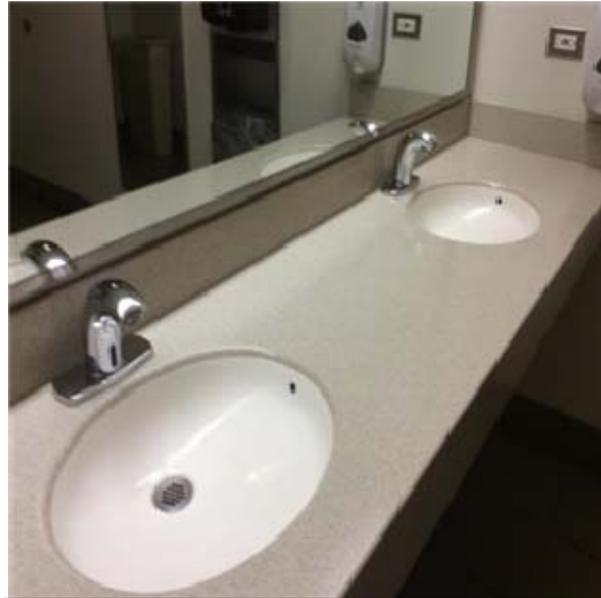
D2013 Counter Top Sink and Faucet - Standard

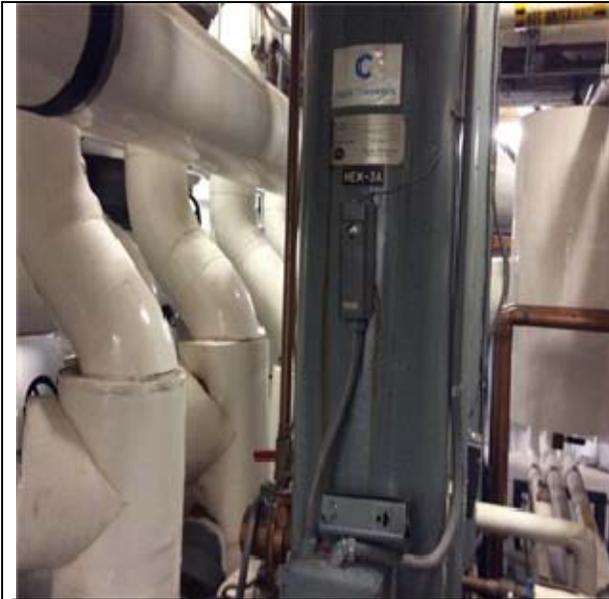
D3020 Water Boiler, Electric 100Kw

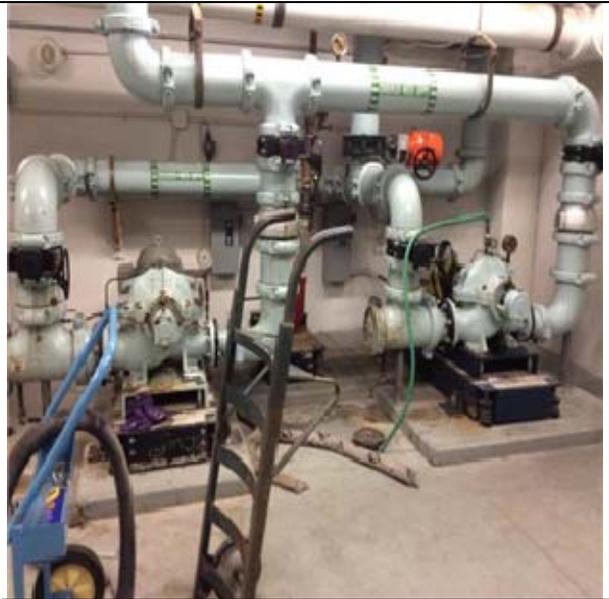
D3022.1 Condensate Return System 5 HP

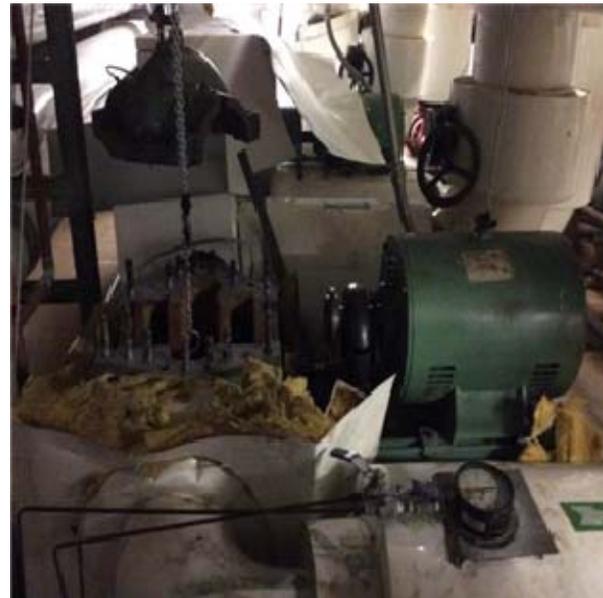
D3022 HVAC Condenser Water - 25 HP

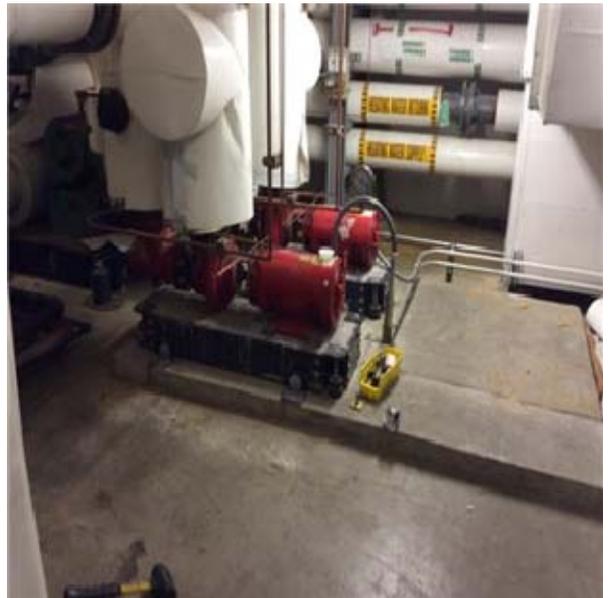
D3022 HVAC Chilled Water Circulation Pumps 40 HP

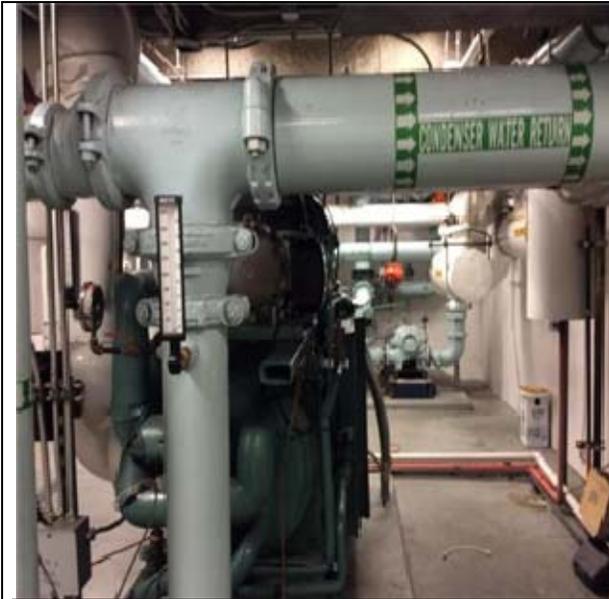
D3022 HVAC Heating Water Circulation Pumps - 25 HP

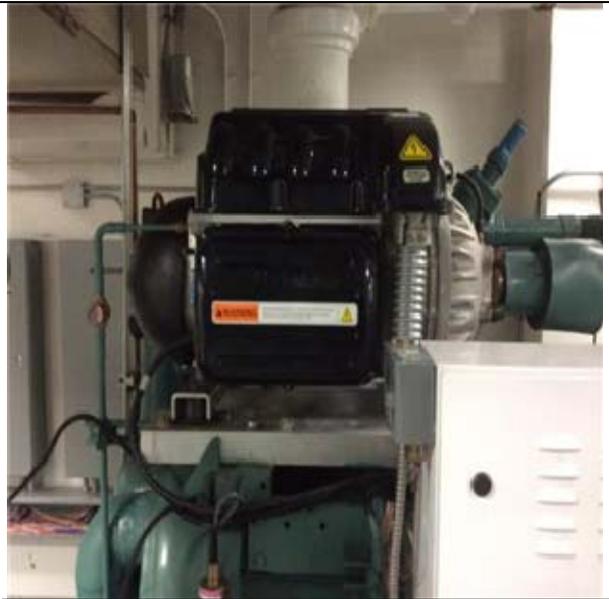
D3031.1 Chiller, Water Cooled, 160 Ton

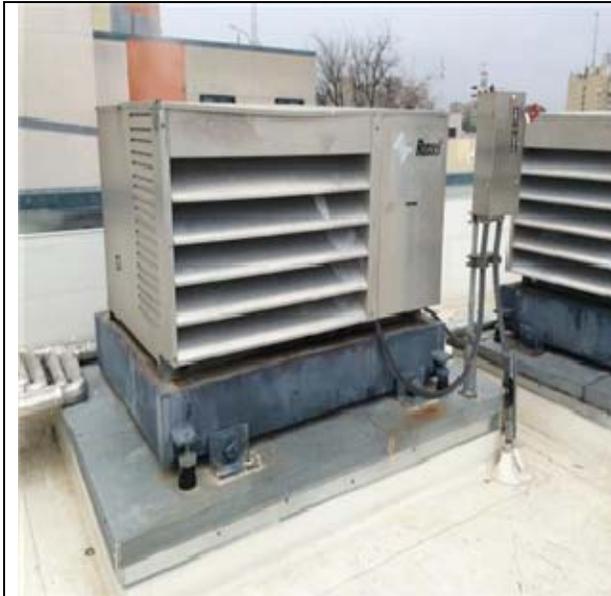
D3032 Roof Mounted Condenser 20-Ton

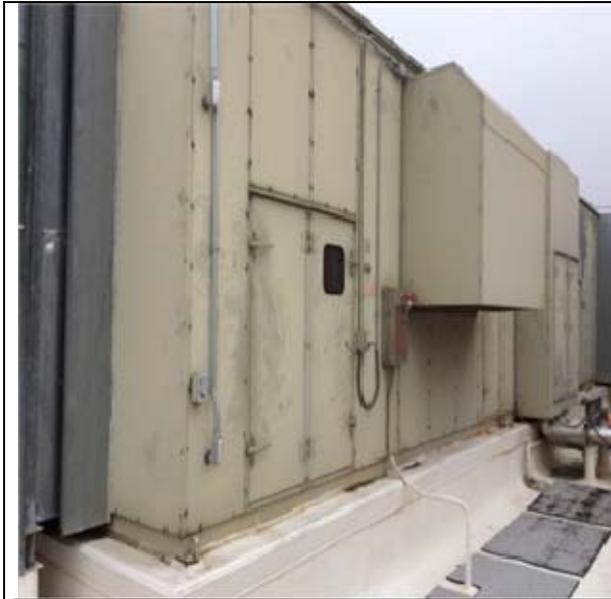
D3041 Interior AHU 28,220 CFM

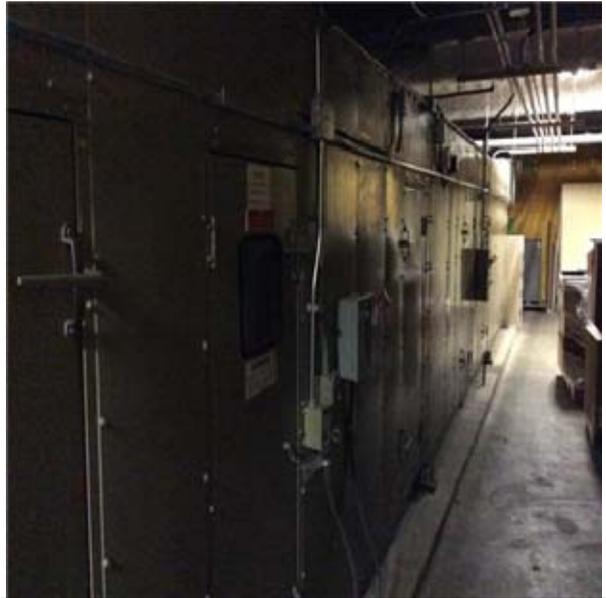
D3041 Interior Fan Coil Units

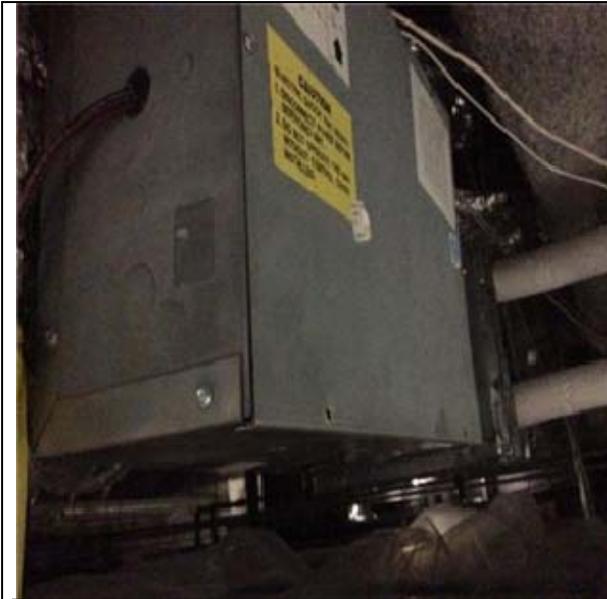
D3041 Interior AHU 12,200 CFM w/ VFD

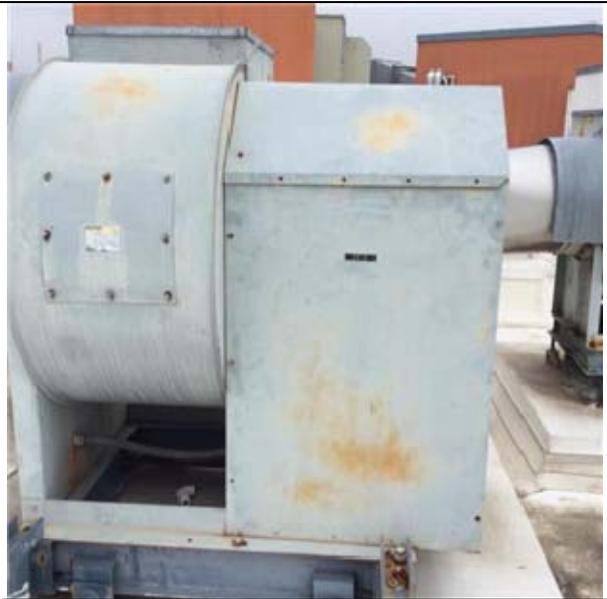
D3041 VAV Boxes

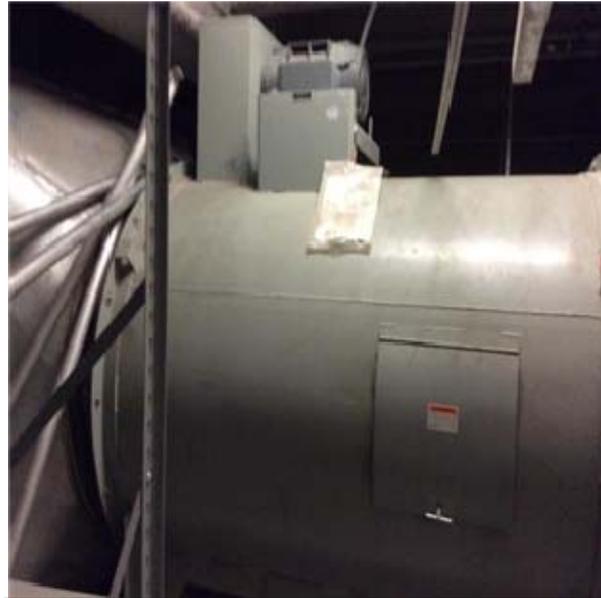
D3042 Exhaust Fan < 15,000 CFM

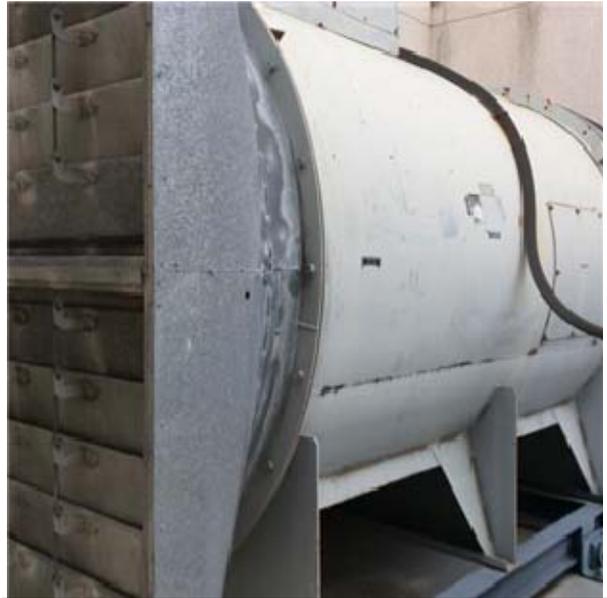
D3042 Exhaust Fan 26,000 CFM

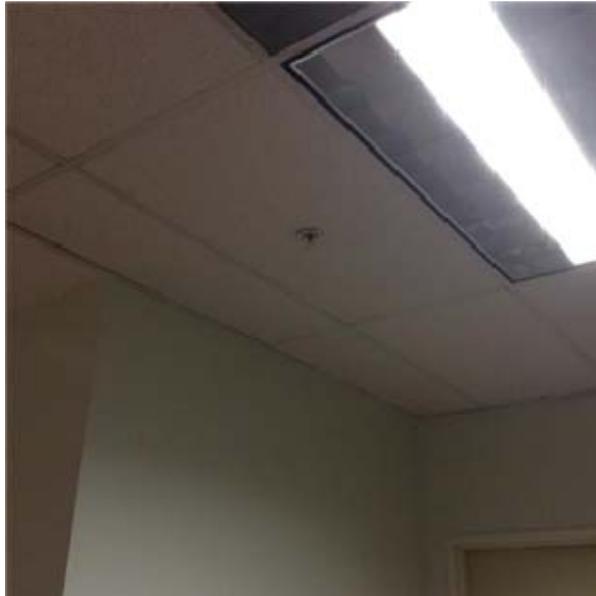
D3068 Pneumatic HVAC Controls

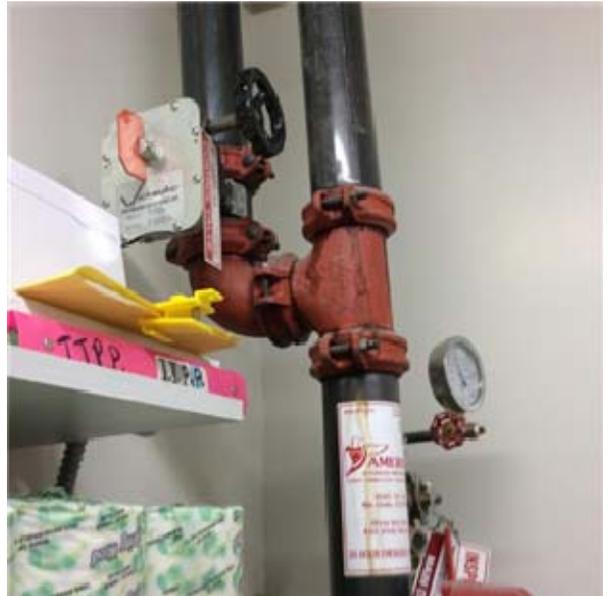
D4011 Sprinkler Heads

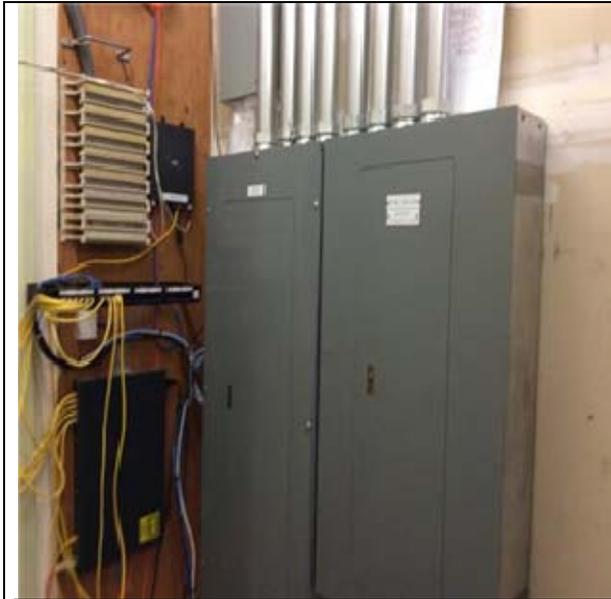
D5012 Breaker Panel 225 Amps, 30 Circuits

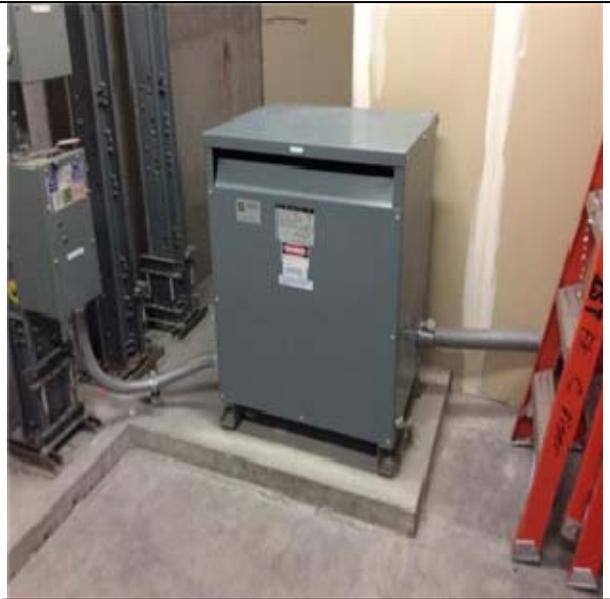
D5012 Secondary Dry Transformer 35 kVA

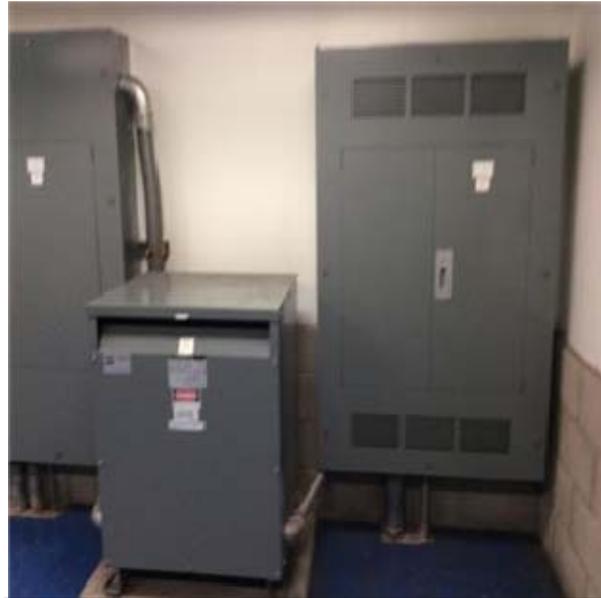
D5012 Secondary Dry Transformer 75 kVA

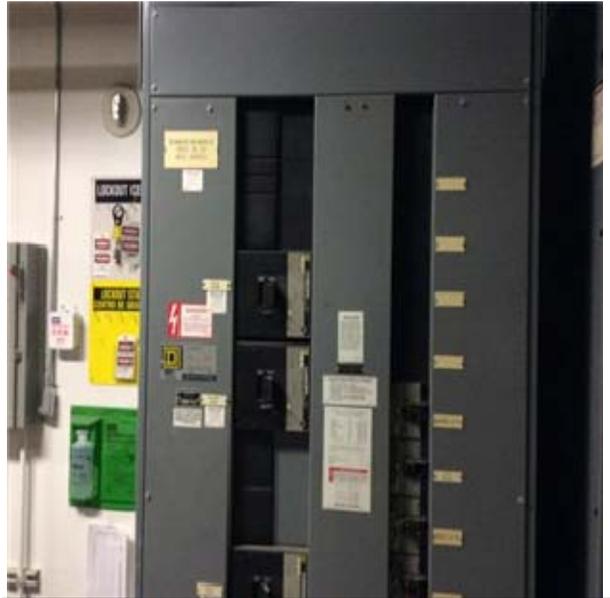
D5010 Switchgear, Mainframe, >1000 Amps

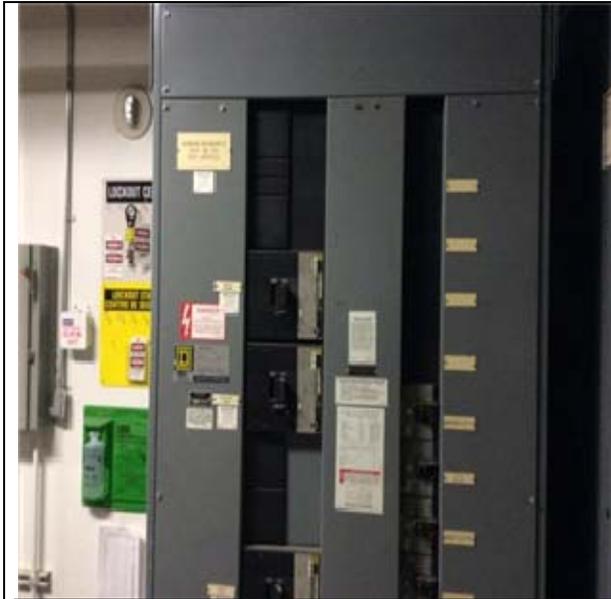
D5010 Switchgear, Mainframe, 1200 Amps

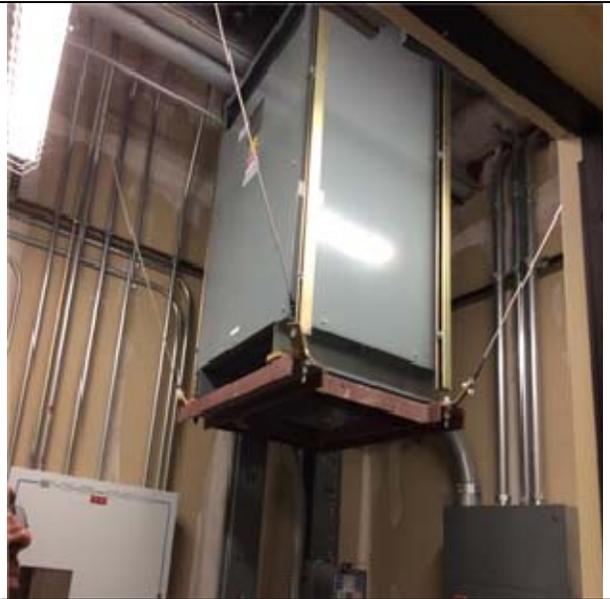
D5012 Secondary Dry Transformer 45 kVA

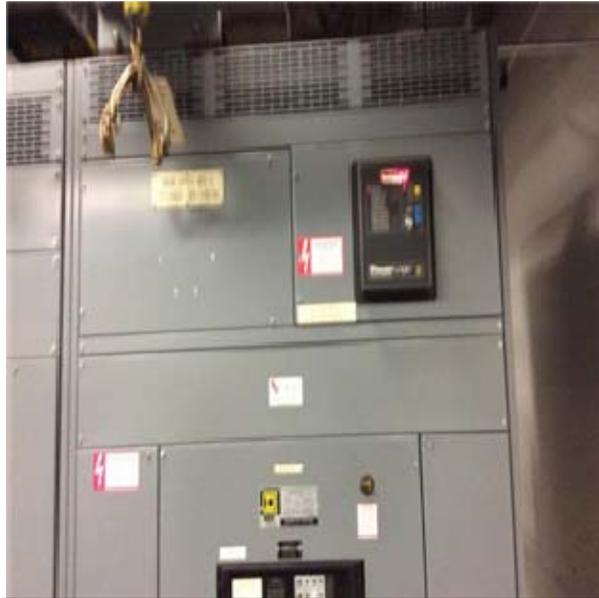
D5010 Switchgear, Mainframe, >1600 Amps

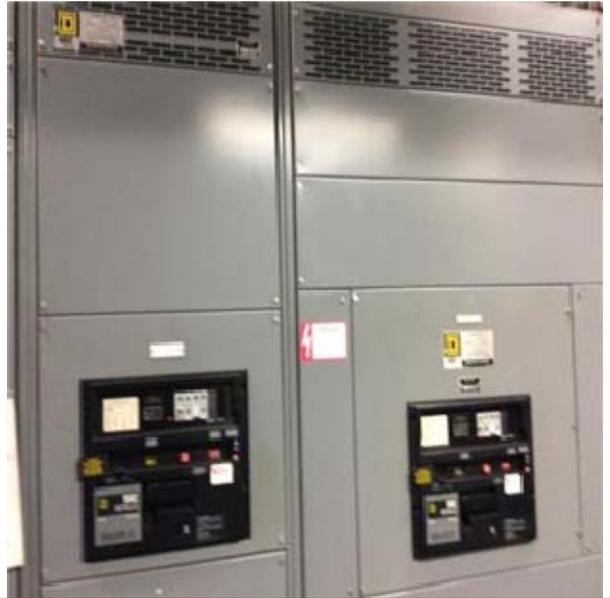
D5010 Switchgear, Mainframe, >1600 Amps

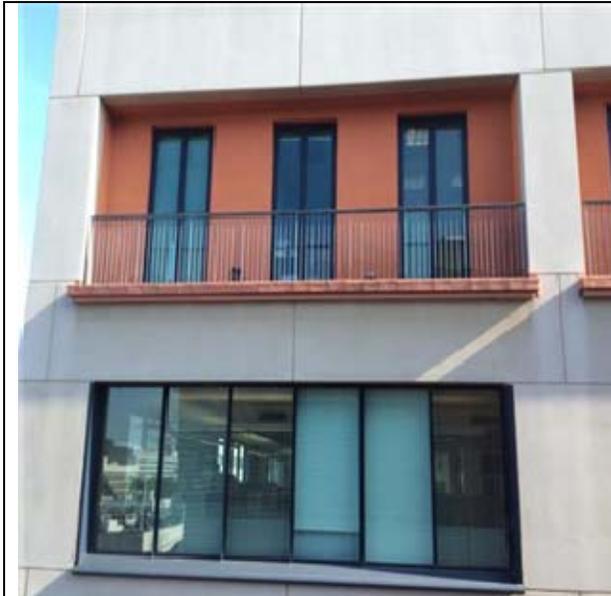
D5022 Exterior lighting

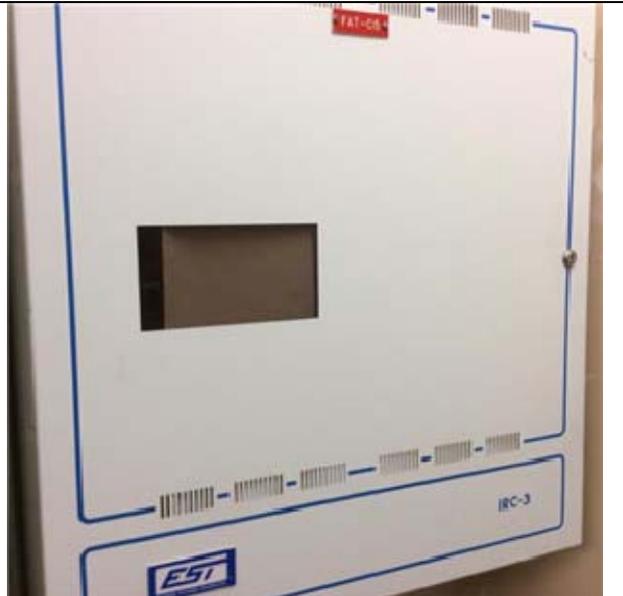
D5037 Fire Alarm System

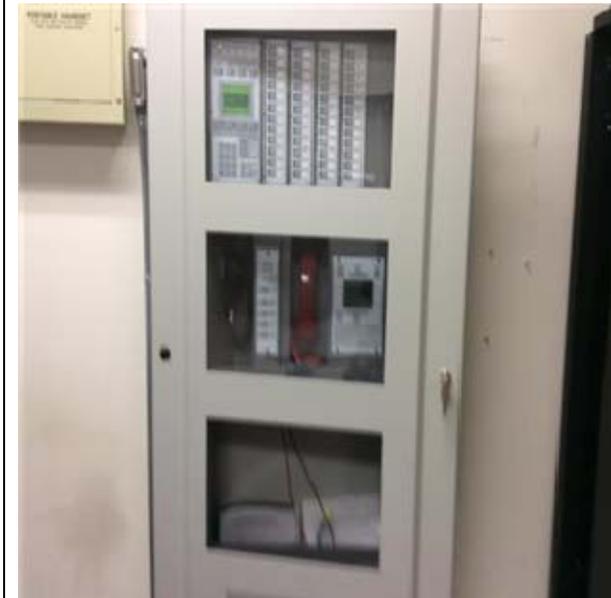
D5037 Fire Alarm Panel

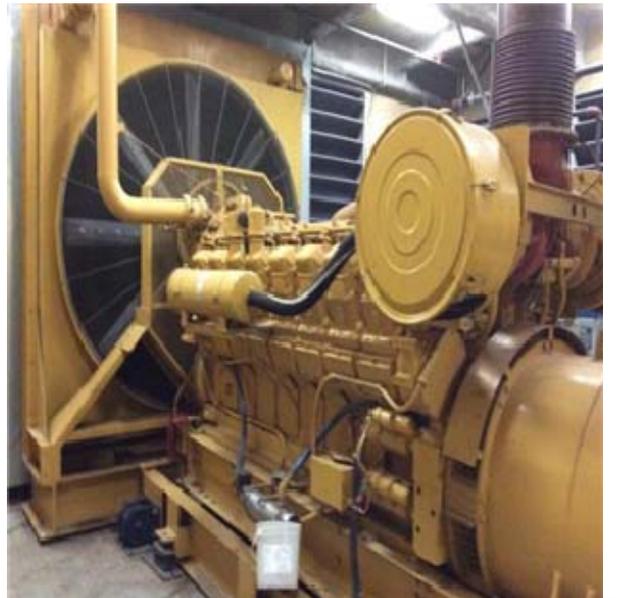
D5092 Emergency Generator 1750 kW

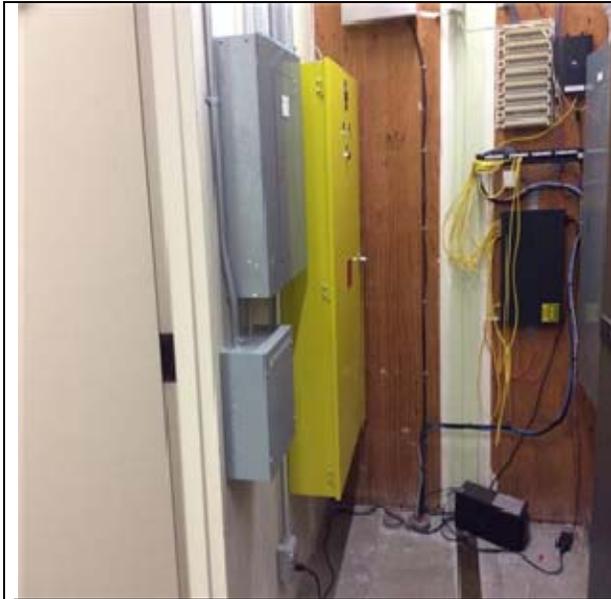
D5092 Emergency Transfer Switch

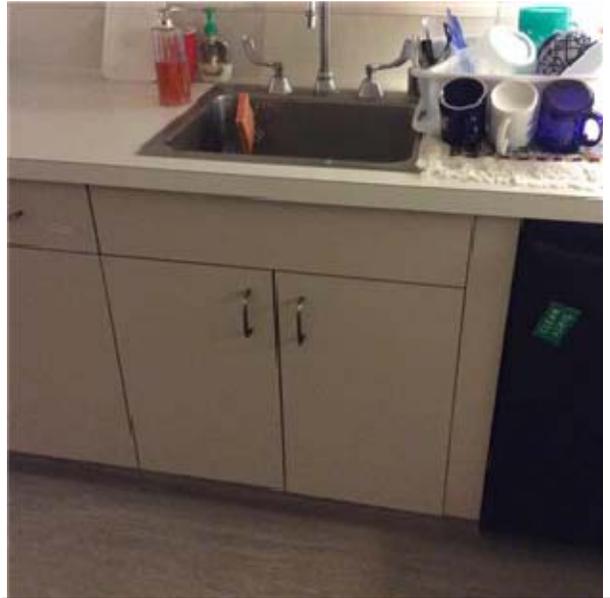
E2012 Counter Top and Sink

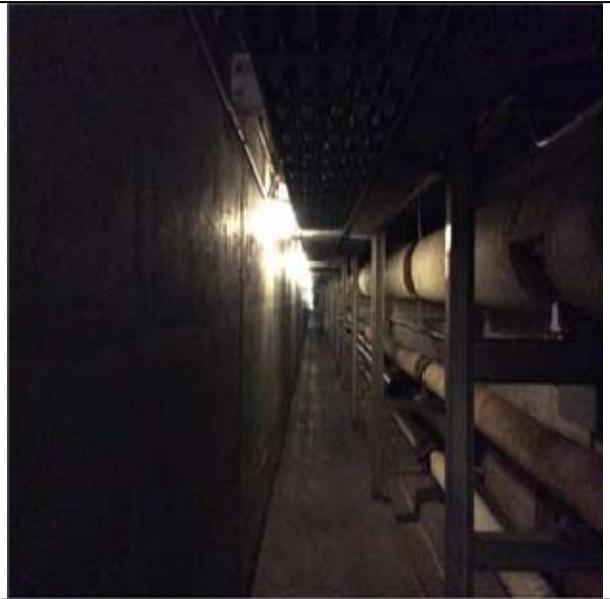
G9010 Service Tunnels

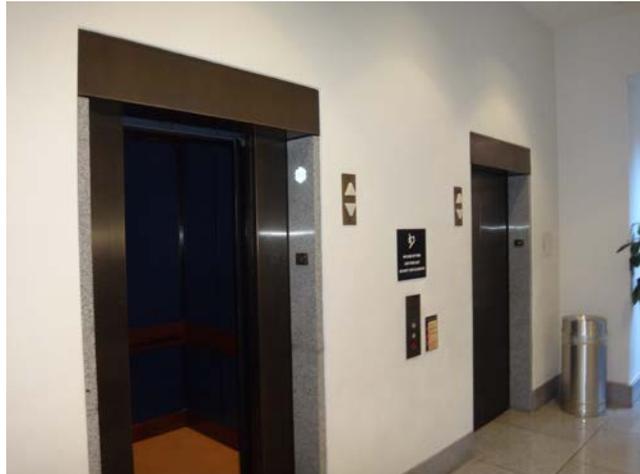
Hall Lanterns:

Hall lanterns inform persons waiting in the hall of which direction the elevator is about to travel in next. ADA requires that the hall lanterns illuminate and sound for the waiting passengers. The existing passenger elevators have hall lanterns for each car. The kitchen service elevator had car lanterns. All cars had the proper gong for up and down.

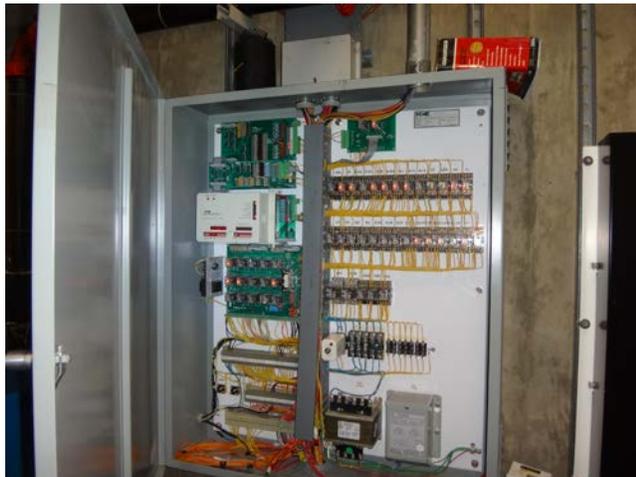
Controller:

The controller for freight car 4 was manufactured by MCE and is the only non U.S. controller at the building.
