## Office Building 8 (039)

714 "P" Street, Sacramento, CA 95814

### Facility Condition Assessment

June 2015

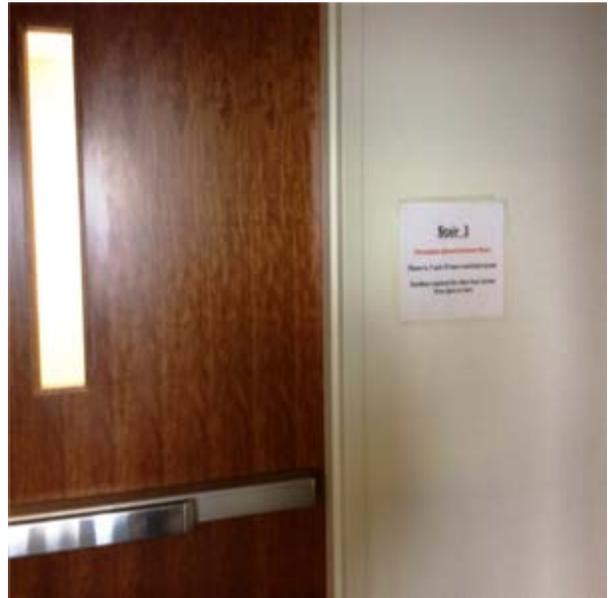
C1021 Interior Door

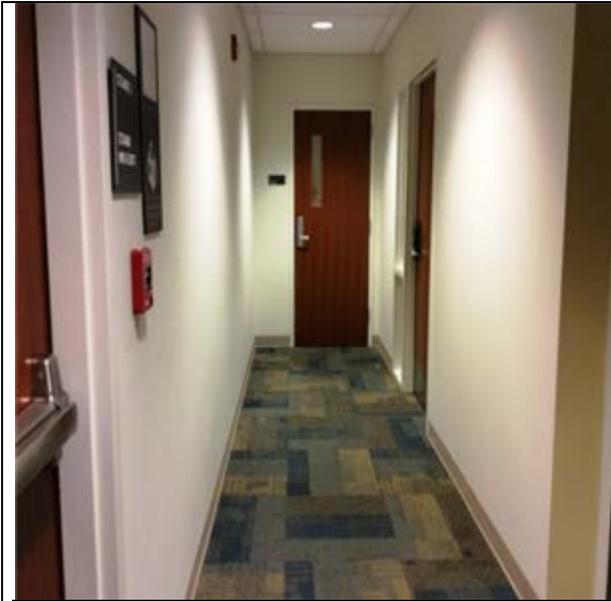
C1021 Interior Door

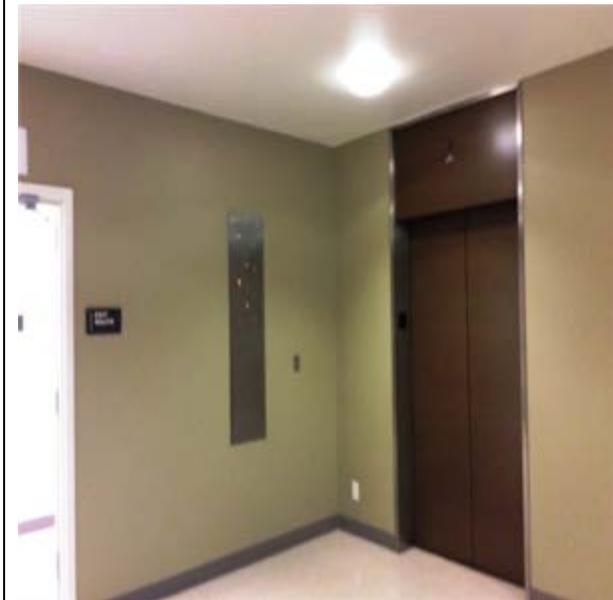
C3012 Interior Walls - Paint

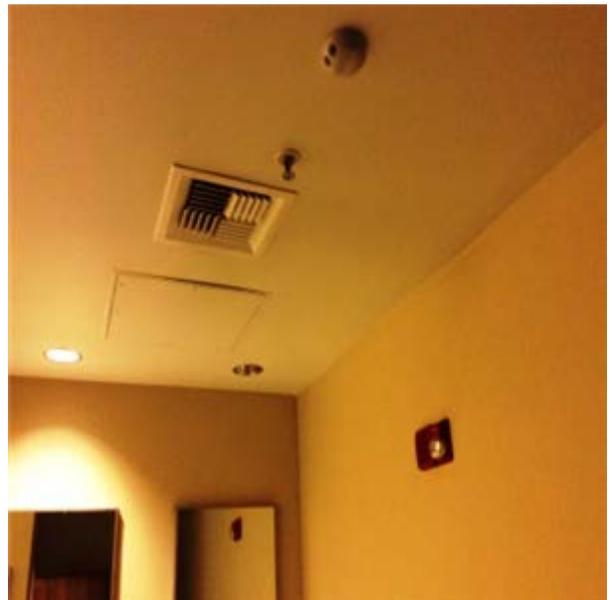
C3012 Interior Walls - Paint

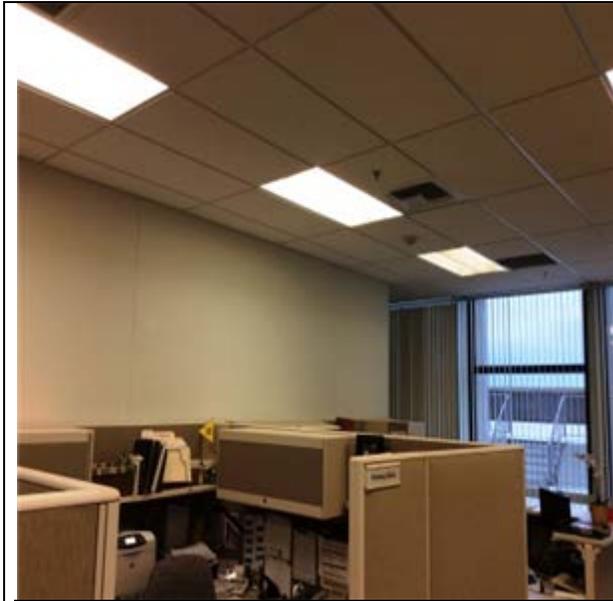
C3012 Interior Walls - Paint

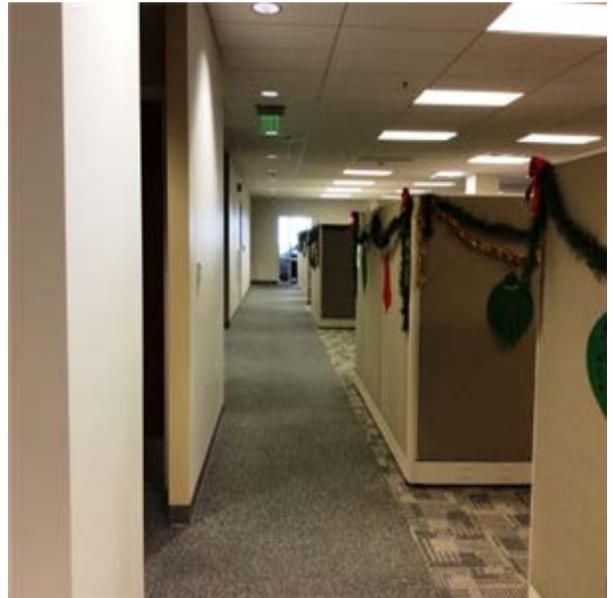
C3025 Carpet flooring

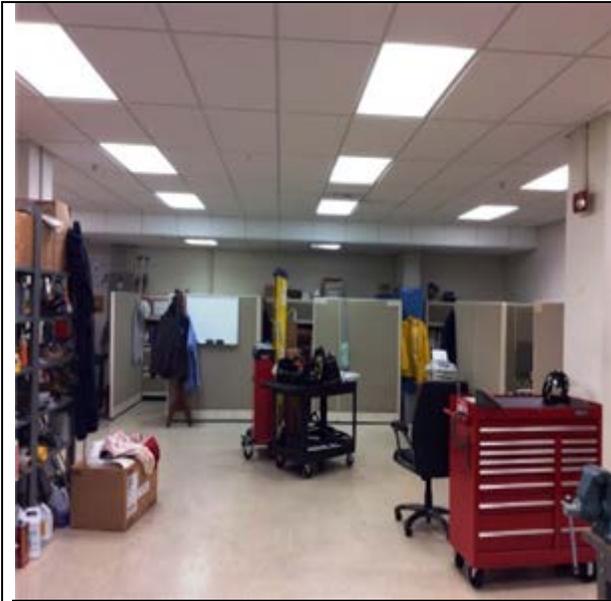
C3032 Offices Area Ceilings

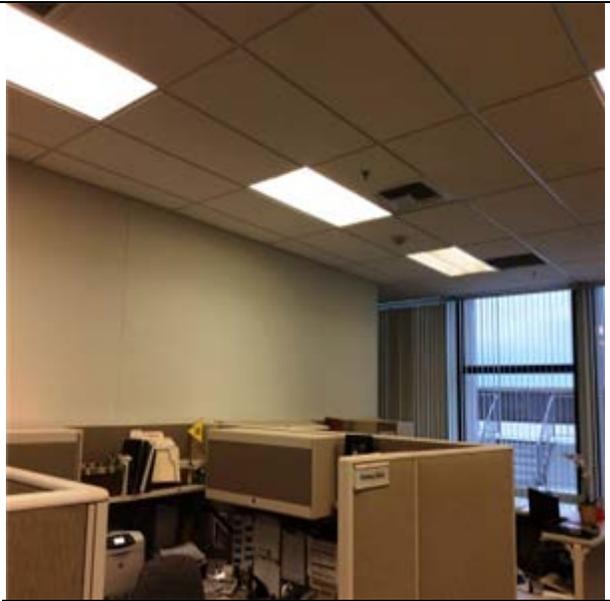
C3032 Offices Area Ceilings

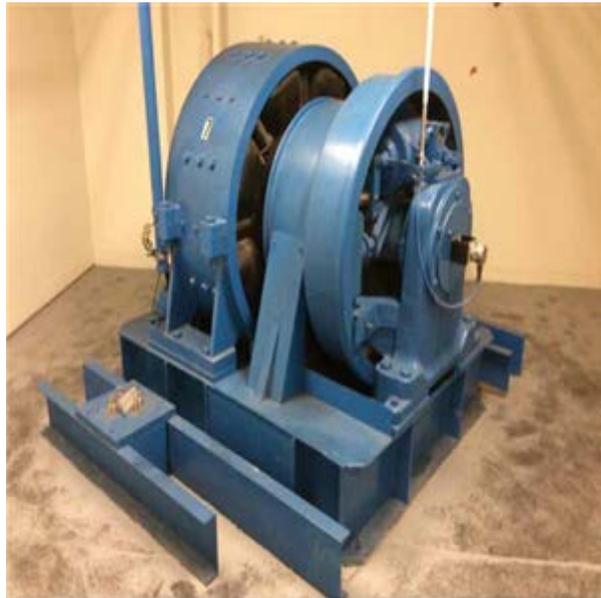
D1011 Traction Gearedless Elevator - High Rise

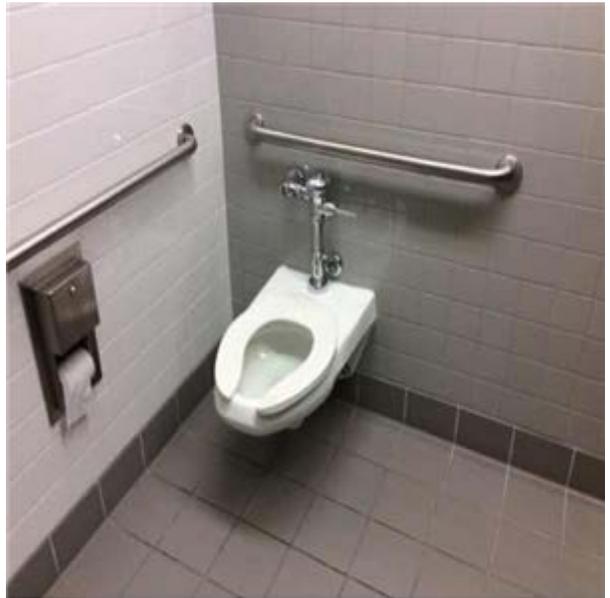
D2011 Commercial Grade Water Closets

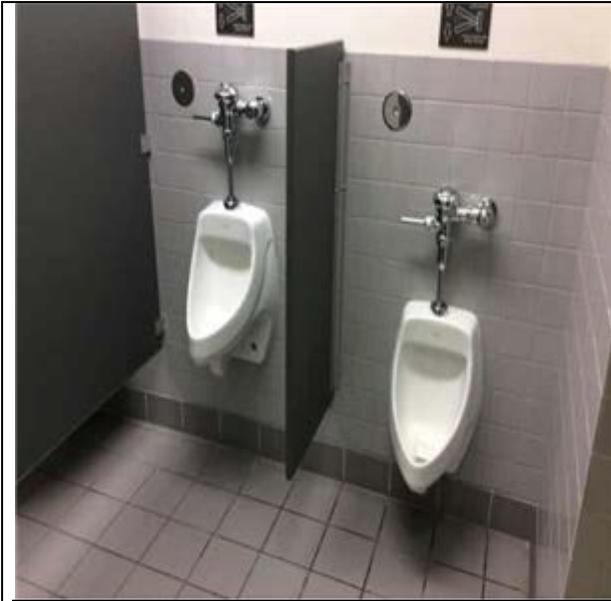
D2012 Urinals

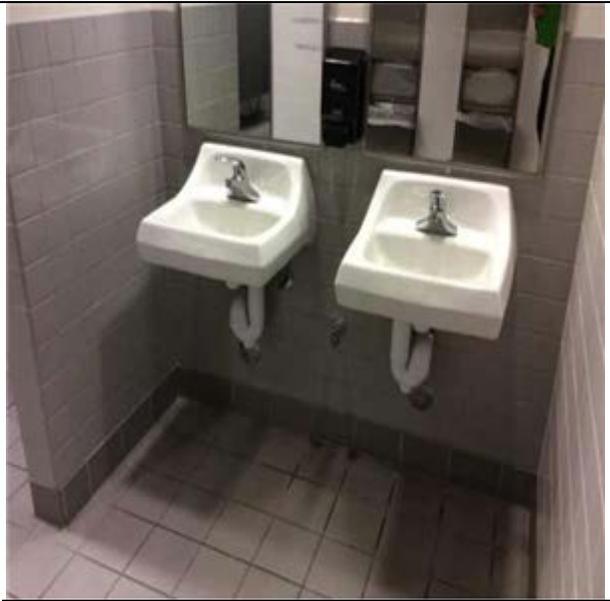
D2013 China Wall-Hung Lavatories and Faucets

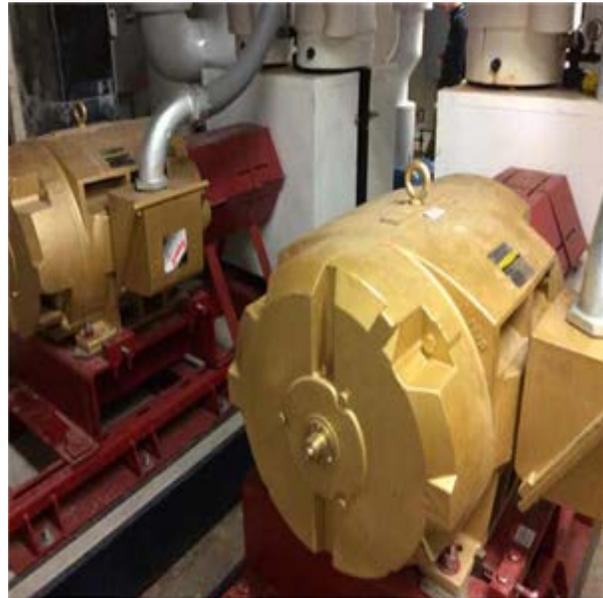
D3022 HVAC Chilled Water Circulation Pumps 200 HP  
:- Chilled water pumps

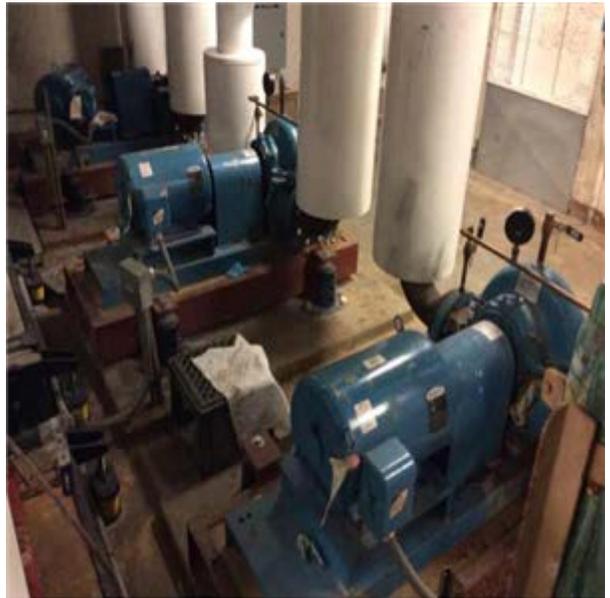
D3022 HVAC Heating Water Circulation Pumps 20  
HP:- HVAC Heating Pumps

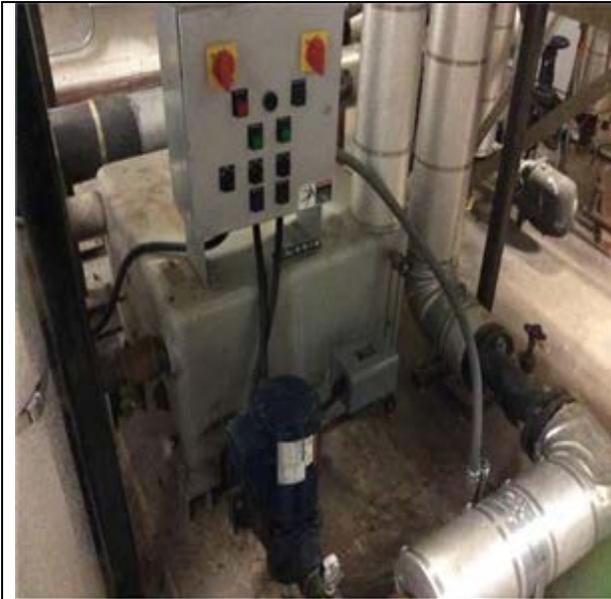
D3023 Condensate Return System :- Condensate return station

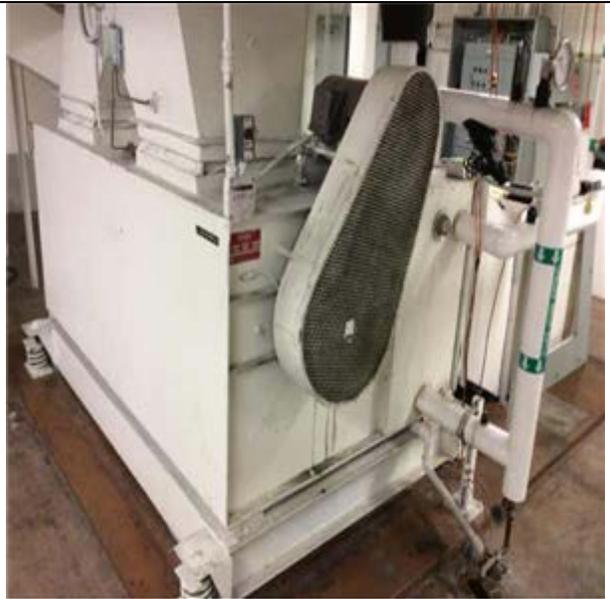
D3041 Interior Air Handlers 4,000-7,000 CFM

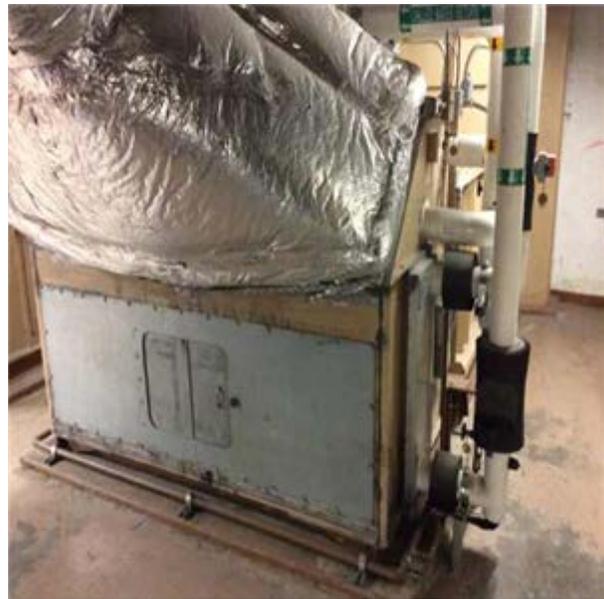
D3041 Interior Air Handlers 11,000-14,000 CFM

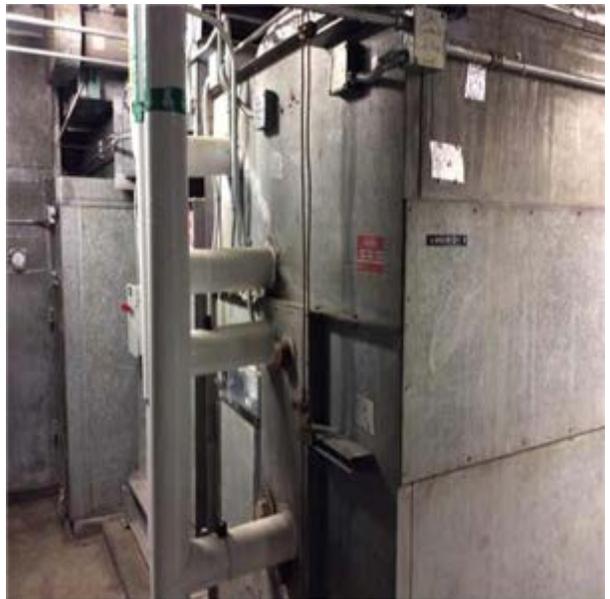
D3041 Interior Air Handlers 18,000-20,000 CFM

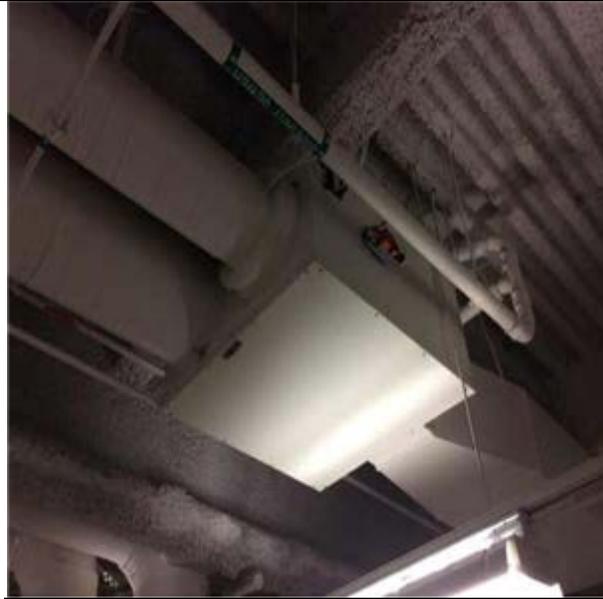
D3041 VAV Boxes

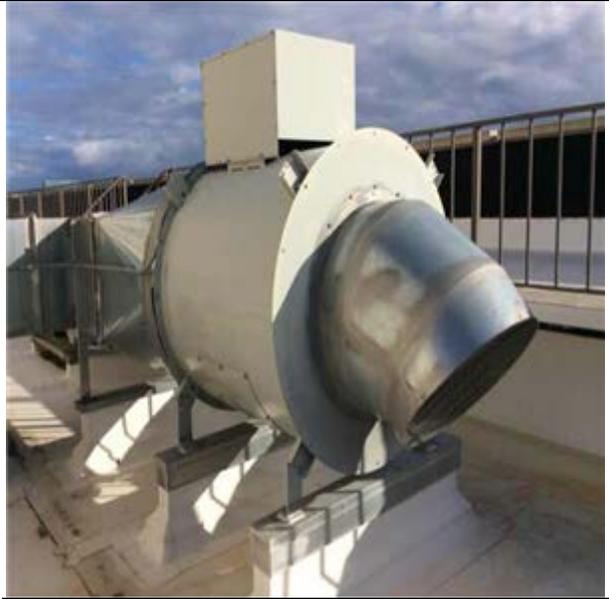
D3042 Exhaust Fan 7,000-13,000 CFM

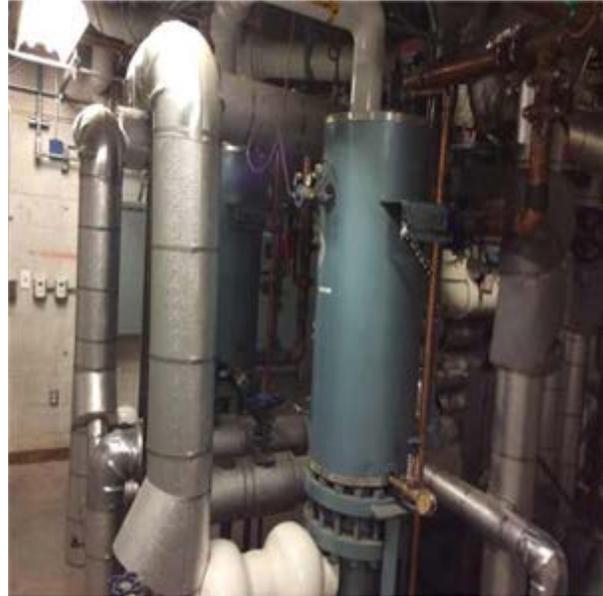
D2022 Domestic Water Heat Exchanger :- Domestic water heat exchangers

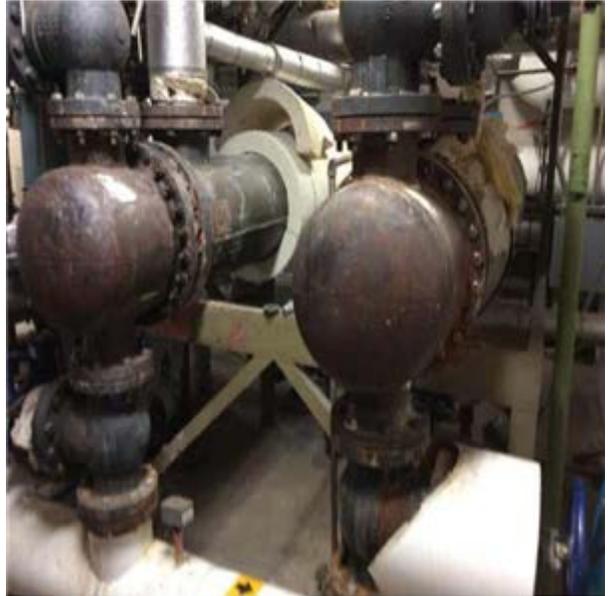
D3043 HVAC Heating Water Heat Exchanger:- HVAC shell and tube HEX

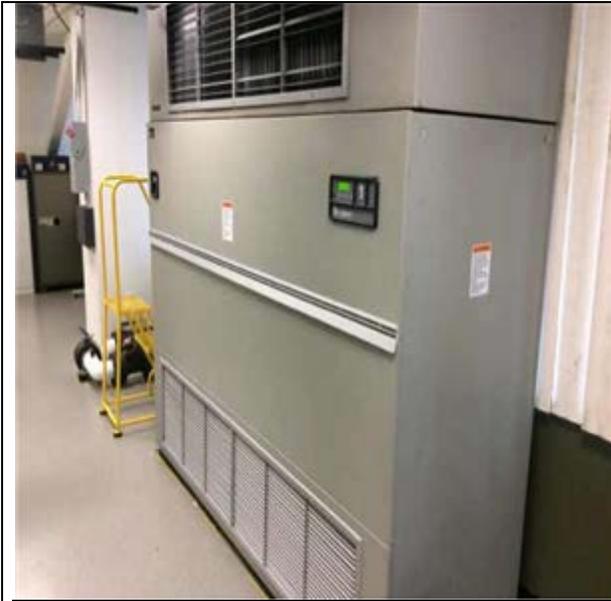
D3052 Computer/Sever Room AC, 5 Tons

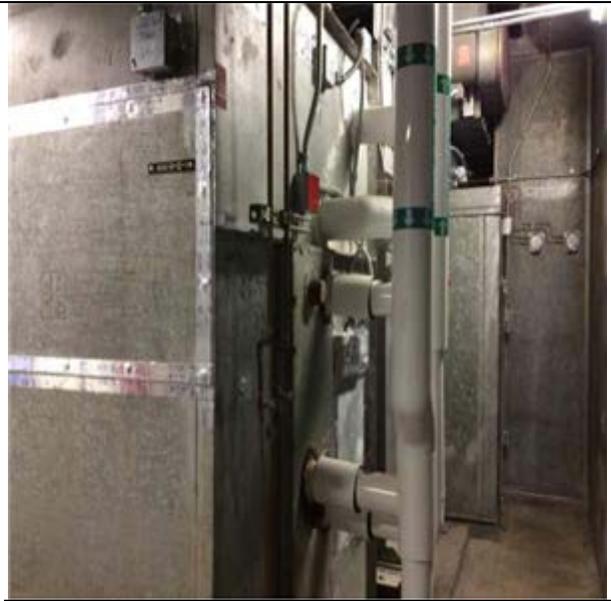
D3063 AHU Dampers

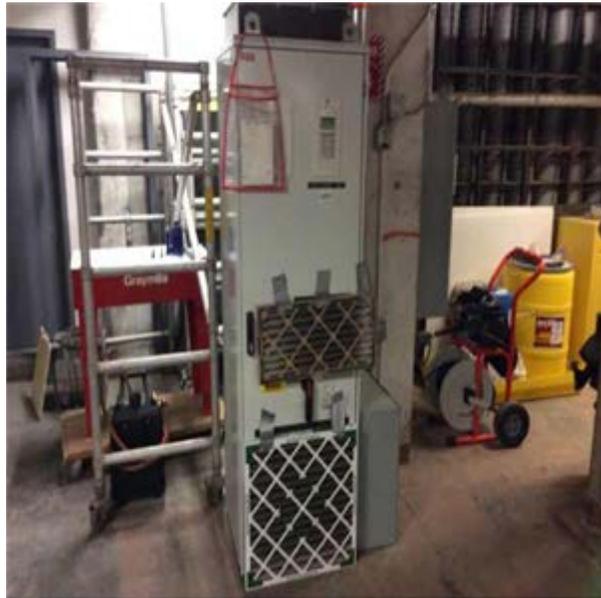
D3063 Variable Frequency Drive, 200 HP Motor :- One VFD shared between two chilled water pumps

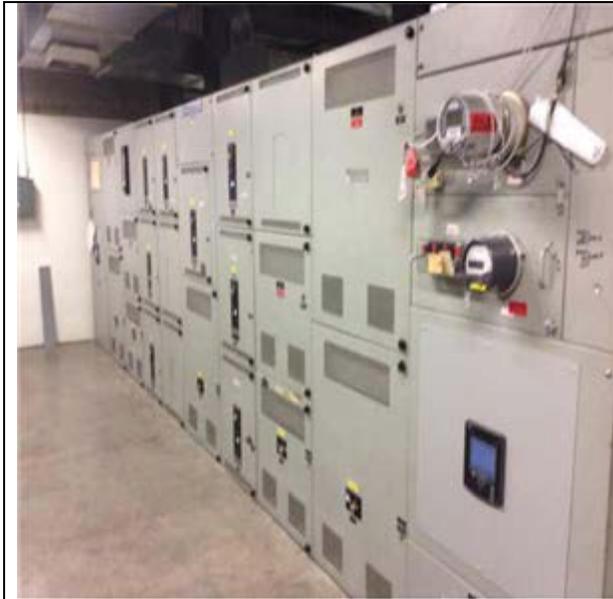
D5012 Switchgear Primary Distribution, 3000 AMP

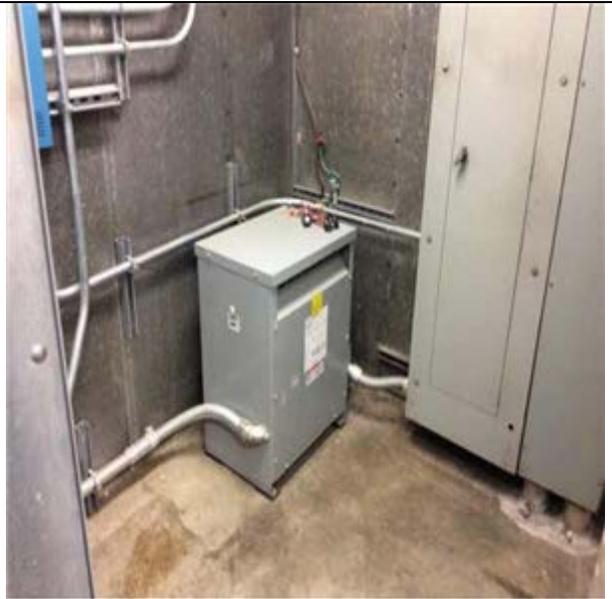
D5012 Secondary Dry Transformer 75 kVA

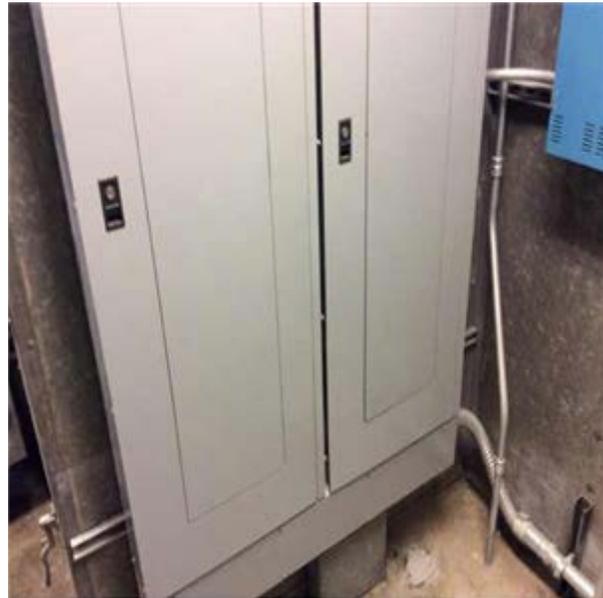
D5012 Breaker Panel 225 Amps, 30 Circuits (new)

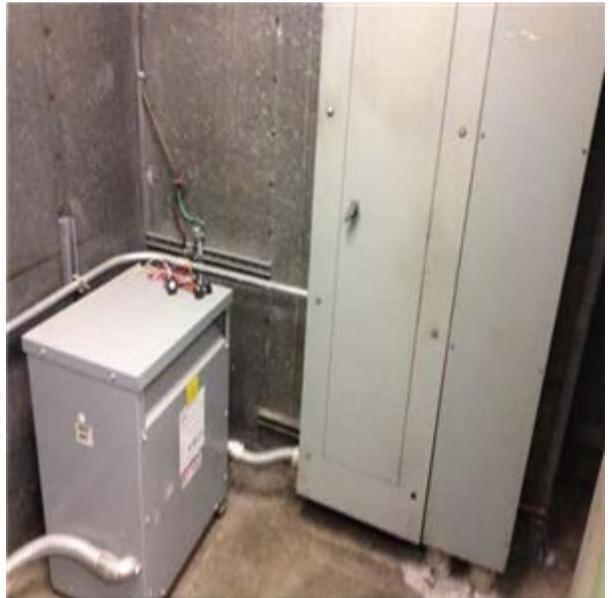
D5012 Breaker Panel 225 Amps, 30 Circuits (old)

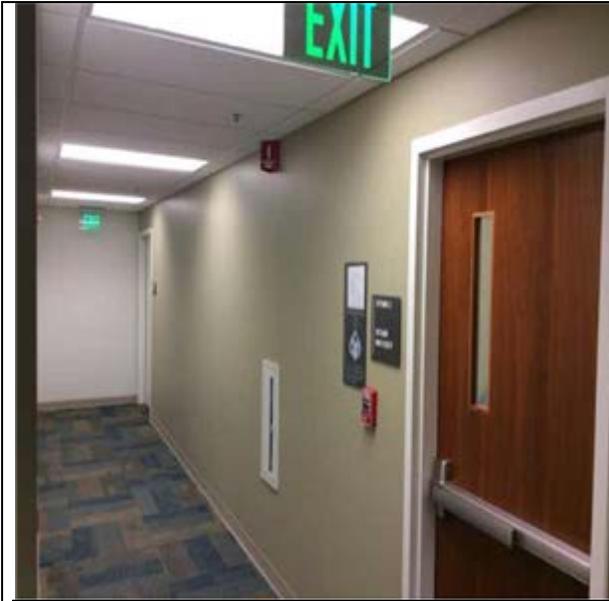
D5037 Fire Alarm System

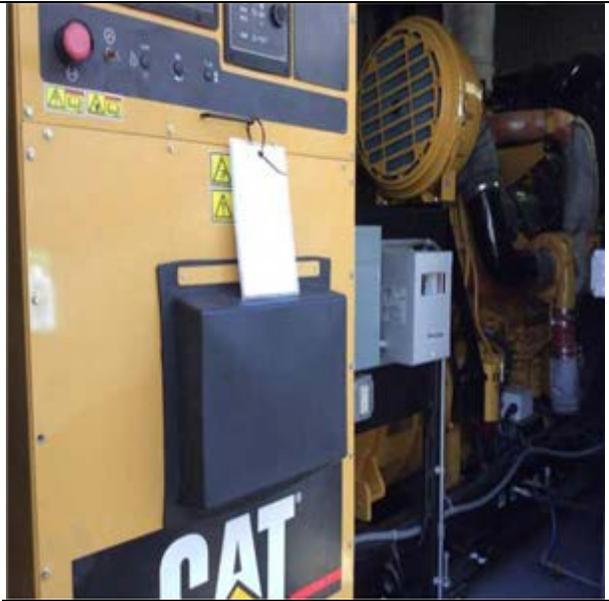
D5092 Diesel Generator 1000 kW

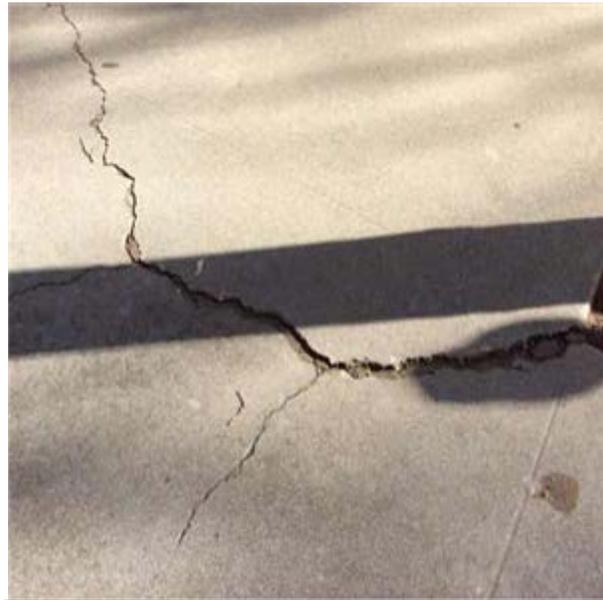
G2031 Concrete Paving

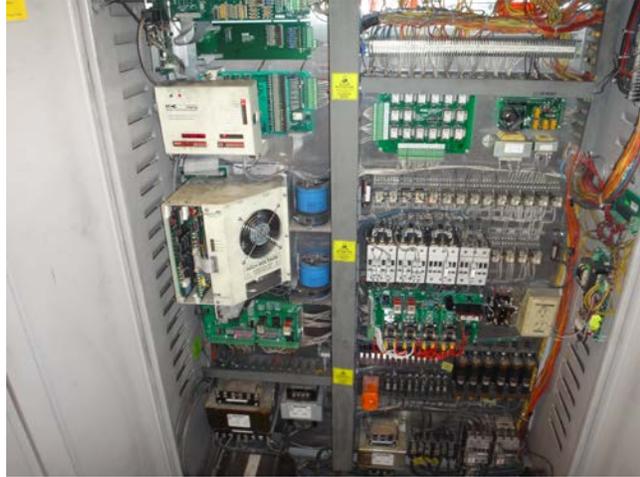
#### **Controllers:**

The controllers for Cars 1-6 were manufactured by MCE and installed locally by Millar when the elevators were modernized in 1997. The controllers utilize motor generator sets. The newer controllers for Cars 7 and 8 have solid state drives.

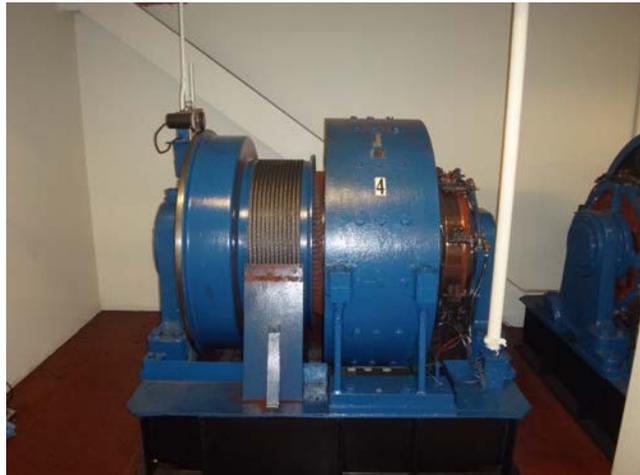
#### **Gearless Machines:**

All the low, high-rise and service cars have Otis gearless machines that were installed in 1968 when the elevators were new. The shuttle cars have geared Otis machines with the original 2 speed AC motors.

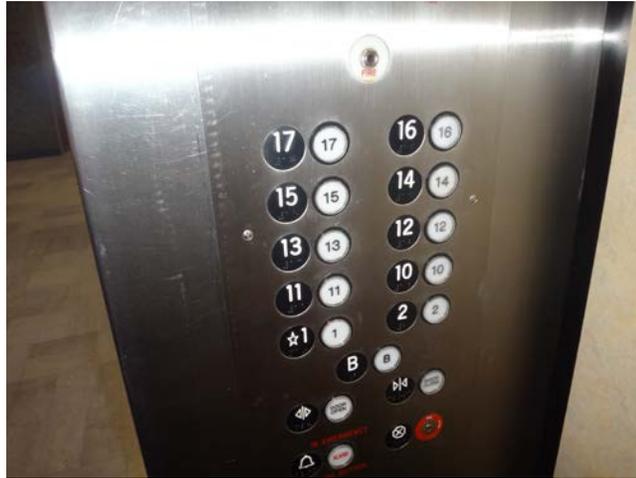
### Car Operating Panels:

All the elevators have newer Car Operating Panels (COP's) that were installed during the elevator modernizations. The panels are in good condition and meet most ADA and T24 but a few buttons are missing the raised cap. In addition the layout for the buttons in the high-rise and service cars has the buttons on floors 10 to 17 backwards. ADA requires them to be left to right. All the even floors for 10 to 16 should be on the left so it is easier for blind persons to find the buttons.

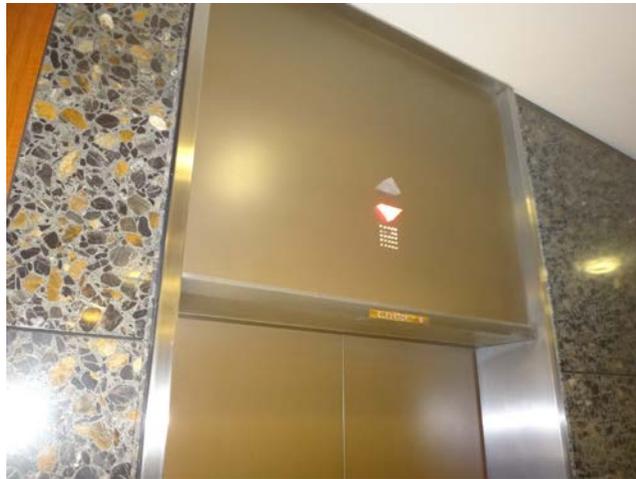
### Hall Lanterns:

Hall lanterns inform persons waiting in the hall of which direction the elevator is about to travel in next. ADA requires that the hall lanterns illuminate and sound for the waiting passengers. The existing passenger elevators have hall lanterns for each car. The lanterns have the proper gong for up and down. The service car has a car riding lantern.

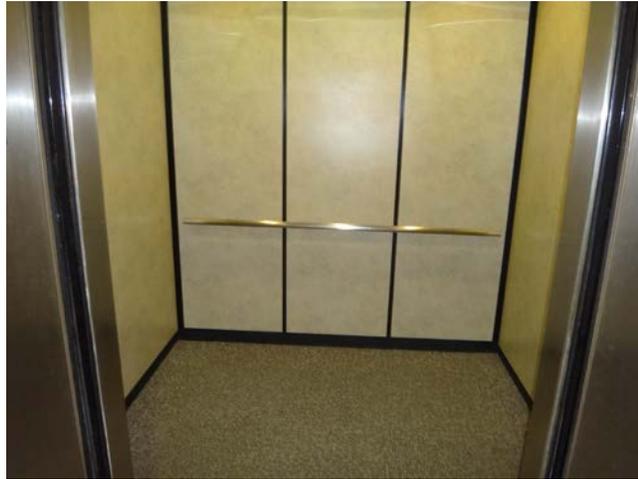
**Wall Finish:**

The existing cab interiors were updated with new plastic laminate in 1997 and now look dated. The back wall has the code required handrail. The railing heights are in compliance with Title 24 California code.
