California Tower (330)

3737 Main Street, Riverside, CA 92501

Facility Condition Assessment

September 2015

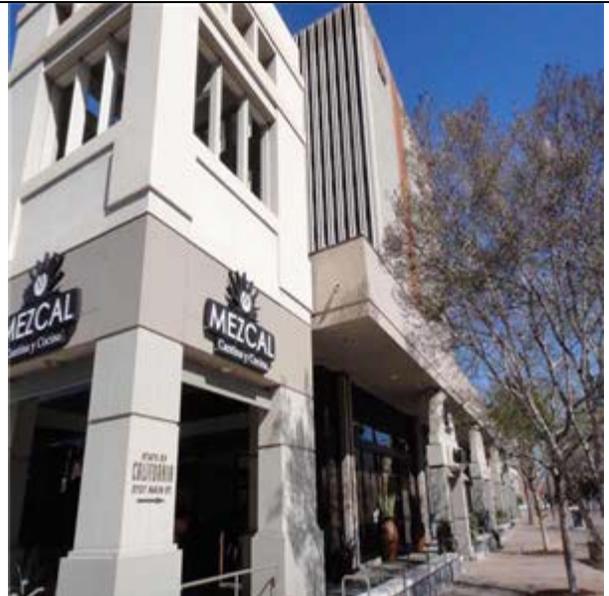
:- Typical elevation

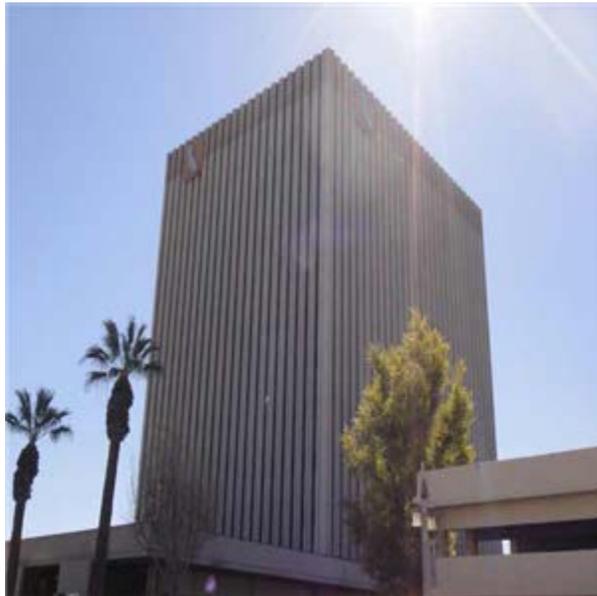
:- Typical elevation

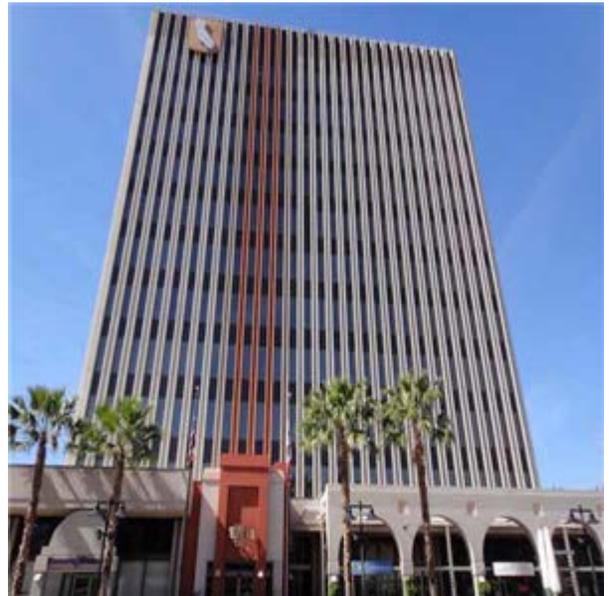
:- Typical elevation

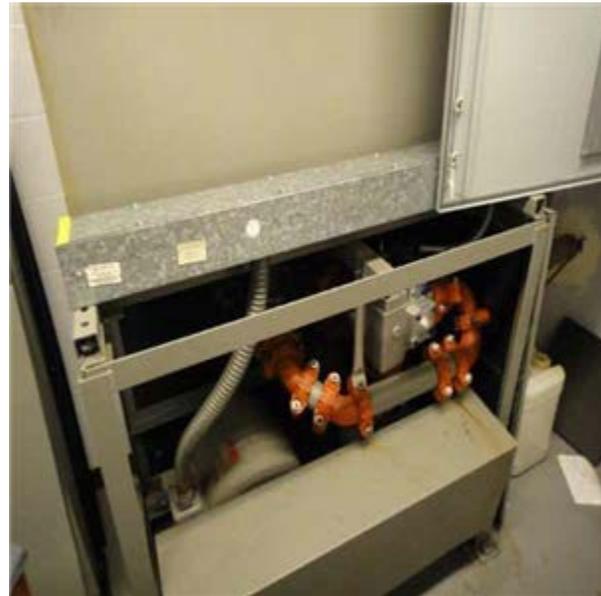
D1011 Hydraulic Elevators, 3000 LB :- Typical Hydraulic Elevator Equipment

- Elevator modernization in accordance with the State of California elevator report.
- Asphalt parking lot pavement replacement.
- HVAC control system replacement throughout to bring direct digital controls in-line with current technology.

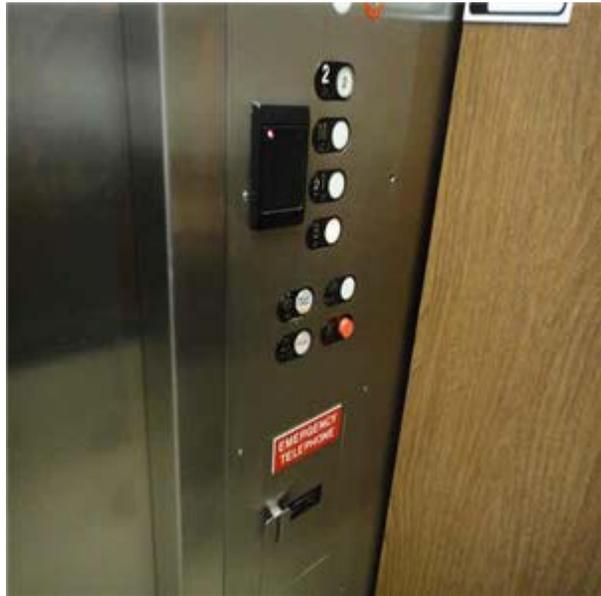
D1011 Hydraulic Elevators, 3000 LB:- Controls for the Passenger Elevator

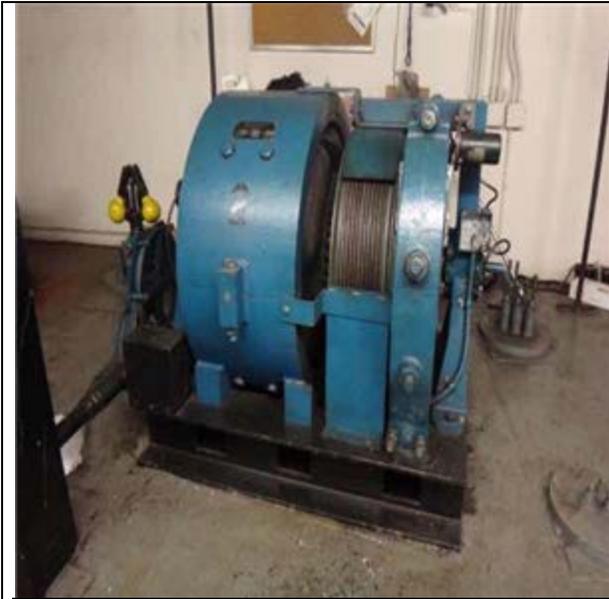
D1011 Traction Elevator Machinery and Controls :-
Electric Motor for Traction a Elevator 2

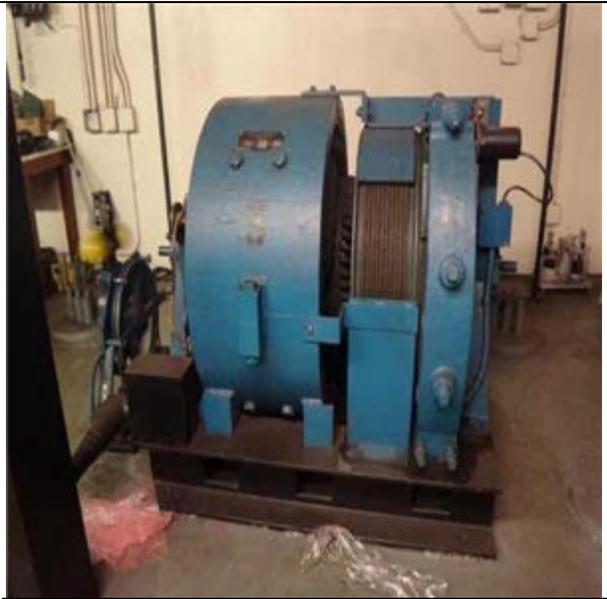
D1011 Traction Elevator Machinery and Controls:-
Traction Elevator Electric Motor 3

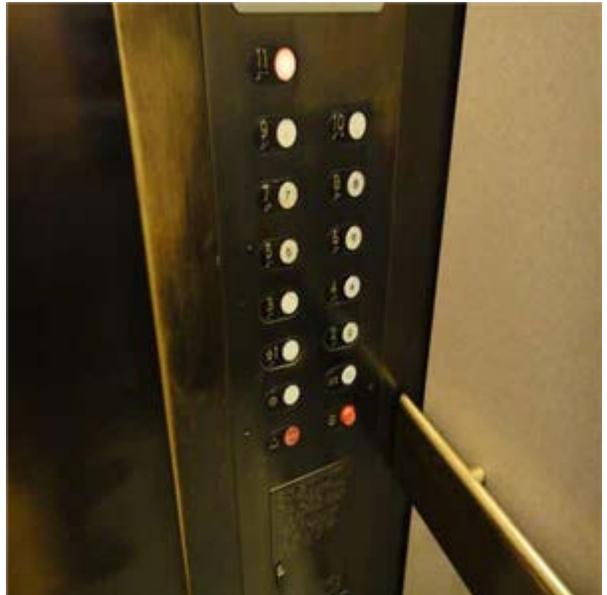
D1011 Traction Elevator Machinery and Controls:-
Passenger Elevator Control Panel

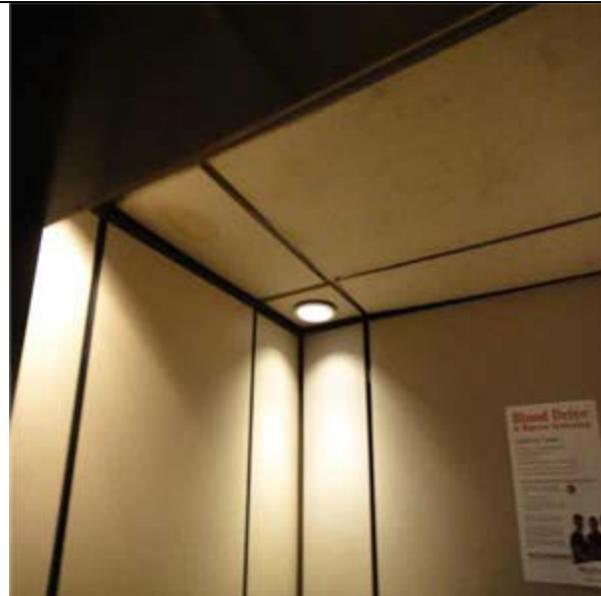
D1011 Traction Elevator Machinery and Controls :- Elevator Cab Interior

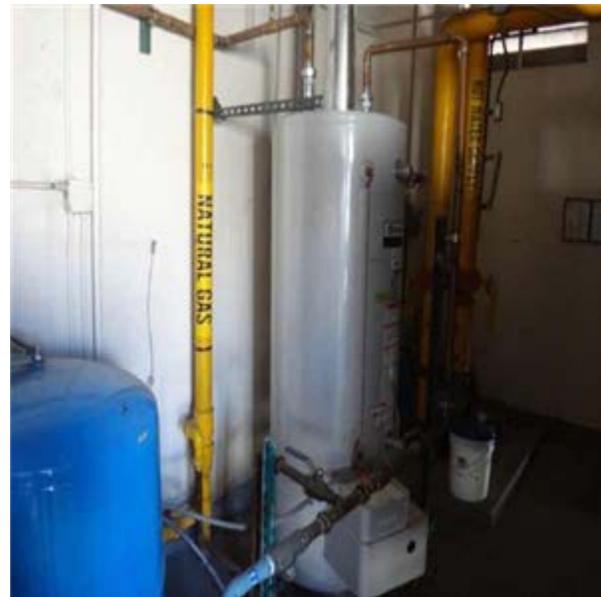
D2030 Domestic Water Heater 100 Gallon :- Domestic Water Heater

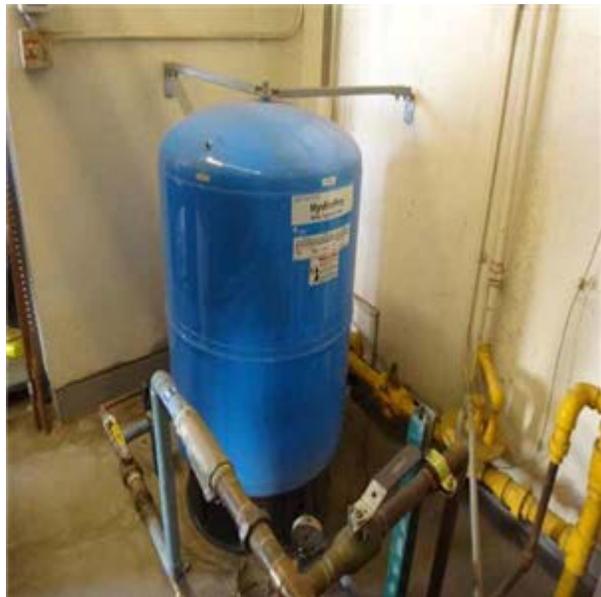
D2030 Domestic Water Heater 100 Gallon:- Domestic Hot Water Expansion Tank

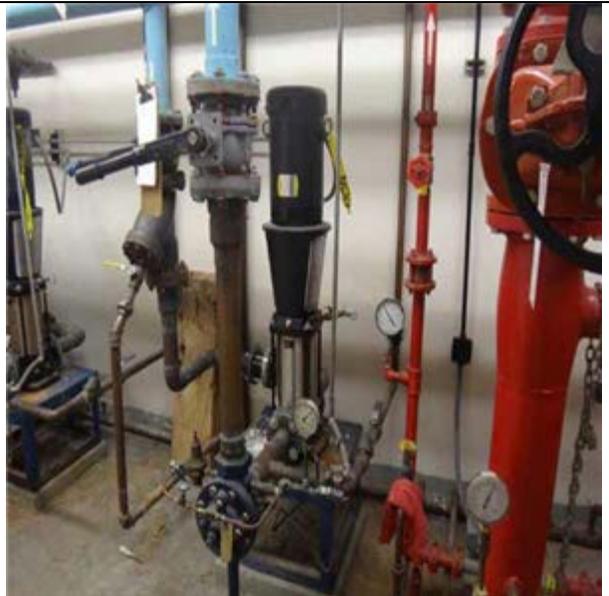
D2023 Domestic Water Booster Pump Station:- Domestic Water Pump 1

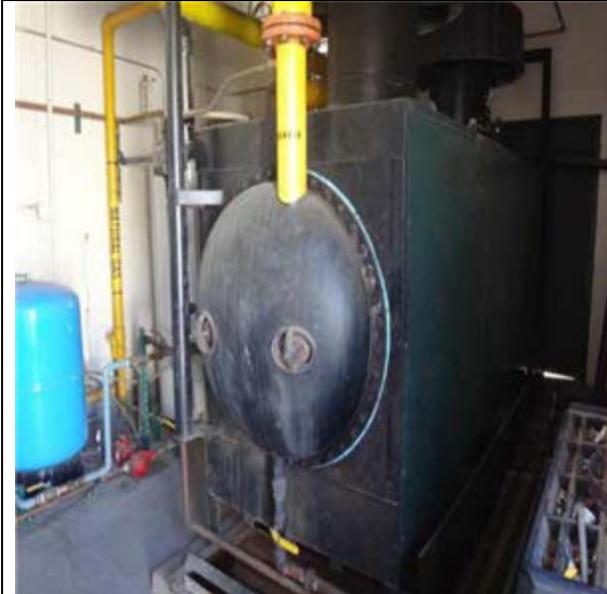
D3020 Water Boiler, Gas 5031 MBH :- Old Hot Water Heating Boiler

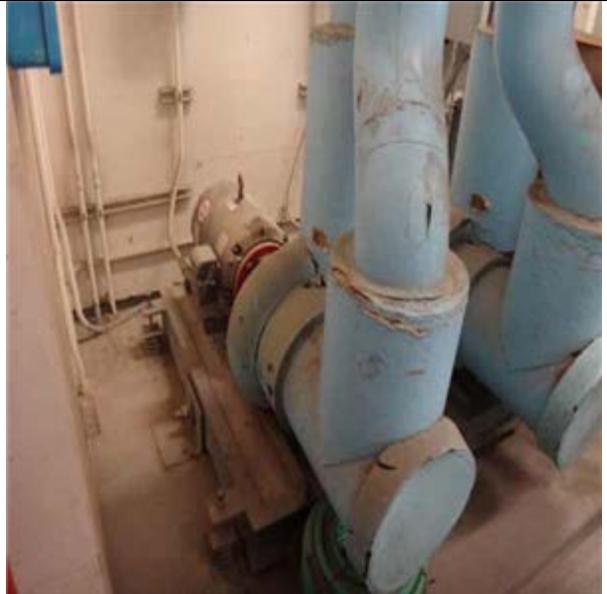
D3022 HVAC Chilled Water Circulation Pumps 20 HP:- CWP 1

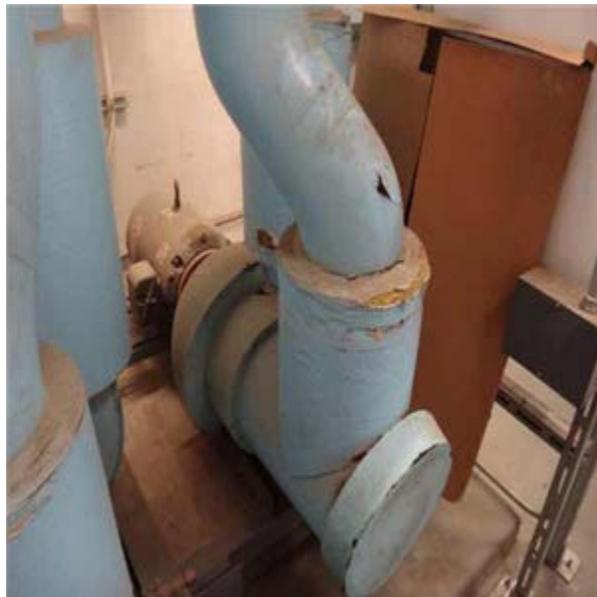
D3022 HVAC Chilled Water Circulation Pumps 20 HP :- CWP 2

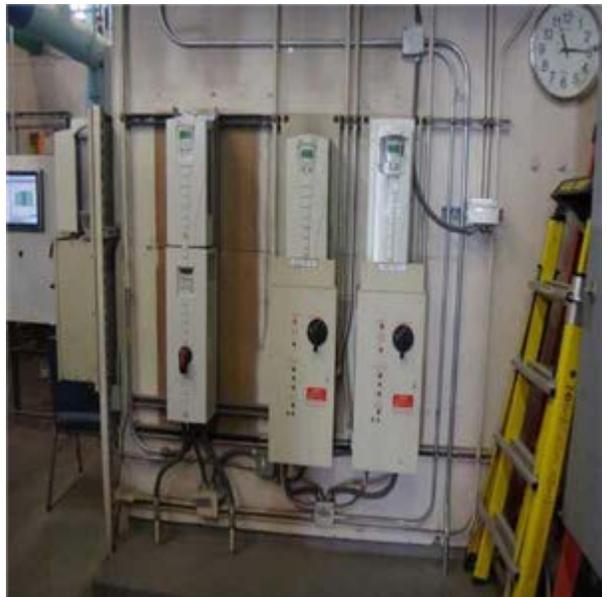
D3022 HVAC Chilled Water Circulation Pumps 20 HP:- VFD

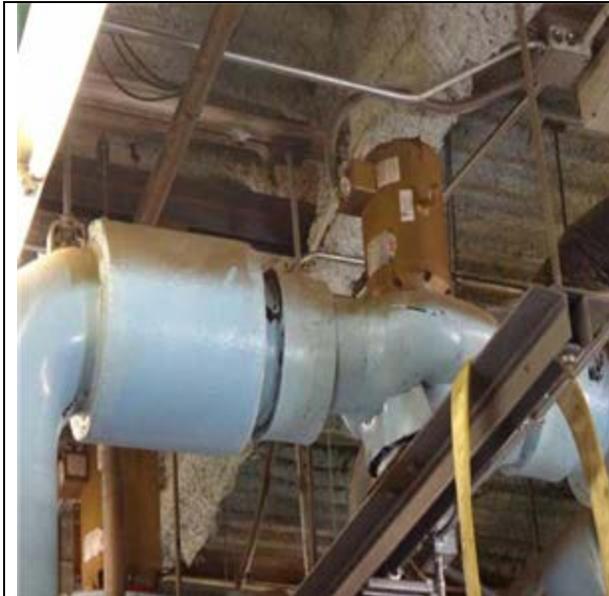
D3022 HVAC Chilled Water Circulation Pumps 5 HP :-
CHWP 2

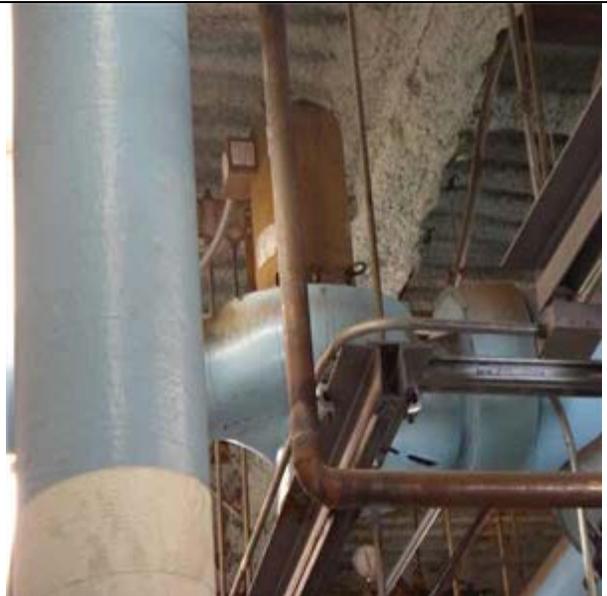
D3022 HVAC Chilled Water Circulation Pumps 5 HP:-
CHWP 1

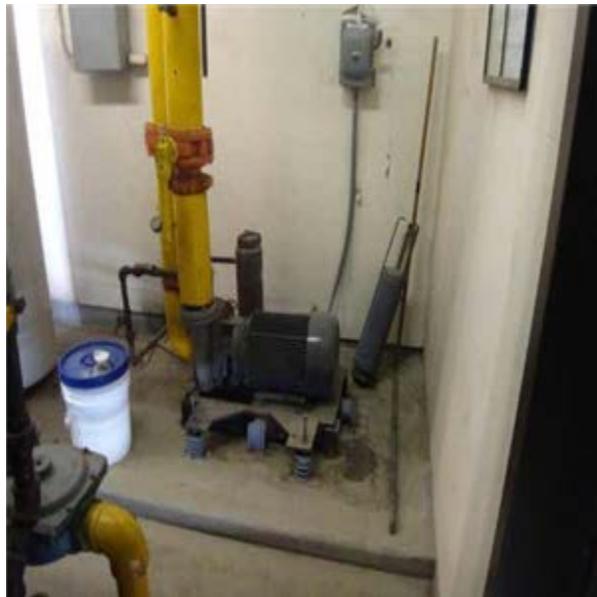
D3022 HVAC Heating Water Circulation Pumps 15 HP
:- Hot Water Distribution Pump

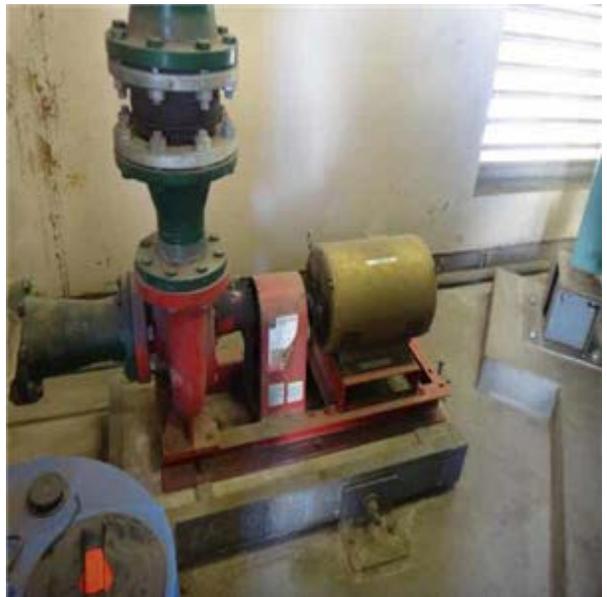
D3023 Condensate Return System:- TVP 3

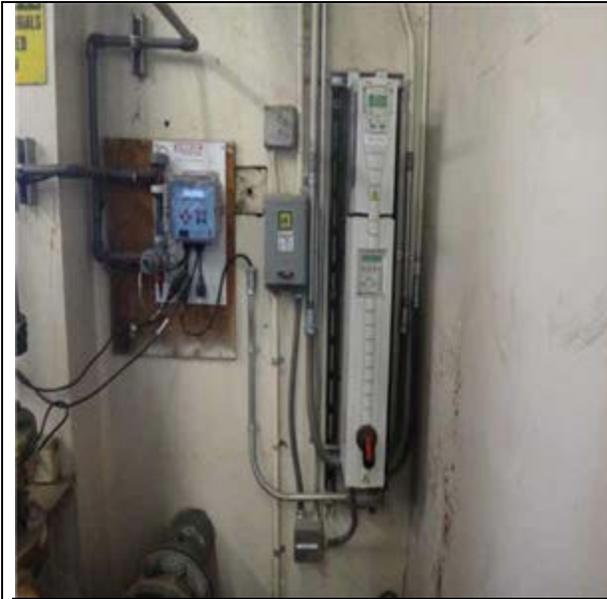
D3023 Condensate Return System :- VFD For Pump TWP 3

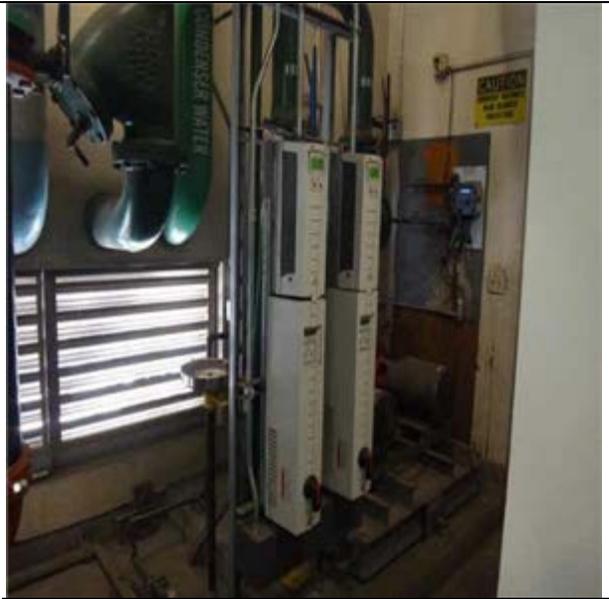
D3023 Condensate Return System:- Condensate pumps and VFD

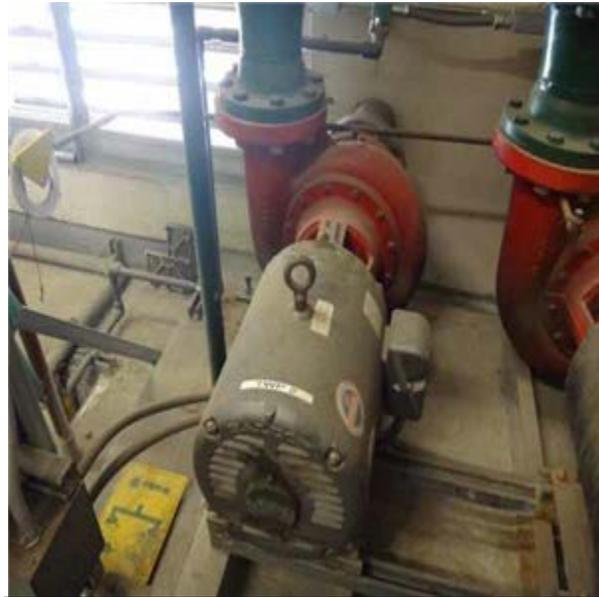
D3023 Condensate Return System :- TWP 1

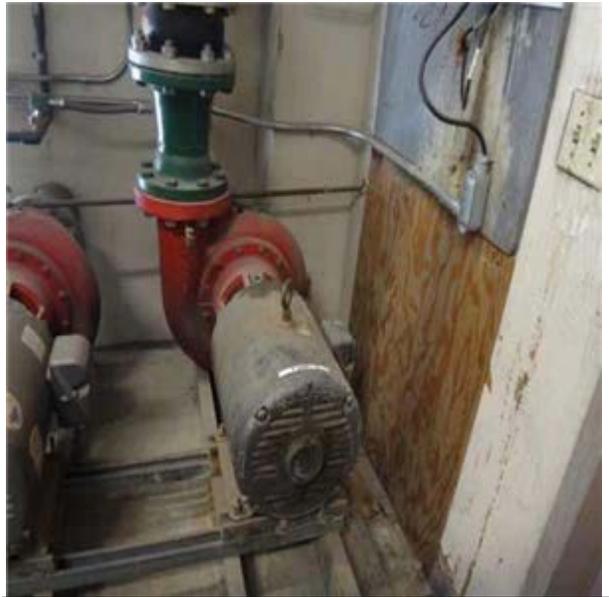
D3023 Condensate Return System:- TWP 2

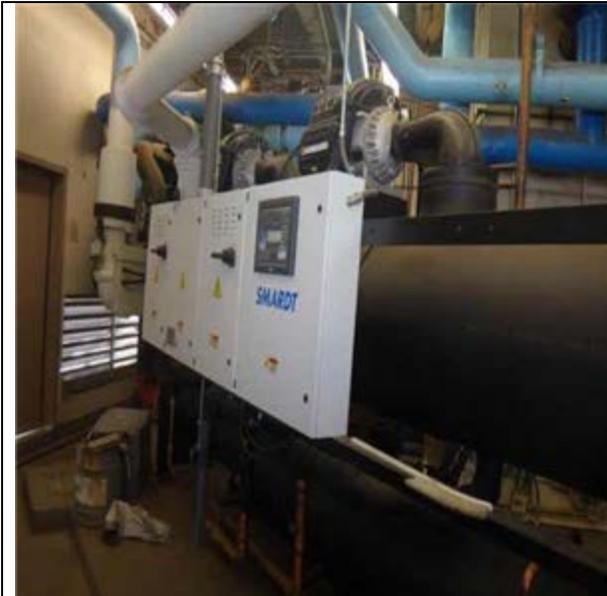
D3031 Chiller, Water Cooled, 350 Ton :- New Larger Chiller

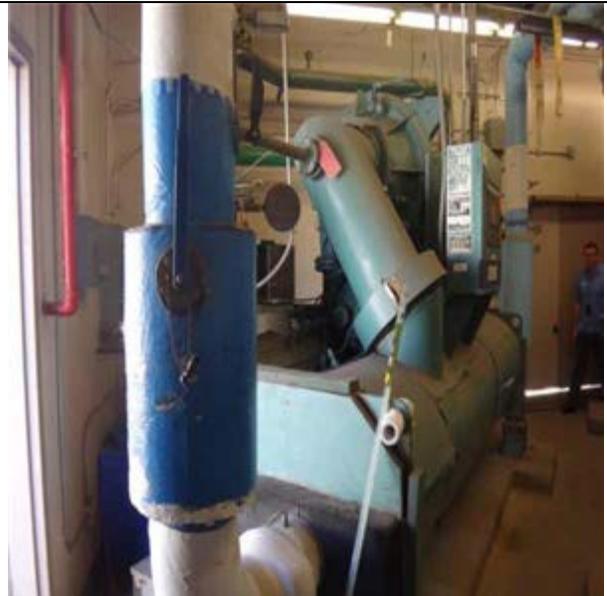
D3031 Chiller, Water Cooled, 150 Ton:- Smaller Chiller

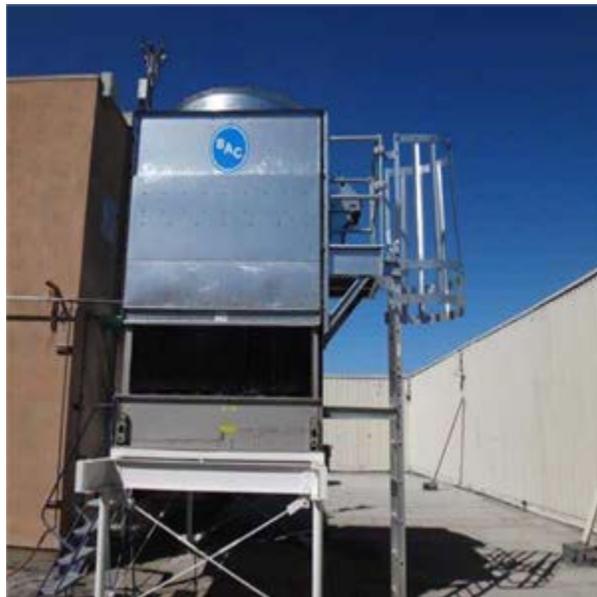
D3031 Cooling Tower, Galvanized Steel, 150 Ton :- Smaller Cooling Tower

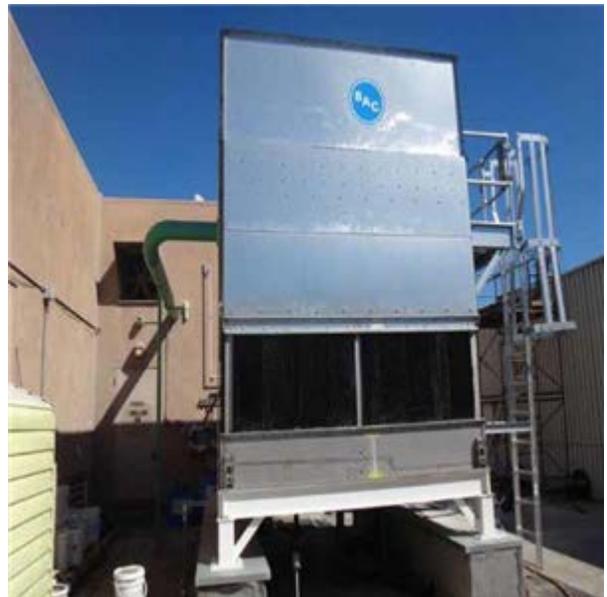
D3031 Cooling Tower, Galvanized Steel, 400 Ton:- Large Cooling Tower

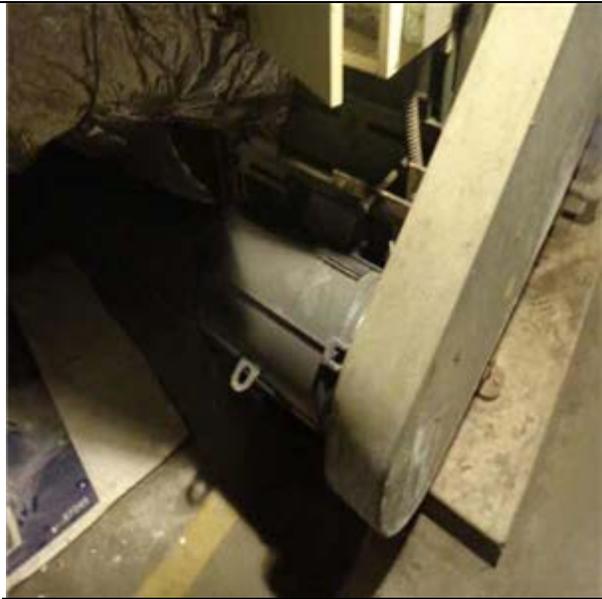
D3041 AHU Fan Motor, 20 - 30 HP

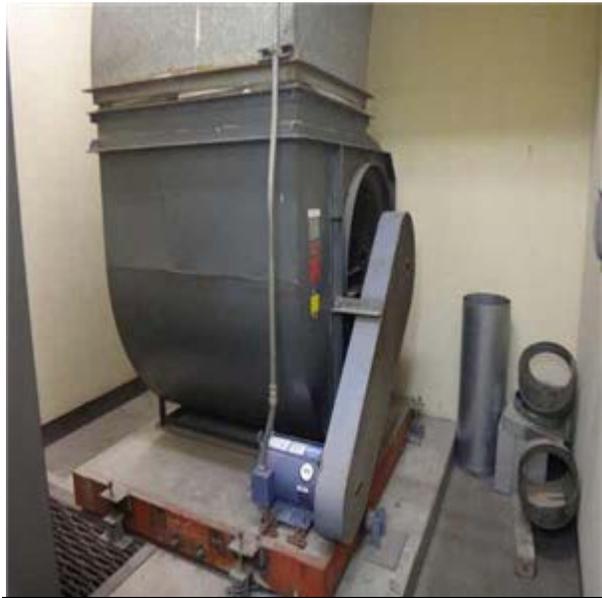
D3042 Exhaust Fan 16750 CFM:- Restroom Exhaust Fan

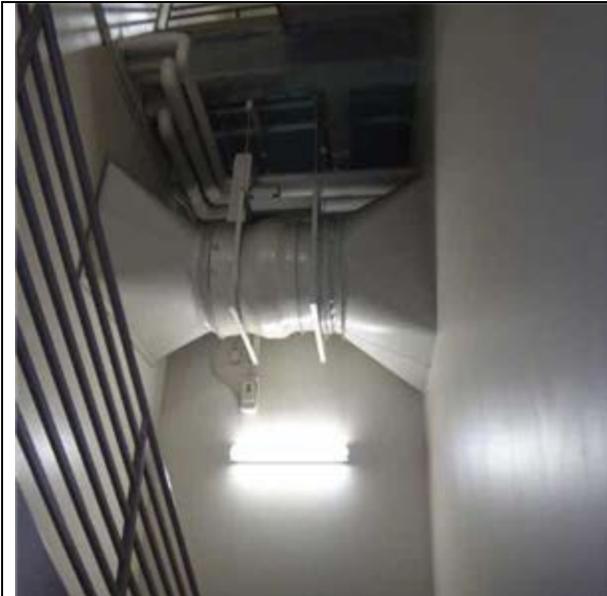
D3042 Exhaust Fan 12000 CFM :- Stair Exhaust Fan North Stair # 2

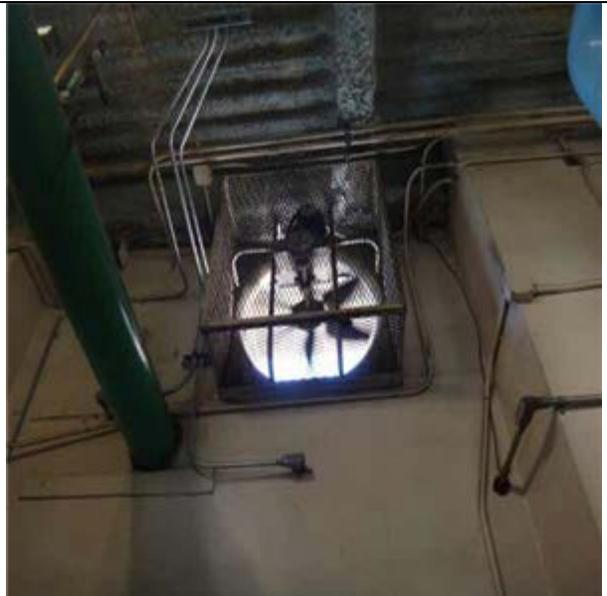
D3042 Exhaust Fan 5500 CFM:- Exhaust fan for the Penthouse

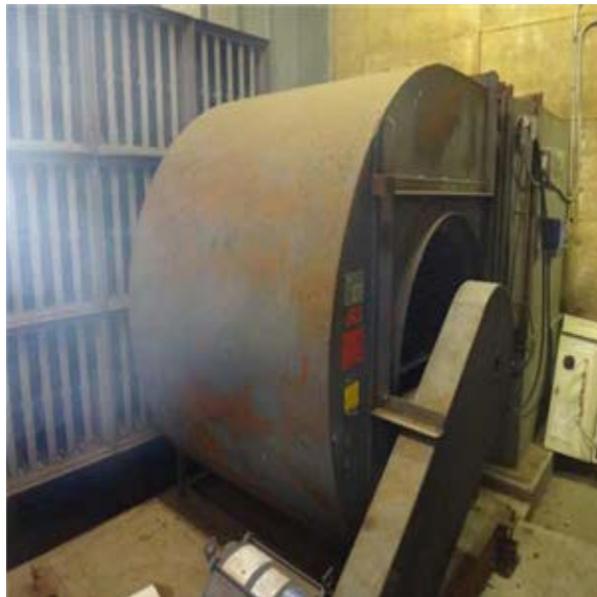
D3042 Make-up Building Air Fan 22500 CFM :- Fresh Air Make-Up Fan Unit

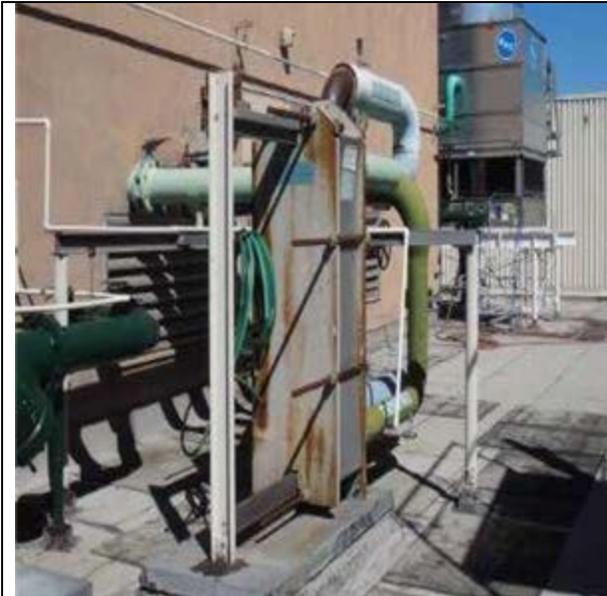
D3043 HVAC Heating Water Heat Exchanger :- Heat Exchanger

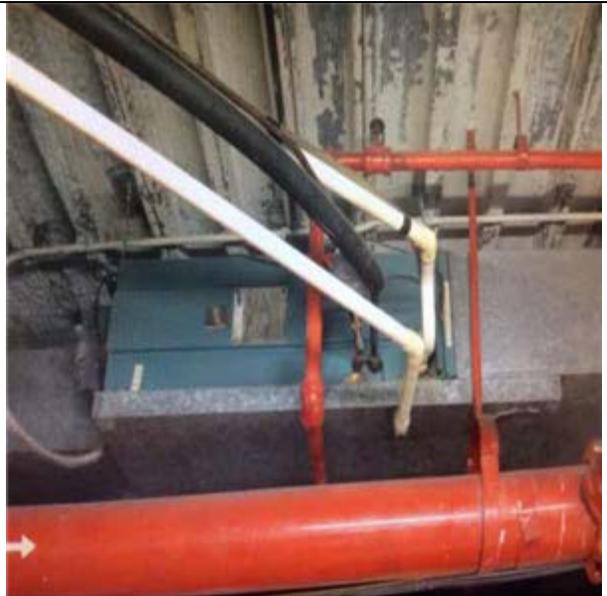
D3050 Heat Transfer Terminal and Packaged Units

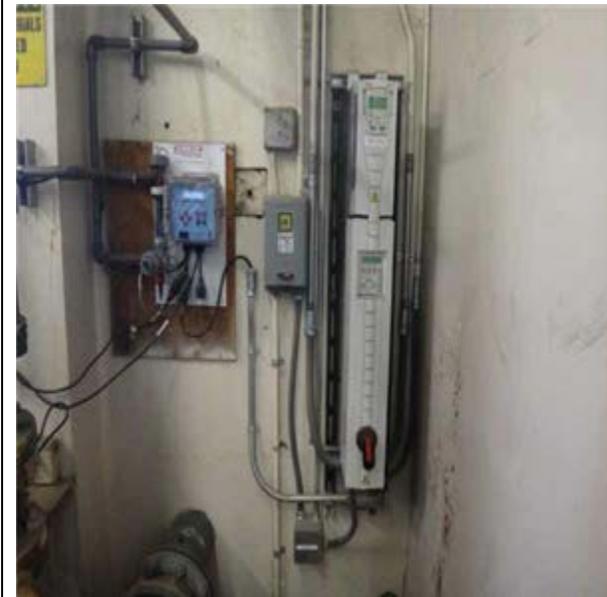
D3063 Variable Frequency Drive, 5 HP Motor

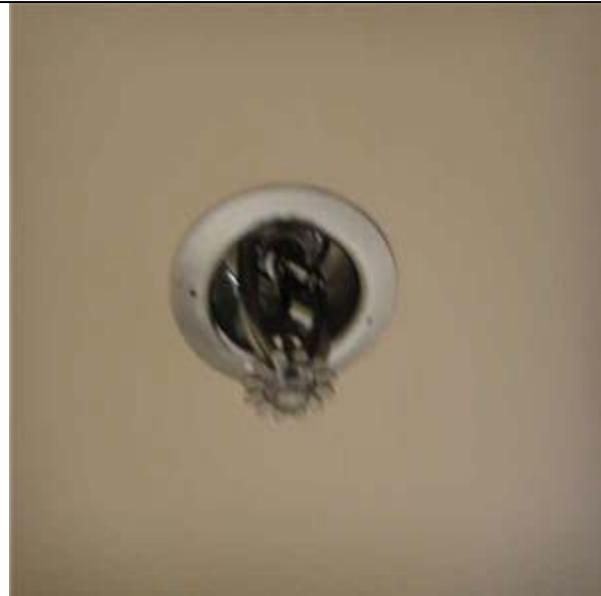
D4011 Wet-Pipe Sprinkler System :- Typical Fire Sprinkler

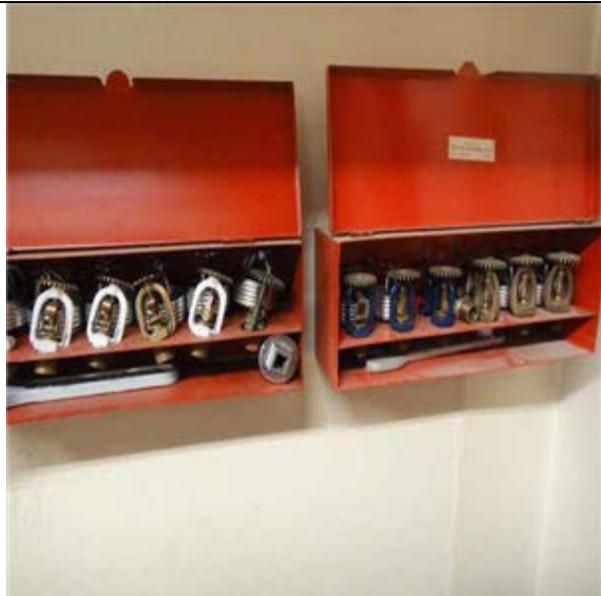
D4011 Wet-Pipe Sprinkler System:- Fire Sprinkler Cabinet

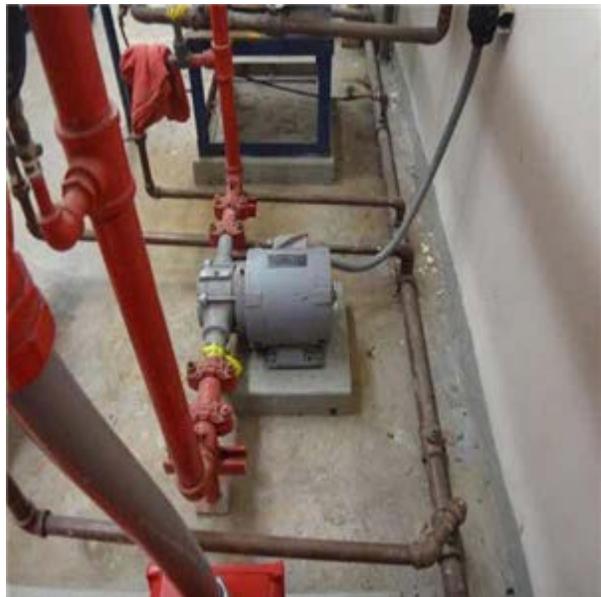
D4015 Sprinkler Pumping Equipment Electric Motor 50 HP:- Fire Jockey Pump

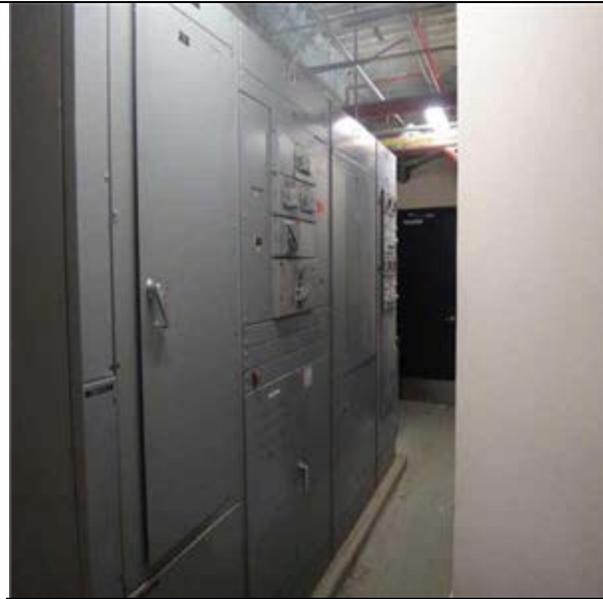
D5010 Switchgear, Mainframe, 4000 Amps

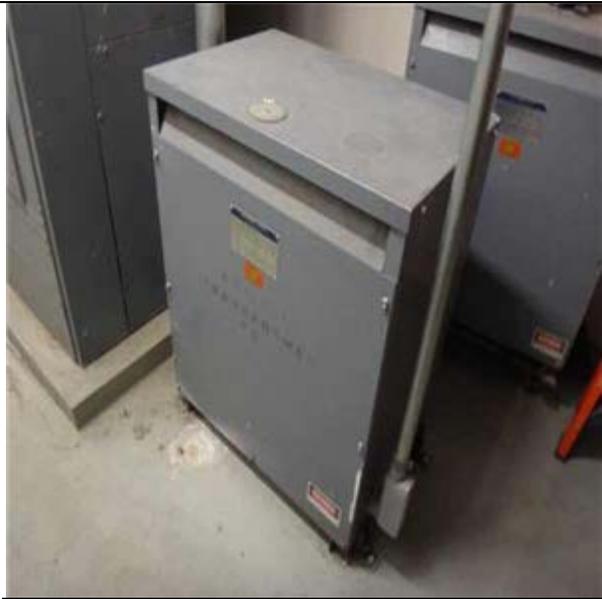
D5012 Secondary Dry Transformer 75 kVA:-
Transformer

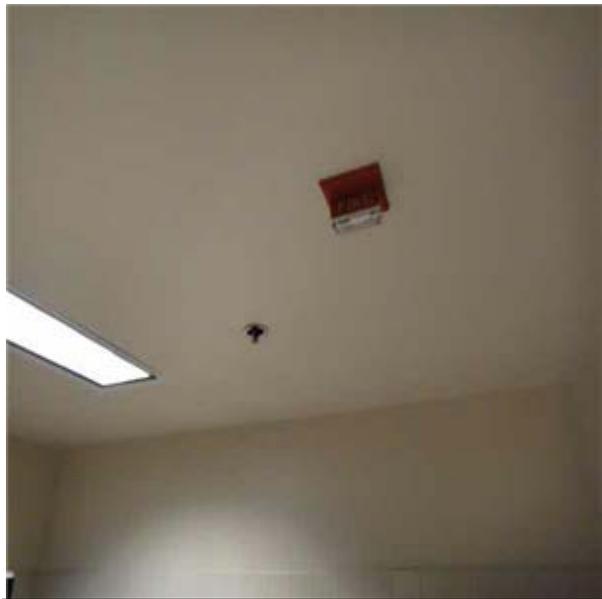
D5037 Fire Alarm System:- Fire Alarm Horn Strobe

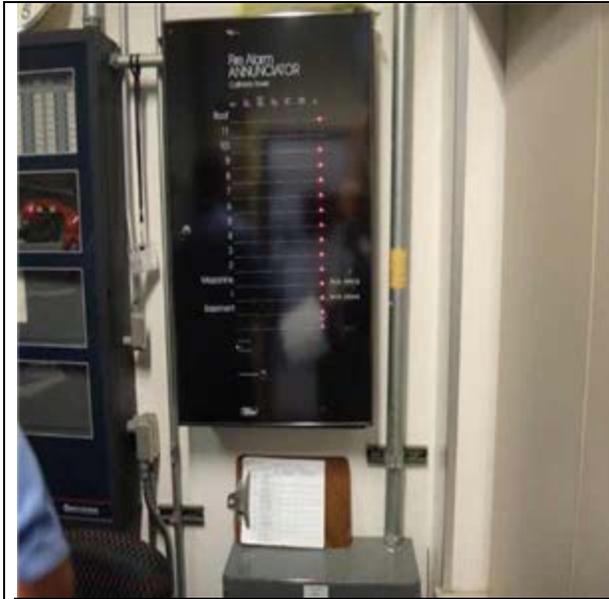
D5037 Fire Alarm Panel :- Fire Panel 1

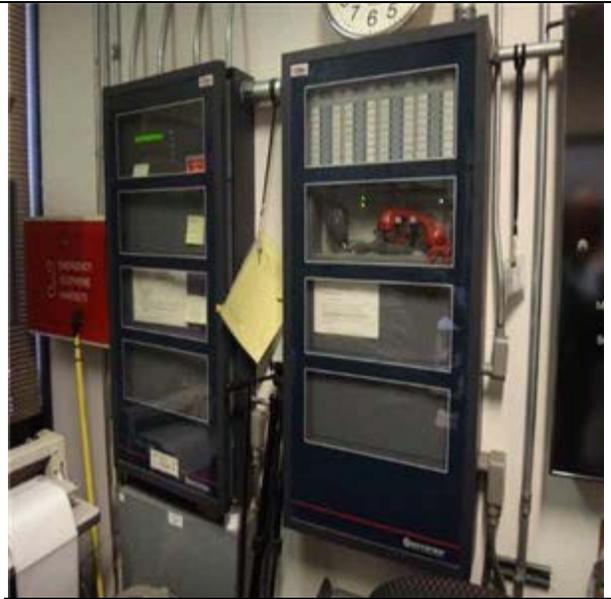
D5037 Fire Alarm Panel:- Fire Panel 2

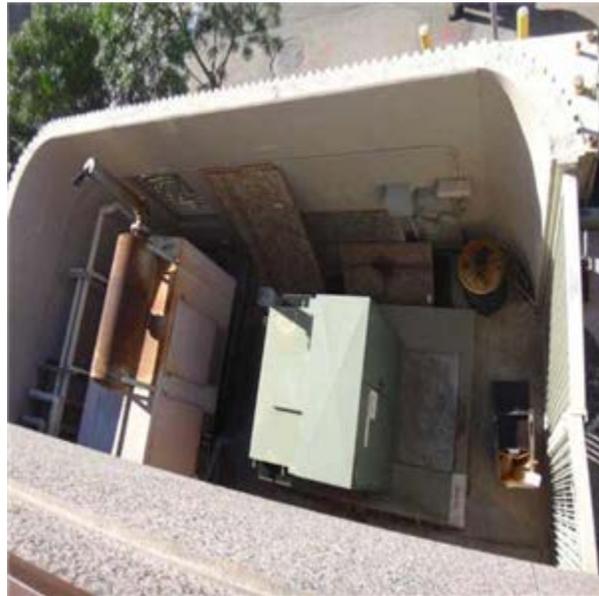
D5092 Emergency Generator 250 kW :- Emergency Generator Ground Level

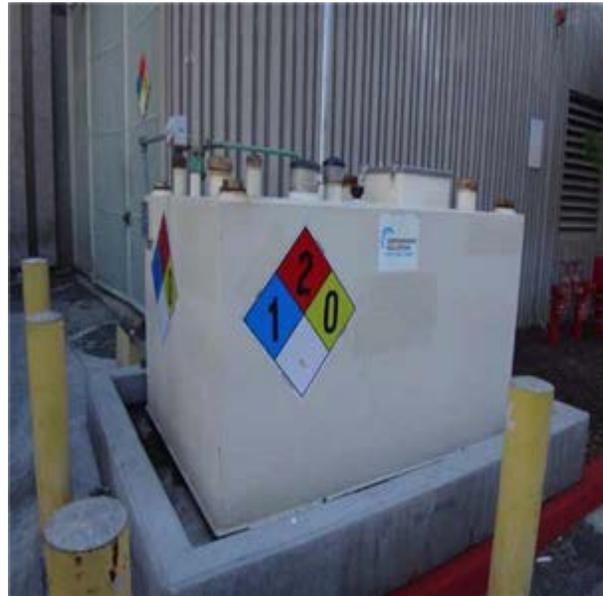
D5092 Emergency Generator 250 kW:- Secondary Around Day Tank

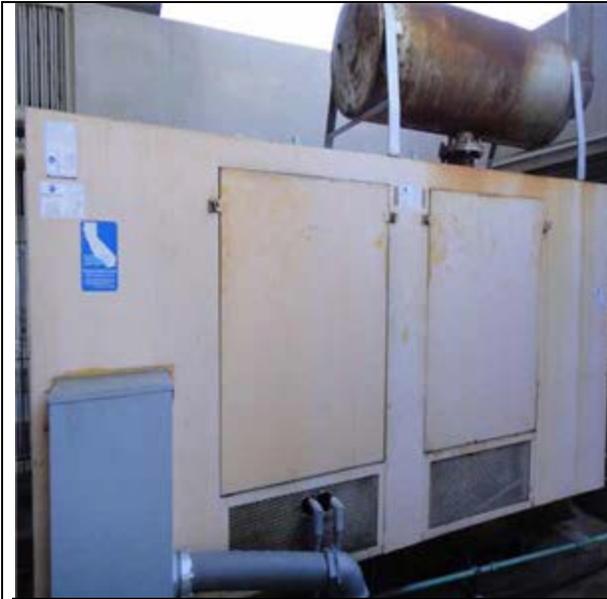
D5092 Emergency Generator 250 kW :- Emergency Generator

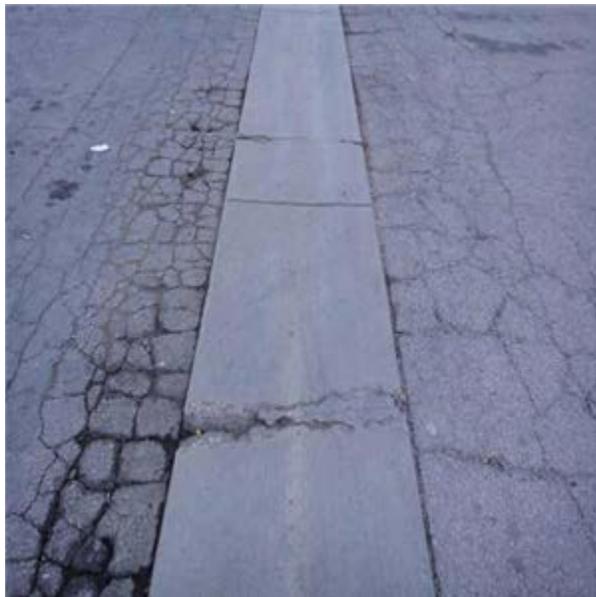
G2012 Asphalt Cut and Resurface 2.0'' - Roadways

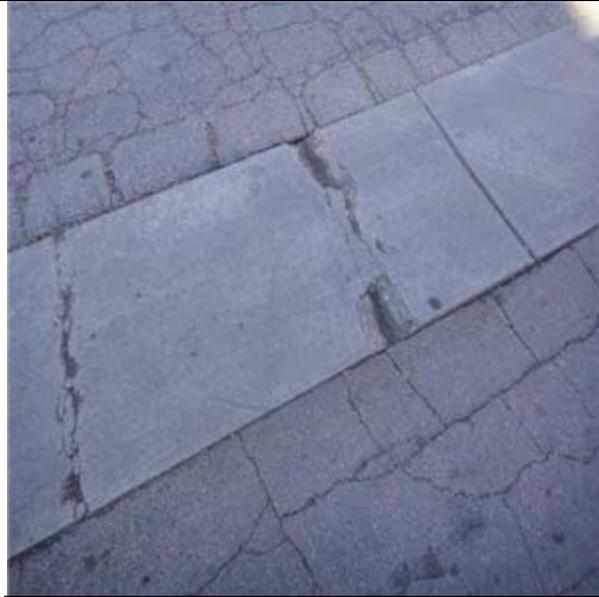
G2013 Concrete Swale
