# Ronald M. George State Office Complex/ Earl Warren Building (402)

350 MacAllister Street, San Francisco, CA 94104

## Facility Condition Assessment

September 2015

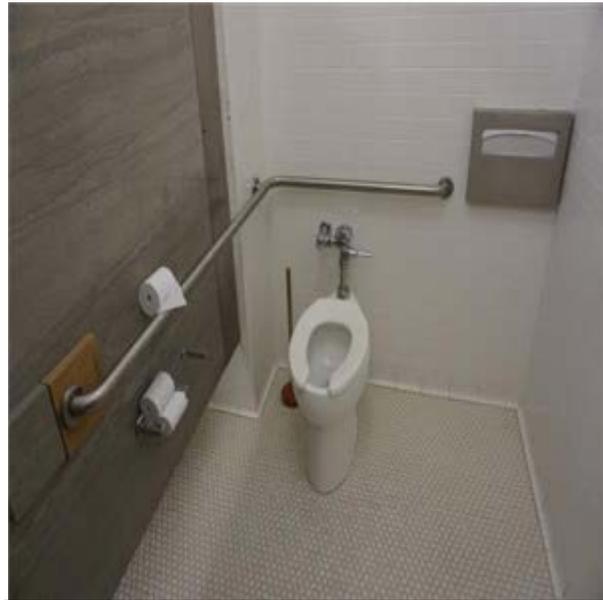
D2011 Commercial Grade Water Closet, 1.6 GPF Unit

- Plumbing fixture improvements to conserve water are recommended.
- Installing Direct Digital Controls (DDC) for the heating and cooling system is recommended.
- Repair of the exterior steps to improve the appearance of the building are recommended.

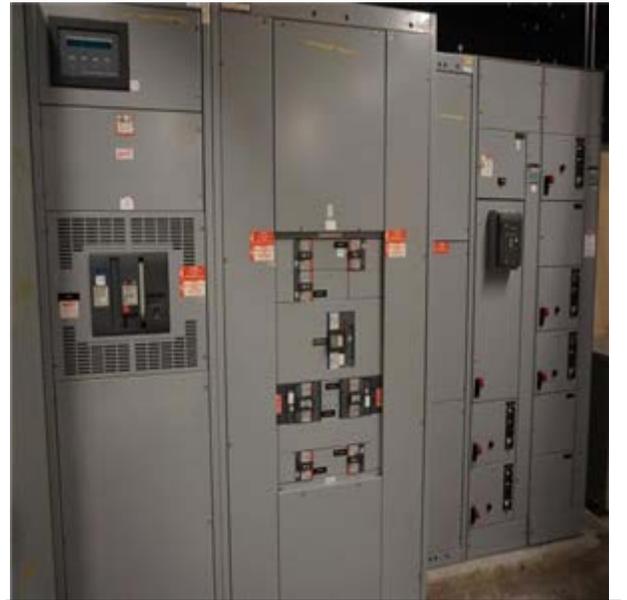
D5010 Switchgear, Mainframe, 1500Amps

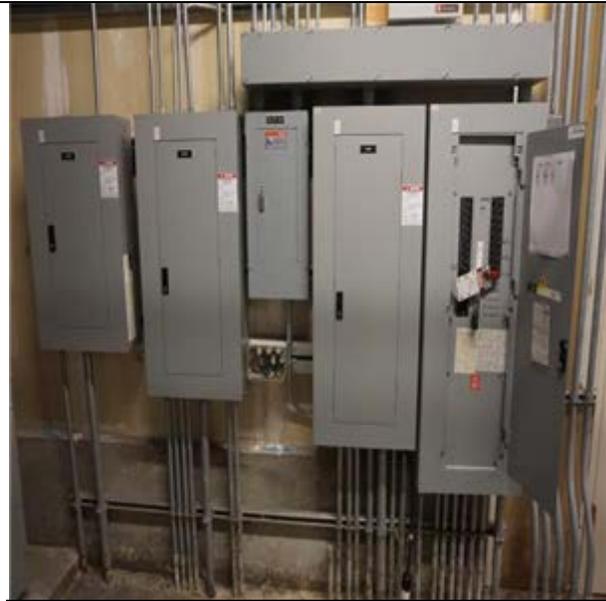
D5010 Switchgear, Mainframe, 1500Amps

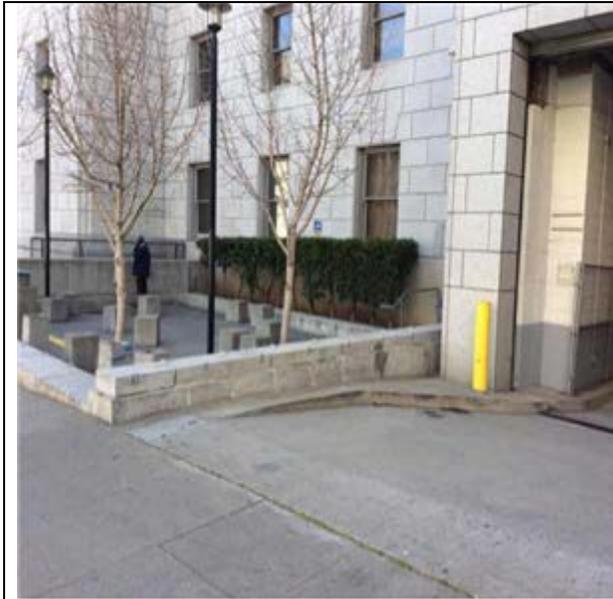
G2031 Concrete Pavement

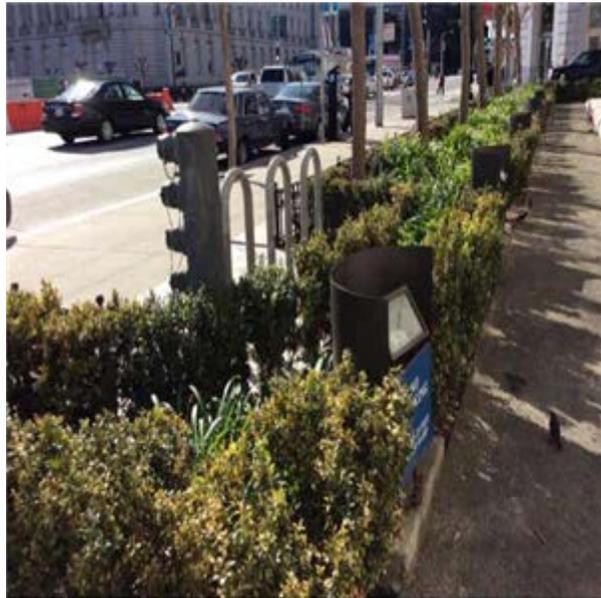
G2053 Landscaping
