Mission Valley State Building (850)

7575 Metropolitan Drive, San Diego, CA 92108

Facility Condition Assessment

September 2015

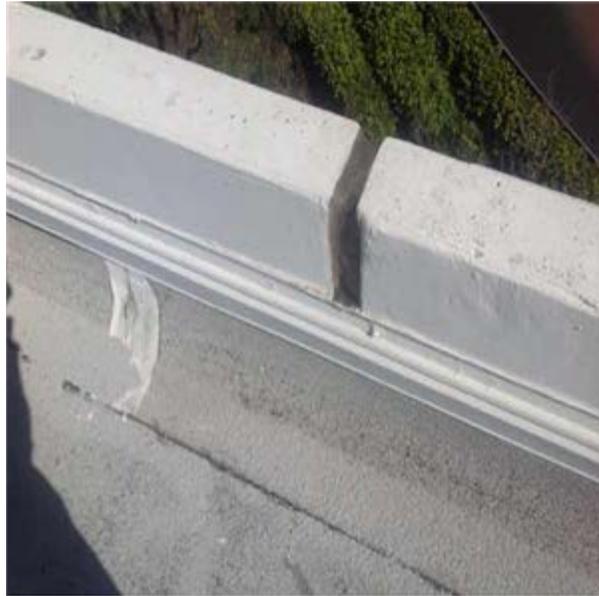
B1031 Structural Steel Columns and Beams Frame

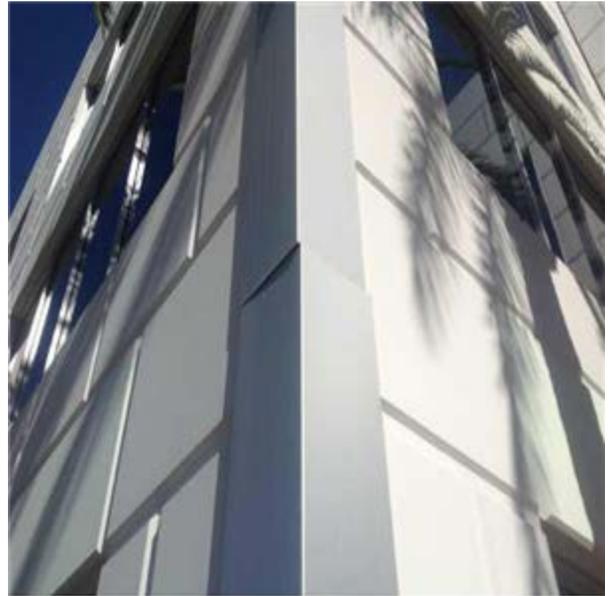
B2011 Paint Concrete Exterior Walls

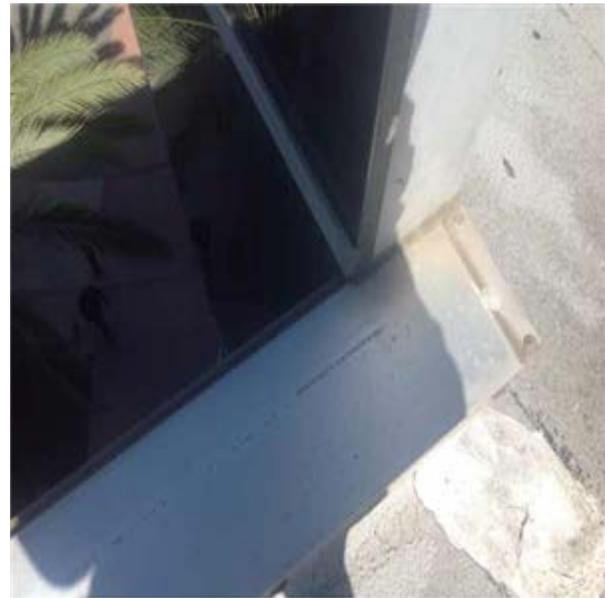
B2021 Aluminum Windows

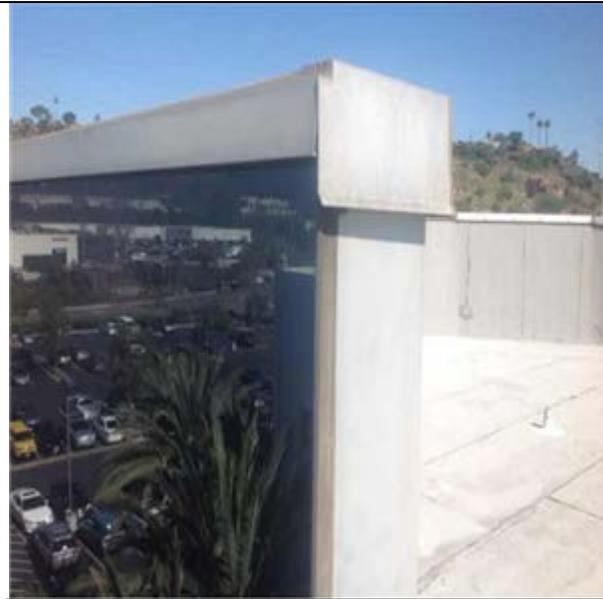
B2021 Aluminum Windows

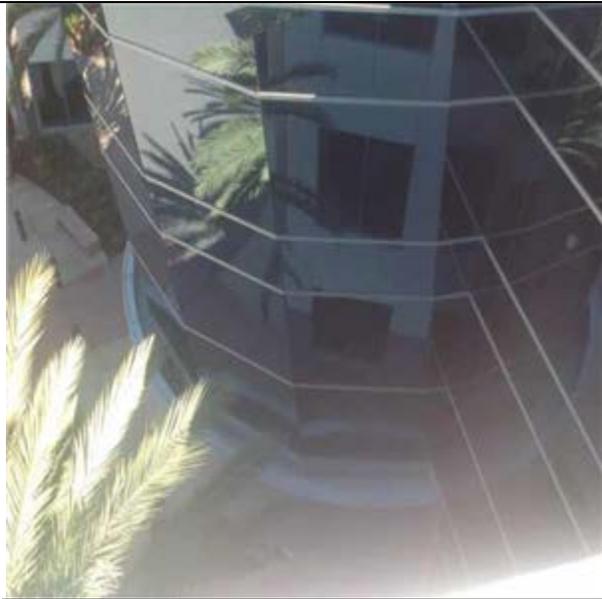
B2021 Aluminum Windows

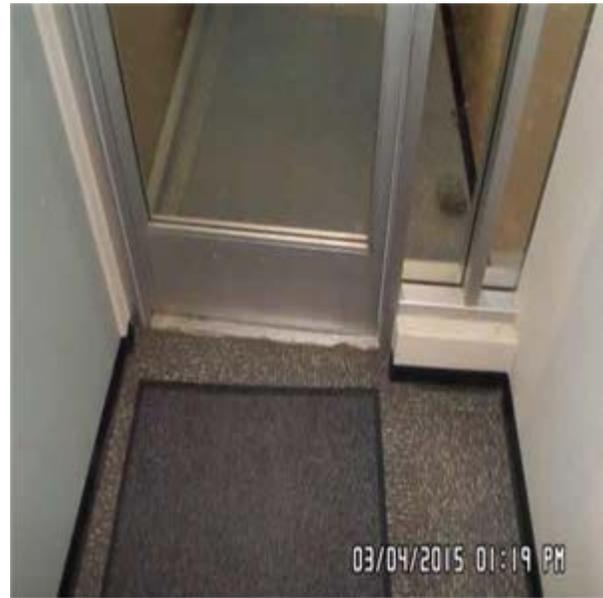
B2021 Aluminum Windows

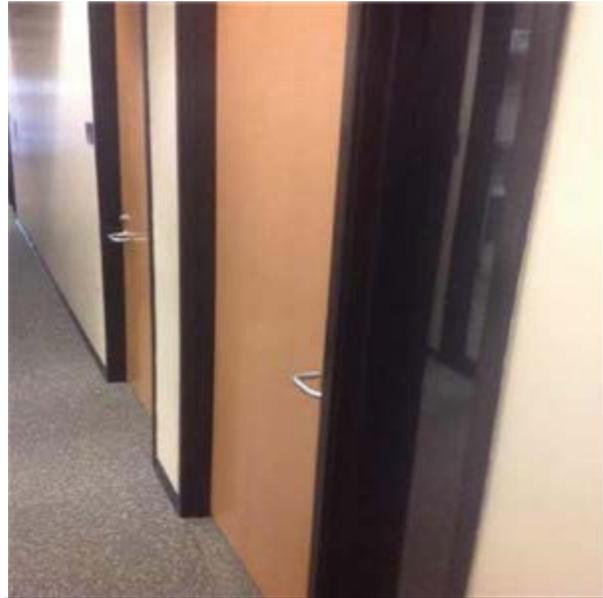
C1021 Interior Doors - newer

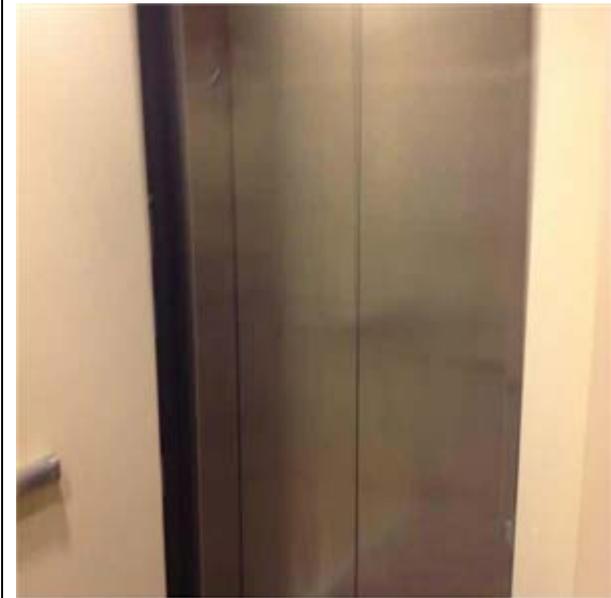
D1011 Hydraulic Service Elevator 4500 lbs

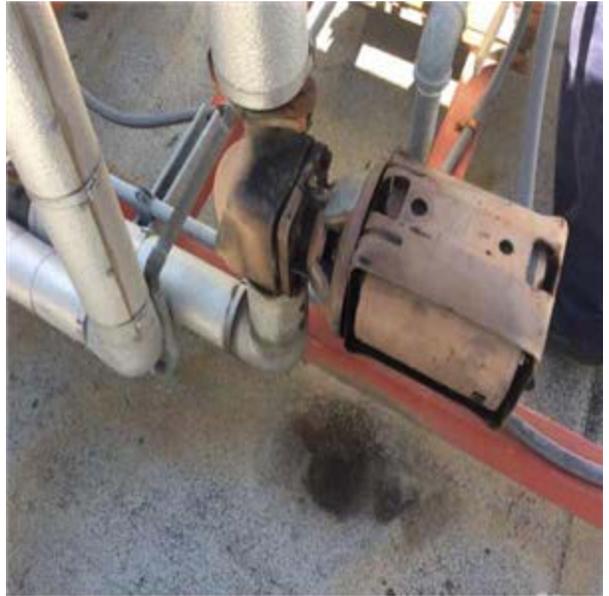
D2023 Domestic Gas Water heater (333 MBH)

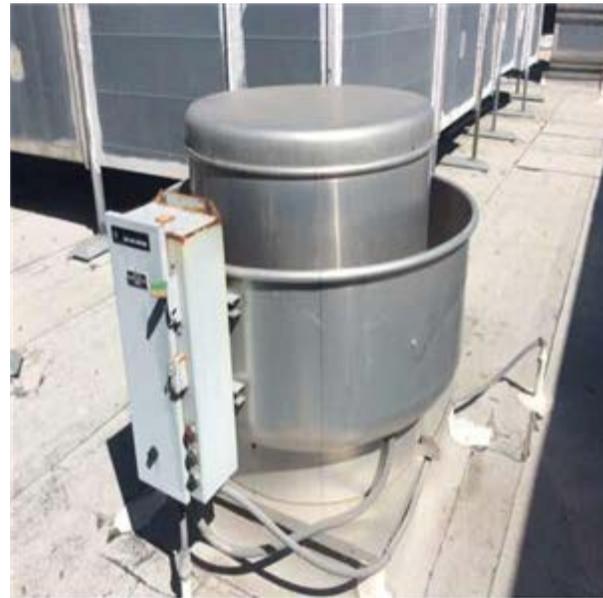
D3042 Exhaust Fan 1300 CFM

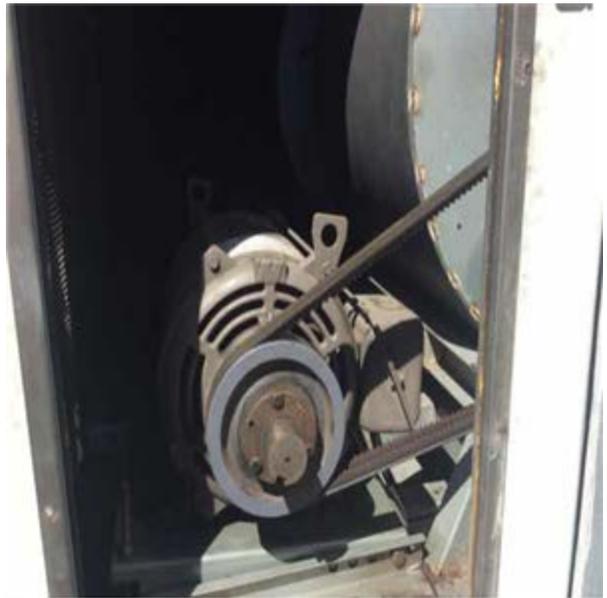
D3042 Exhaust Fan upto 6775 CFM

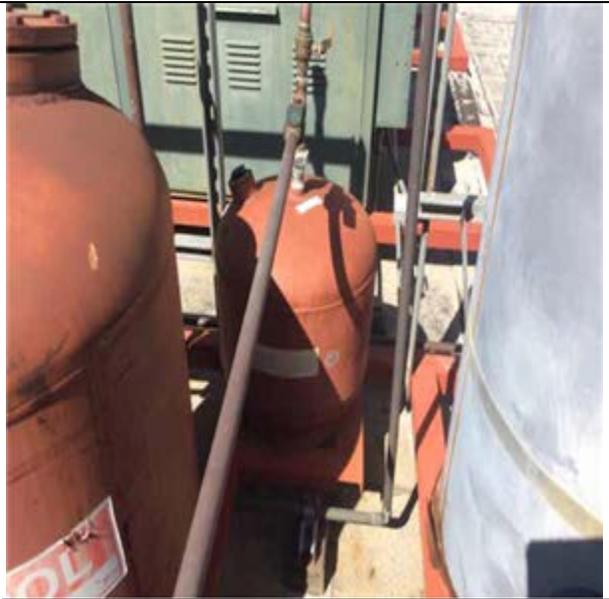
D3023 Expansion Tank 53 Gal

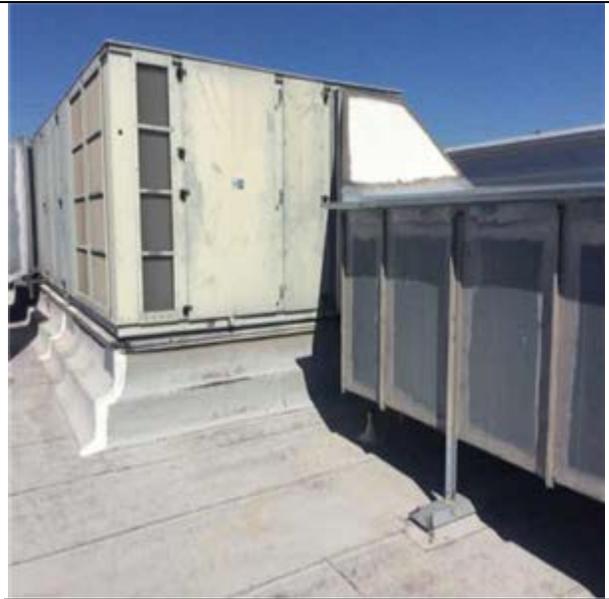
D3052 Packaged Rooftop Unit 90 Tons

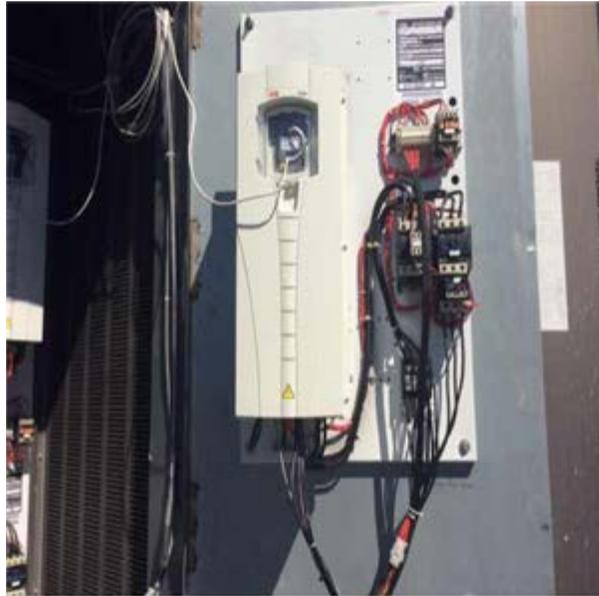
D3052 Packaged Rooftop Unit 90 Tons

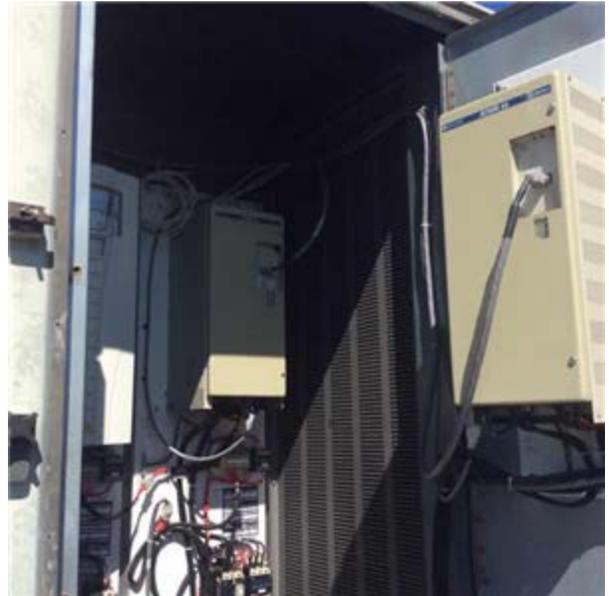
D3063 Variable Frequency Drive, 25-30 HP Fan Motor - New

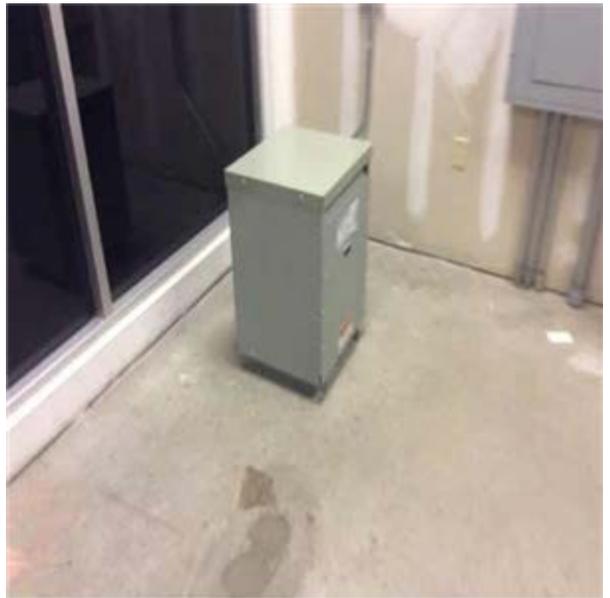
D5012 Dry Transformer 150 kVA

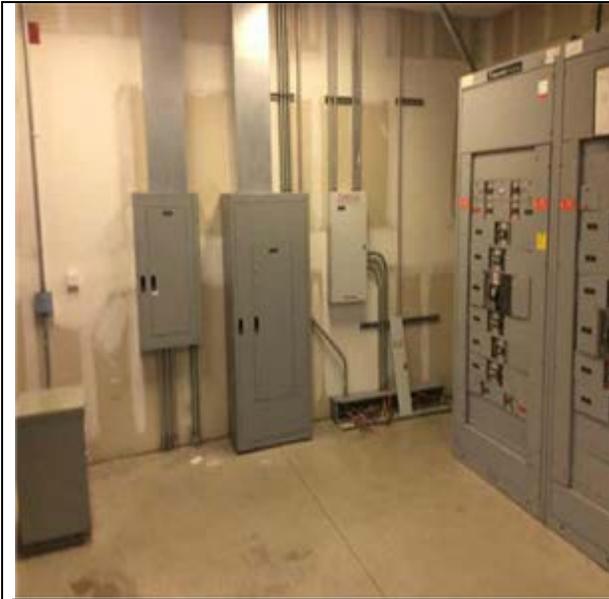
D5012 Secondary Dry Transformer <45 kVA

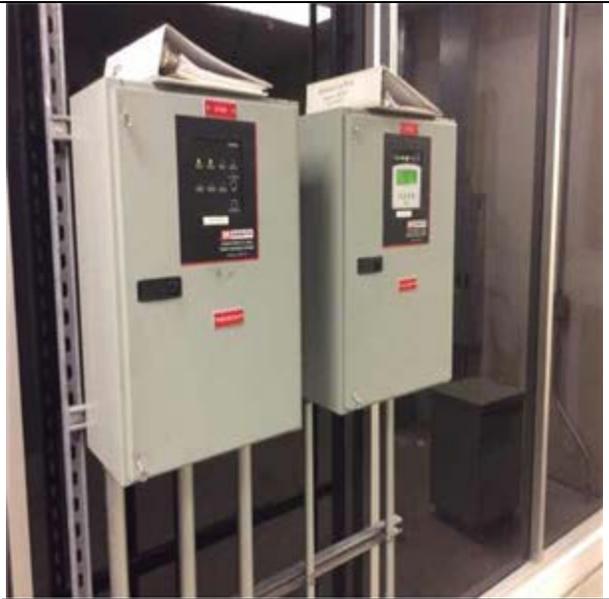
D5012 Distribution Panel, 400-1200 Amp

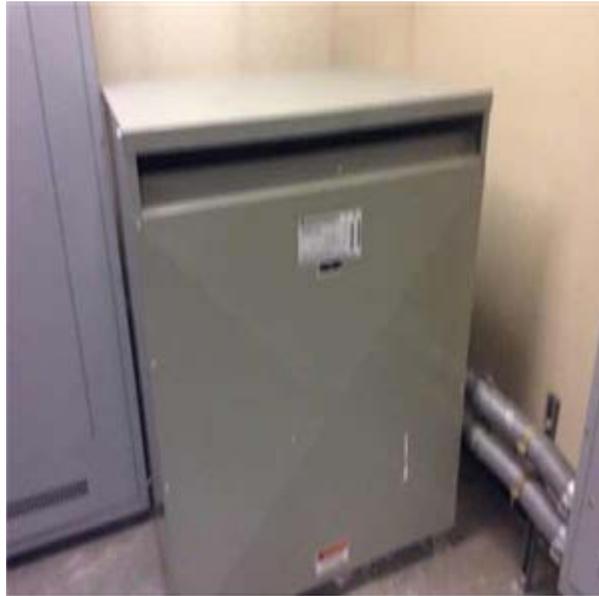
D5012 Emergency Switchgear 150 Amps

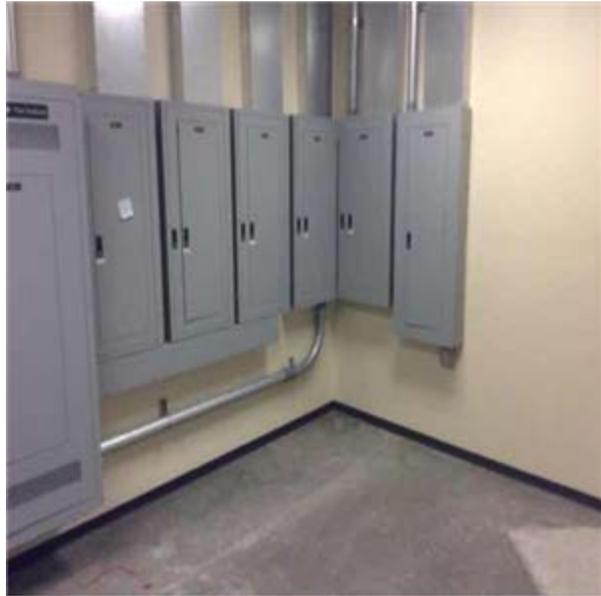
D5012 Transformer, 225 kVA

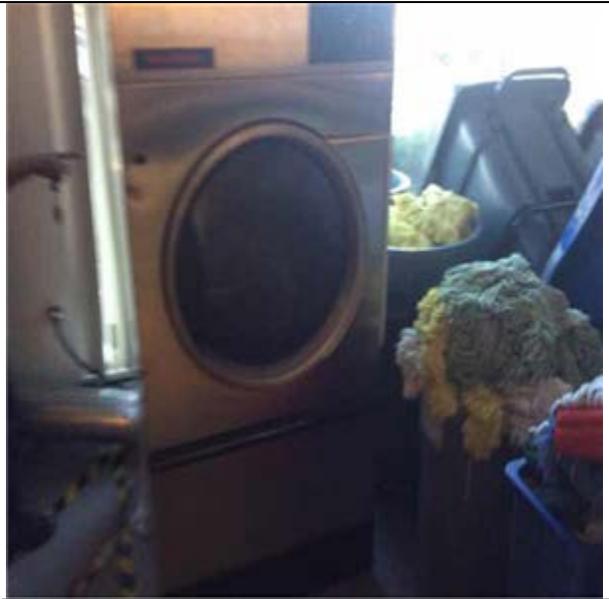
E1016 Gas Dryer 50 Lb

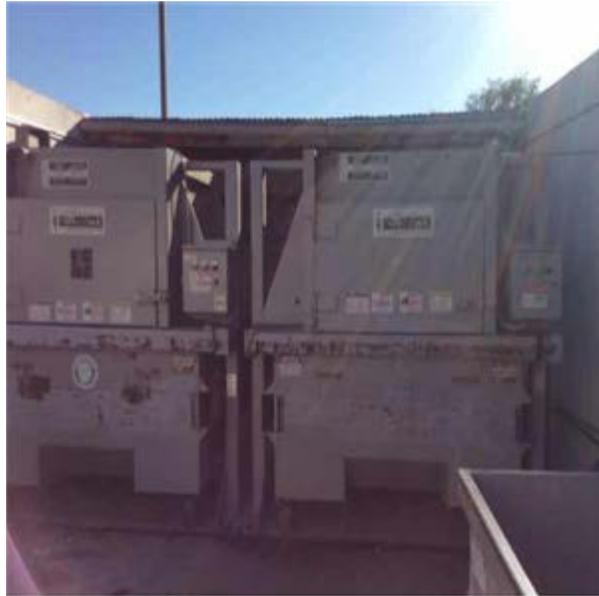
E1016 Commercial Washers 35 Lb

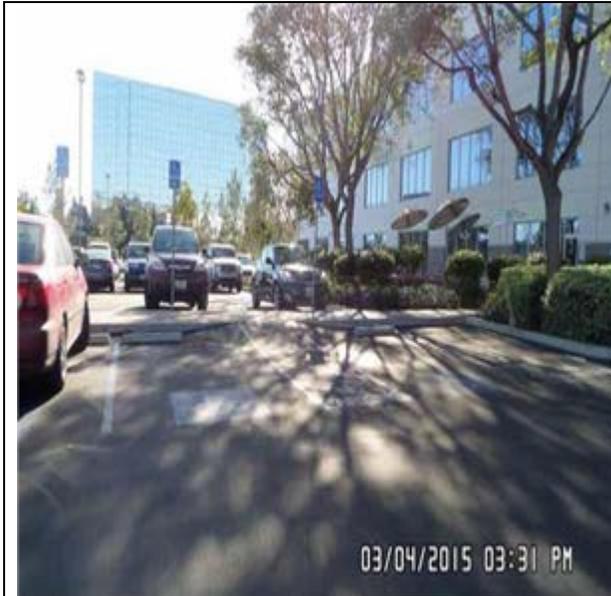
G2012 Asphalt Seal Coat

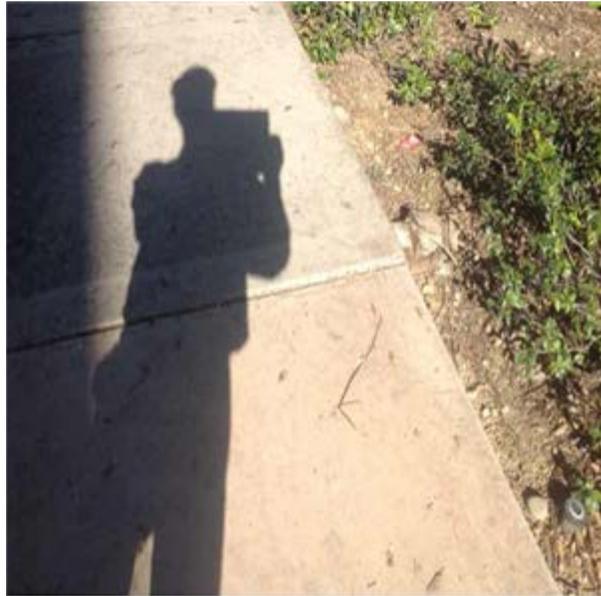
G2035 - Install Accessible ramp at path of travel

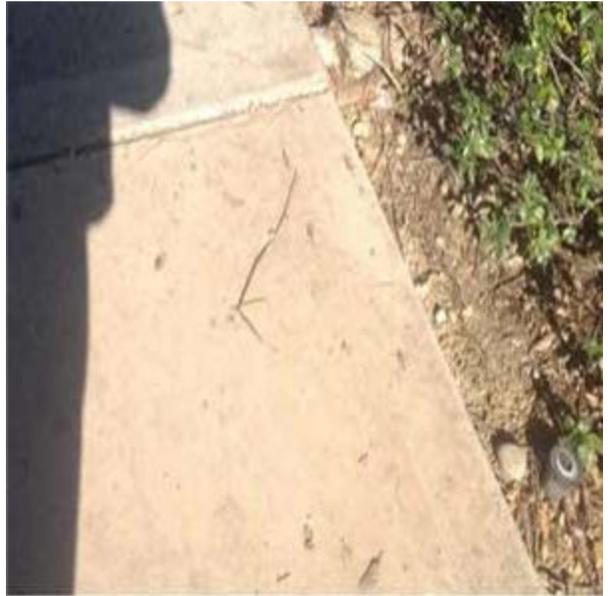
G2035 - Install Accessible ramp at path of travel

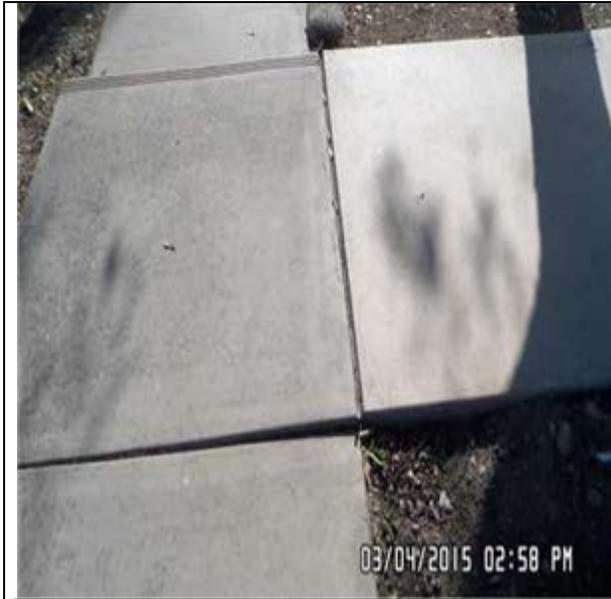
G2031 4' Wide Concrete Sidewalk

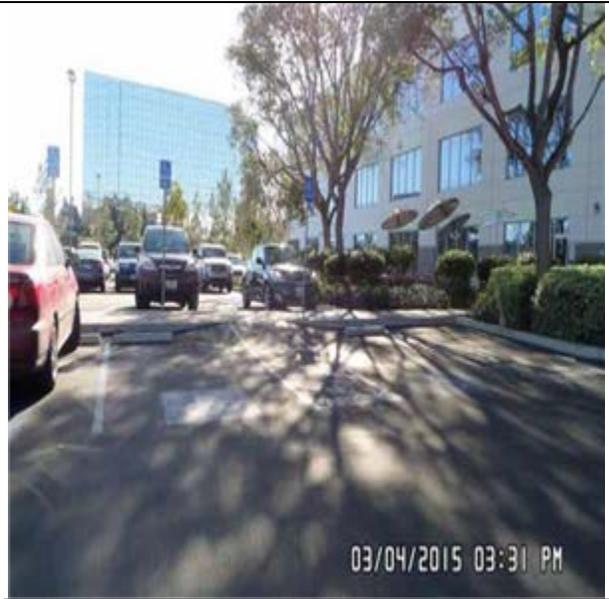
G2031 4' Wide Concrete Sidewalk

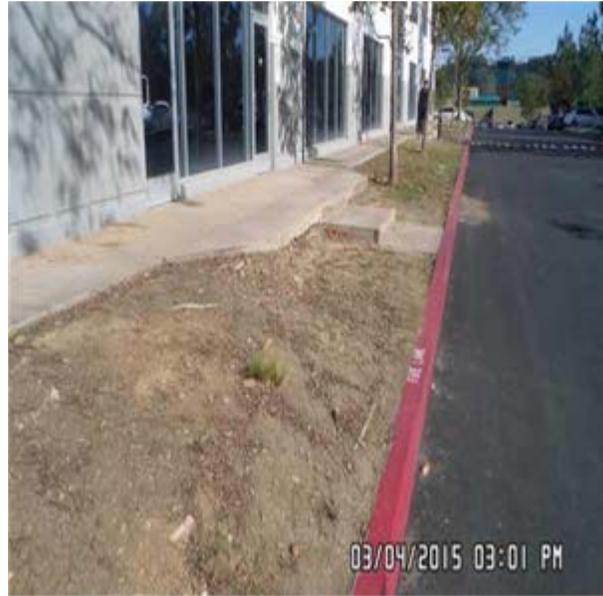
G2035 Curb Cuts to Serve Disabled Parking
