## Justice Joseph A. Rattigan Building (480)

50 D Street, Santa Rosa, CA 95404

### Facility Condition Assessment

September 2015

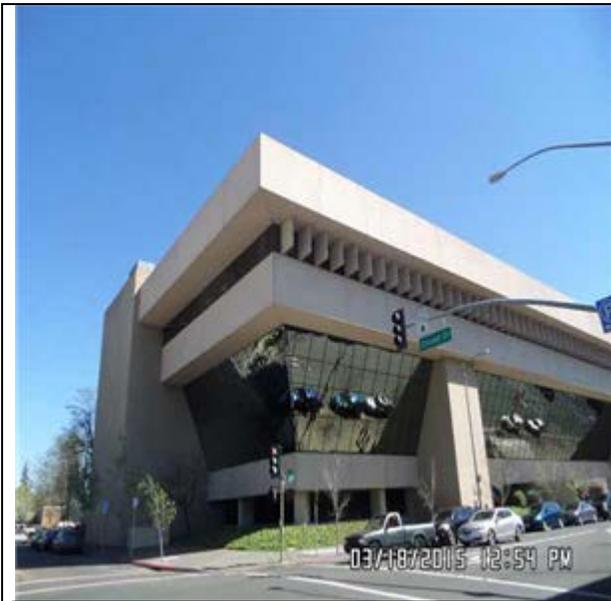
View of northwest corner of building

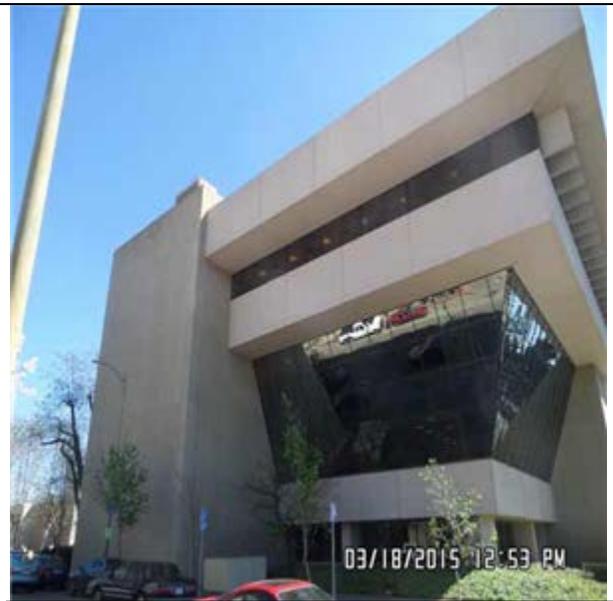
North elevation

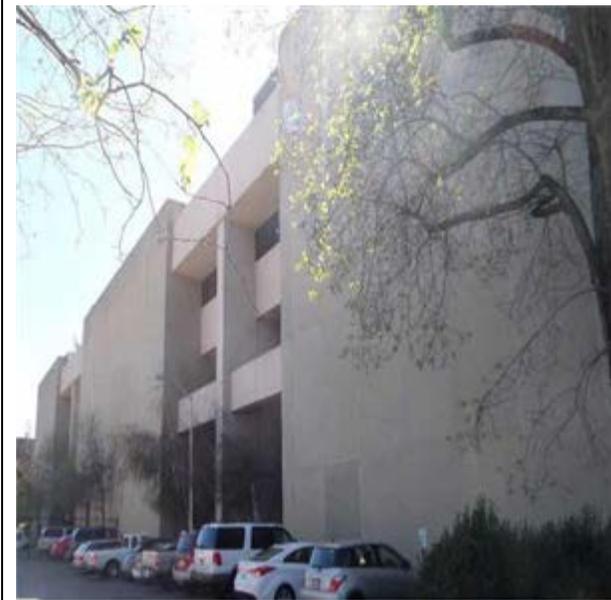
East elevation

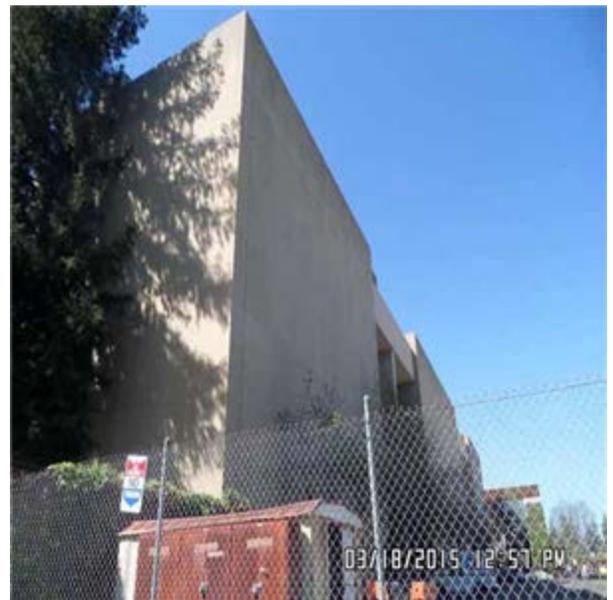
Southeast corner of building

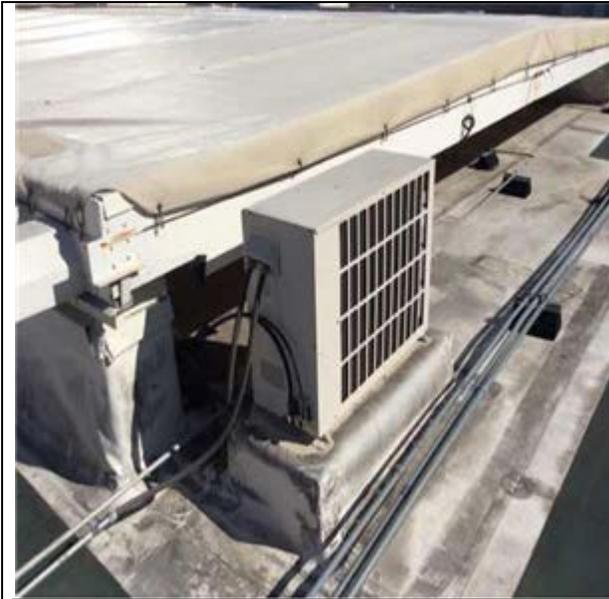
D3052 Air Conditioner, Split unit 1.5 tons

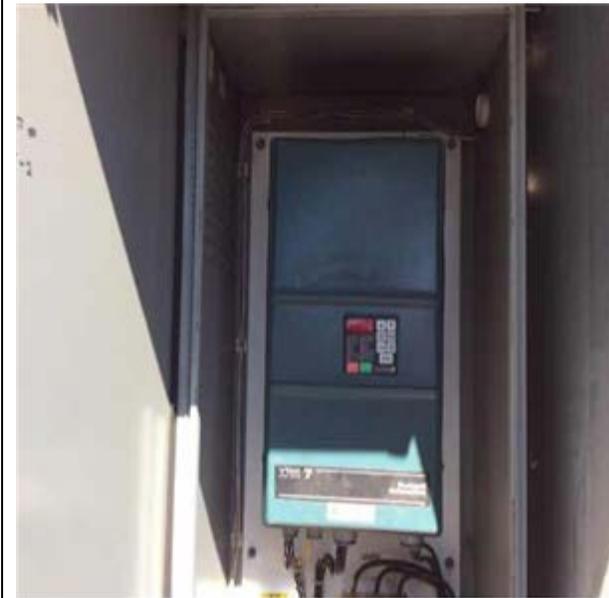
D3063 Variable Frequency Drive, 30 HP Fan Motor,

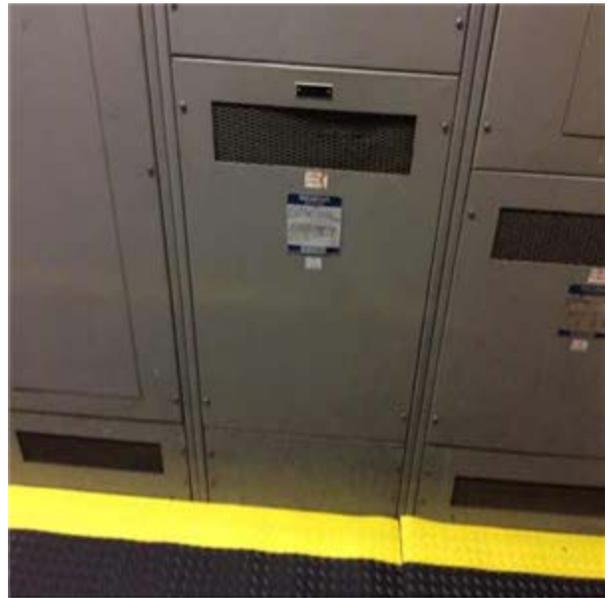
D5012 Switchgear 600 Amps

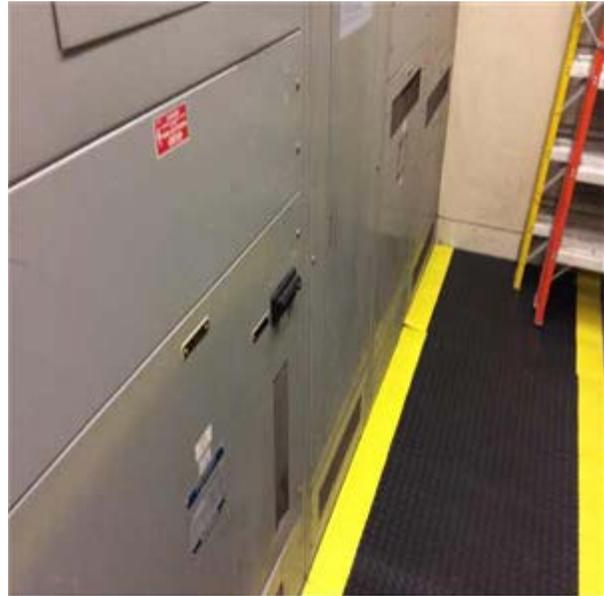
D5012 Breaker Panel 100-800 Amps

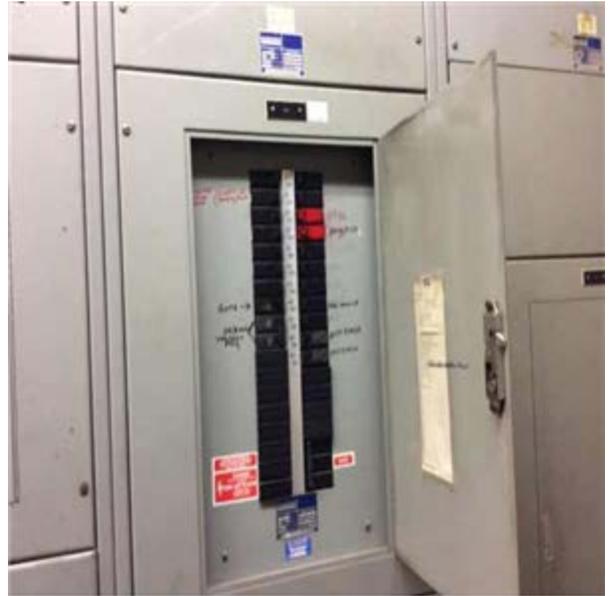
D5012 Dry Transformer 75 kVA

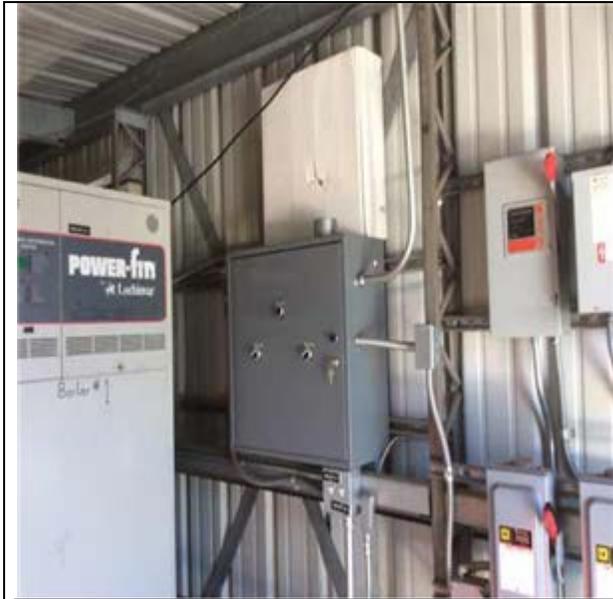
D5012 Breaker Panel 225 Amps
