Board of Equalization Headquarters Building (028)

450 N Street, Sacramento, CA 95814

Facility Condition Assessment

June 2015

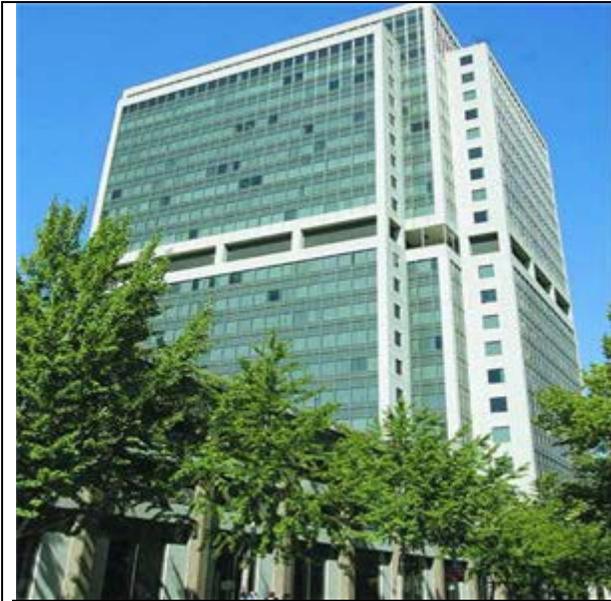
:- Front elevation

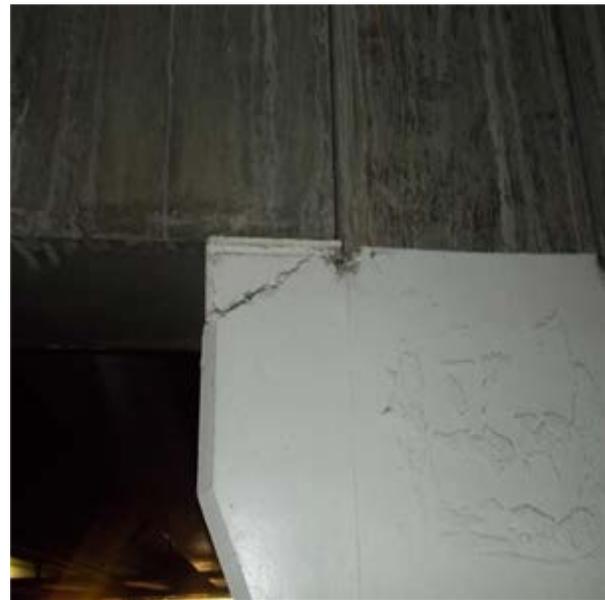
B1012 Seismic bracing of the garage

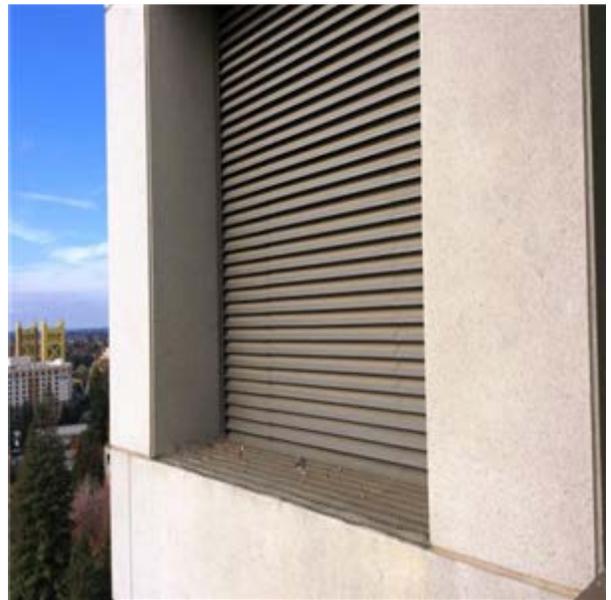
B2011 Exterior Painted Walls

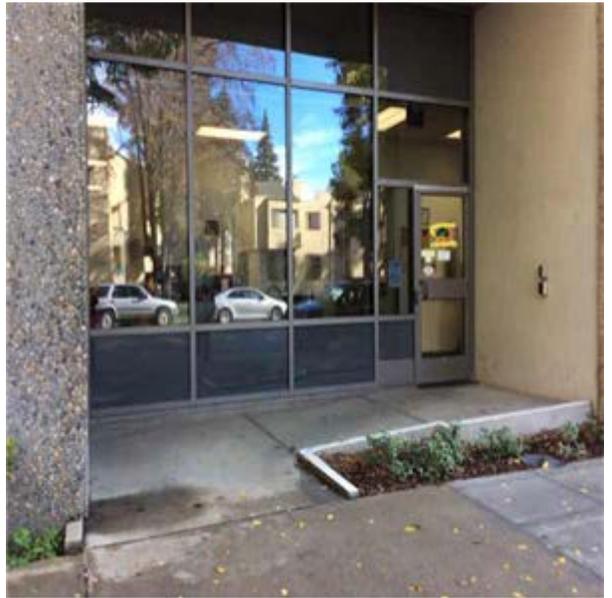
B2031 Exterior Glazed Doors

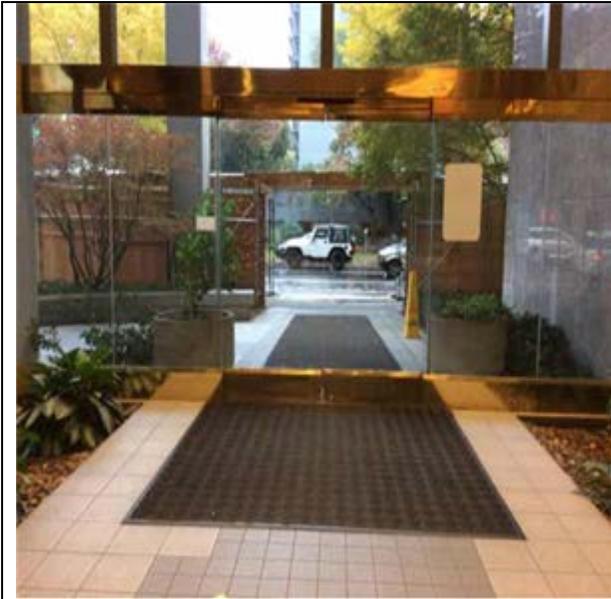
B2031 Main Auminum Doors with Glass Panels :- main door at east side

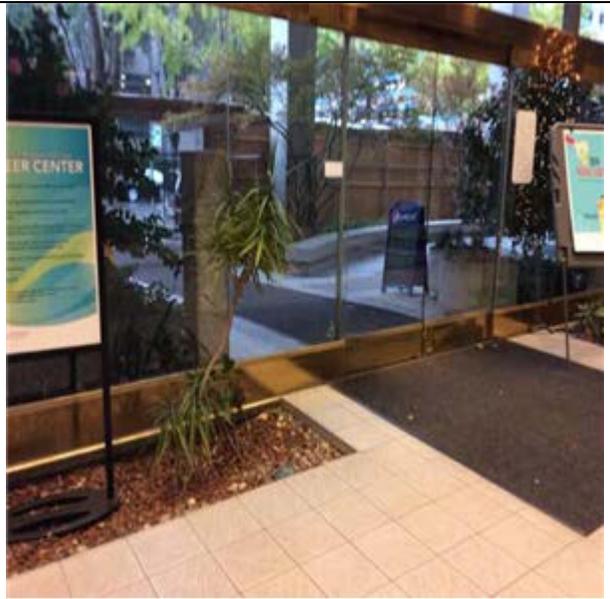
B2031 Main Auminum Doors with Glass Panels:- North side Entrance

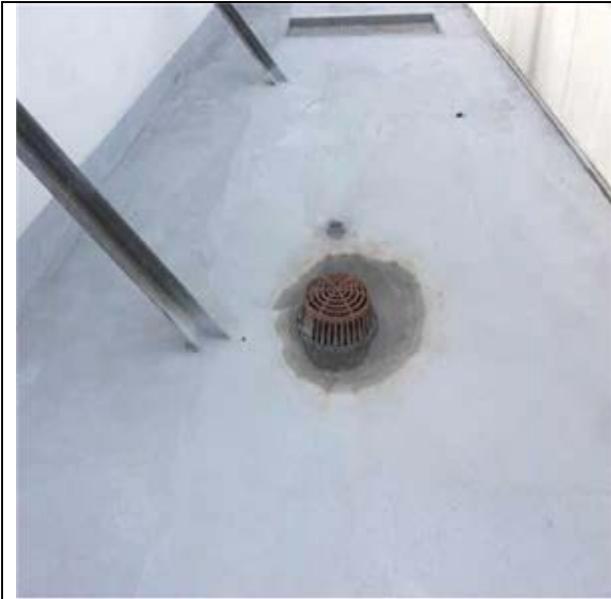
B3011 PVC Membrane Roofing :- Roof drainage

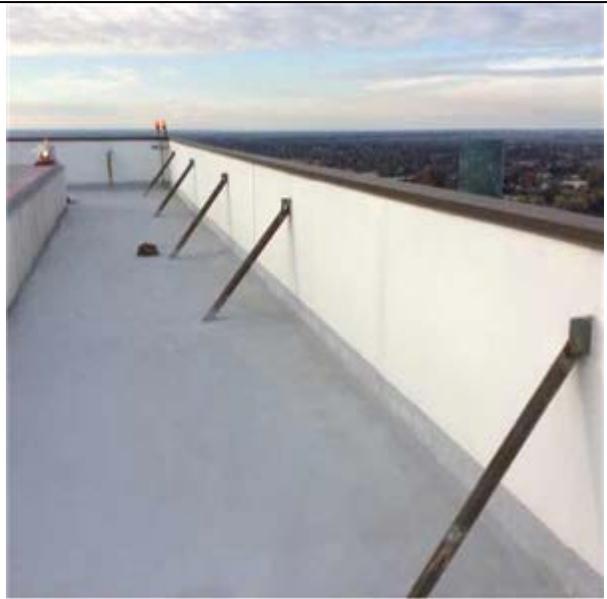
B3011 PVC Membrane Roofing:- Roof parapet

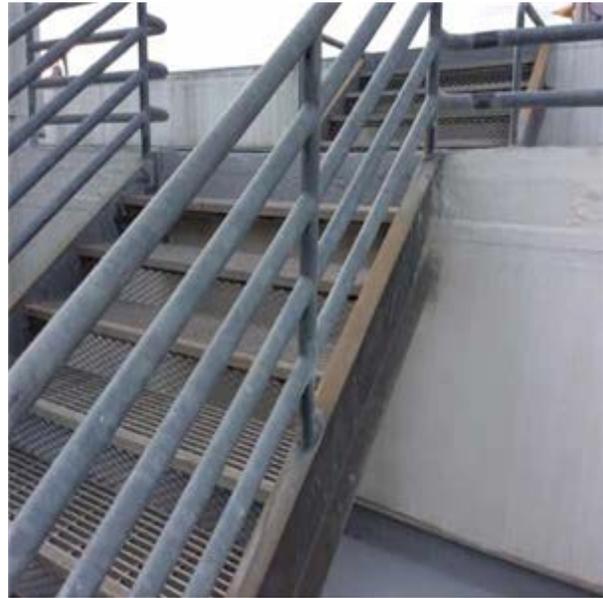
C2011 Fire Exit Stairs

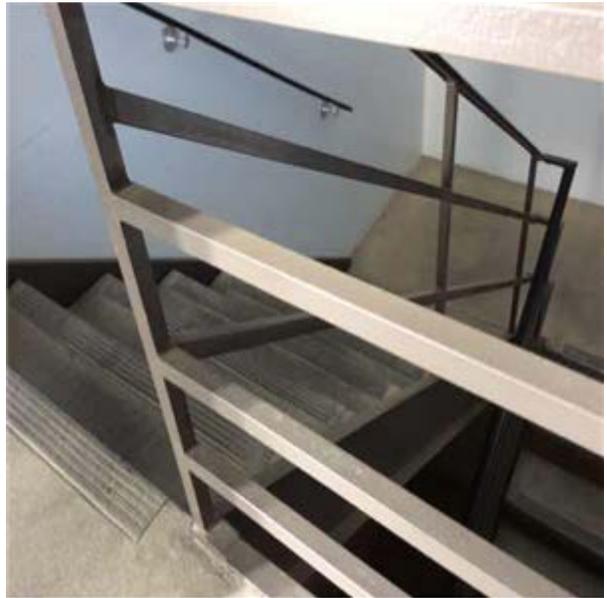
C2011 Fire Exit Stairs

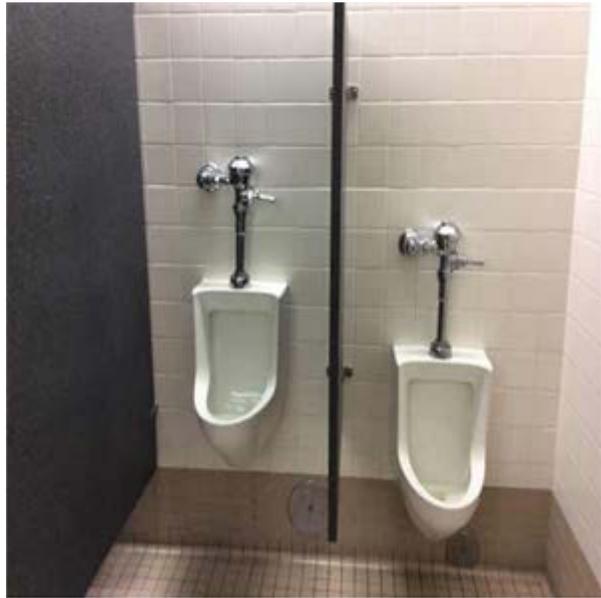
C3005 Restrooms /ADA Renovations

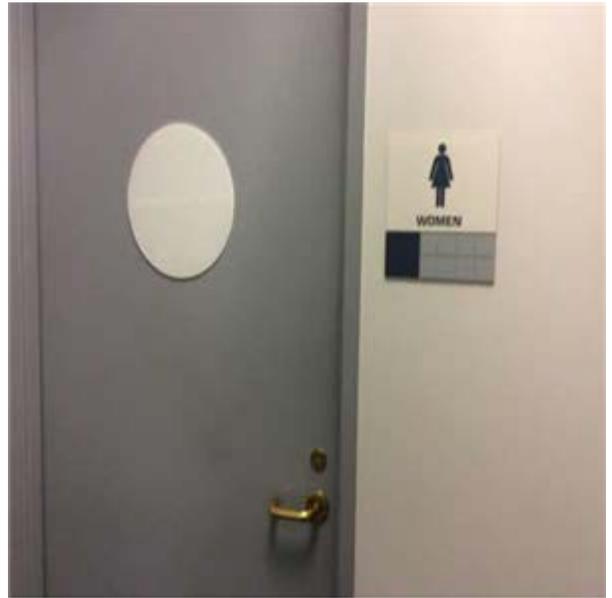
C3005 Restrooms /ADA Renovations

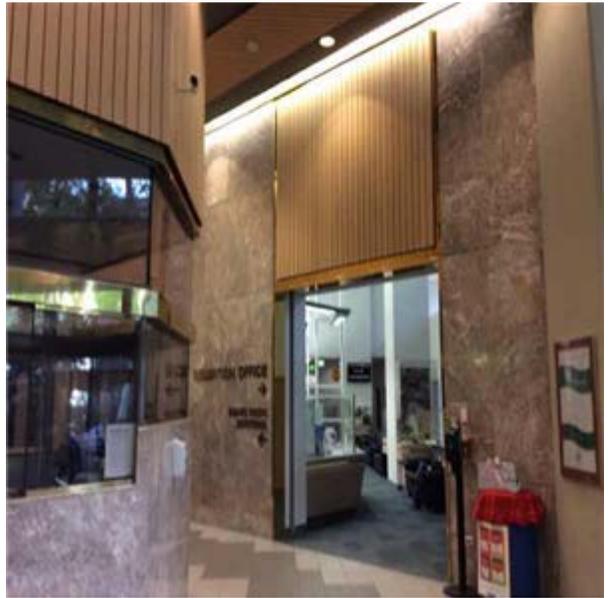
C3012 Marble Tile

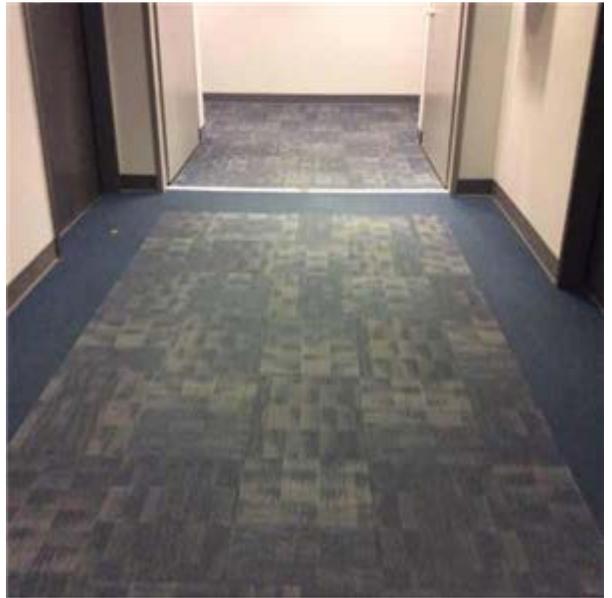
C3025 Carpet Tiles - Standard

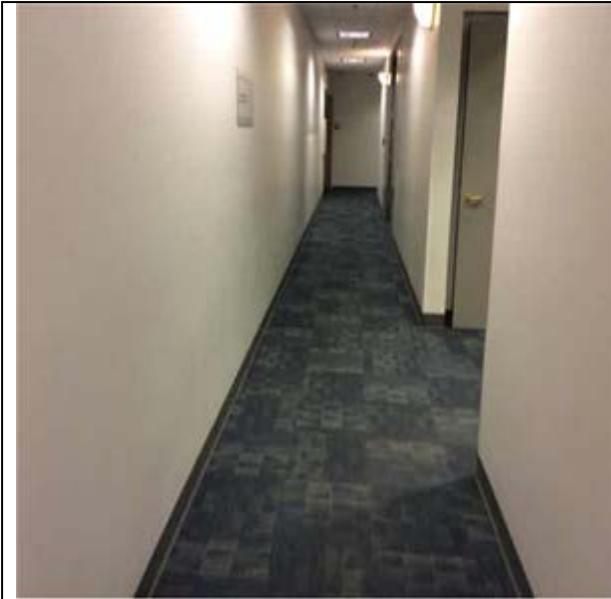
C3025 Carpet Tiles - Standard

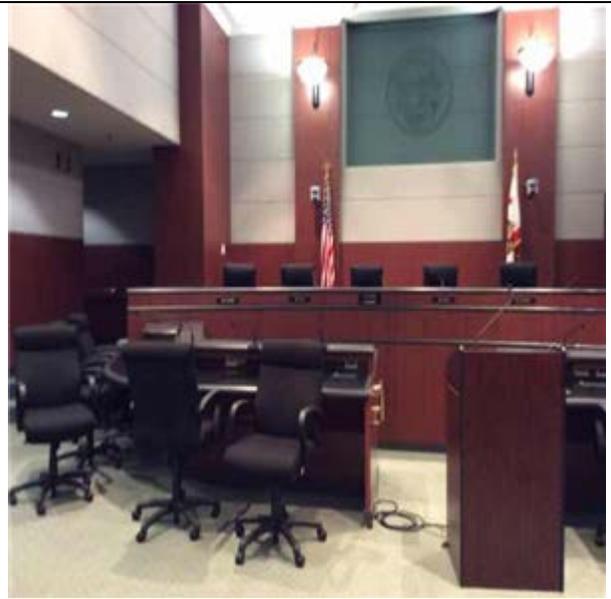
C3025 Board Room finishes

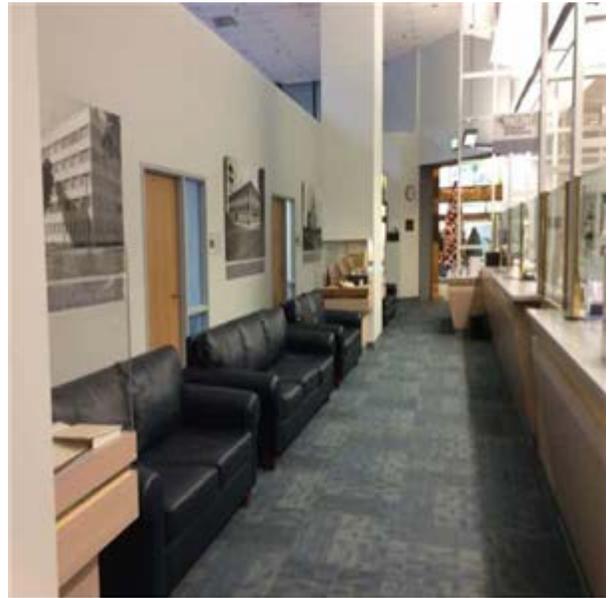
C3025 Lobby Floor:- Lobby

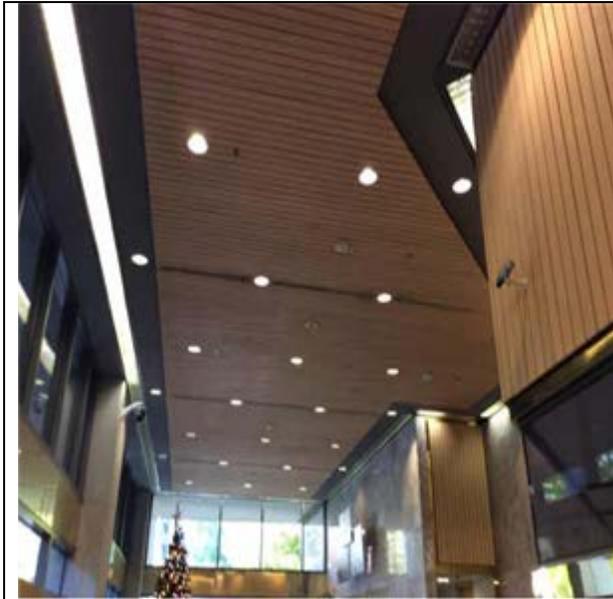
C3032 Lobby ceiling :- main lobby

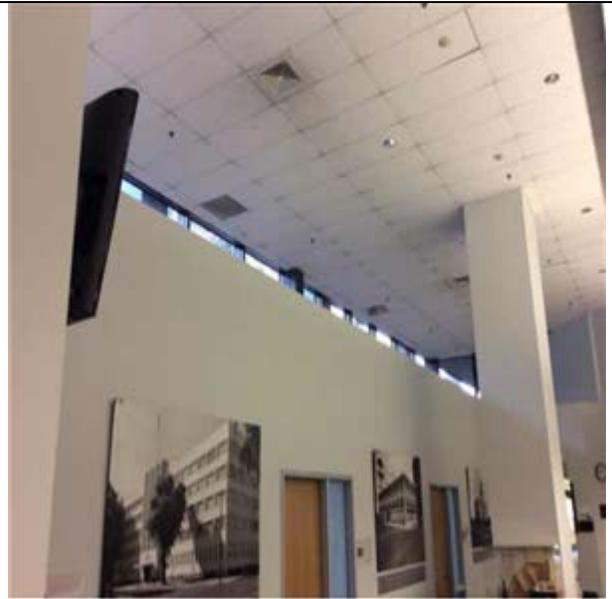
C3032 Lobby ceiling:- reception

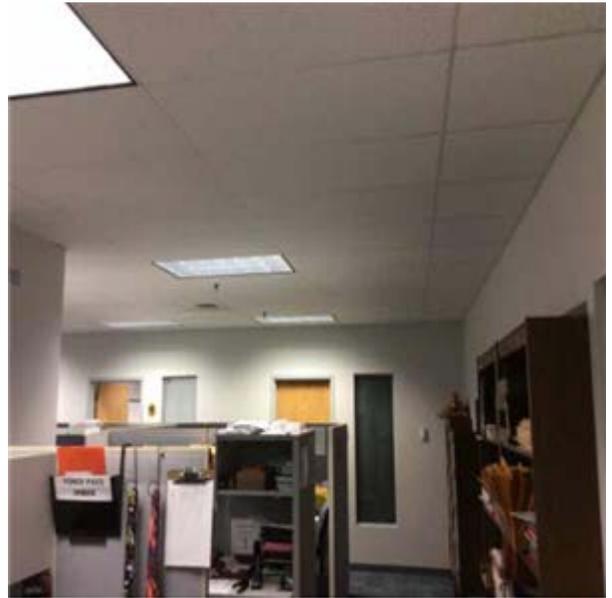
C3032 Acoustical Ceiling Tiles

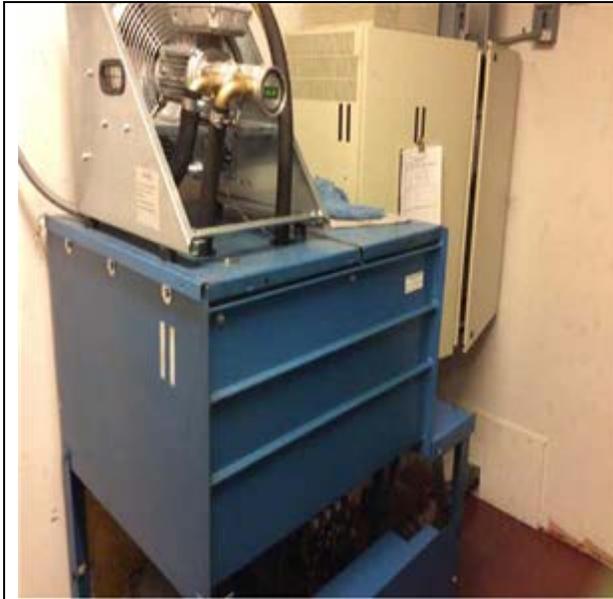
D1010 Hydraulic Parking Garage Elevators, 3,000 LB Capacity :- Hydraulic elevator equipment

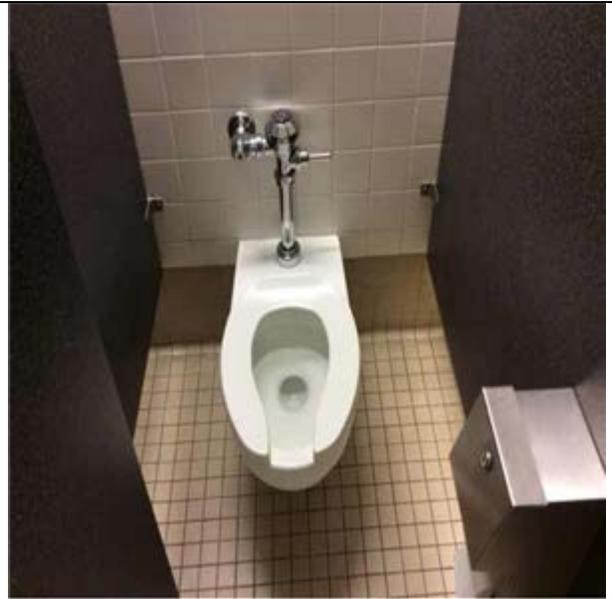
D2011 Commercial Grade Water Closet, 1.6 GPF:- Toilet

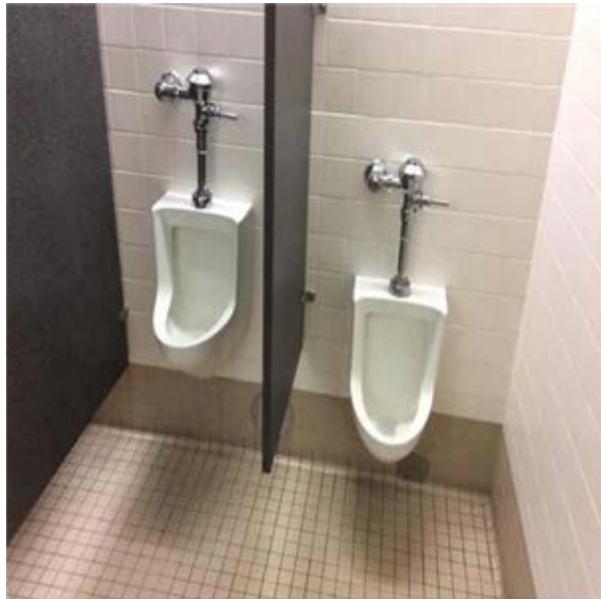
D2012 Urinal :- Urinals

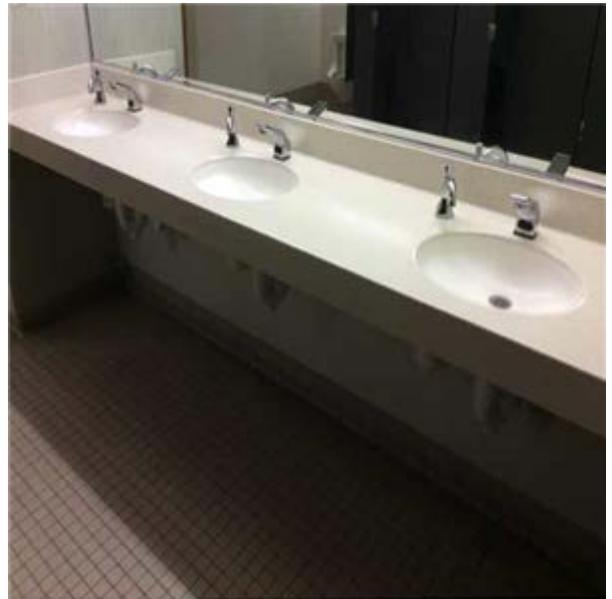
D2013 Counter Top Sink and Faucet:- Countertop sinks and faucets

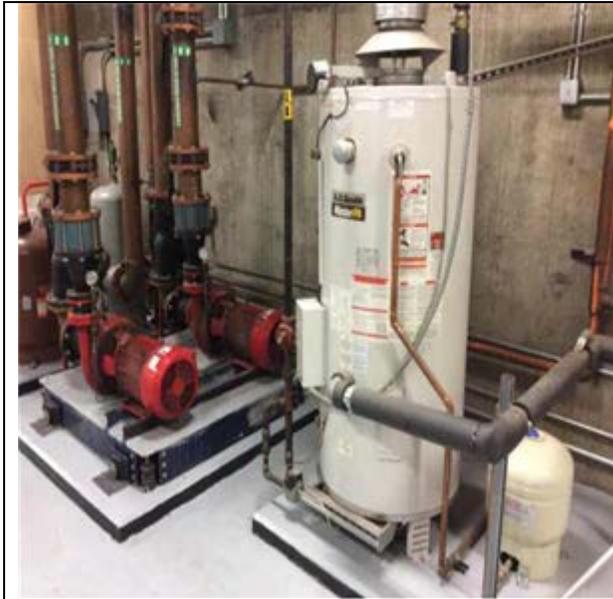
D2023 Commercial Gas-Fired Domestic Water Heater, 390 MBH :- Water heater for old section of building

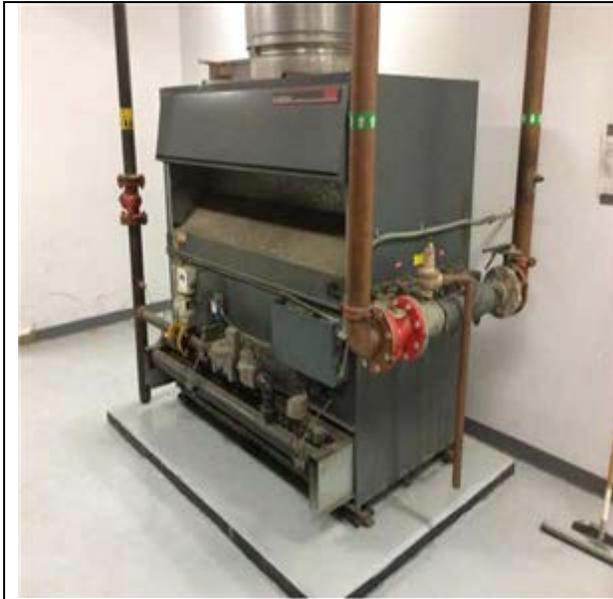
D3021 HVAC Water Boilers, Gas 5500 MBH:- HVAC boilers

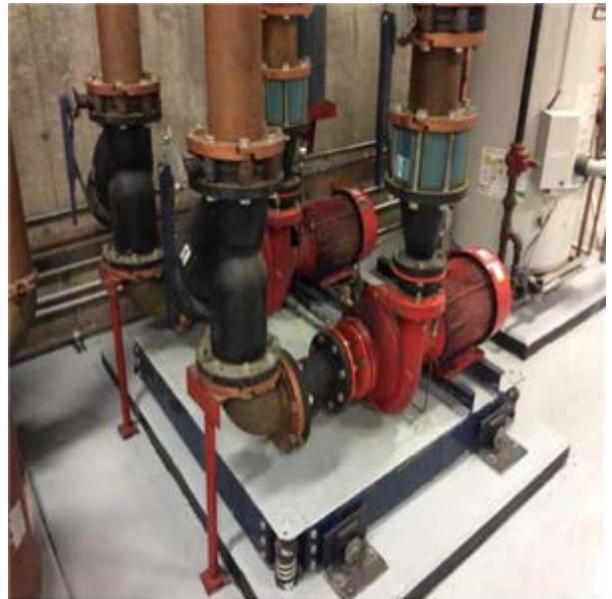
D3022 Pony Chiller Water Pumps 10 HP :- Pony chiller chilled and condenser water pumps

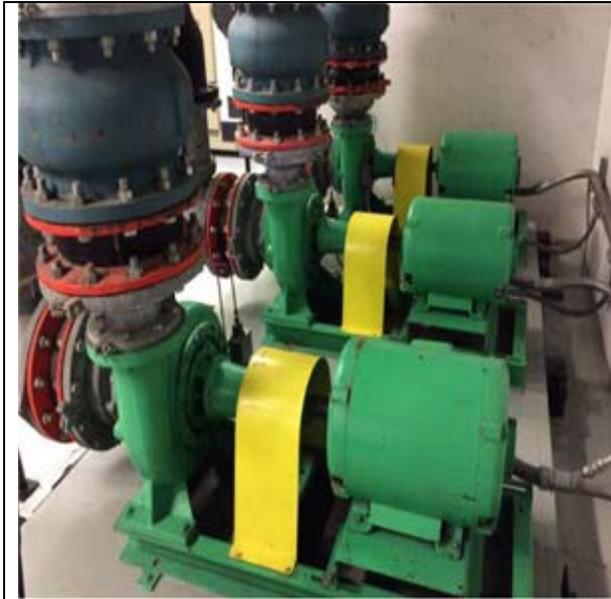
D3022 WSHP Condenser Water Pumps 15 HP:- Water source heat pump condenser water pumps

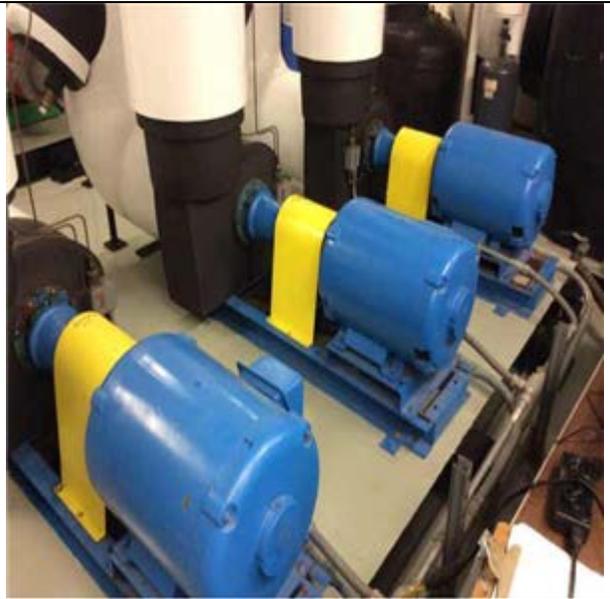
D3022 Condenser Water Pumps 50 HP :- Condenser water pumps

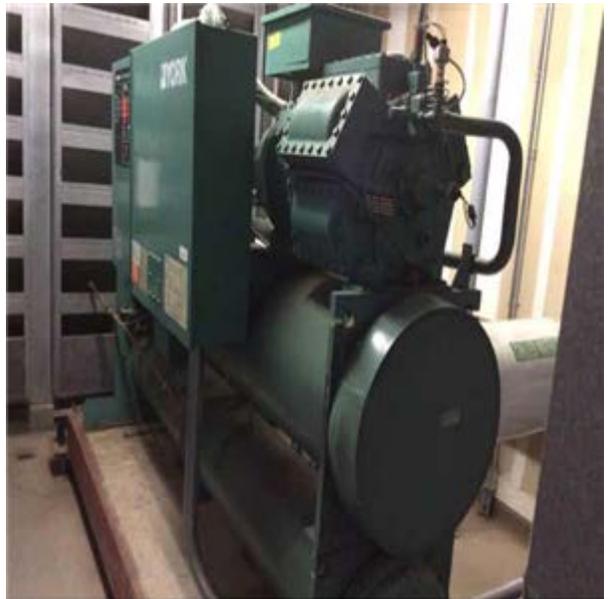
D3031 Water Cooled Chiller, Centrifugal, 700-800 Ton

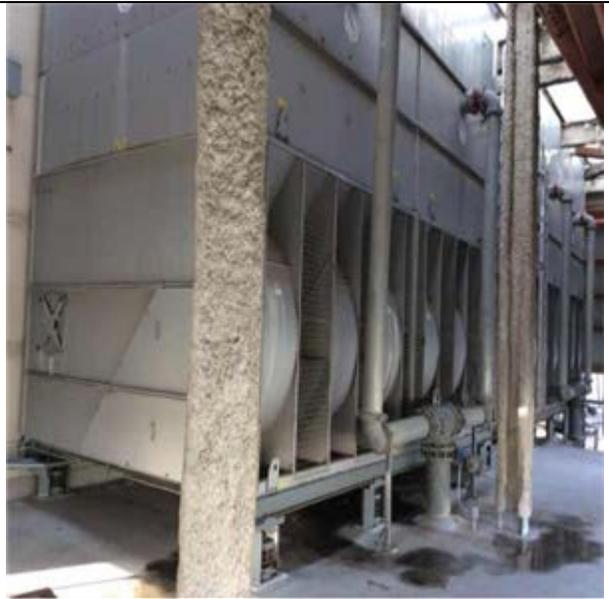
D3031 Fluid Cooler, Galvanized Steel, 288 Tons :- Fluid cooler for water source heat pumps

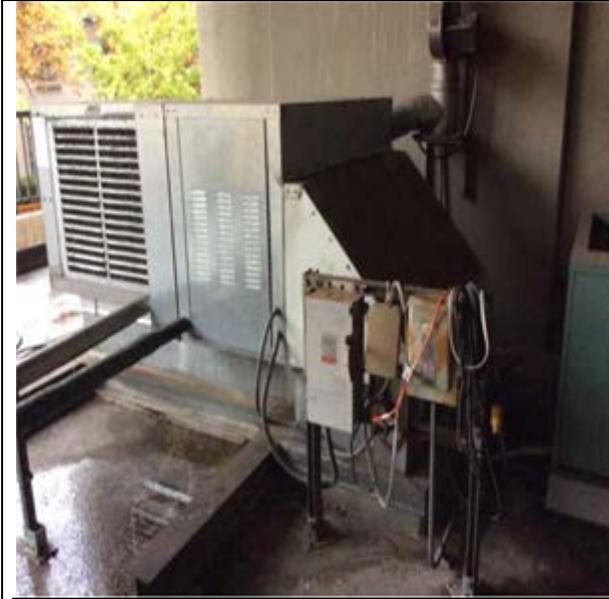
D3042 Restroom Exhaust Fans:- Restroom exhaust fan box

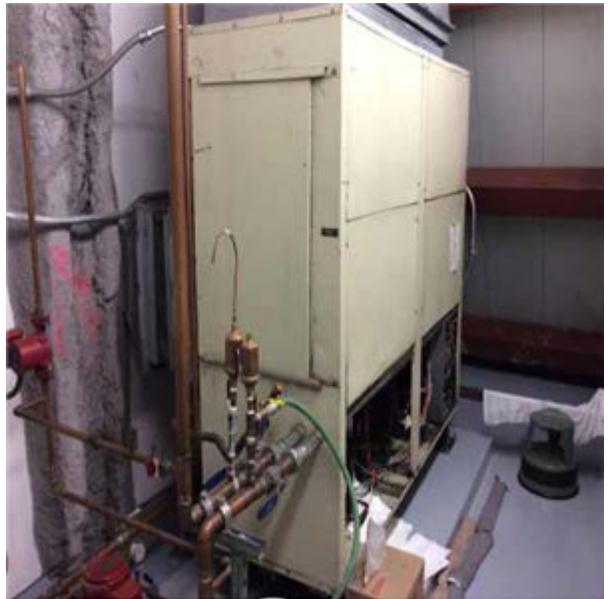
D3051 Heat Pump Water Source, 10-Ton :- Water source heat pumps, old section of building

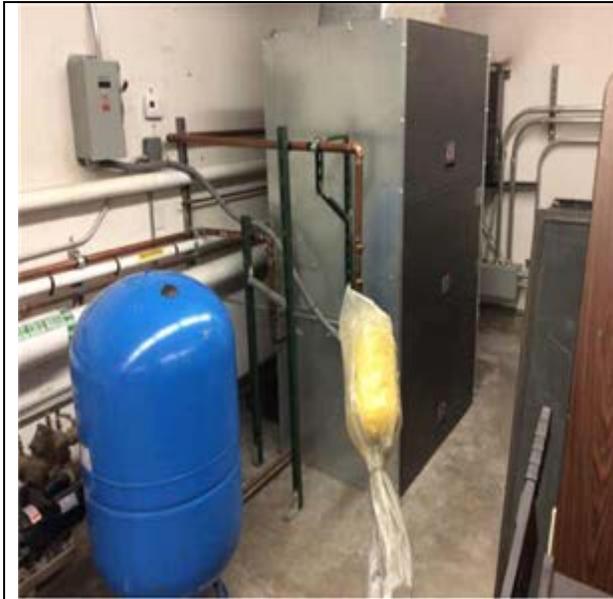
D3051 Elevator Cooling Unit ECU-1:- Elevator cooling unit

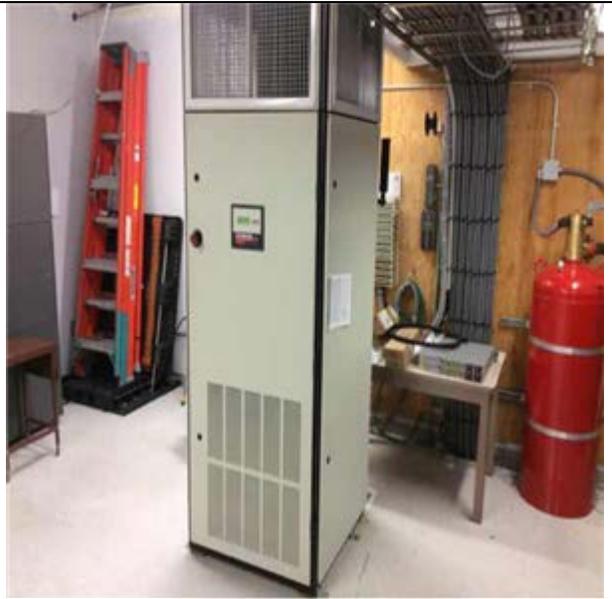
D3051 Penthouse Heat Pump Water Source, 10-Ton :- Heat pump for penthouse area

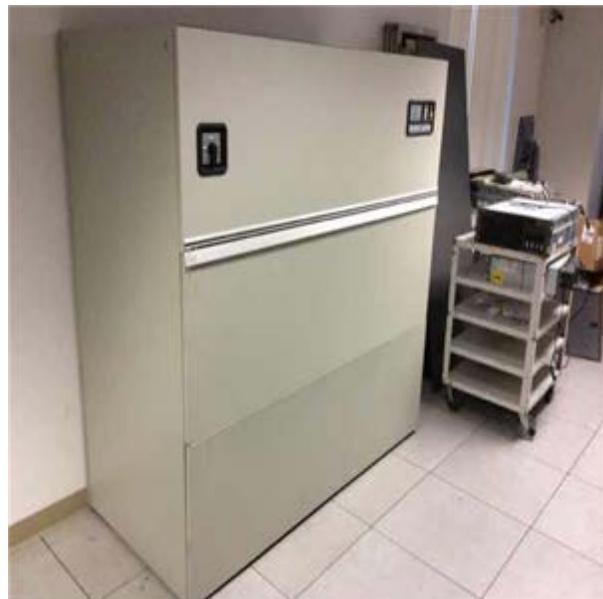
D3052 Phone Room A/C Unit, Water Cooled 7-Ton:- Phone room AC unit

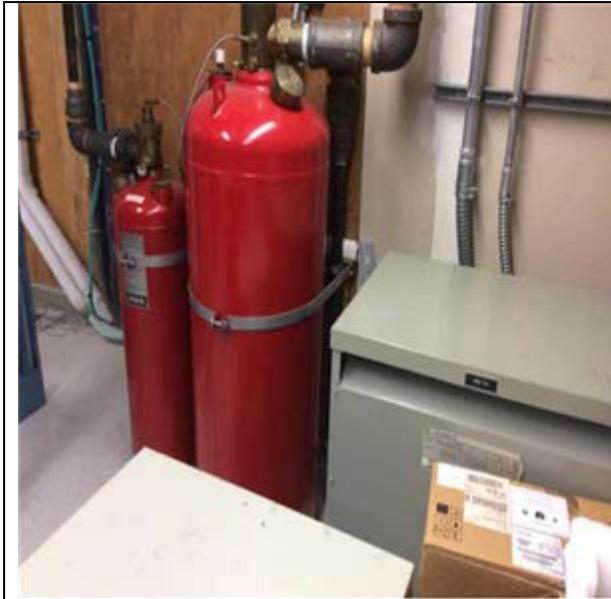
D4094 Dry Chemical System (Phone Room):- Halon
tank for phone room

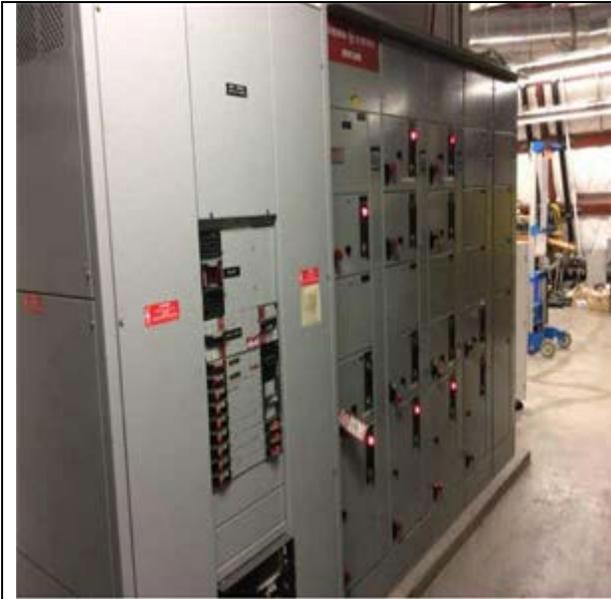
D5012 Main Switchgear, Mainframe, 5000 Amps:- Main sections of switchgear

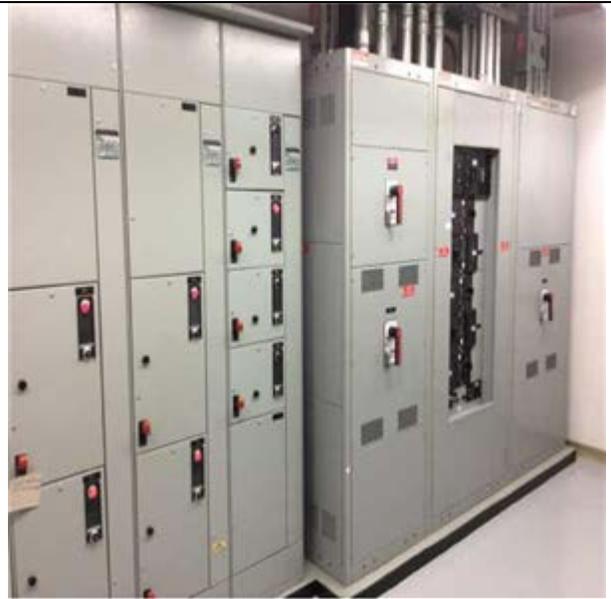
D5012 Switchgear, Mainframe, 600-800 :- Motor control centers and switchboards

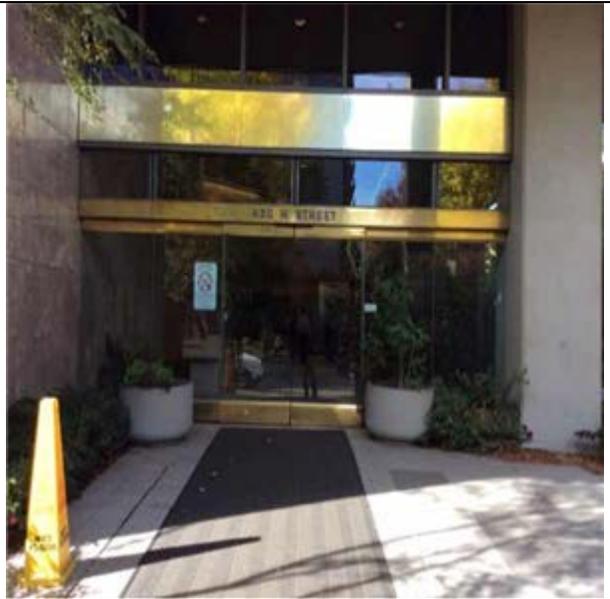
G2031 Surfacing & Quarry tiles :- inside of the main entrance

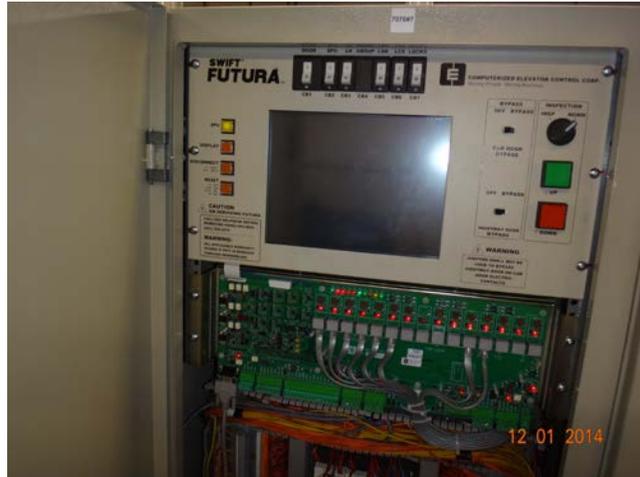
The controllers were manufactured by CEC/Swift and installed locally by TKE when the elevators were modernized. The controllers have energy efficient SCR drives made by Magnetec, the world's leading supplier of SCR drives.

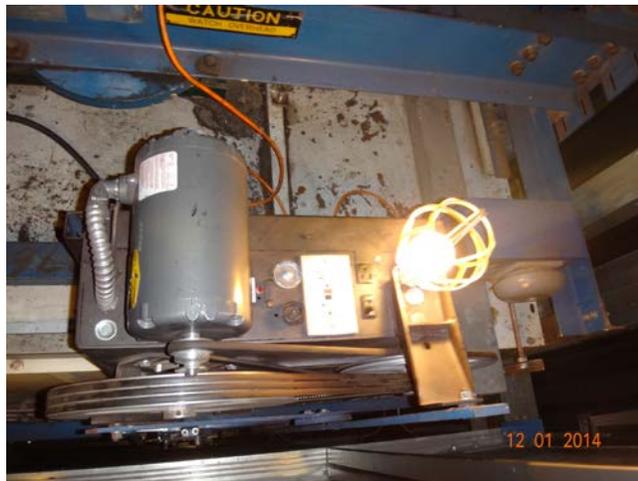
The door operators were made by TKE and are closed loop. The door operation was noted to be fair with room for improvement. All of the traction cars are equipped with door restrictors. The TKE door operators that are installed are known to be reliable and have a long life cycle.

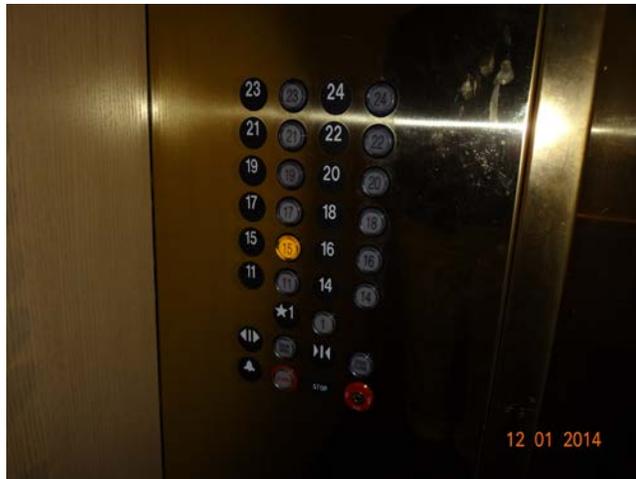
All the elevators have the newer Car Operating Panels (COP's) installed during the recent elevator modernization. The panels are in good condition meet ADA and T24 and do not need any work at this time. Service Car 10 does not have raised buttons.

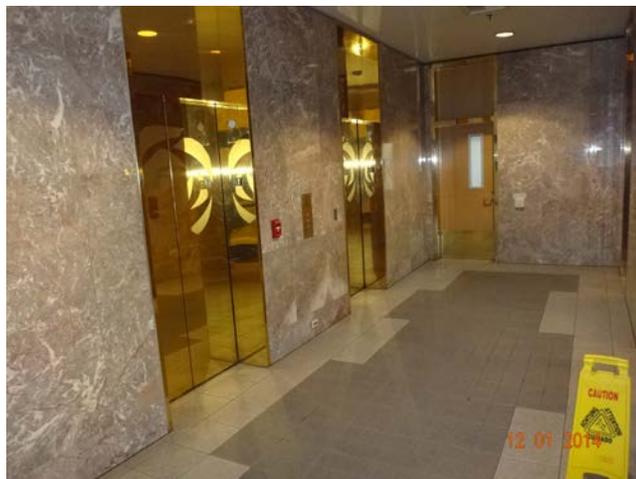
Hall lanterns inform persons waiting in the hall of which direction the elevator is about to travel in next. ADA requires that the hall lanterns illuminate and sound for the waiting passengers. The existing elevators have hall lanterns for each car. The lanterns have the proper gong for up and down.

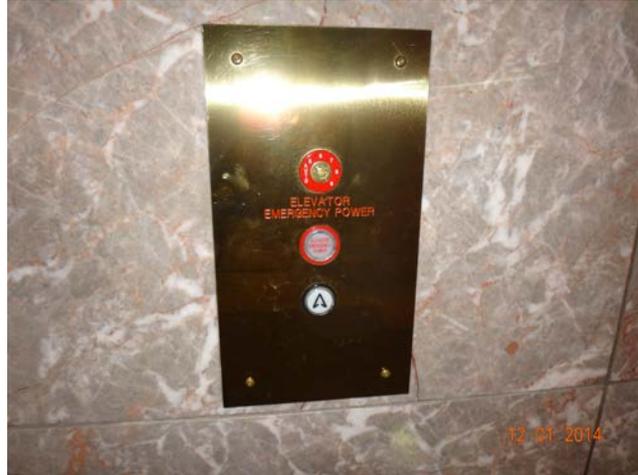
At each floor hall call push buttons are located so that users can call the elevator. The hall call stations have raised operation buttons which meet ADA and California Title 24. These were all noted to be in good condition.

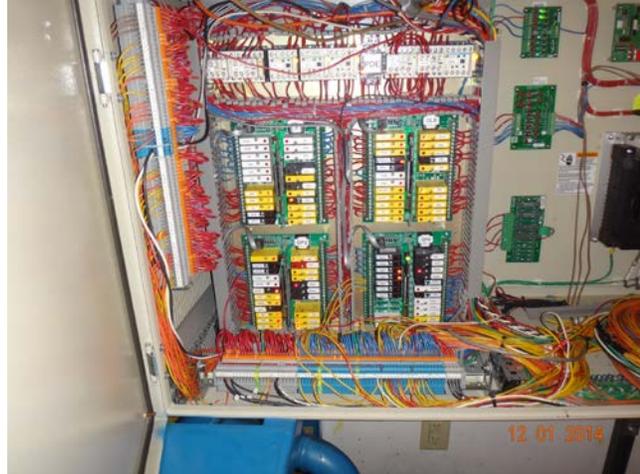
The controllers were manufactured by Swift/CEC and installed locally by TKE during a recent elevator modernization. No work is anticipated for the next 20 years.

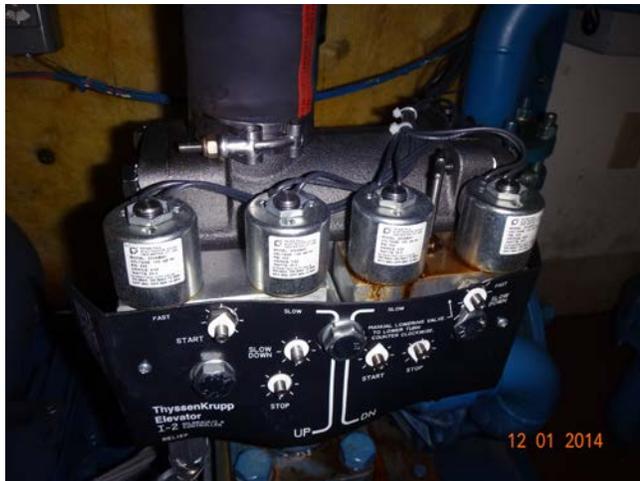
All the elevators have newer TKE I2 valves installed in the original Dover power units. The original tanks, motors and IMO pumps were retained. These are in good condition.

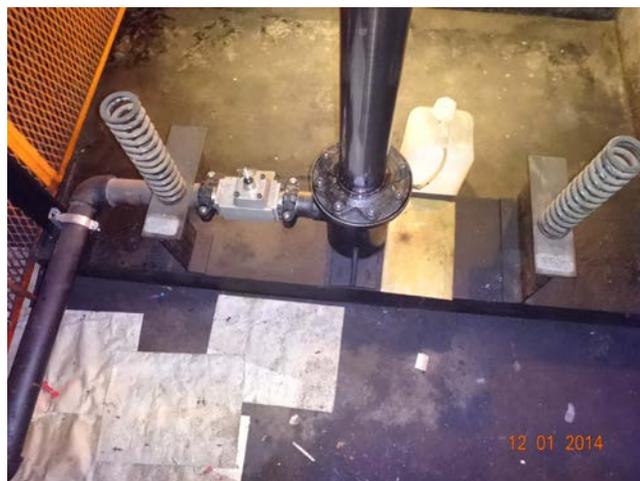
The pits were found to be clean and dry. The jack heads and pistons appeared to be in good condition. All the pits had seismic rupture valves.
