Senator William P. Campbell Building California Office of Emergency Services (087)

3650 Schriever Avenue, Mather, CA 95655

Facility Condition Assessment

June 2015

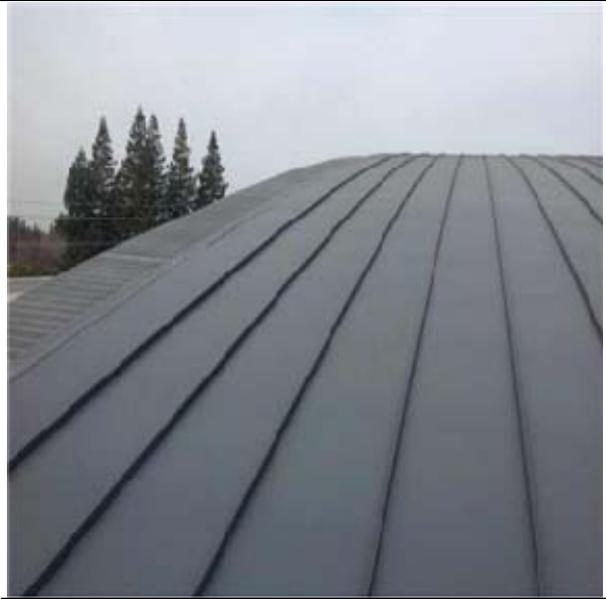
B3011 Metal Low Slope Roofing, Total

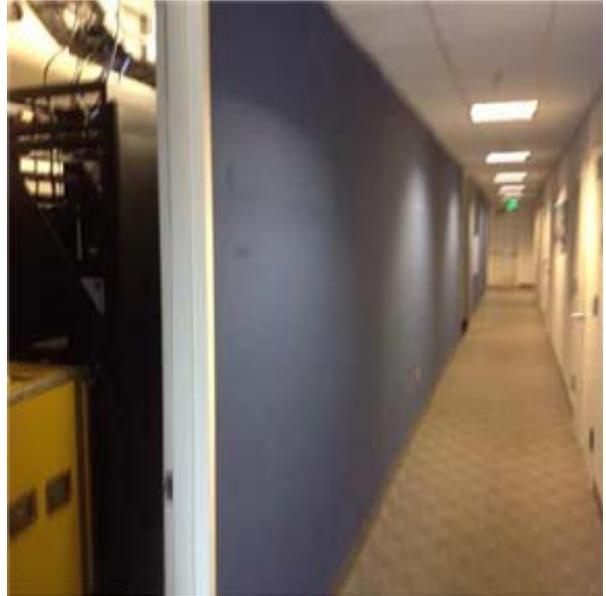
C3012 Repaint interiors

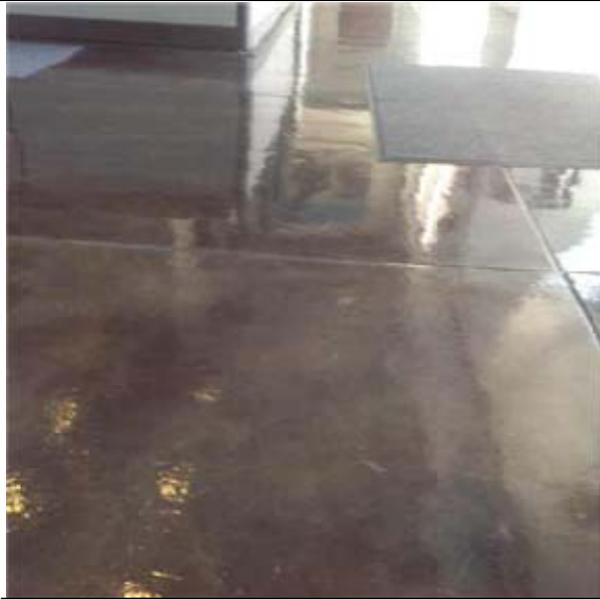
C3023 Seal Lobby Floor

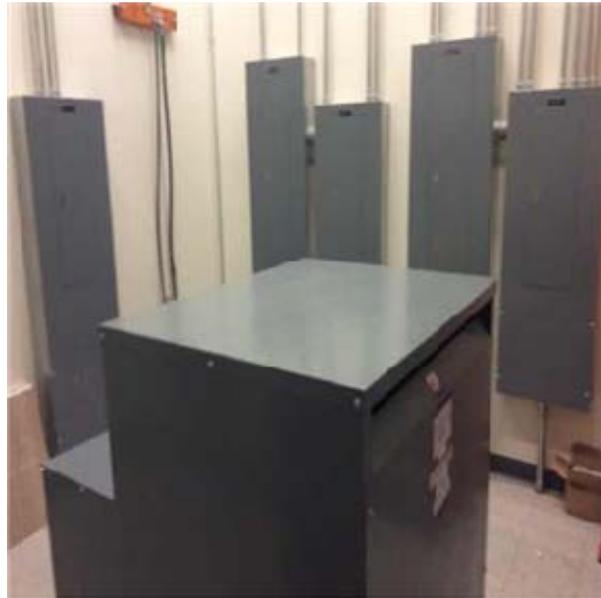
D5012 Breaker Panel 400 <1600 Amps

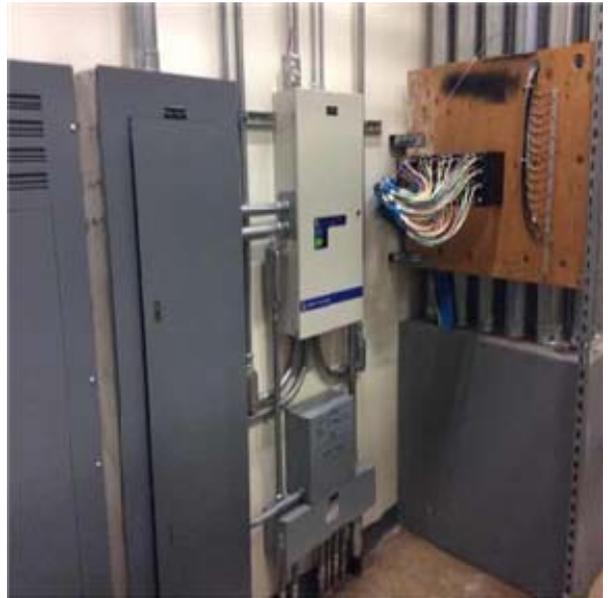
D5012 Breaker Panel <250 Amps

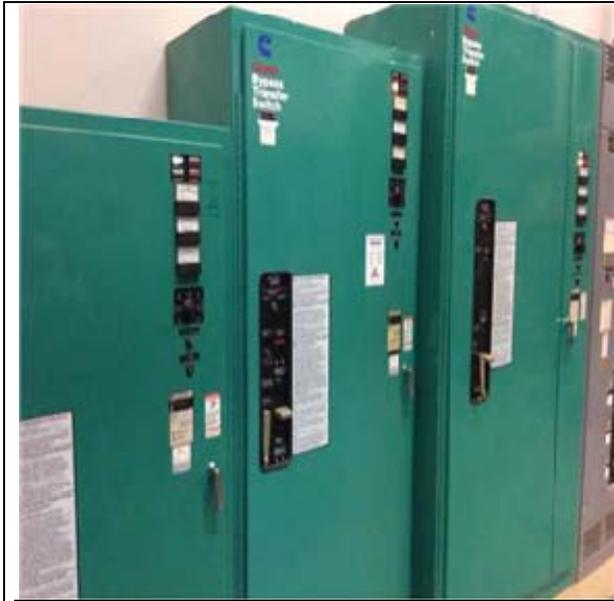
D5012 Breaker Panel 250<400 Amps

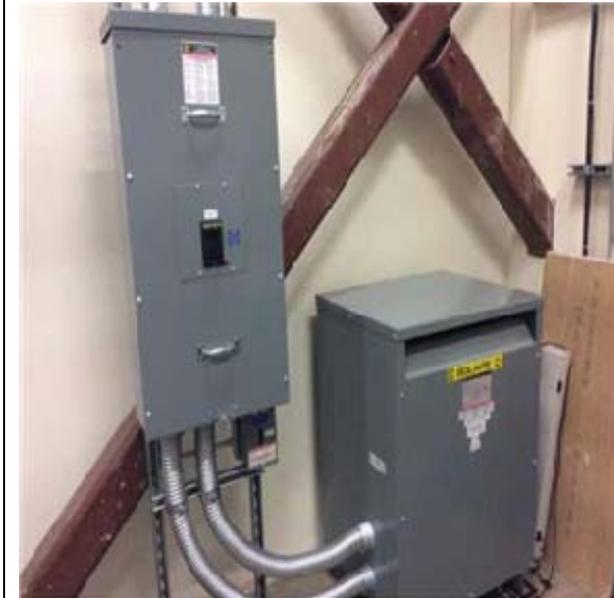
D5012 Dry Transformer 112.5 kVA

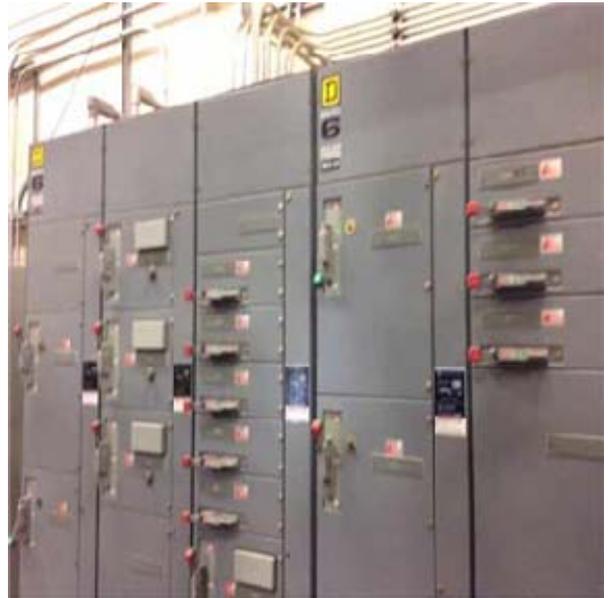
D5012 Dry Transformer 45 kVA

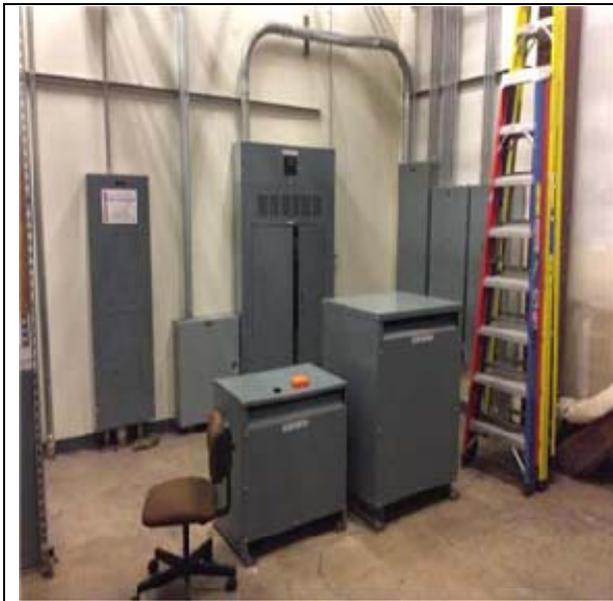
D5012 Emergency Distribution Panel, 1200 Amp

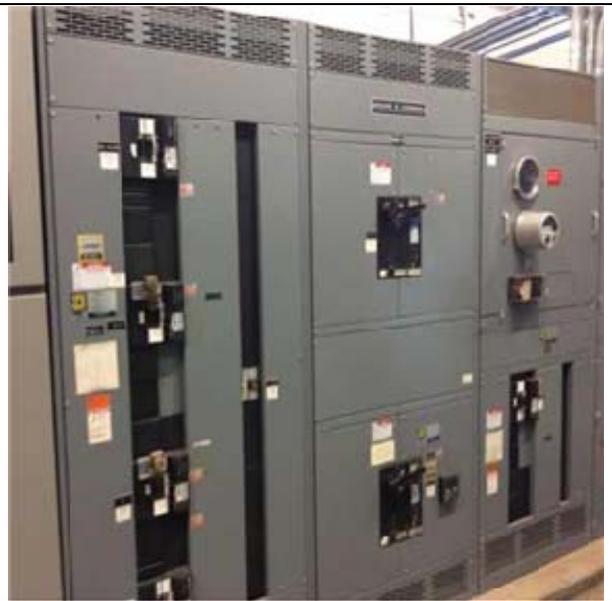
D5012 Dry Transformer 150 kVA

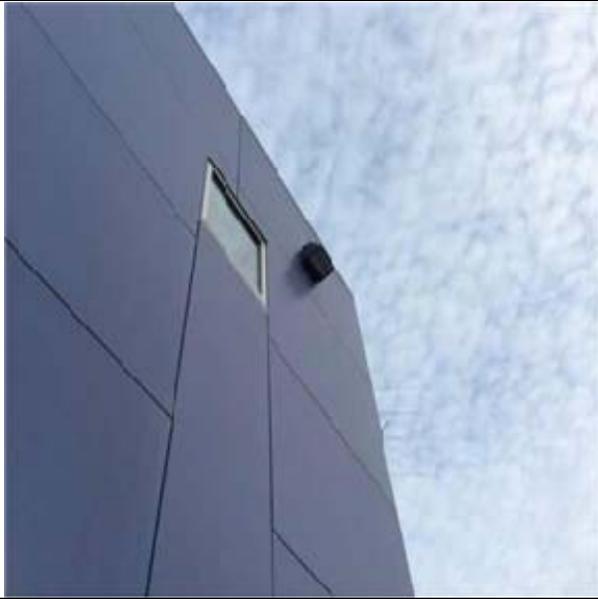
D5021 Lighting Control Unit

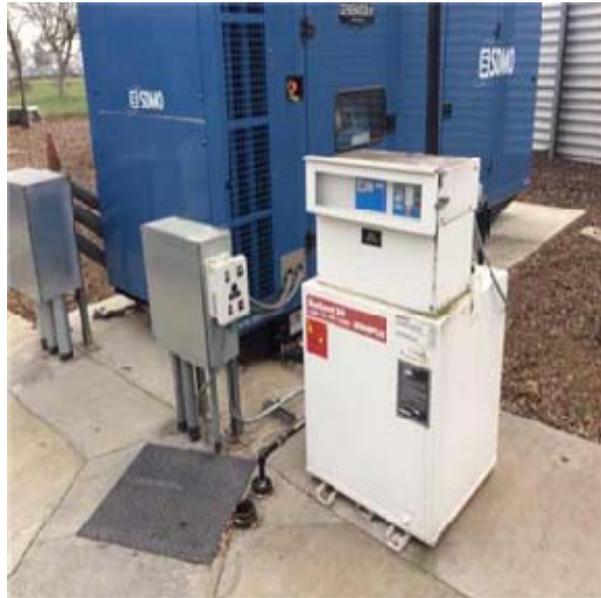
D5092 Diesel Generator 1000 KW

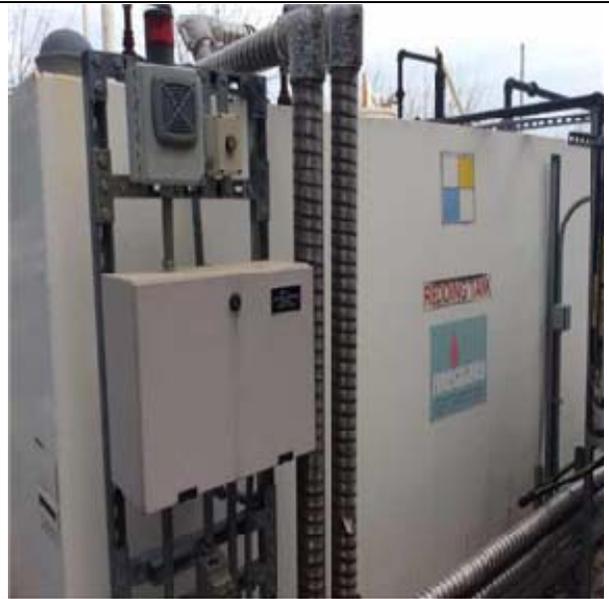
G3063 Diesel Tank, 1500 Gallon

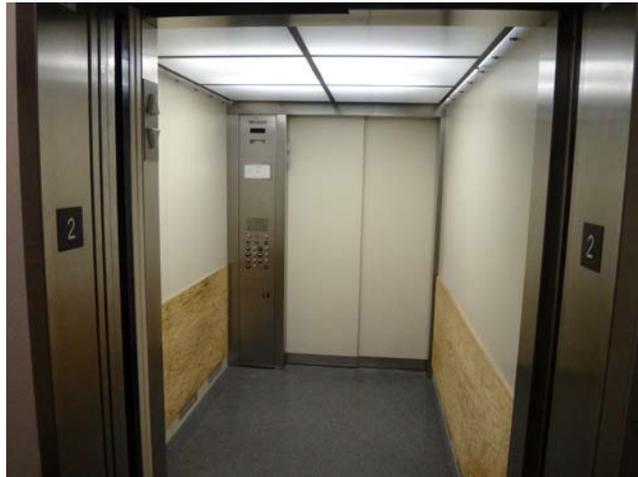
Hall/Car Lanterns:

Hall or Car lanterns inform persons waiting in the hall of which direction the elevator is about to travel in next. ADA requires that the lanterns illuminate and sound for the waiting passengers. The existing elevators have Car lanterns. The lanterns have the proper gong for up and down, however on Car 2 neither of the car lanterns and gongs are operational.

D1011	Freight Elevator, Hydraulic Equipment, 4,000 Lb	D1011 Hydraulic Service Elevator 4500 lbs	Building B - Elevator Rooms	D1011 Repair car lanterns	15	0	2.00	EA	\$150.00	CC - Building Code	Priority 1	\$300	\$0	\$0	\$0	\$0	\$0	\$0	\$0	\$0	\$0	\$0	\$0	\$300	\$0
	Freight Elevator, Hydraulic Equipment, 4,000 Lb	D1011 Hydraulic Service Elevator 4500 lbs	Building B - Elevator Rooms	Install Braille plate at phone	10	0	1.00	EA	\$100.00	CC - Accessibility	Priority 1	\$100	\$0	\$0	\$0	\$0	\$0	\$0	\$0	\$0	\$0	\$0	\$0	\$100	\$0
	Freight Elevator, Hydraulic Equipment, 4,000 Lb	D1011 Hydraulic Service Elevator 4500 lbs	Building B - Elevator Rooms	Install handrails on the service car	15	0	2.00	EA	\$600.00	CC - Building Code	Priority 1	\$1,200	\$0	\$0	\$0	\$0	\$0	\$0	\$0	\$0	\$0	\$0	\$0	\$1,200	\$0
	Freight Elevator, Hydraulic Equipment, 4,000 Lb	D1011 Hydraulic Service Elevator 4500 lbs	Building B - Elevator Rooms	Remove plywood panelling, install fire rated wood	10	0	1.00	EA	\$4,000.00	CC - Building Code	Priority 1	\$4,000	\$0	\$0	\$0	\$0	\$0	\$0	\$0	\$0	\$0	\$0	\$0	\$4,000	\$0
