Franchise Tax Board San Diego Building (084)

9645 Butterfield Way, Rancho Cordova, CA 95827

Facility Condition Assessment

June 2015

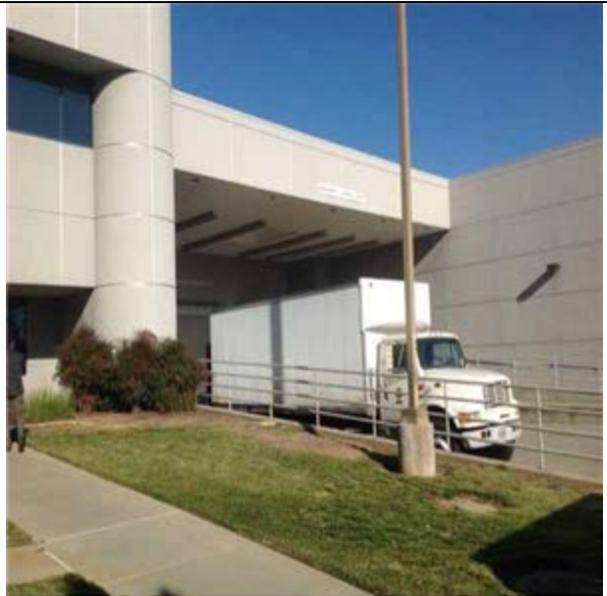
:- Loading Dock Entry

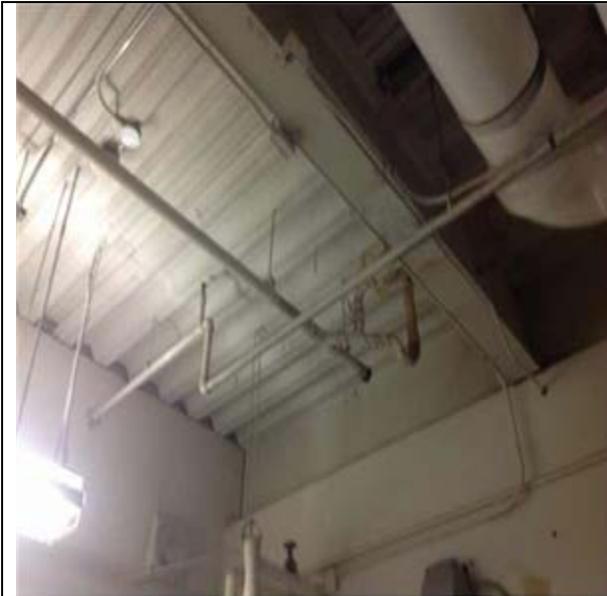
B1030 Structural Steel main building :- move to main bldg

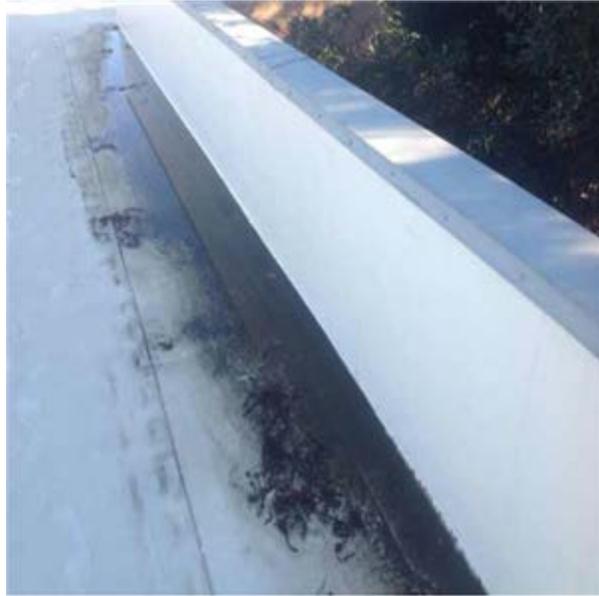
B3011 TPO Single Ply Membrane :- ponding

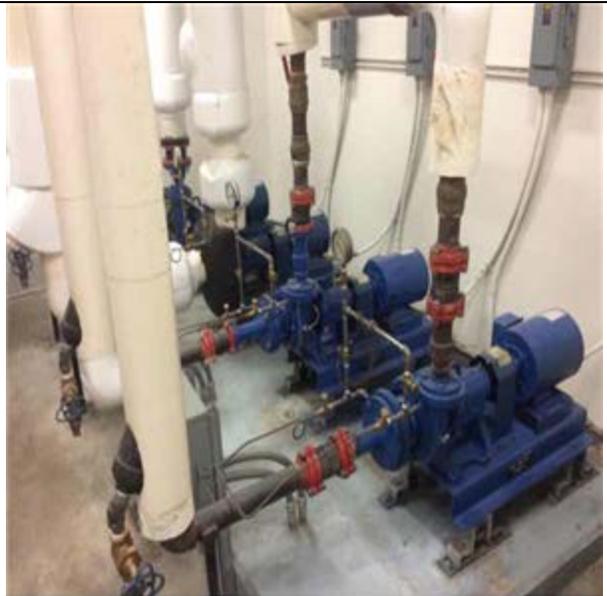
D2023 Domestic Hot Water Booster Pumps 5 HP

- There is a mixture of old and new carpet in the building. Replacement of the older carpet is recommended.
- The domestic water system booster pumps are original to the building construction. Replacement of the pumps is recommended.
- The computer room/data room has a separate rooftop mounted cooling system. The units are old and in poor condition. Replacement with a system connected to the on-site central plant is recommended.
- The building is using a mixture of the original pneumatic and newer digital controls as part of the energy management system. Pneumatic systems are prone to leakage issues and they are antiquated. Replacement with digital controls is recommended.

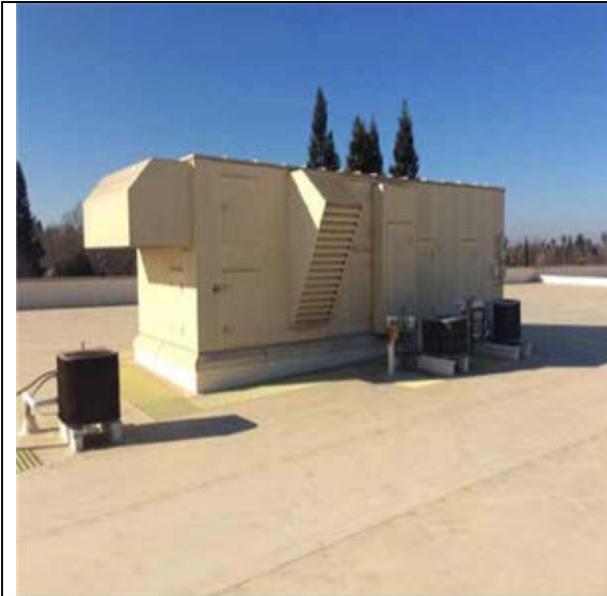
D3041 Rooftop AHU 2000-8000 CFM

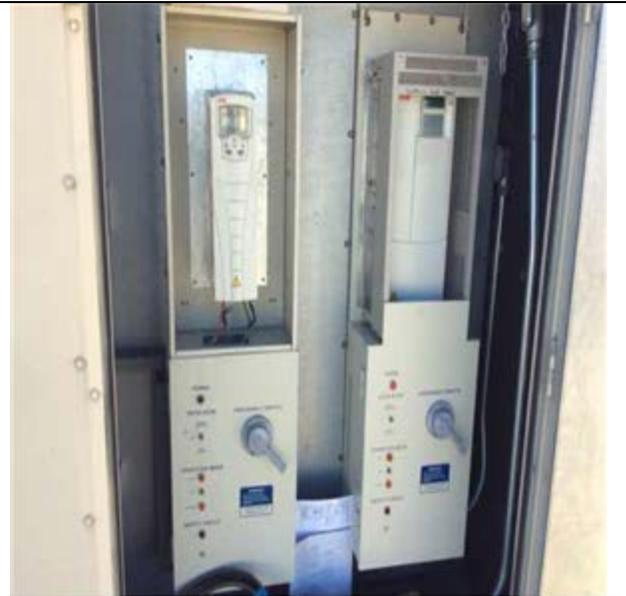
D3041 Rooftop AHU 2000-8000 CFM

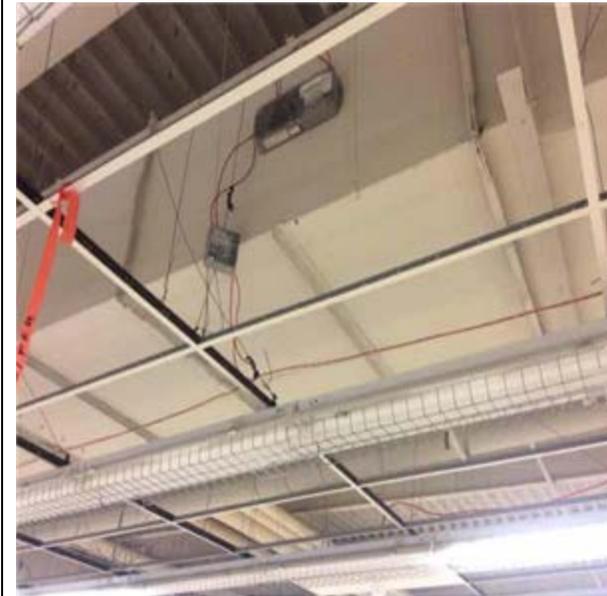
D3041 VAV Boxes

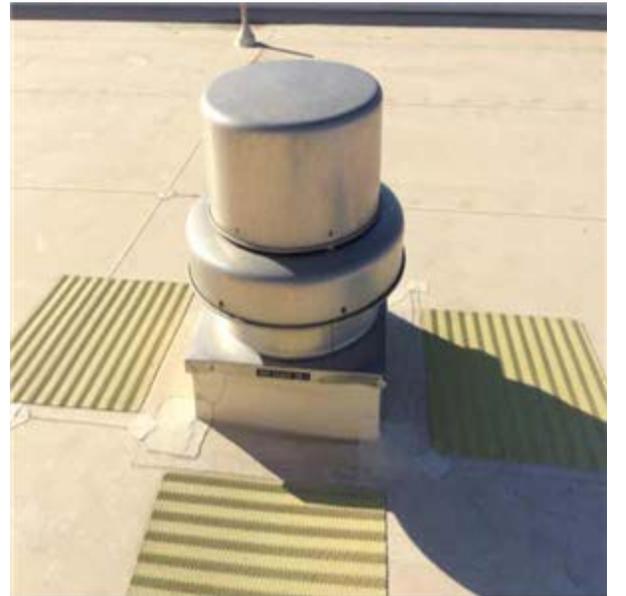
D3042 Exhaust Fan 2650 CFM

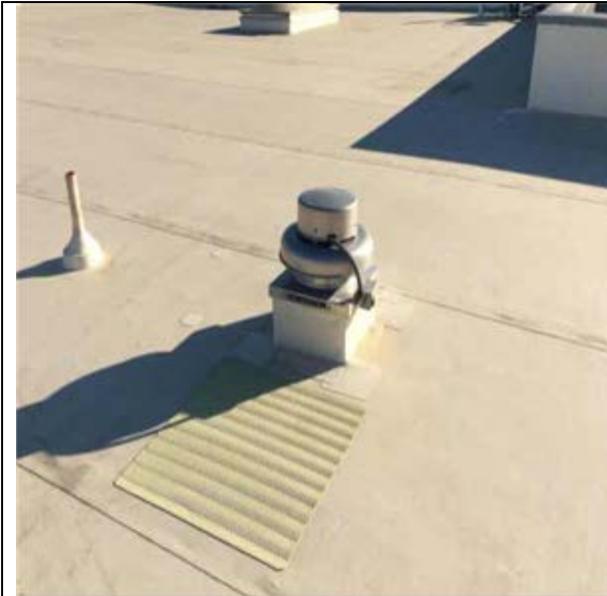
D3042 Exhaust Fan 100-600 CFM

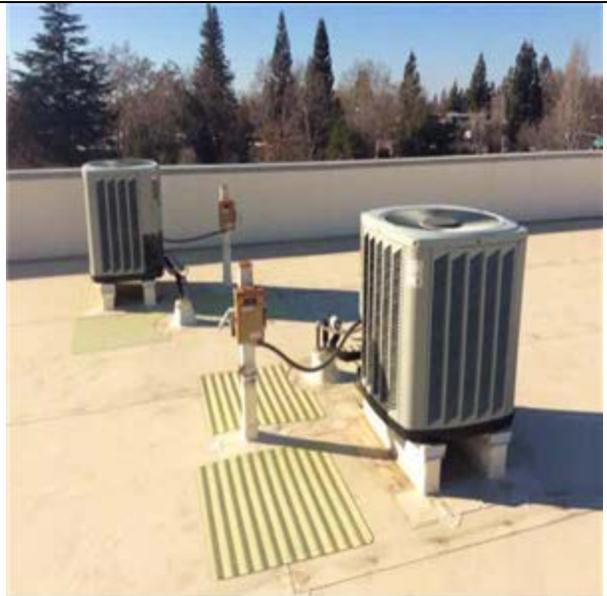
D3053 Split System units 2.5 tons - Newer

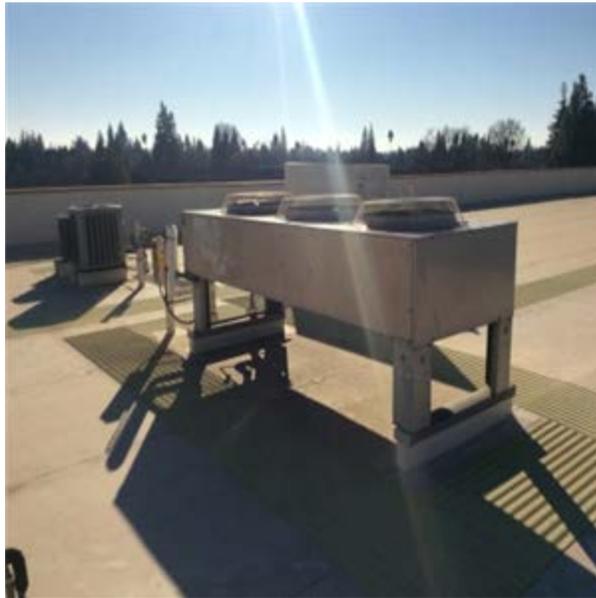
D3053 Split system units 16 tons each- Older

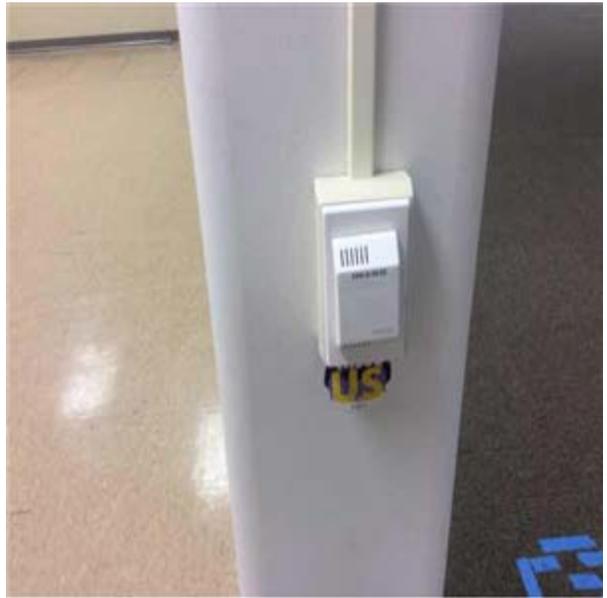
D3068 Direct Digital Controls (DDC)

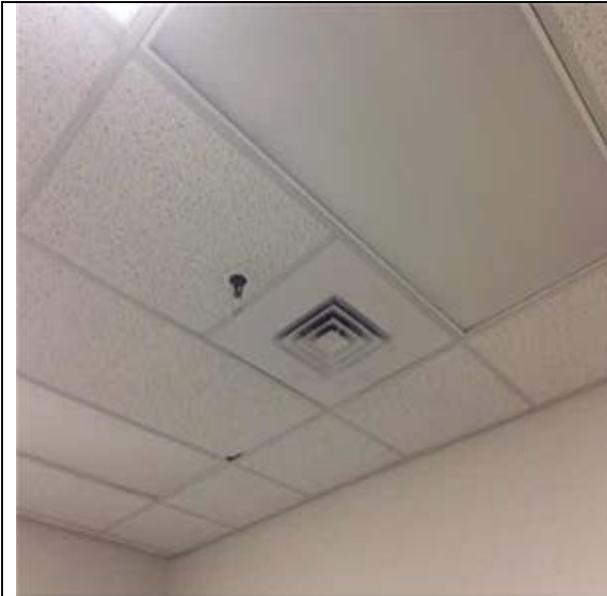
D4011 Sprinkler Heads

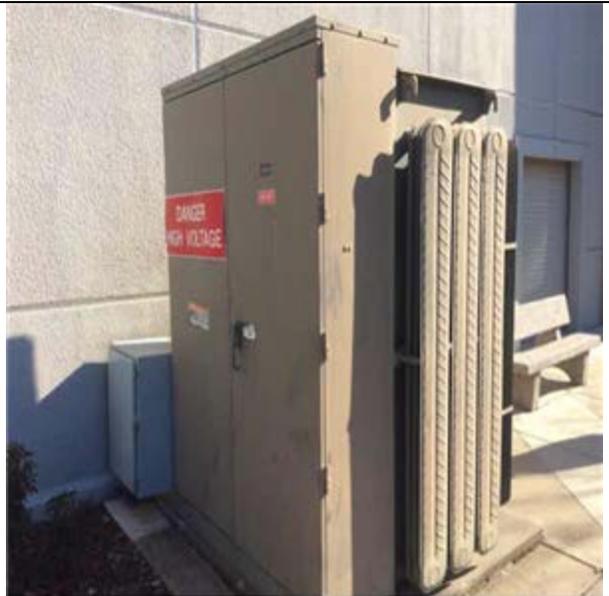
D5011 Transformer for SD

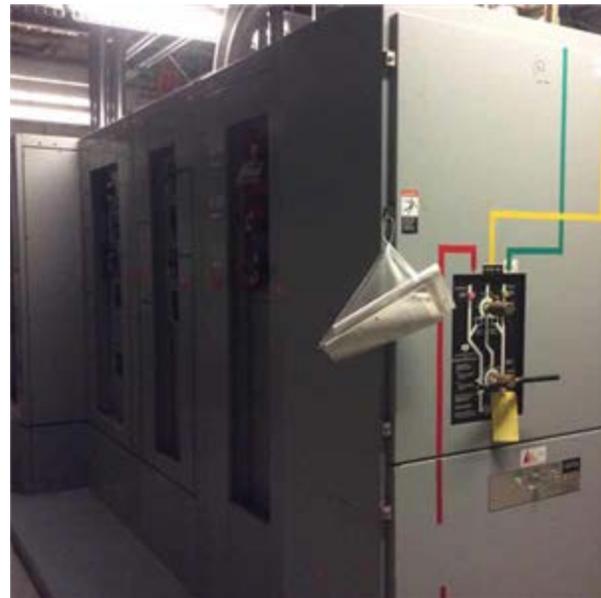
D5012 Main Switchgear, Mainframe, 4000 Amps

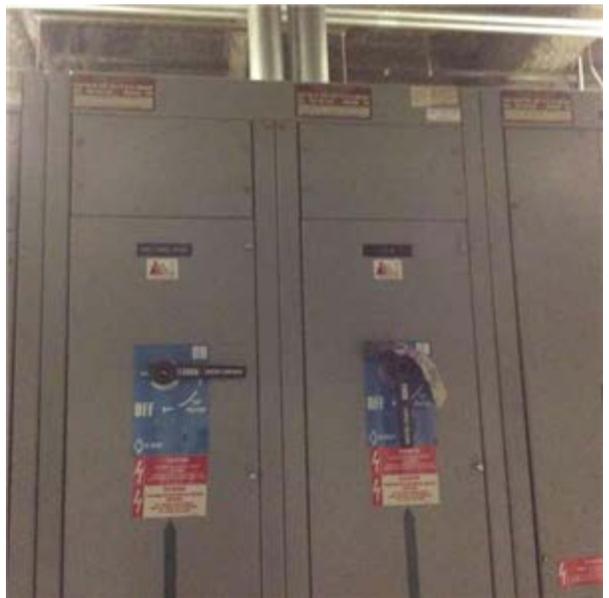
D5012 Breaker Panels

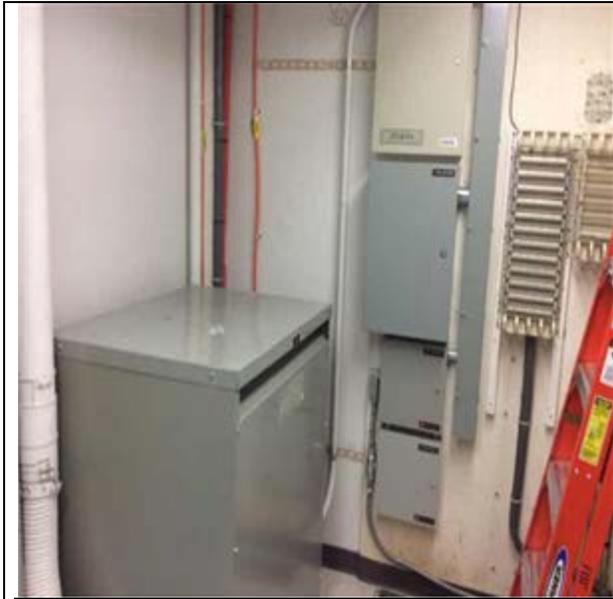
D5012 Dry Transformer 112.5 kVA

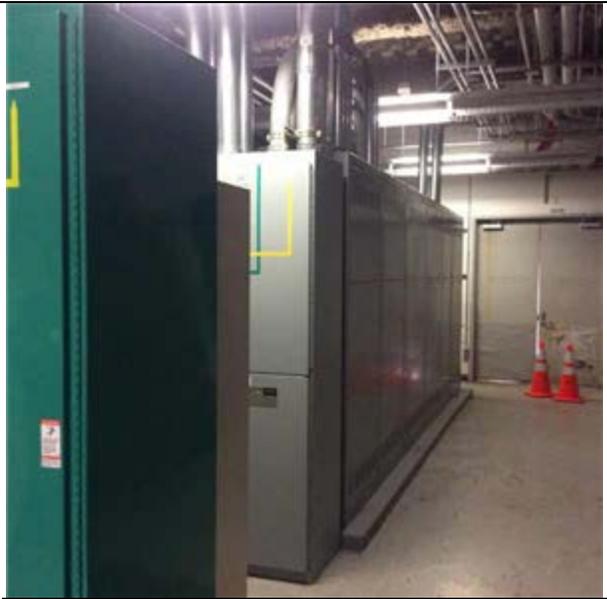
D5012 Switchgear, Mainframe < 600 Amps

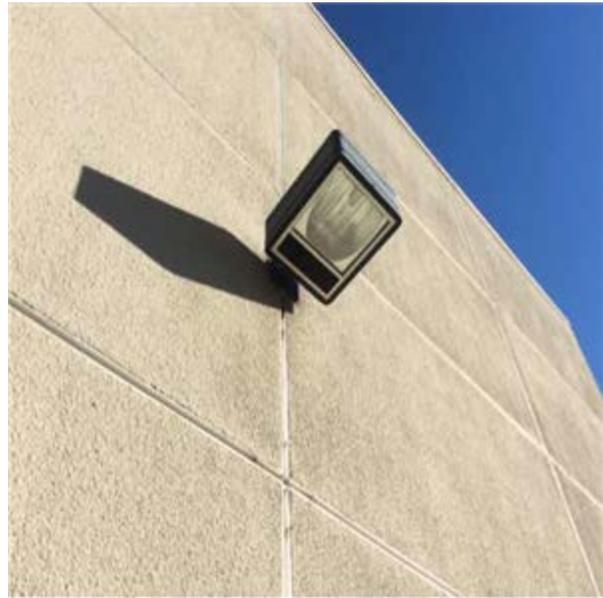
D5022 Wall Pack 150 Watt HPS

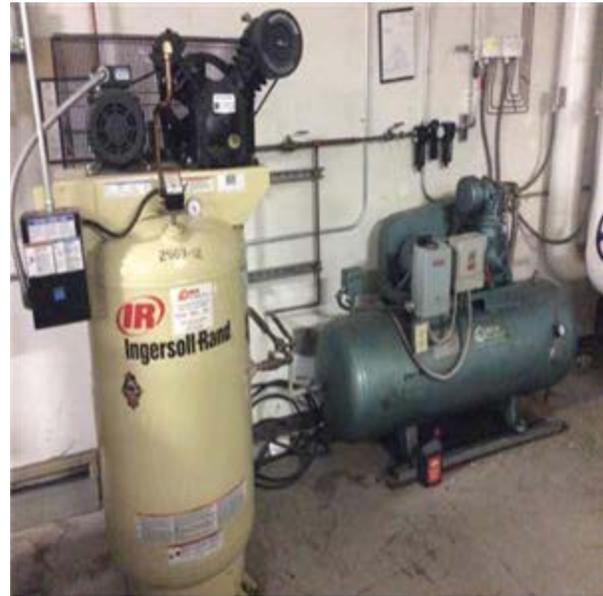
E1019 Air Compressor 3 HP 60 Gal

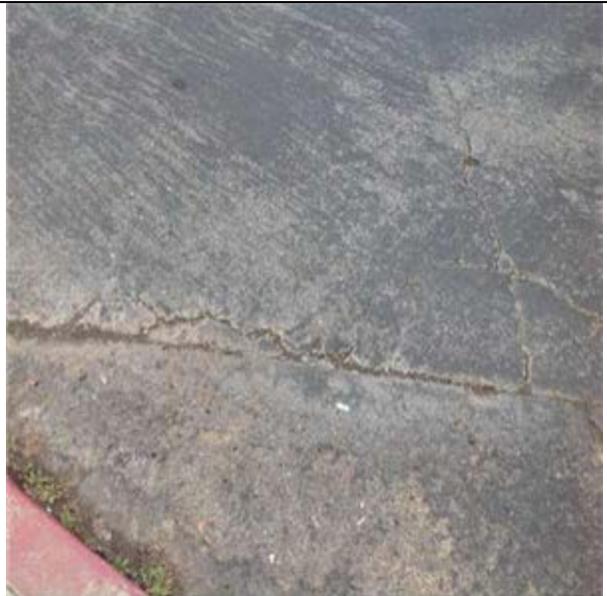
G2020 Asphalt- Seal Coat- Parking lots and Driveways

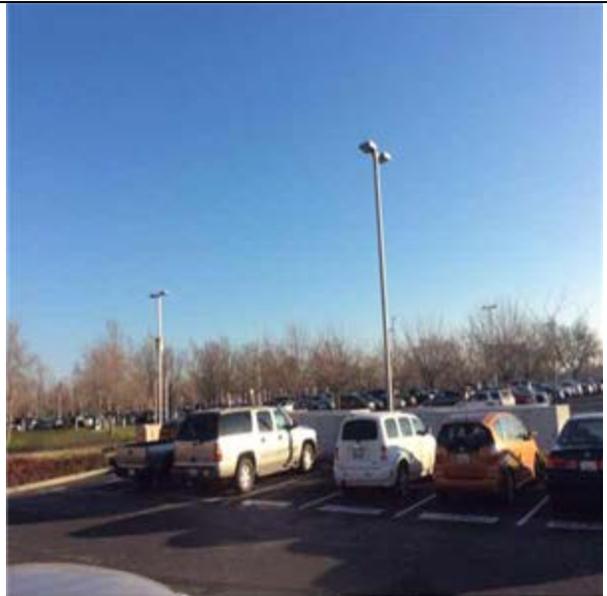
G4022 Pole-Mounted Parking Light 400 W HPS
