Franchise Tax Board Sacramento and San Francisco Buildings (084)

9645 Butterfield Way, Rancho Cordova, CA 95827

Facility Condition Assessment

June 2015

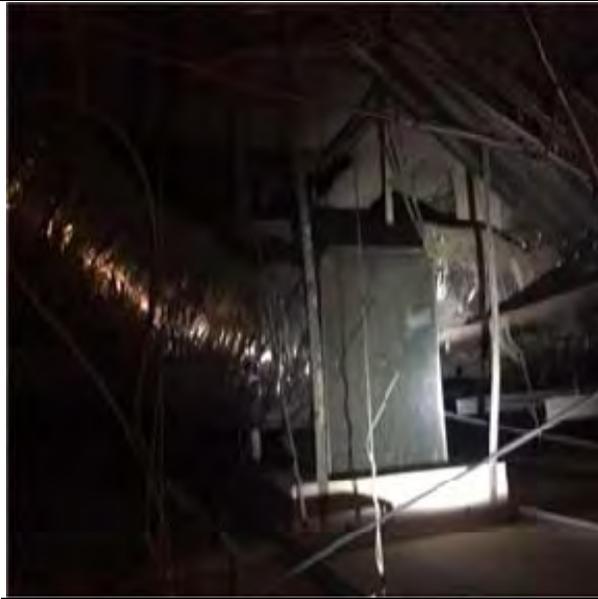
D3051 Fan coil unit 1.5 - 16 tons cooling

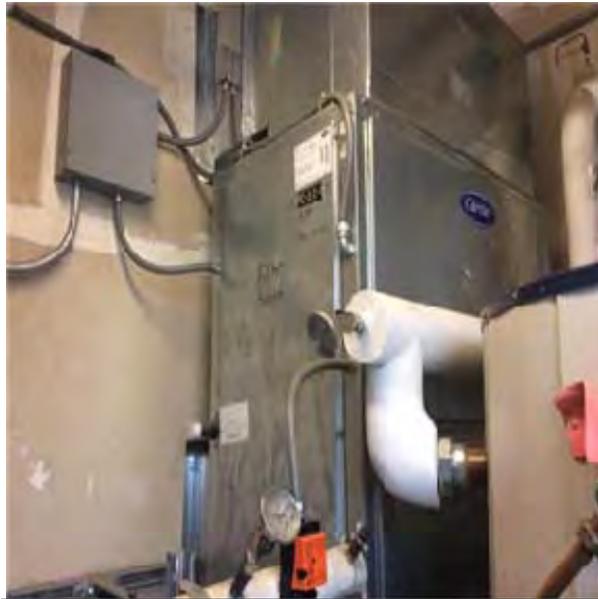
D3051 Fan Coil with 6 tons cooling

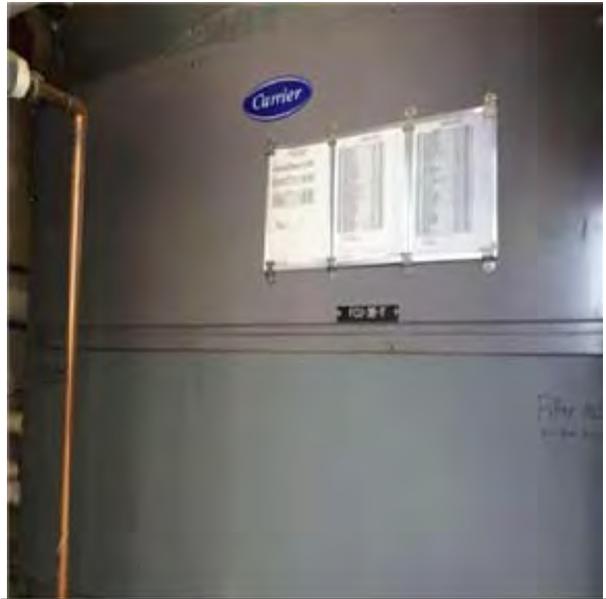
D3051 Fan Coil with 6 tons cooling

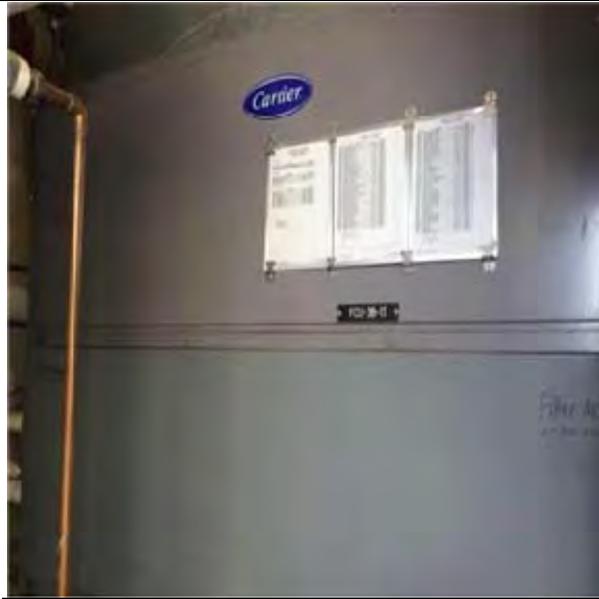
D3051 Fan Coil with 8 tons cooling

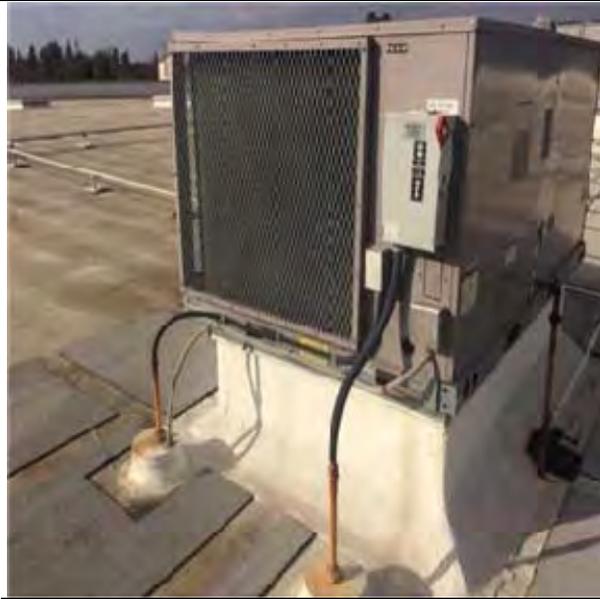
D3052 Packaged Units, Gas Heat, 7.5-Ton Cooling

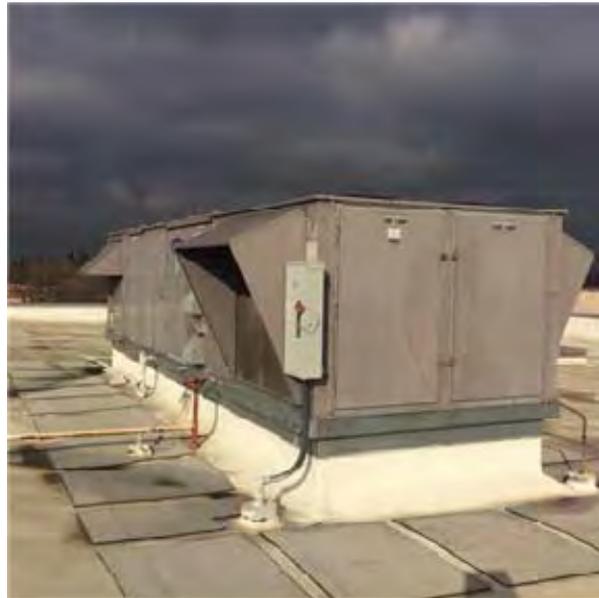
D3052 Packaged Units, Gas Heat, 28 Ton Cooling

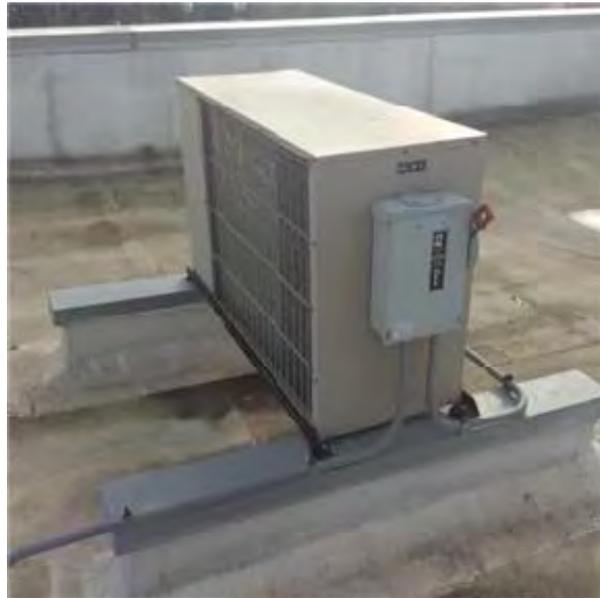
D3052 Split system Libert 1.5 ton cooling only

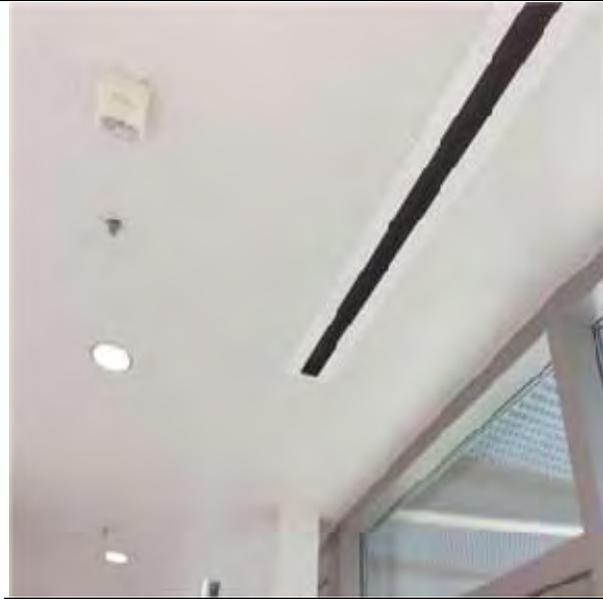
D4011 Wet-Pipe Sprinkler System

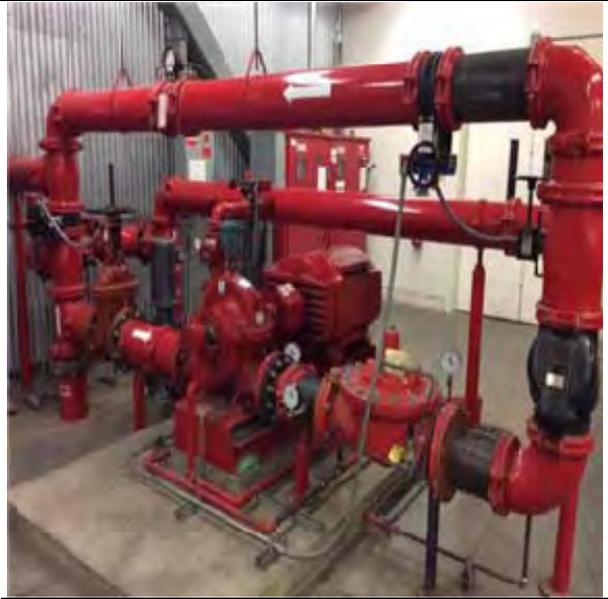
D4012 Fire pump (250 hp) - Central Plant

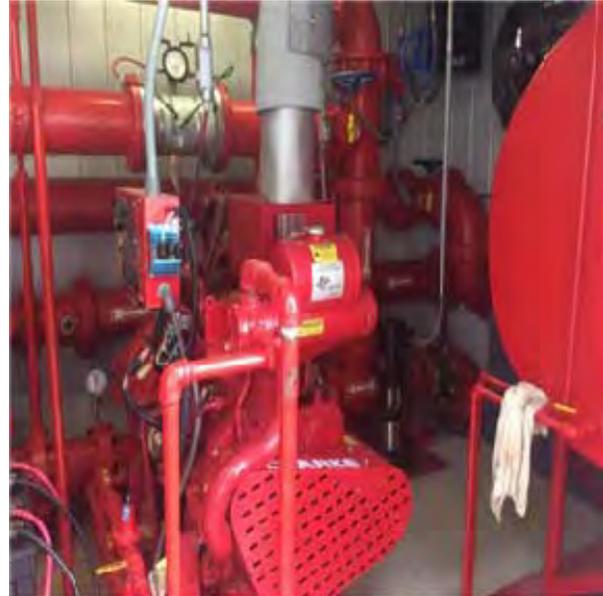
D4012 Fire pump (105 hp)

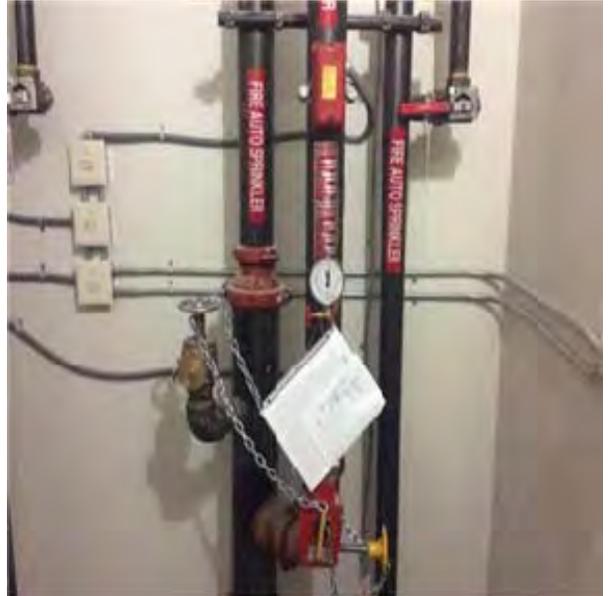
D4023 Riser pressure relief valves

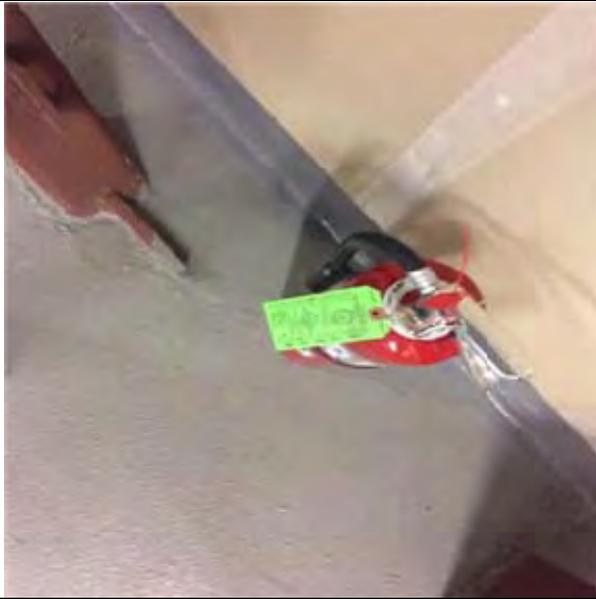
D4031 Fire Extinguishers 5 Lb, Install

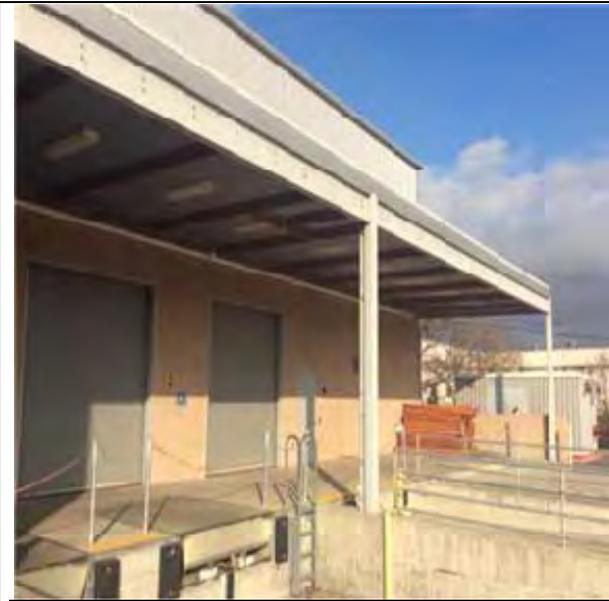
D5022 T8 fixtures

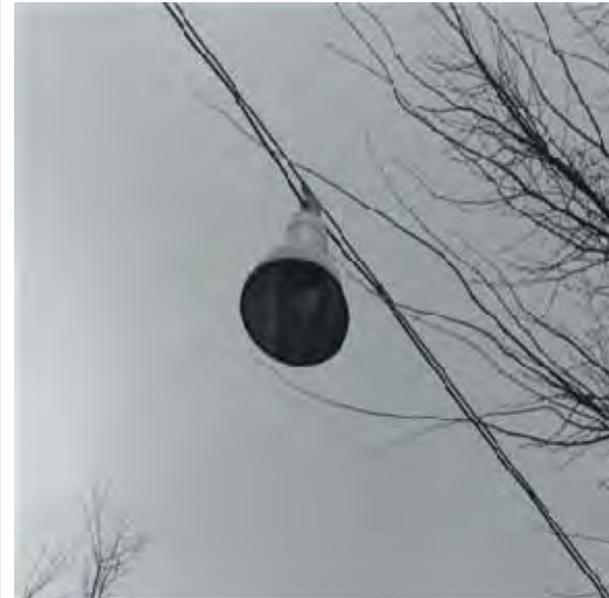
D5022 Canopy and Wall packs 70 W HPS

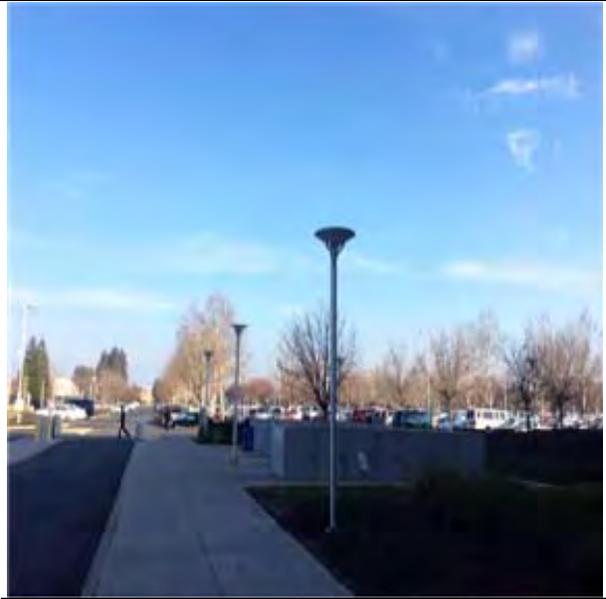
D5022 150W Pole lamps

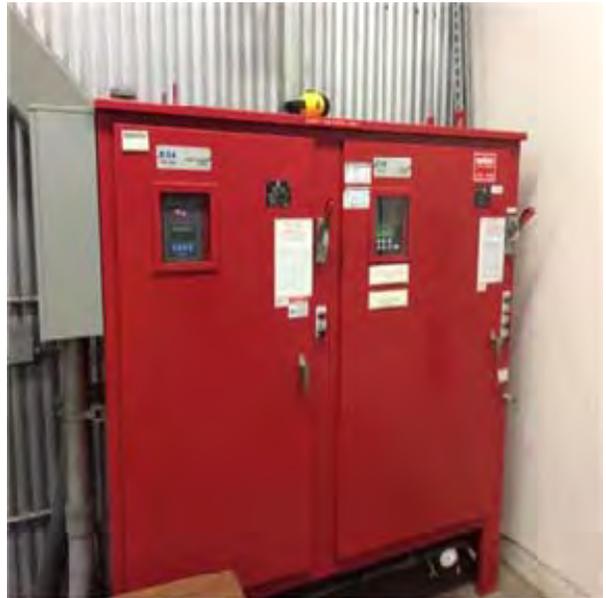
D5037 Central Panel and fire pump control - Central Plant

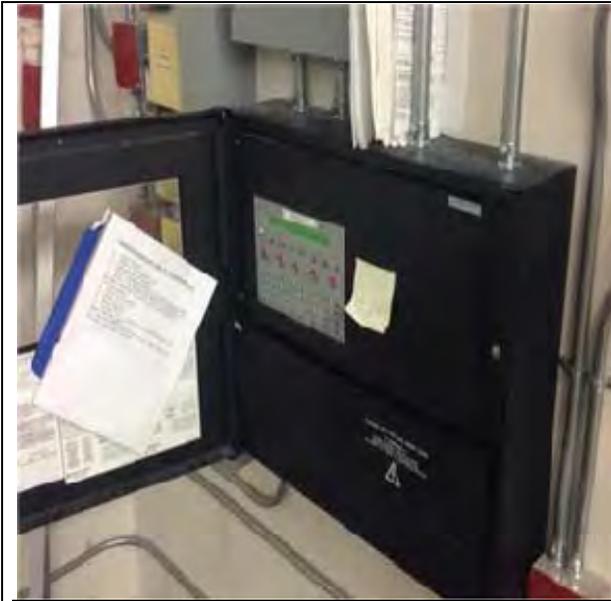
D5037 Fire Alarm Panel

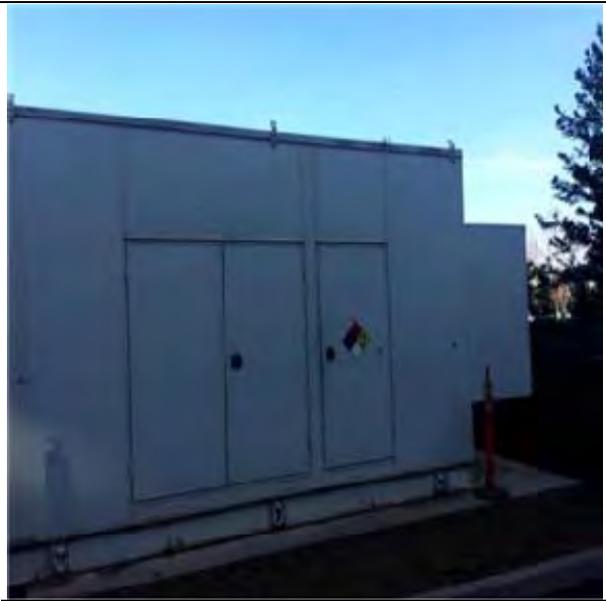
D5092 Diesel Generator 1000 kW

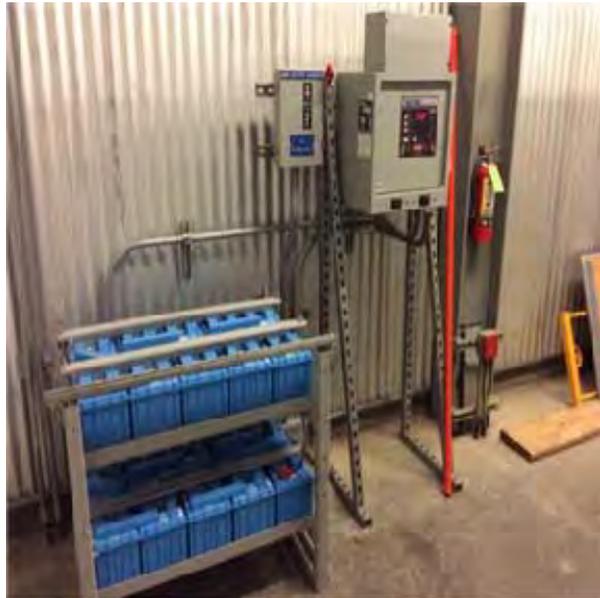
D5092 UPS System Batteries - Central Plant

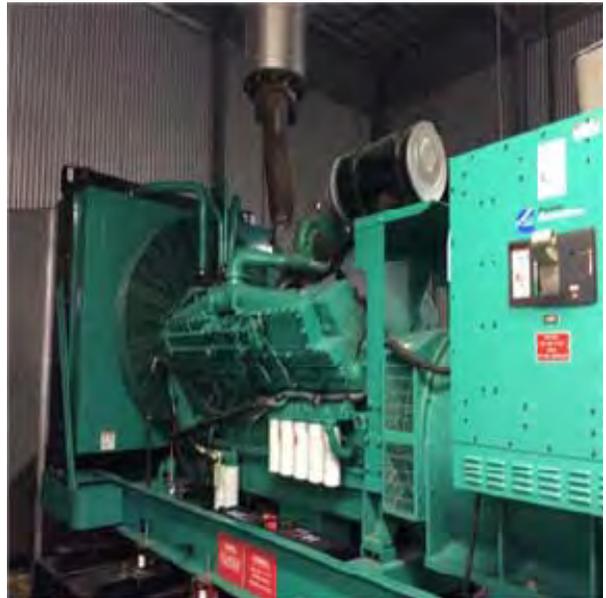
D5092 Diesel Generator 1560 kVa - Central Plant

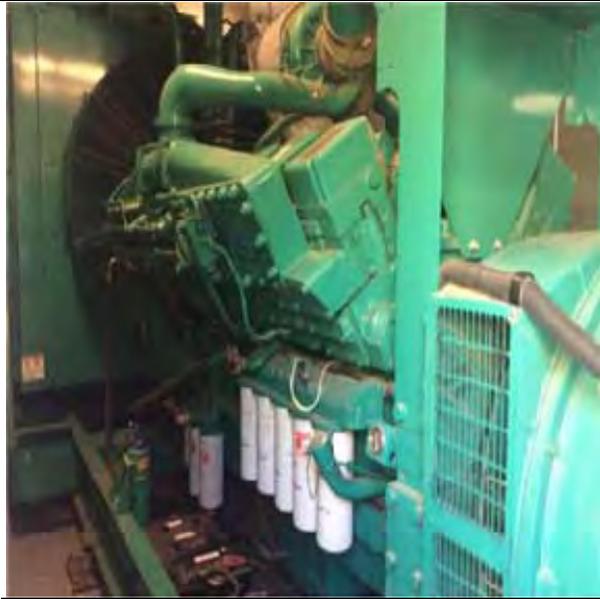
D5092 Diesel Generator 1250 kW

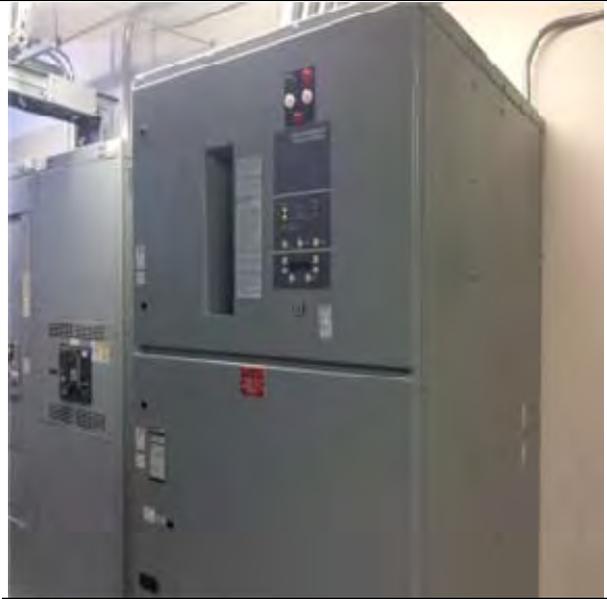
D5092 Emergency Transfer Switch

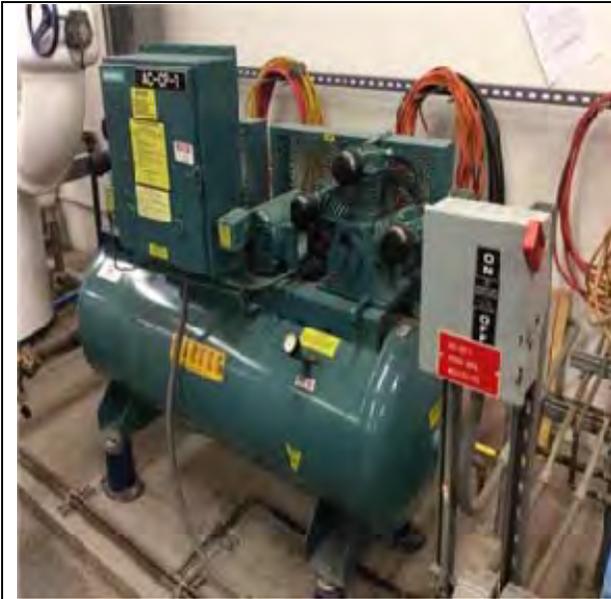
E1019 Air Compressor 1.5 hp motor - Central Plant

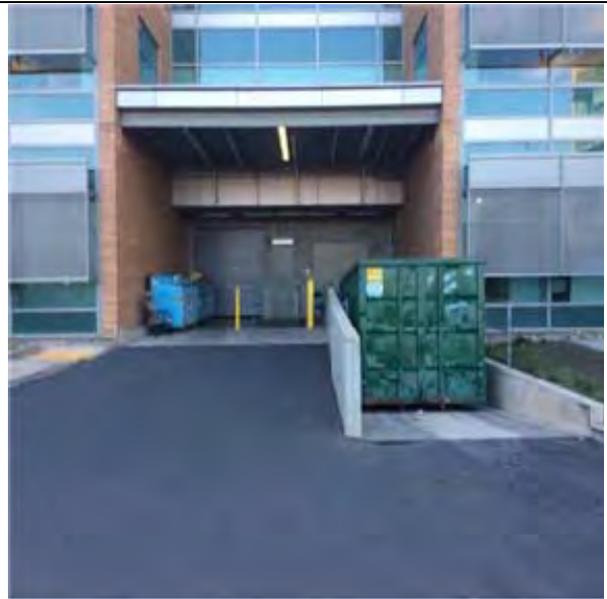
E1092 Trash Compactor 28 hp

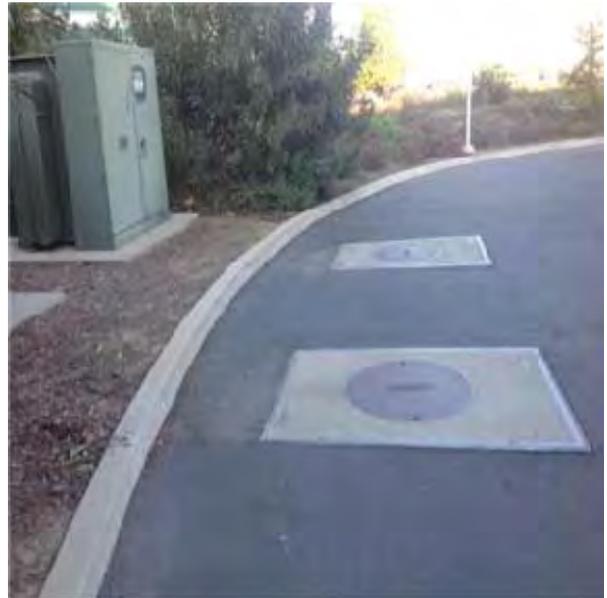
G2012 Asphalt Seal Coat

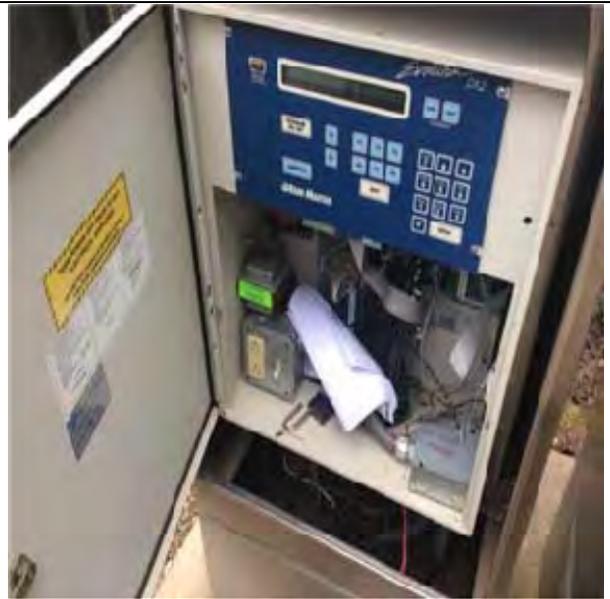
G2057 Irrigation system upgrade -exterior

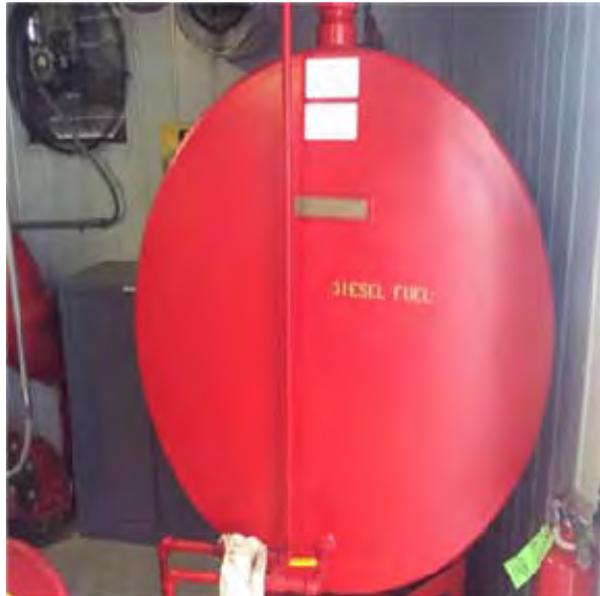
G3063 Diesel Tank,280 Gallon - WH

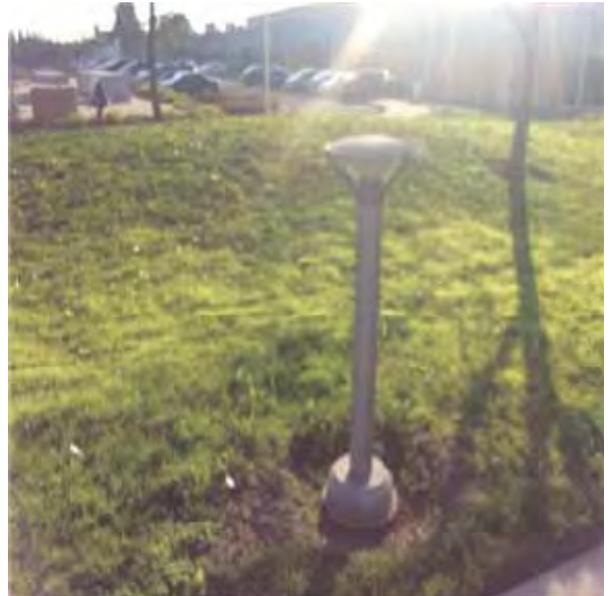
G4021 Bollards 70W

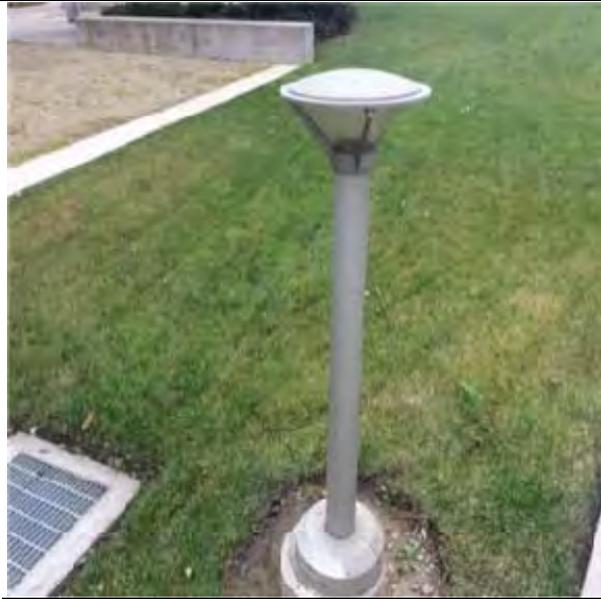
G4021 Bollards 70W

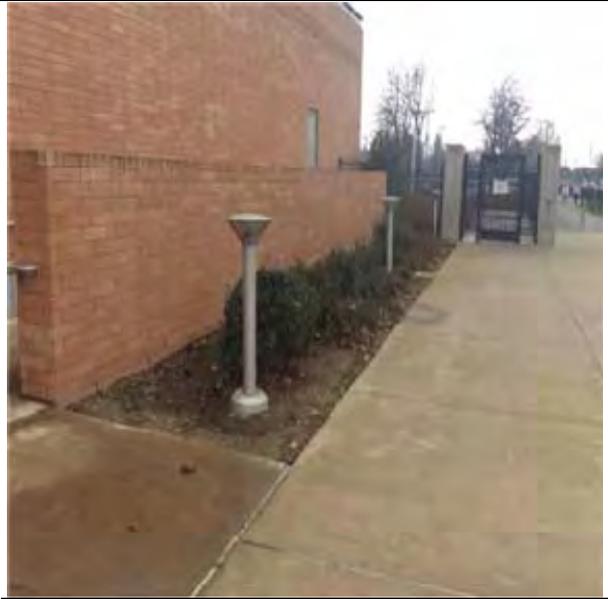
G4021 Bollards 70W MH

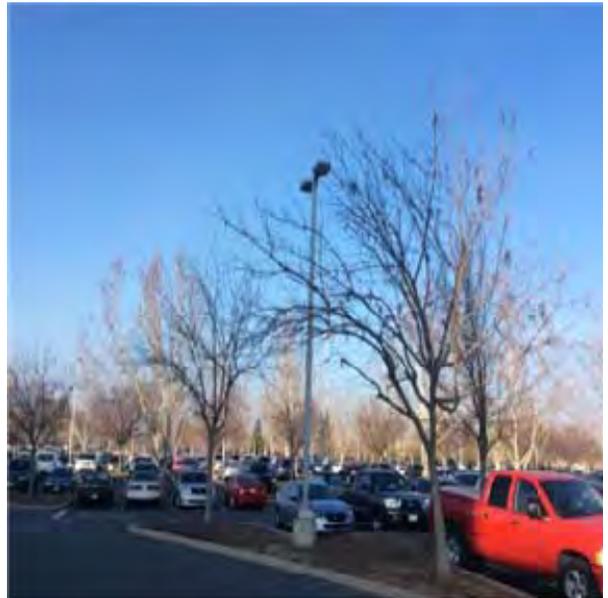
G4021 Pole Lamps 400 W
