## Department of Justice Office Building (030)

1300 "I" Street, Sacramento, CA 95814

### Facility Condition Assessment

June 2015

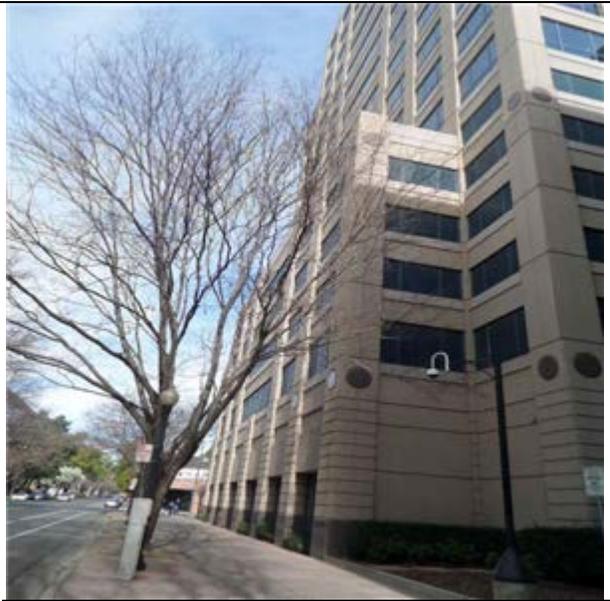
:- West building elevation.

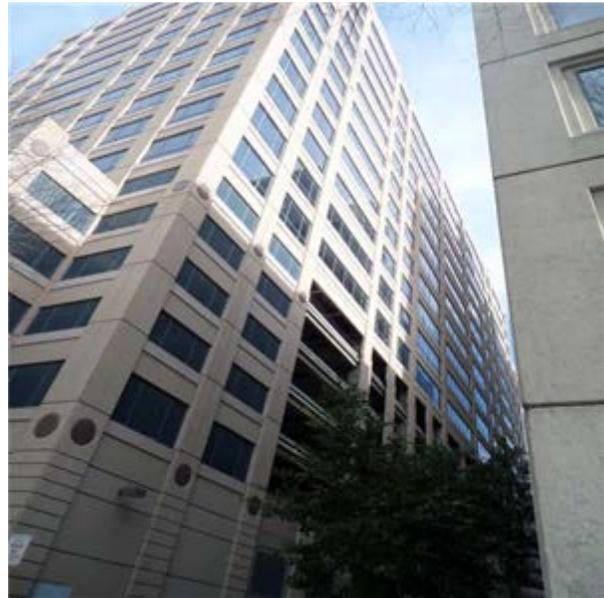
:- Partial view of the south building elevation.

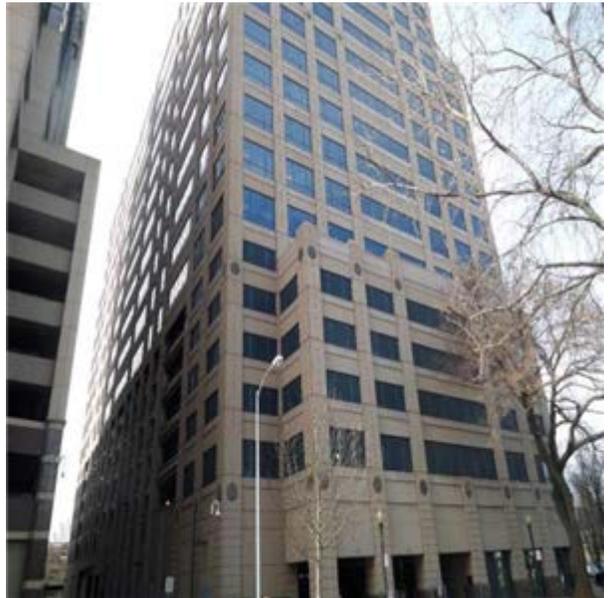
:- East building elevation.

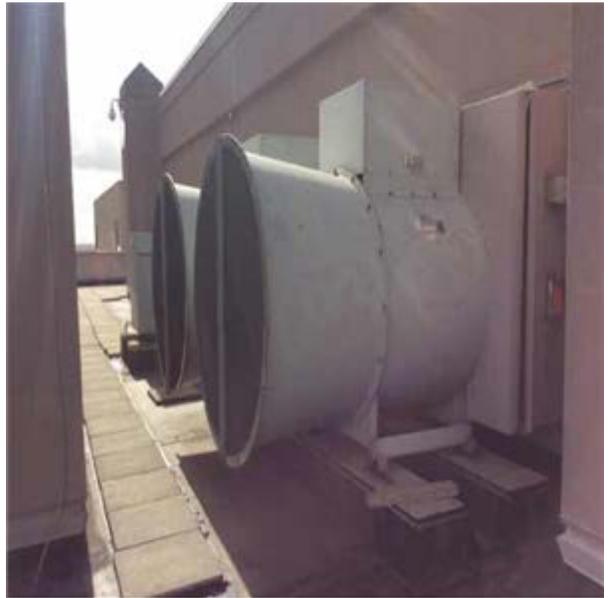
D3042 Exhaust fan 1/4hp :- D3042 Exhaust fan at top of wall

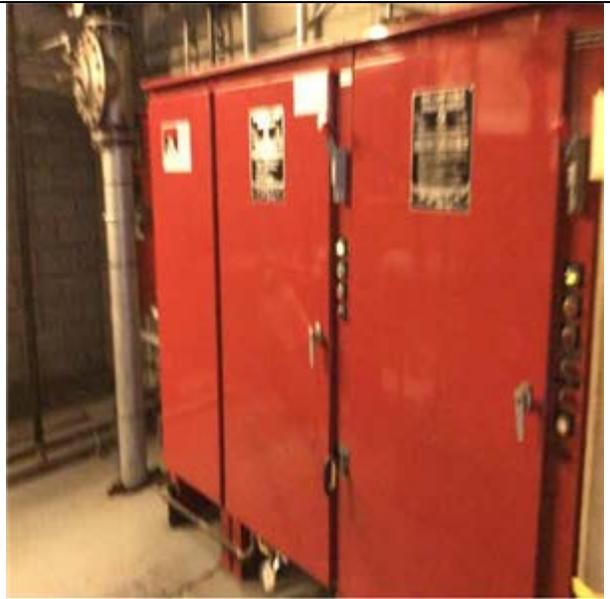
D5037 Electric Pump Panel and control of fire pump

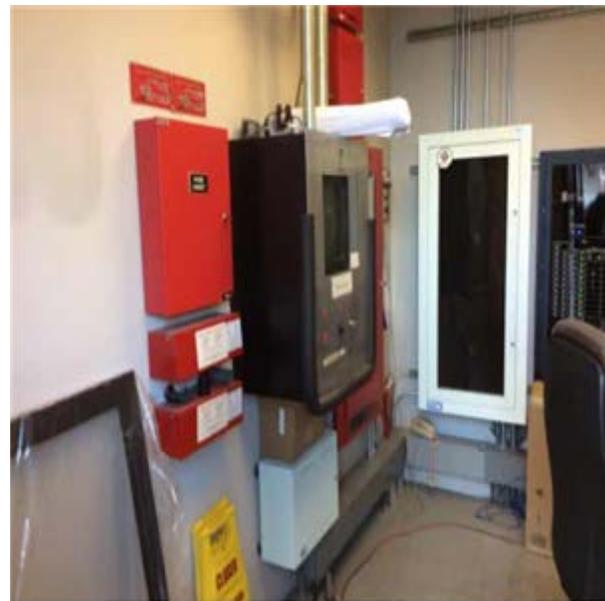
D5037 Central Diesel Pump Panel and control of fire pump

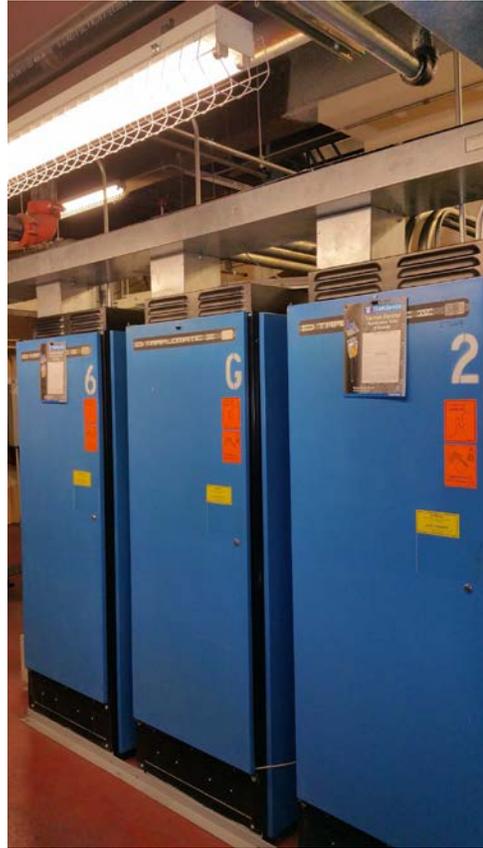
The controllers were manufactured and installed by Dover Elevator in 1995 when the building was constructed. The controllers are Dover's Trafloomatic IV with Dover solid state drives which are known to be a reliable elevator system.

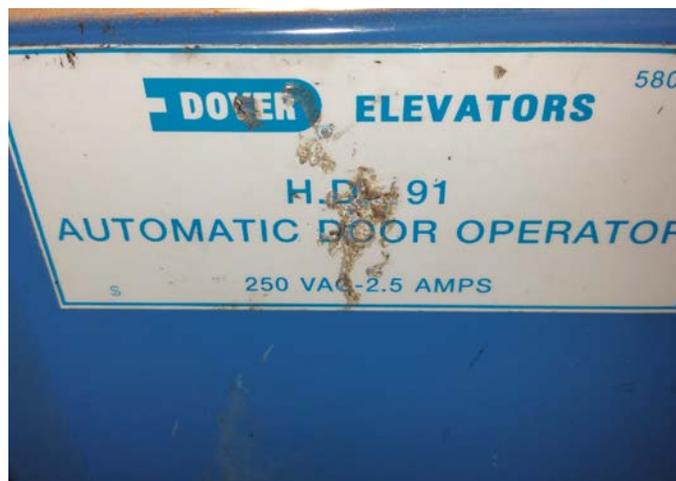
The door operators are Dover HD 91 units which are known to be reliable. They were found to be in good condition.

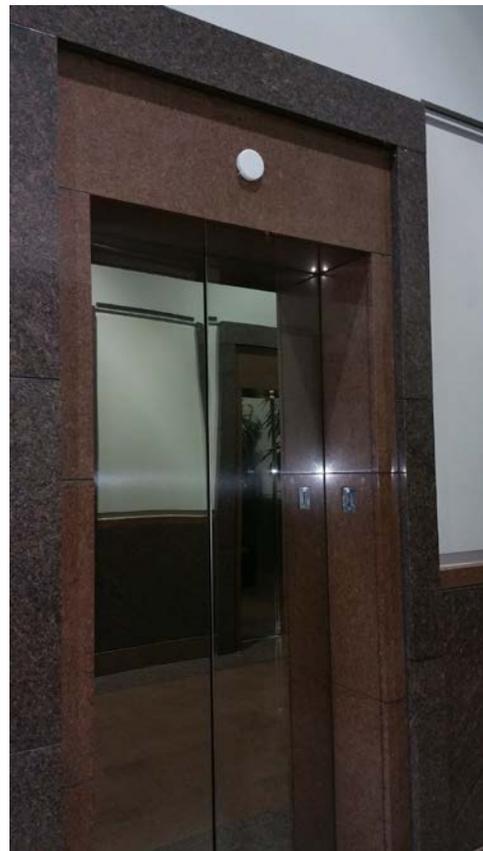
At each floor hall call push buttons are located so that users can call the elevator. The hall call stations have raised operation buttons which meet ADA and California Title 24. They also have the code required fire exit signs in station.

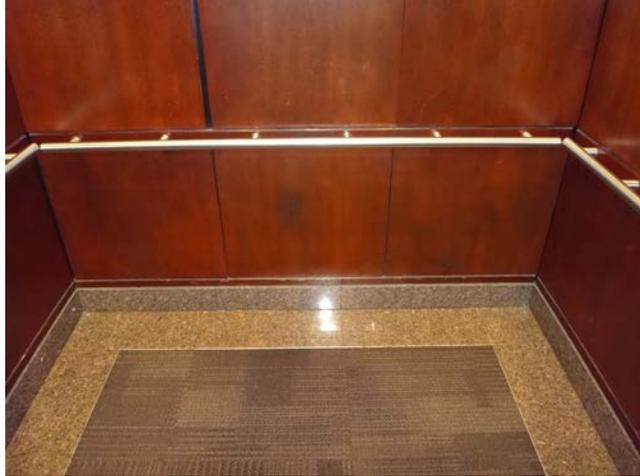
The existing cab interiors have decorative wood panels and are in good condition. They have the code required handrails. No work is needed unless it is desired to update them for aesthetics.
