Stanley Mosk Library and Courts Building (003)

914 Capitol Mall, Sacramento, CA 95814

Facility Condition Assessment

June 2015

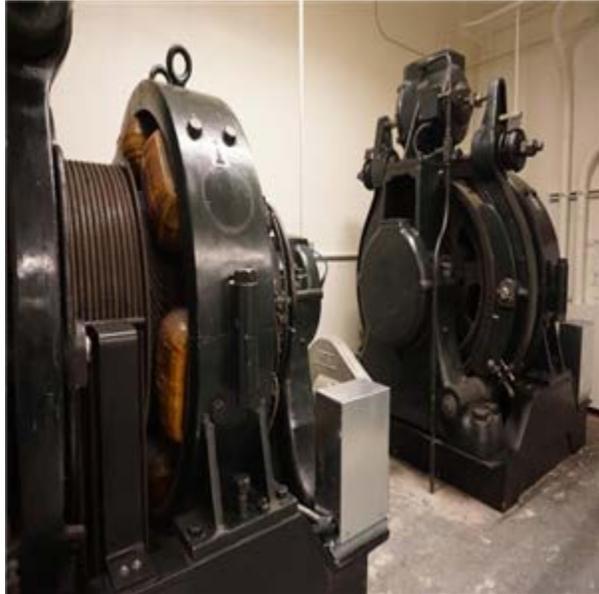
D1011 Traction Elevator Machinery and Controls

- The elevators require five-year load tests. The test tags on the cars are dated 2006.
- The emergency generator does not have a secondary containment barrier around the diesel tank to prevent contamination in the event of a fuel leak.

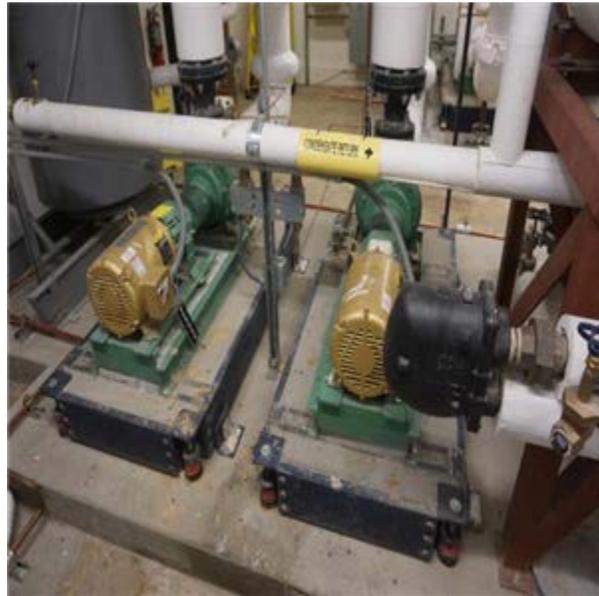
D3022 HVAC Chilled Water Circulation Pumps

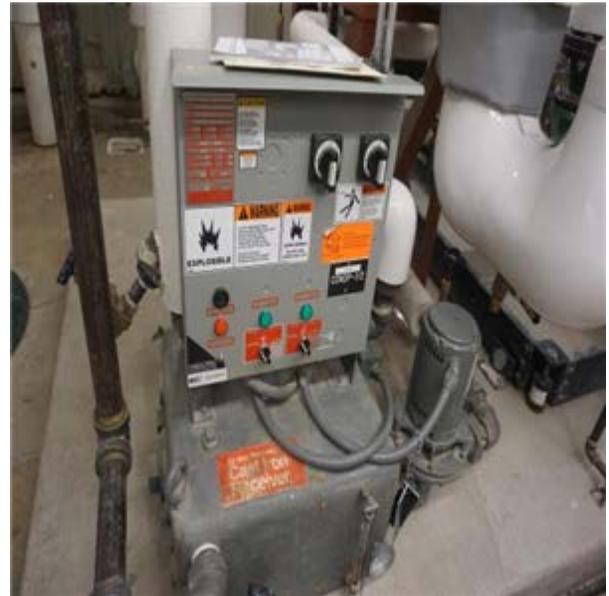
D3022 HVAC Heating Water Circulation Pumps

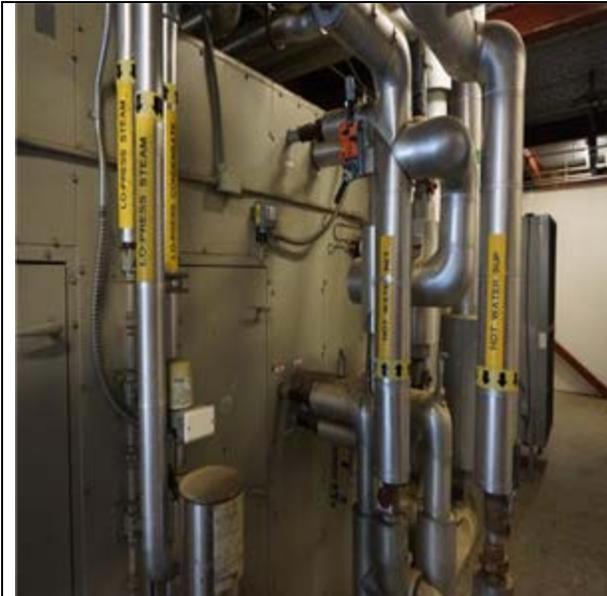
D3023 Condensate Return System

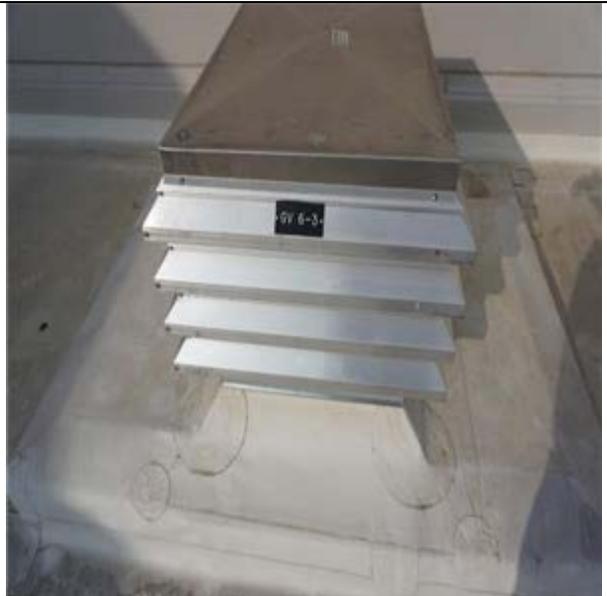
D3041 Interior AHU 6000-22000 CFM

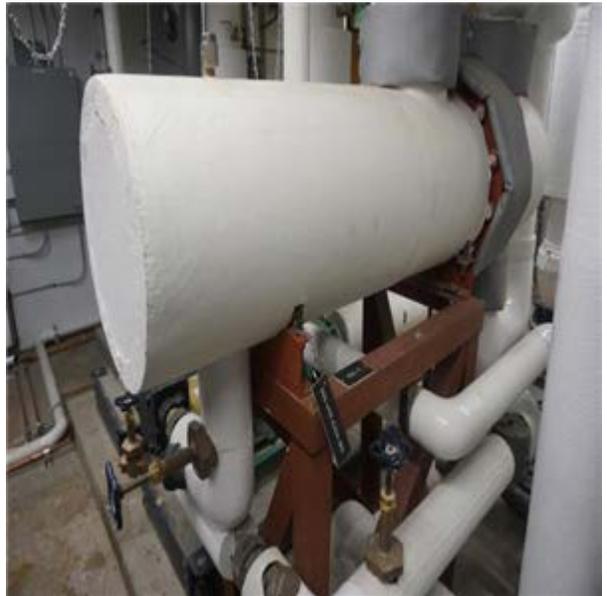
D2022 Domestic Water Heat Exchanger

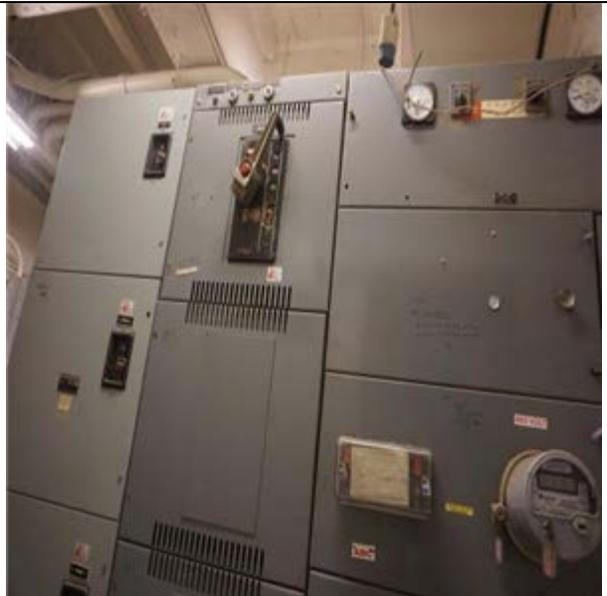
D5012 Breaker Panel 800 Amps, 42 Circuits

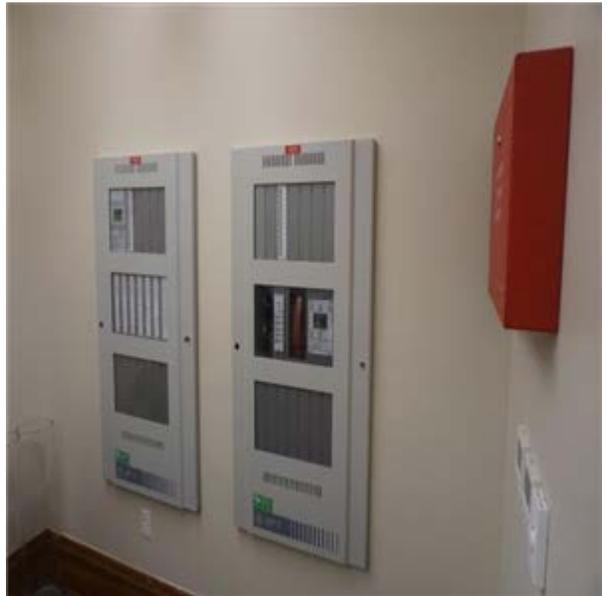
D5037 Fire Alarm System

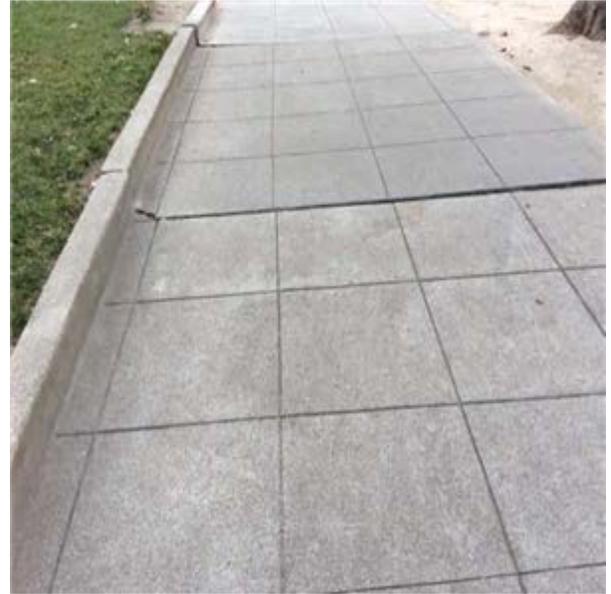
G2031 Concrete Pavement

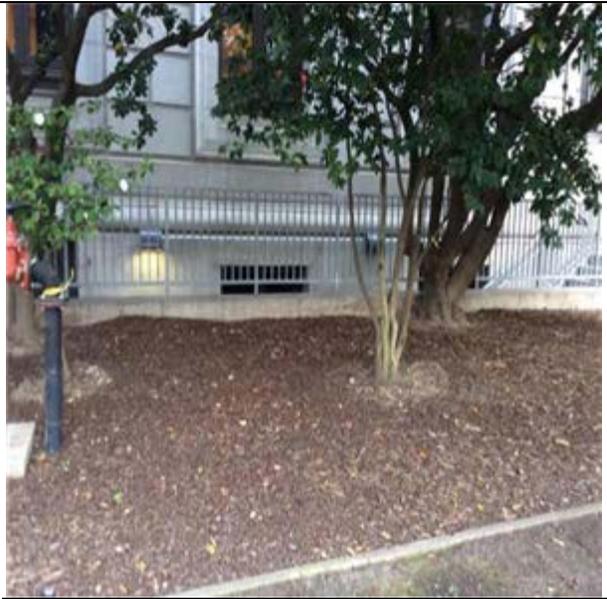
G2053 Landscaping

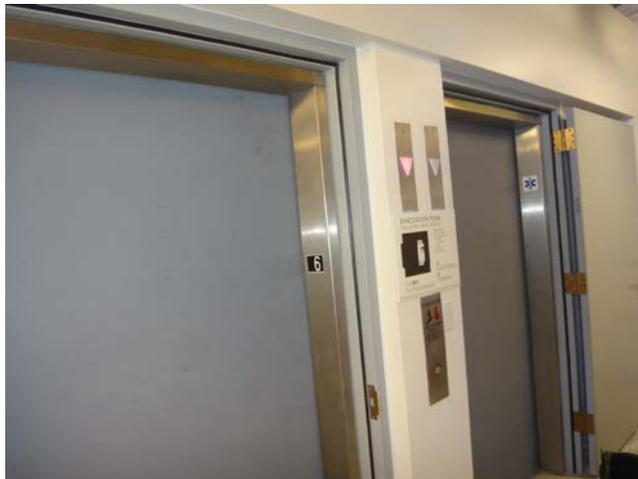
Hall Call Pushbuttons:

At each floor hall call push buttons are located so that users can call the elevator. The hall call stations have raised operation buttons which meet ADA and California Title 24. These were all noted to be in good condition.
