Justice Building (075)

4949 Broadway, Sacramento, CA 95820

Facility Condition Assessment

June 2015

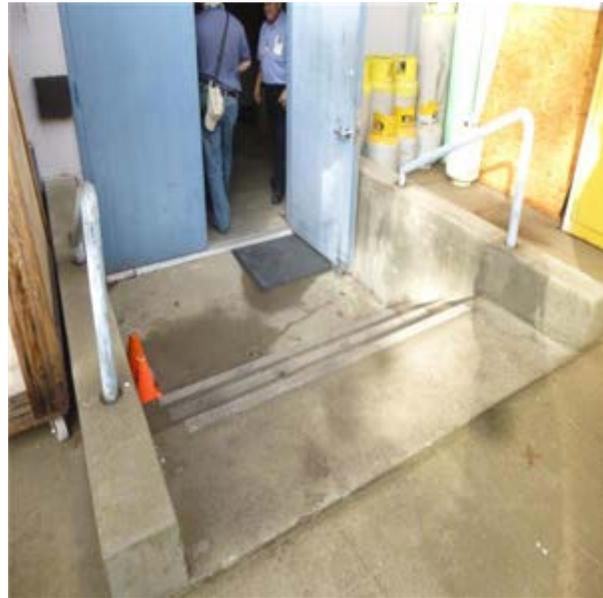
B2030 Steel Double Door with Frame and Hardware :- Steel doors

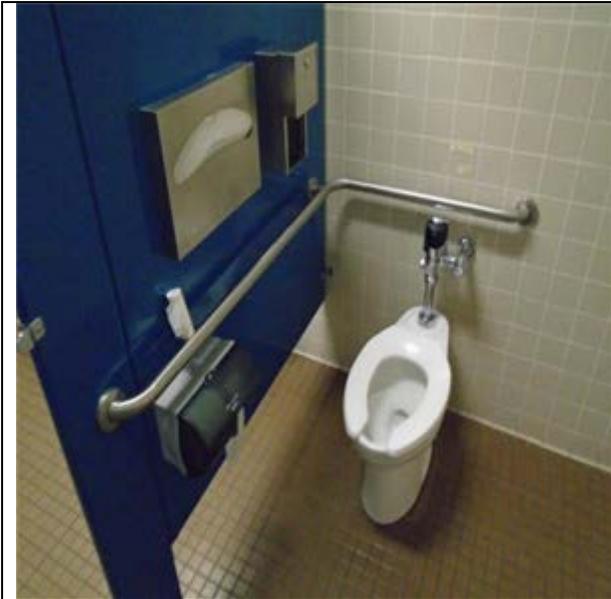
D2011 Commercial Grade Water Closet, 1.6 GPF Unit :- Men's room Building E.

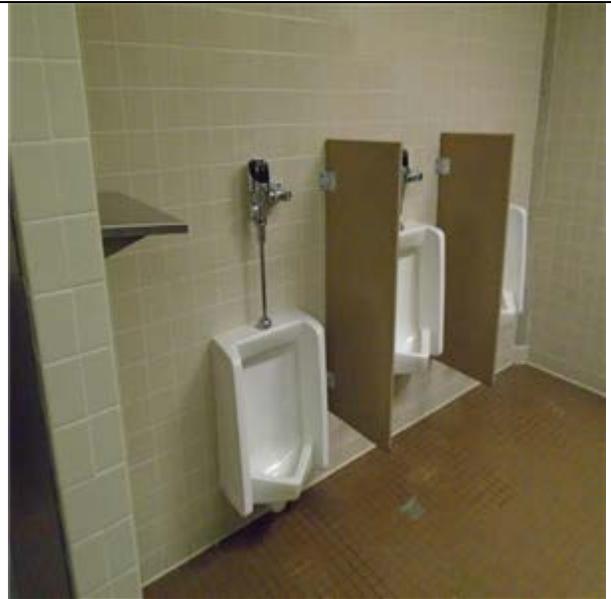
D2012 Urinal:- Building E Urinals

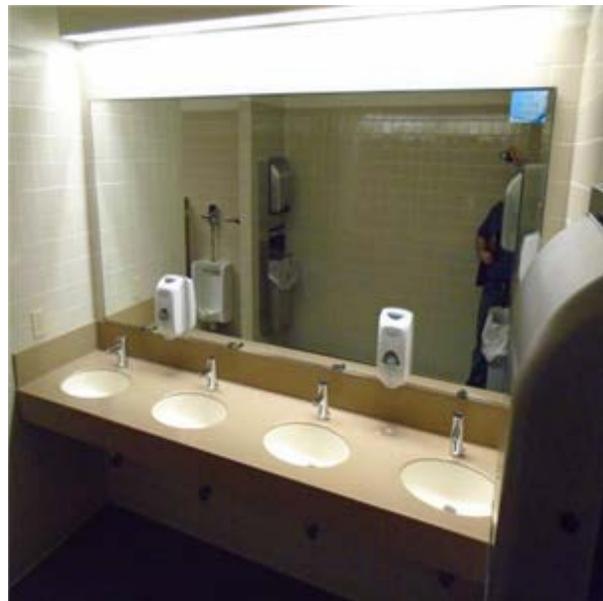
D2013 Counter Top Sink and Faucet :- Building E Lavatories

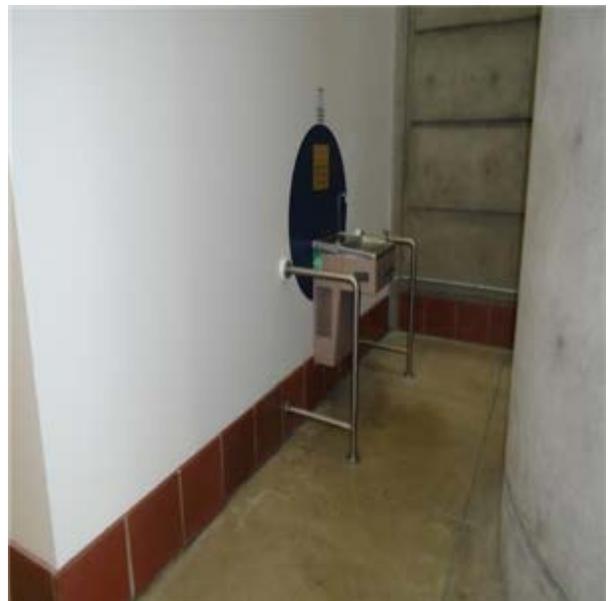
D2018 Drinking Fountain:- Building D Drinking Fountain

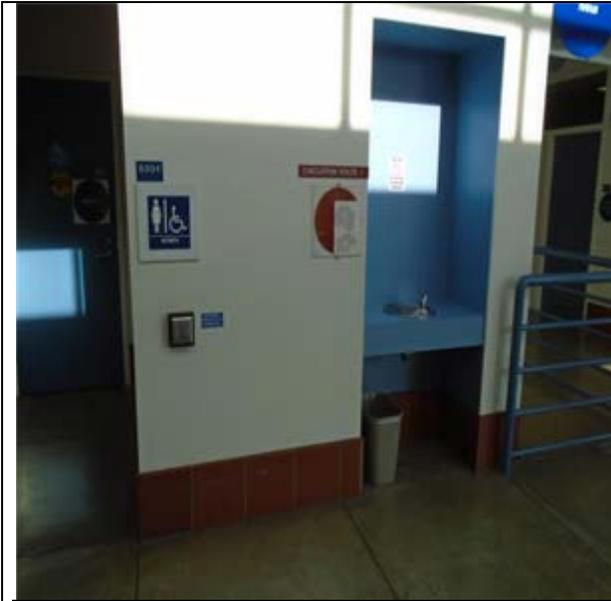
D2018 Drinking Fountain :- Building B Drinking Fountain.

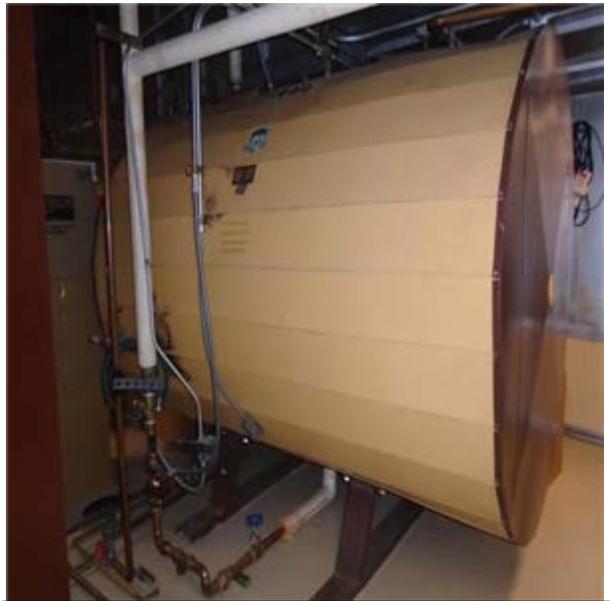
D2023 Solar Water Storage Tanks 500 Gallon:- Solar hot water storage tank

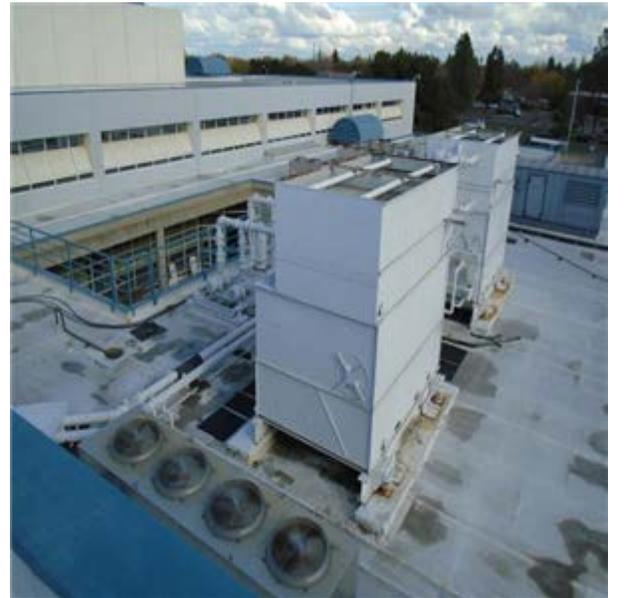
D3031 Chiller, Water Cooled, 400 Ton

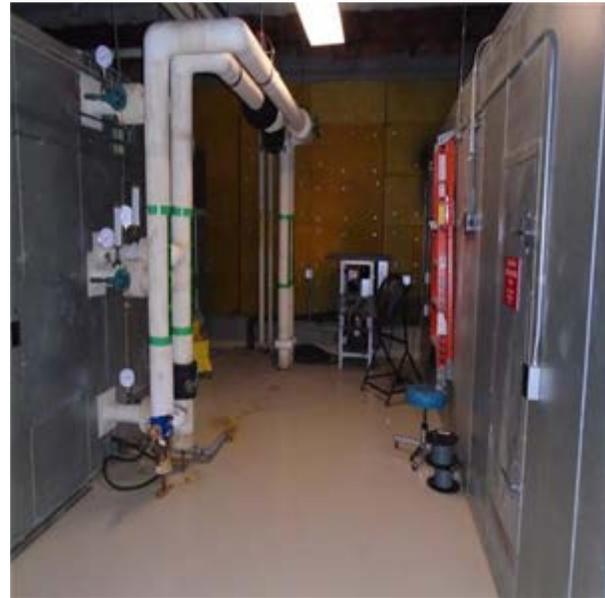
D3041 Rooftop AHU 2,400-13,000 CFM

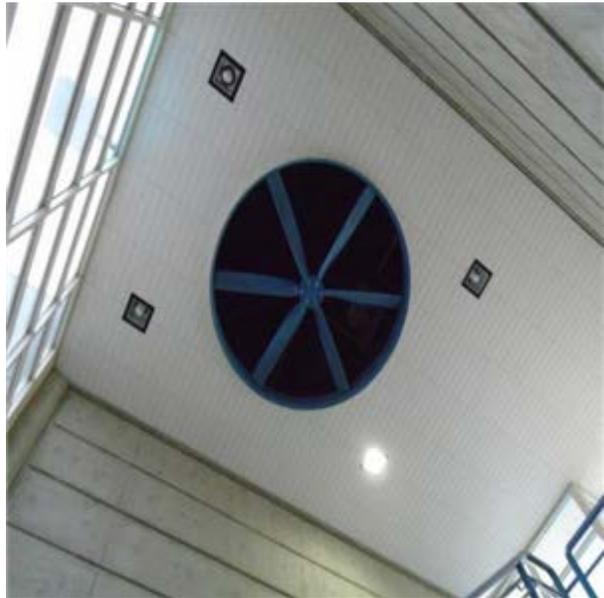
D3041 Rooftop AHU 20,000-34,000 CFM

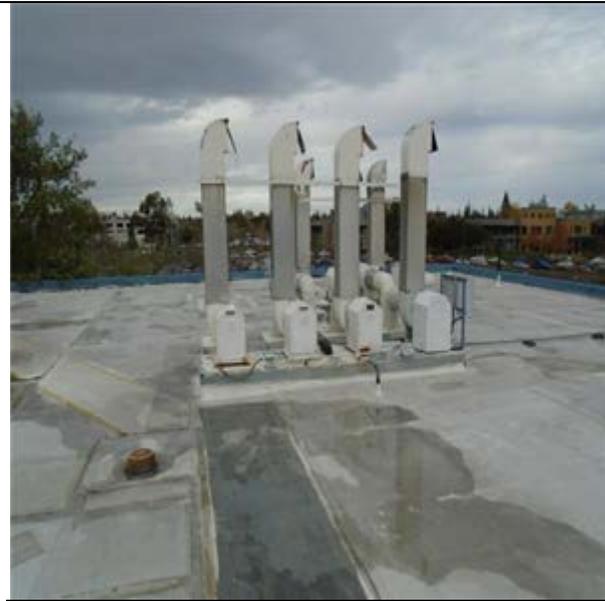
D3042 Exhaust Fan 8500 CFM:- Building G Night Vent
Flush exhaust fan

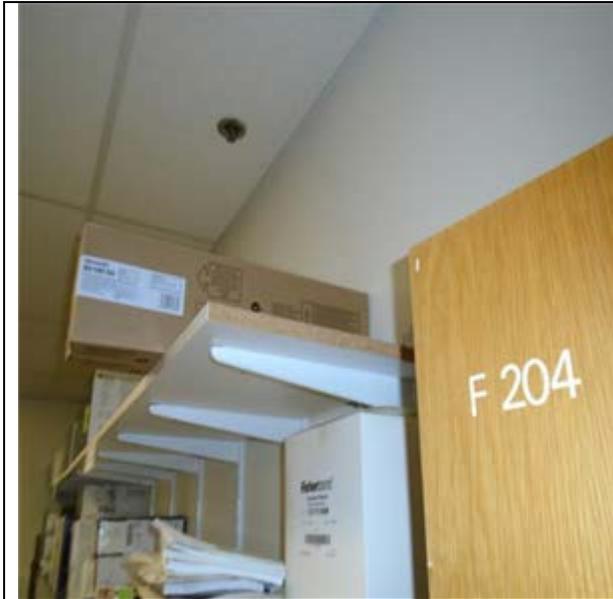
D3068 DDC Actuators

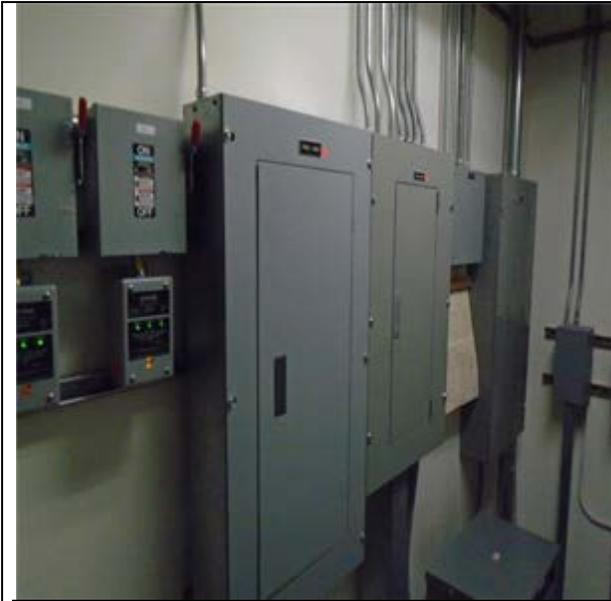
D5012 Secondary Dry Transformer 75 kVA

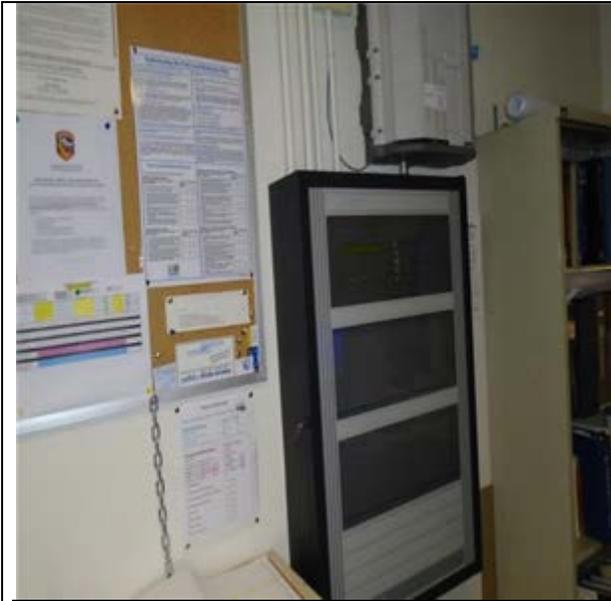
D5037 Fire Alarm Panel

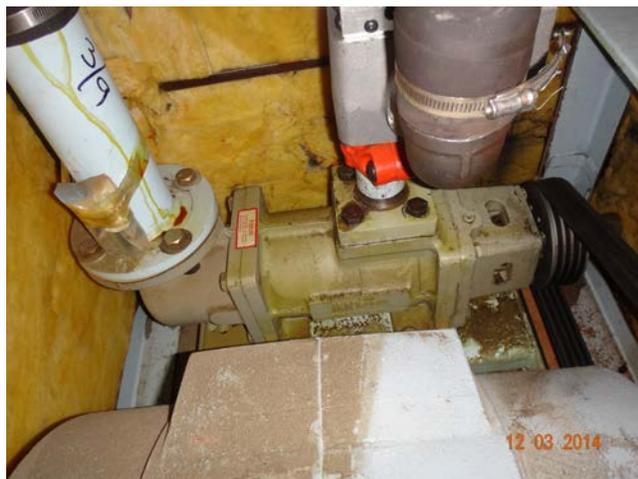
The power units are equipped with Maxton control valves, IMO pumps, and AC electric motors. None of the units have shut off valves in the machine rooms.

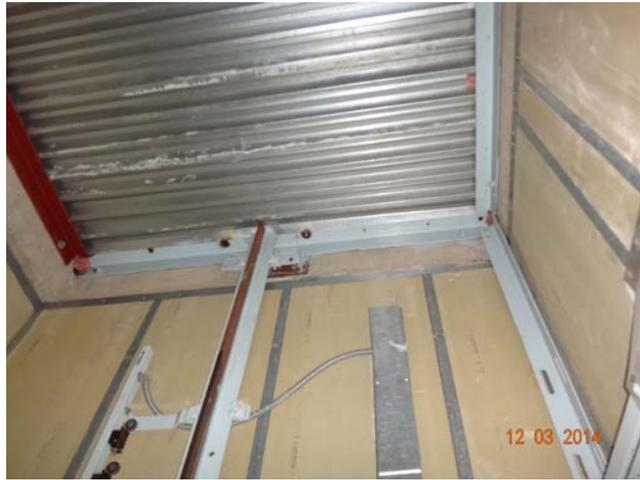
The hoistway (elevator shaft) is the main area where the elevators go up and down. The hoistways are mostly built of drywall and some concrete. There are no vents in the shafts.

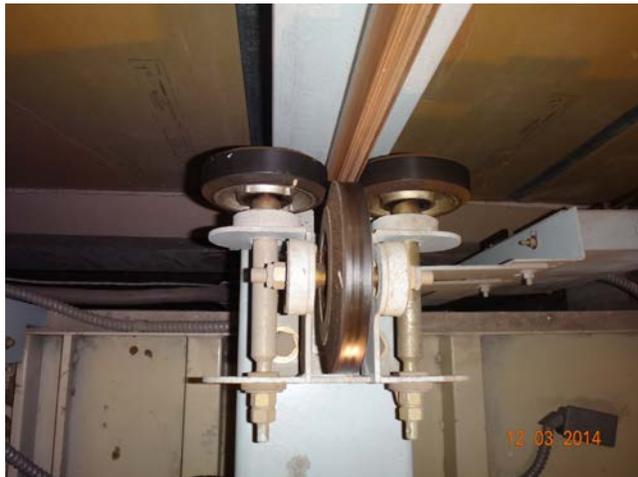
On both sides of the elevators and on the top and bottom roller guides keep the elevators riding up and down the steel guide rails. The existing ride quality was fair. These are original equipment and are not equipped with seismic retainer plates. New guide rollers or entire assemblies equipped with seismic retainer plates should be installed during modernization to improve ride quality.

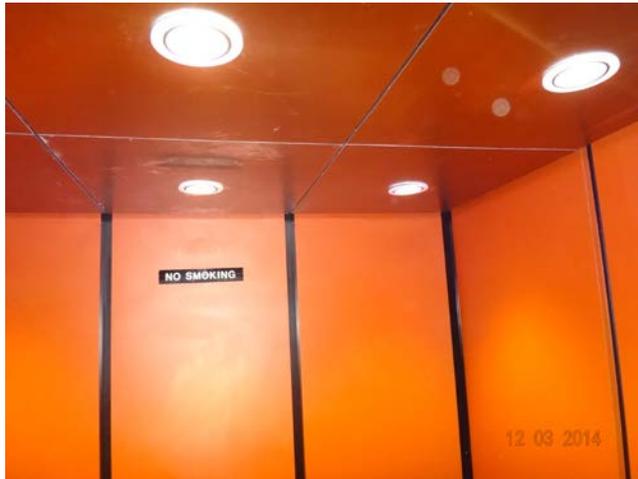
The cabs have down light ceilings with incandescent light fixtures. The light fixtures could be updated with energy efficient LED's and/or the entire ceiling could be replaced.
