Warren-Alquist State Energy Building (008)

1516 9th Street, Sacramento, CA 95814

Facility Condition Assessment

June 2015

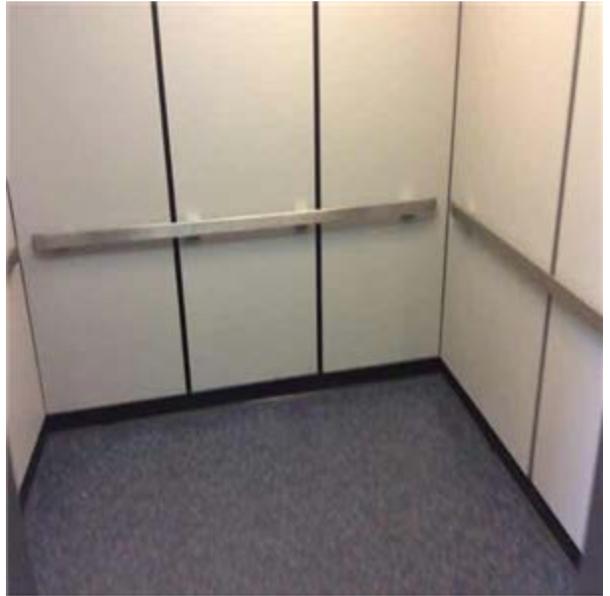
D1011 Traction Geared Elevator - Low rise 4000 lbs

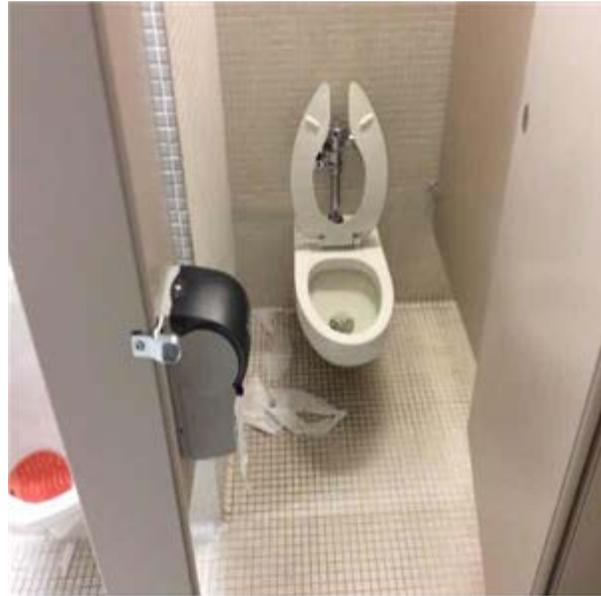
D2011 Water Closet 1.6 Gpf

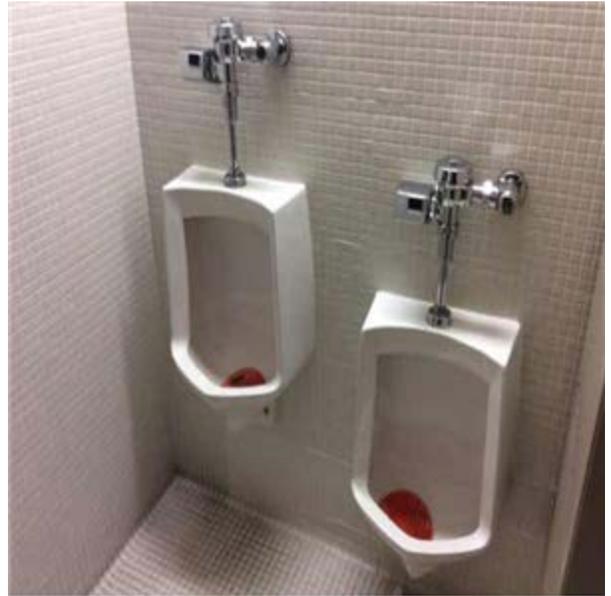
D2012 Urinals with sensors

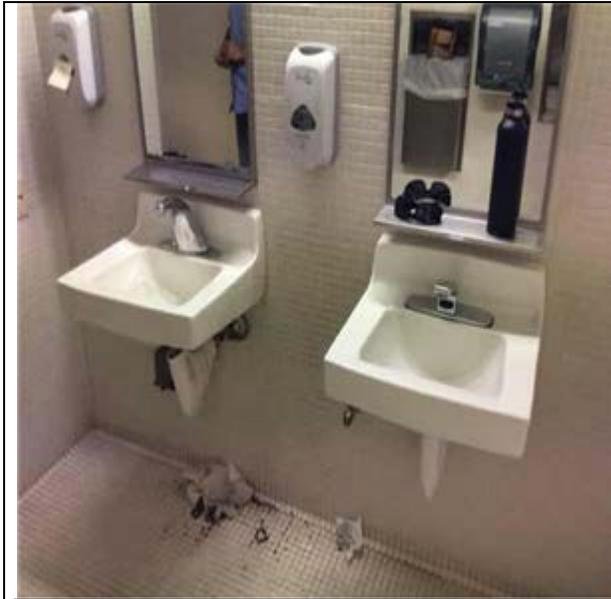
D2013 Restroom Sink and Faucet

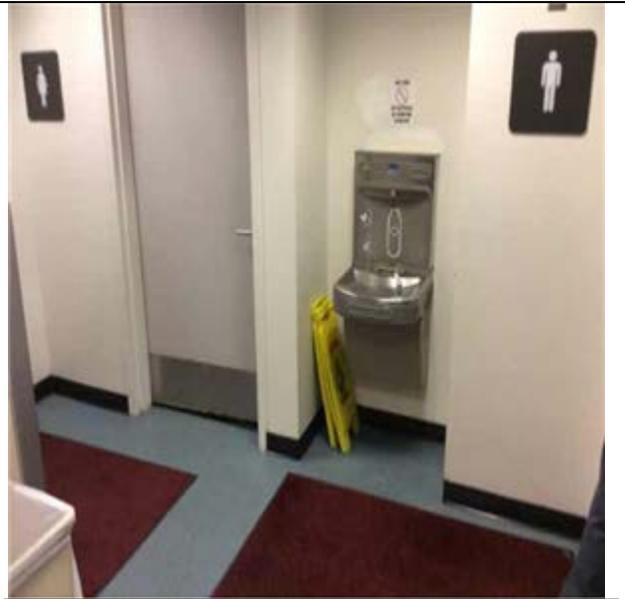
D2010 Drinking Fountains

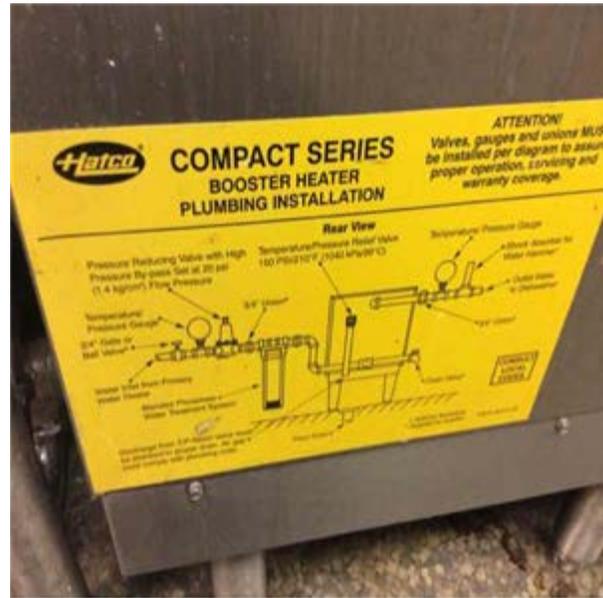
D2023 Electric Hot Water Heater

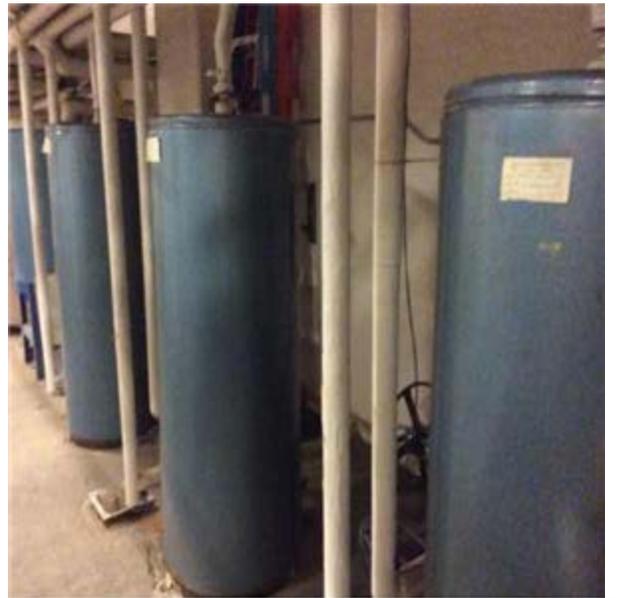
D2023 Solar Water Storage Tank 100 Gal

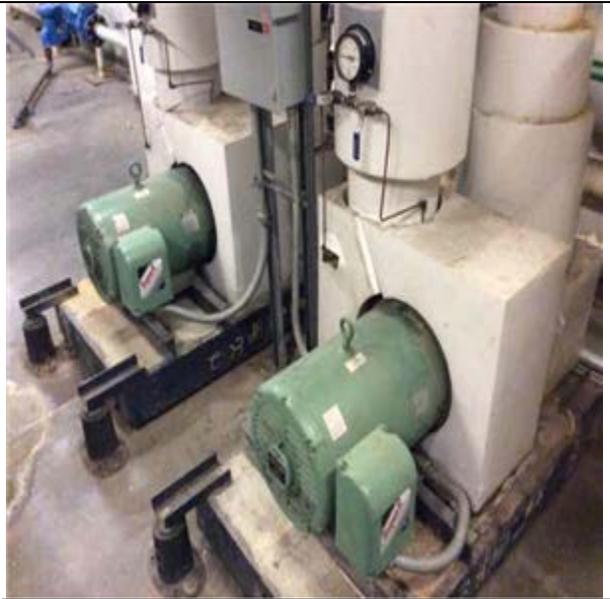
D2023 Chilled Water Pumps (30 hp) water

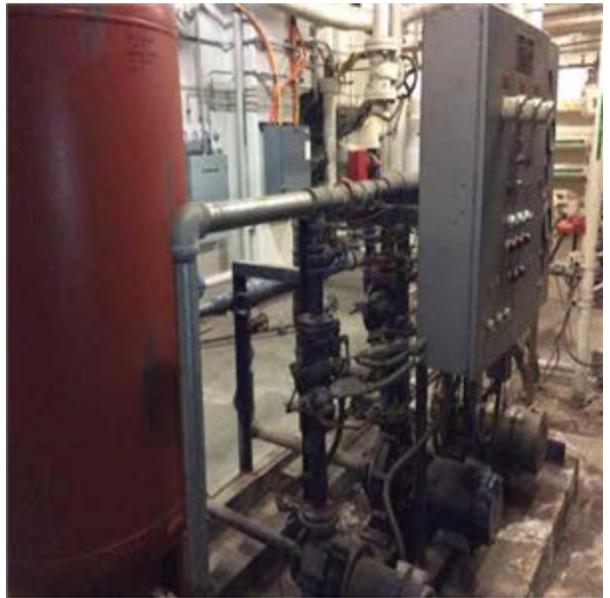
D2023 CW Booster Pumps

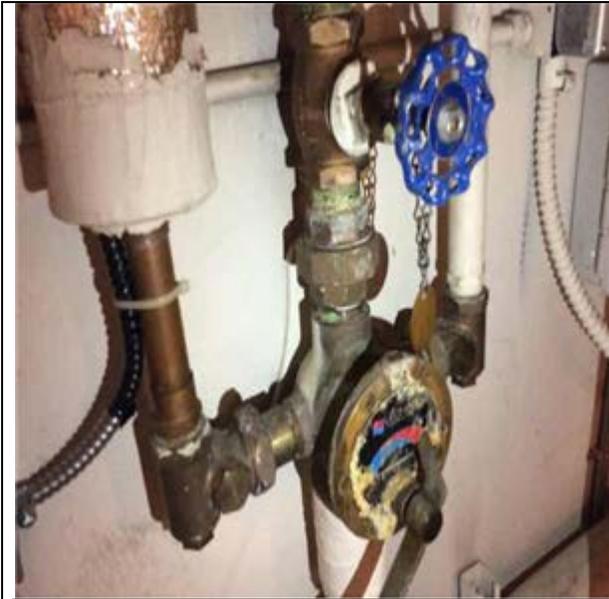
D2023 DHW Mixing valve

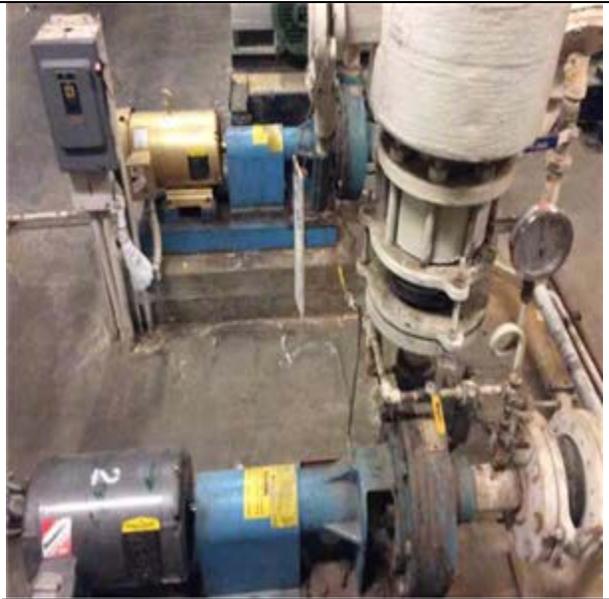
D3022.1 Pumps HW distribution 5hp no VFD

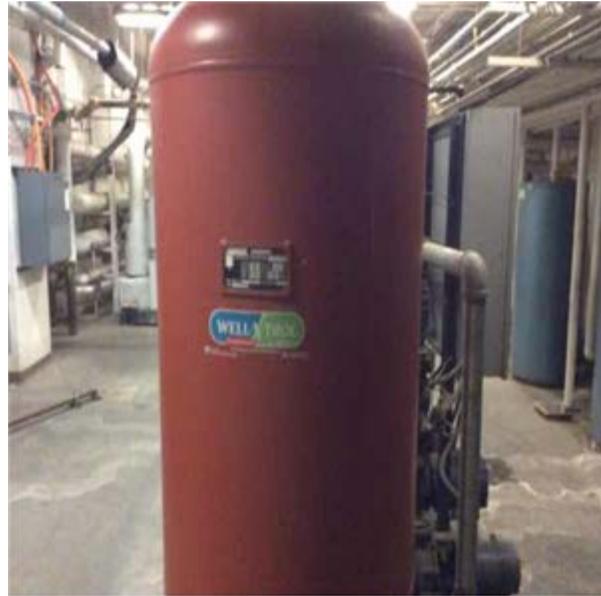
D3023 Expansion Tank 158 Gal

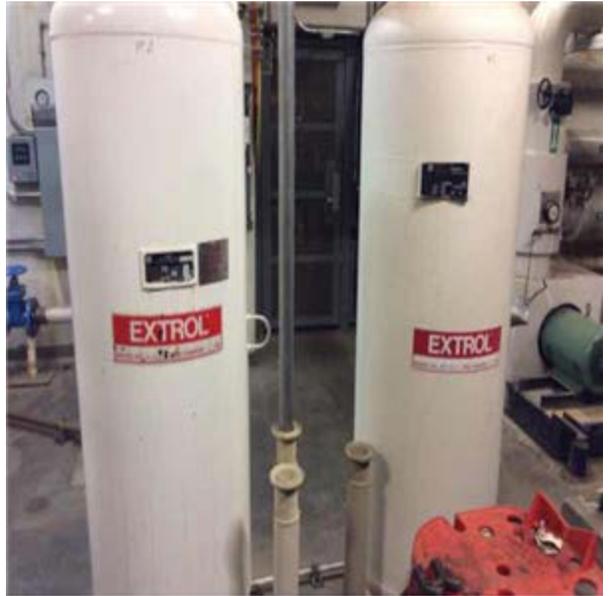
D3023 240 Gallon Expansion Tank

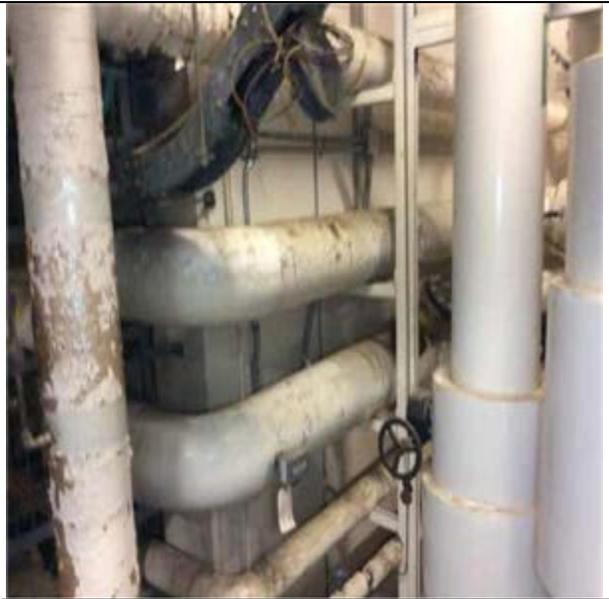
D3023 Steam pressure reducer system

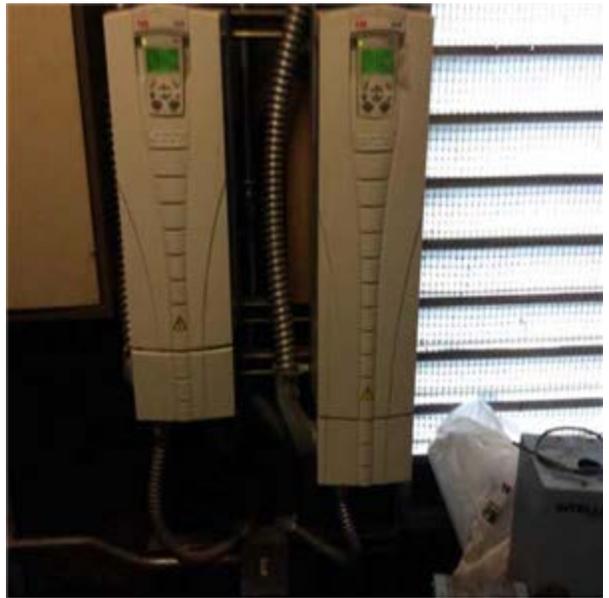
D3041 AHU 27000 CFM - External

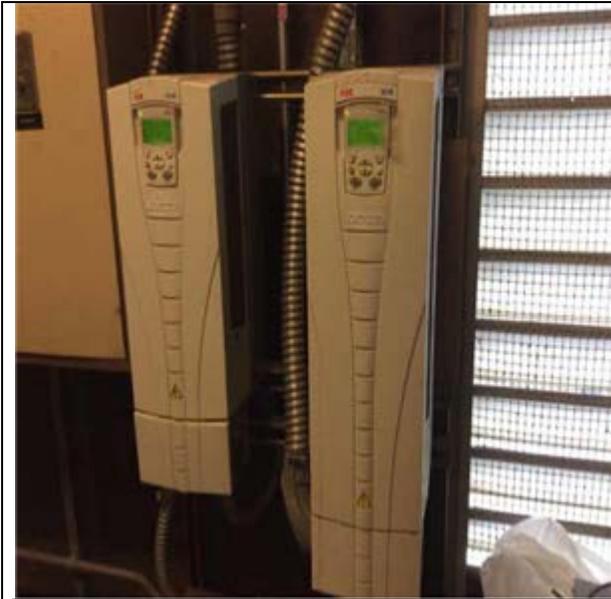
D3041 AHU 55,000 CFM - Internal

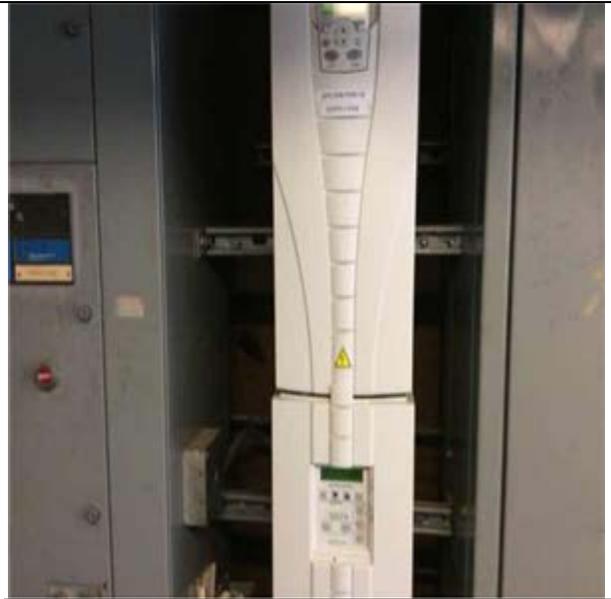
D3041 AHU 27000 CFM - External

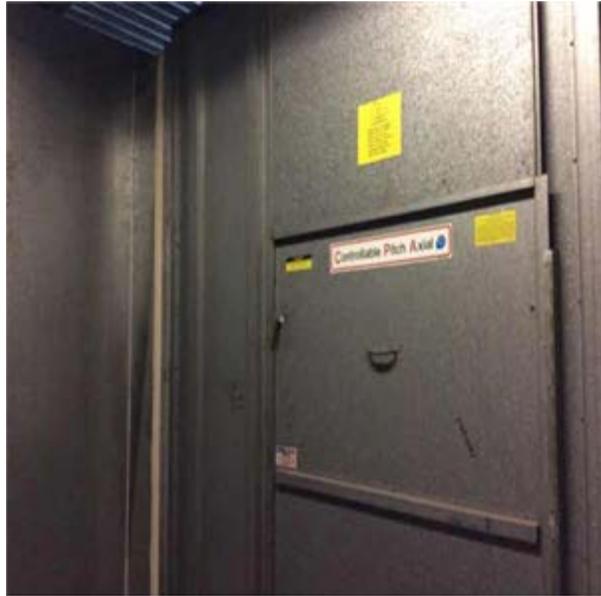
D3041 AHU 27000 CFM - External

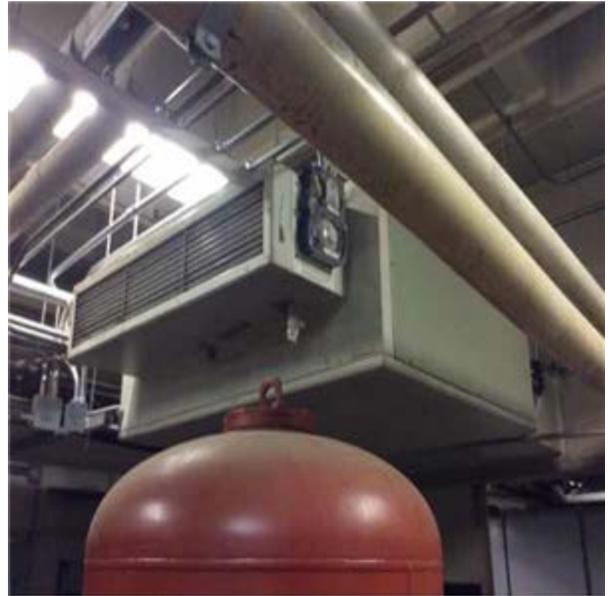
D3041 Air handler 2400 cfm with cooling.

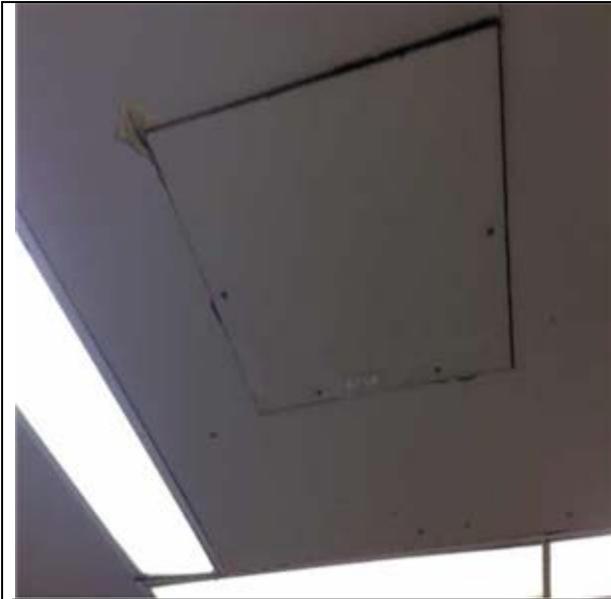
D3041.1 Fan Coil Unit 3 Ton,

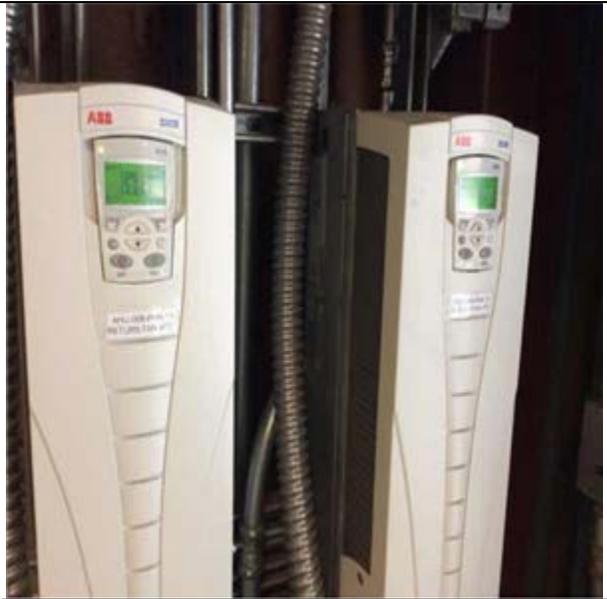
D3041 AHU 55,000 CFM - Internal

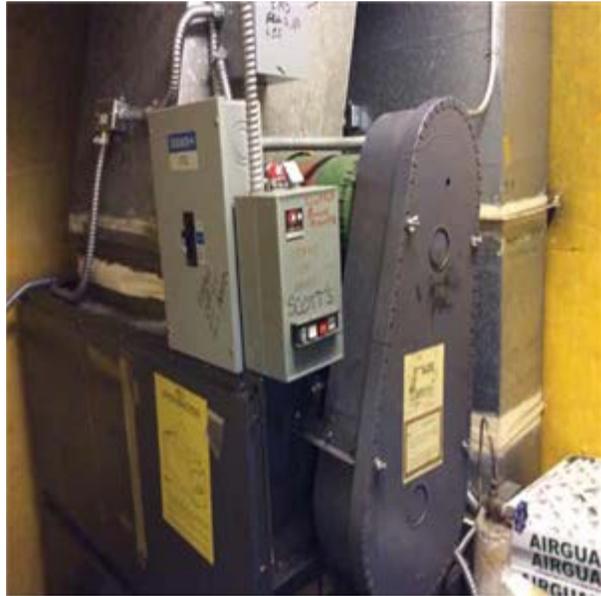
D3041 AHU IT room 5000 CFM Motors

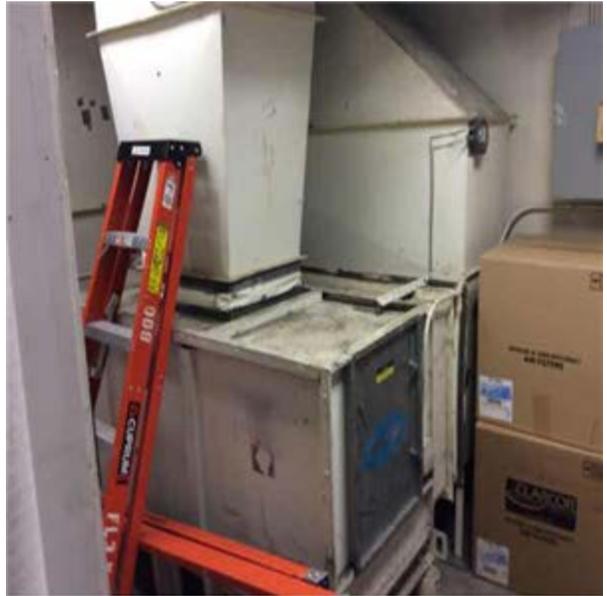
D3041 AHU 5000 CFM Motors

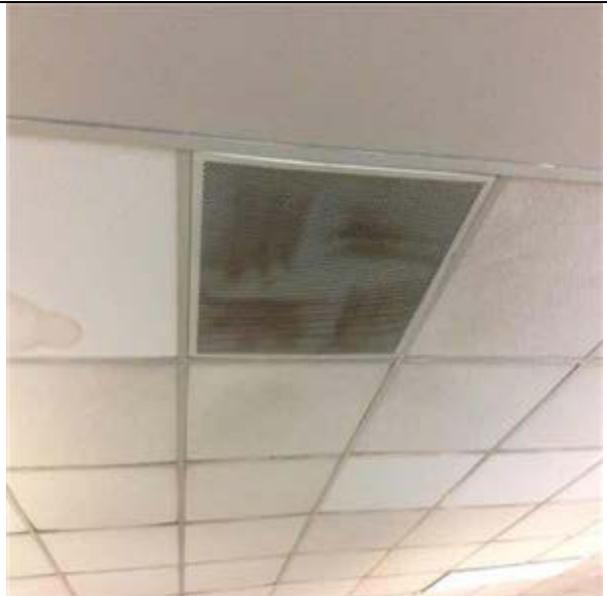
D3041.2 VAV Boxes- interior

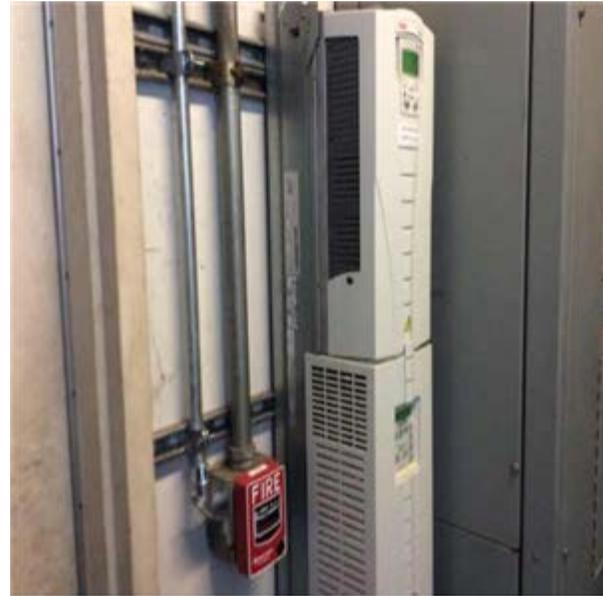
D3042 Return fans 46000 cfm

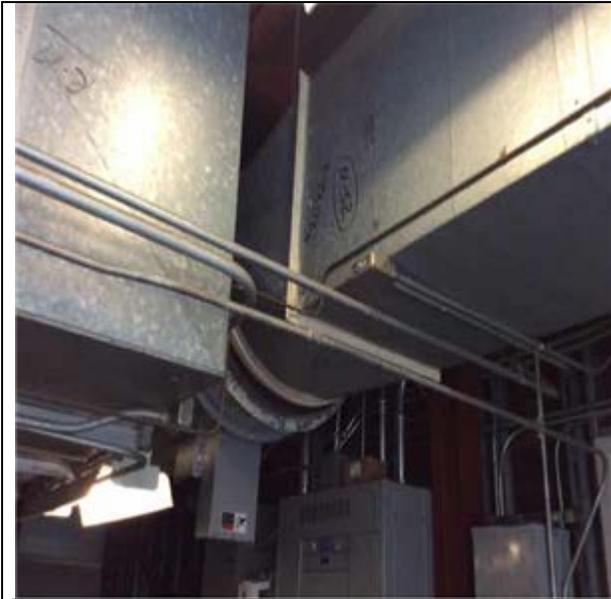
D3042 Exhaust fan restroom 5500 CFM

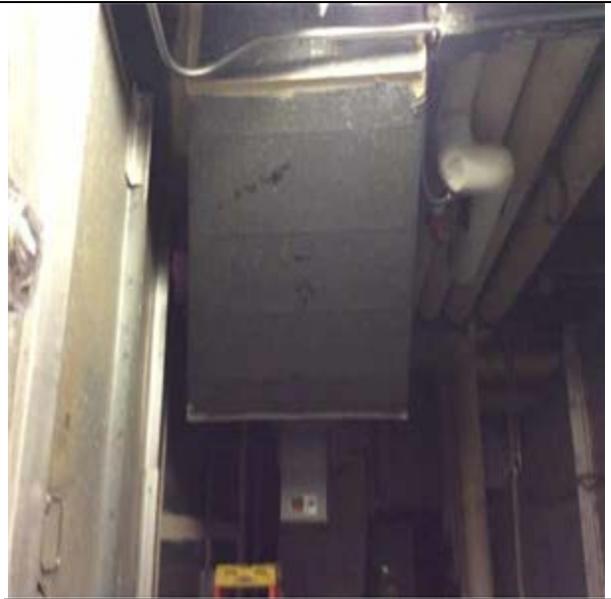
D3042 Exhaust fan restroom 6010 CFM

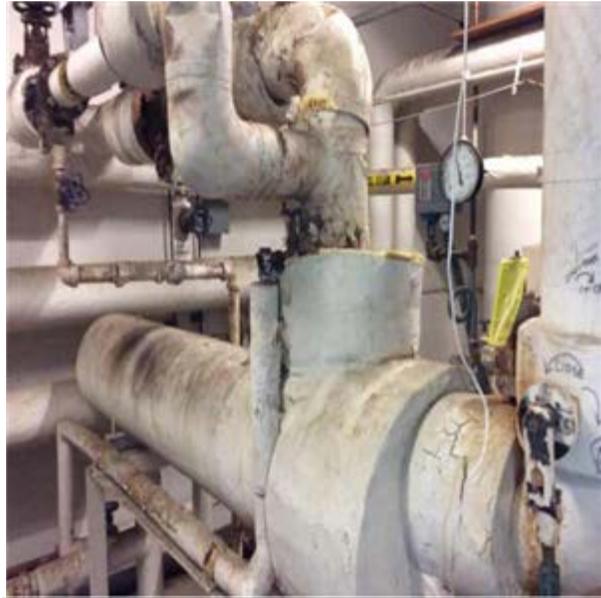
D3043 Heat Exchanger for Heating

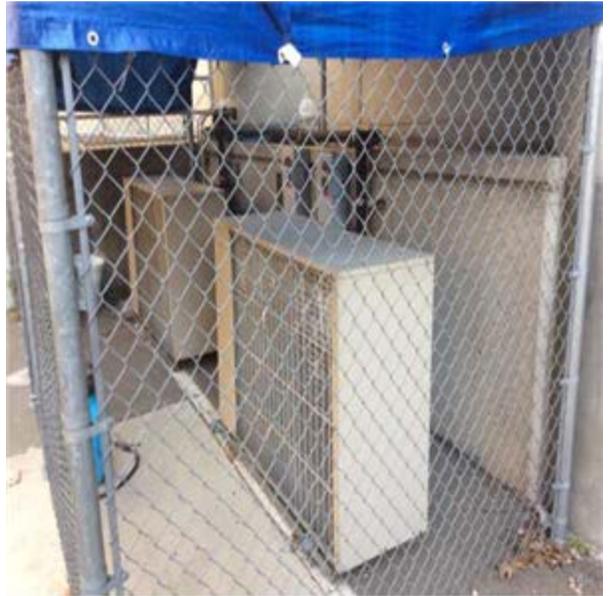
D3052 Dx Cooling Unit 1.5 Ton

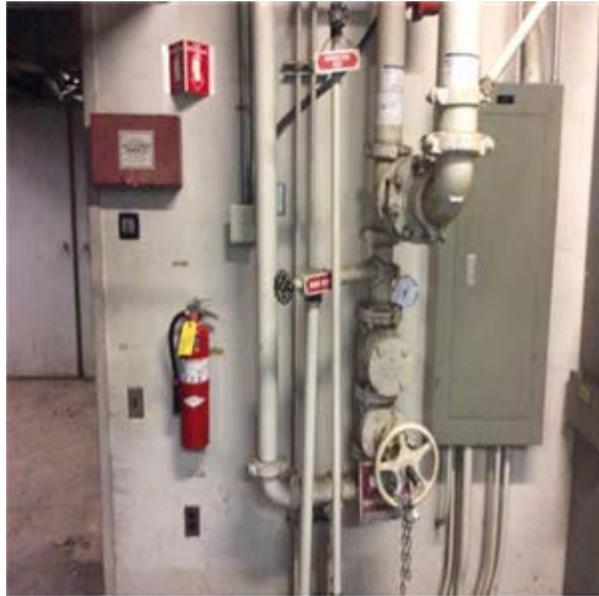
D4011 Wet- Pipe Sprinkler system

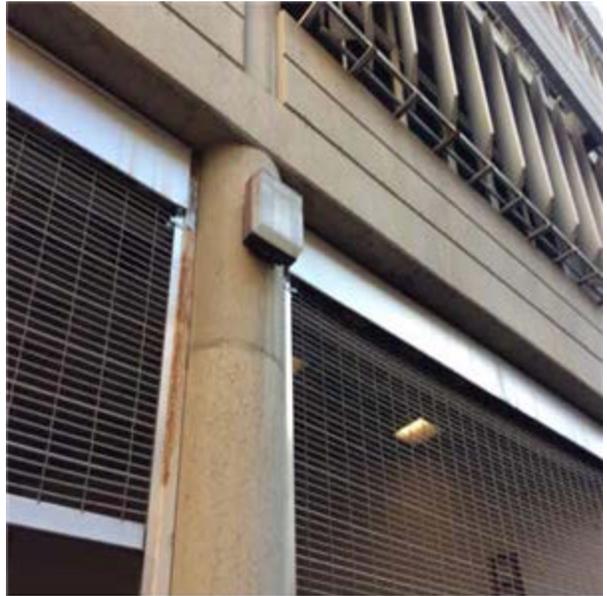
D5022 T10 lamps replace with Induction 65 W canopies

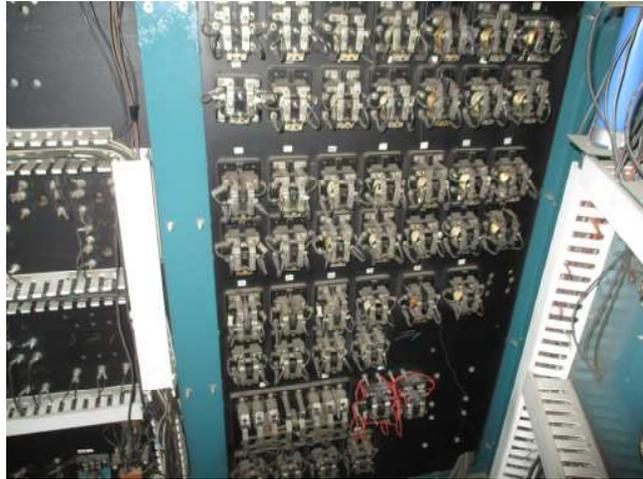
Traction Controllers:

The controllers for the traction elevators were manufactured and installed by Dover elevator and use relay logic. They are Dover's composite system and old but still maintainable.

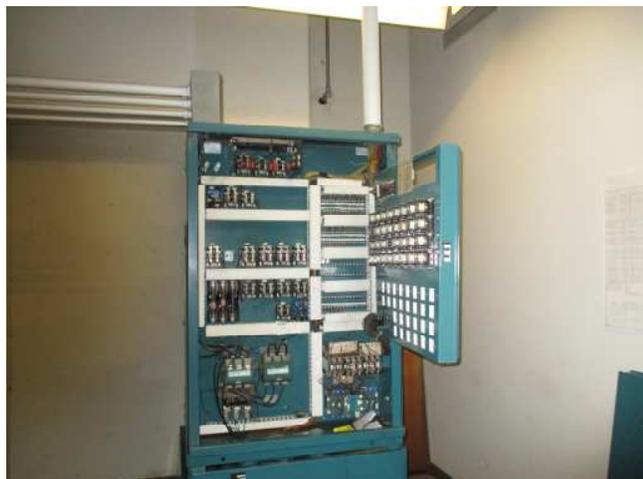
Hydraulic Controller:

The controller for the hydraulic elevator was also manufactured and installed by Dover. It is Dover's wired contact relay controller.

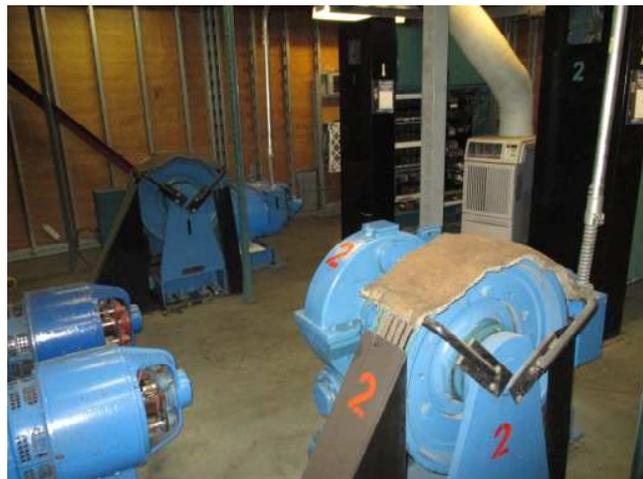
Machines:

Traction elevators 1 and 2 have geared machines with DC motors that were manufactured by Dover Elevator. The elevators use motor generator sets to convert the incoming power from AC to DC.

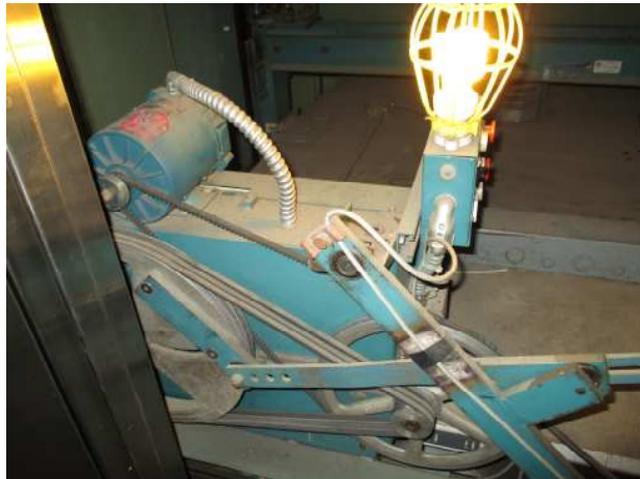
Door Operator:

The door operators are Dover's HD 73 which are known for dependability. When the elevators are modernized they should be upgraded with new closed loop door operators.

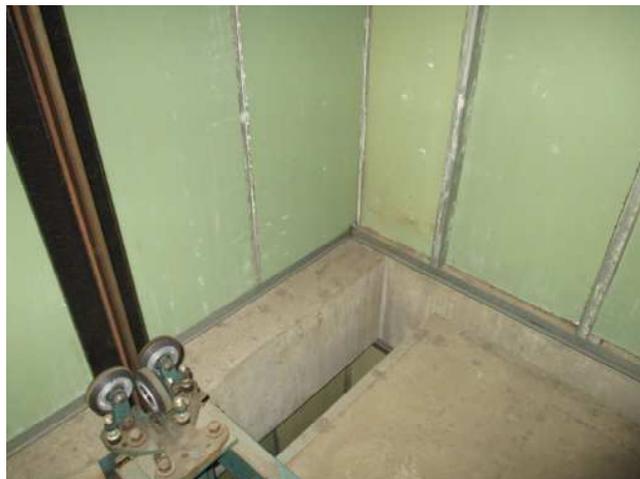
Car Roller/Slide Guides:

On both sides of the elevators and on the top and bottom roller guides keep the elevators riding up and down the steel guide rails.
