Elihu M. Harris State Building (602)

1515 Clay Street, Oakland, CA 94612

Facility Condition Assessment

September 2015

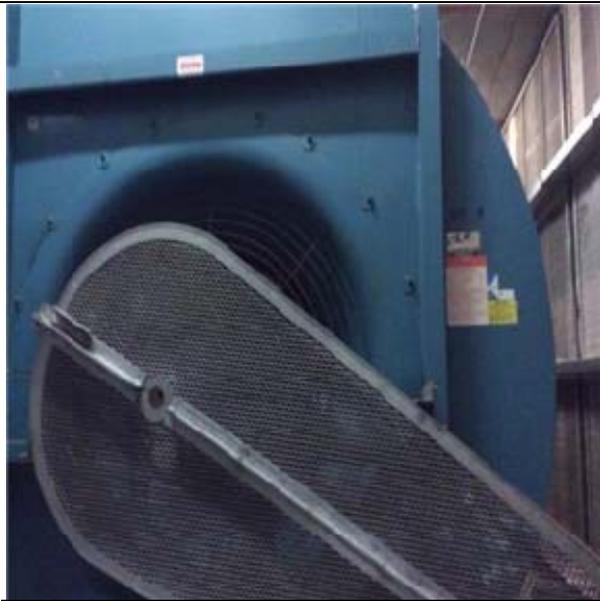
D3041 Supply Air SFI-4 - 96,750 CFM

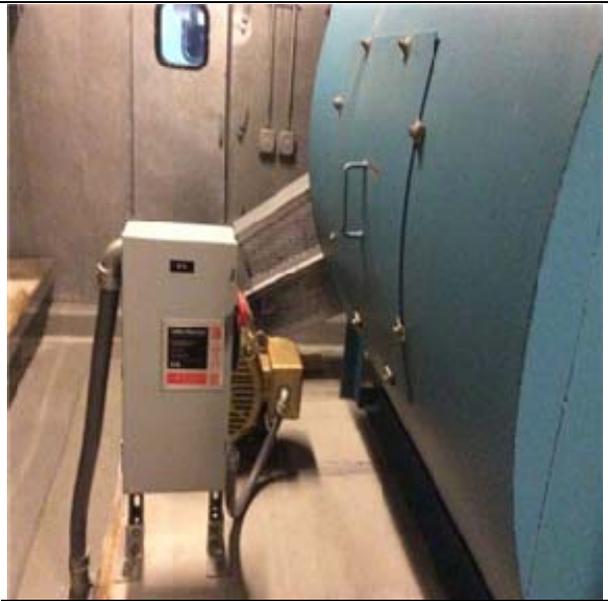
D3041 Supply Air SF 9 - 42,000 CFM

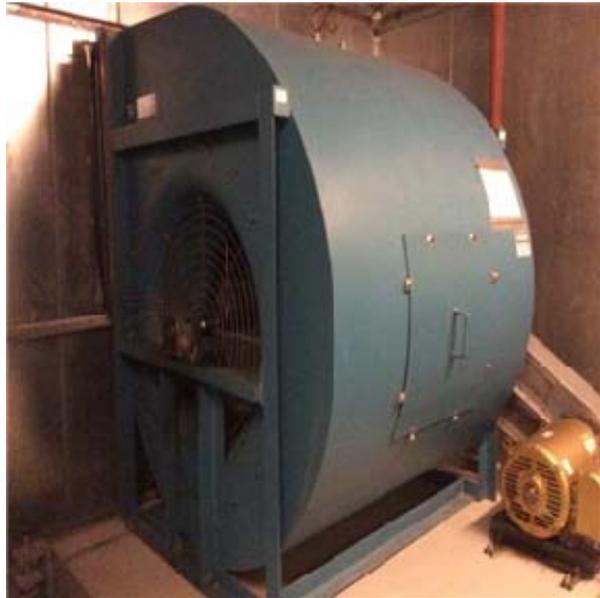
D3041 Return Air RE 5-8 - 40,500 CFM - 30HP

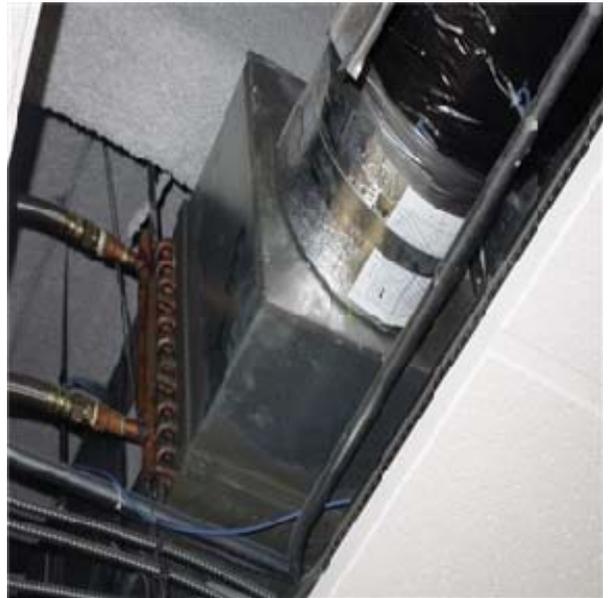
D3041 VAV Boxes with Coils

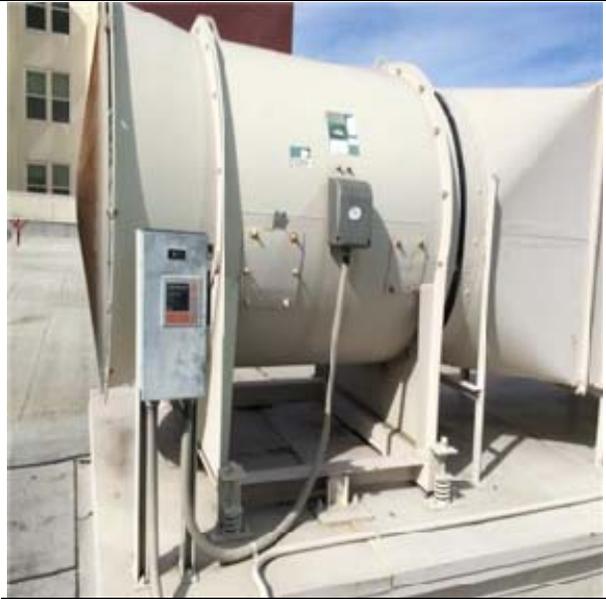
D3042 Exhaust Fan 40,000 CFM - Atrium

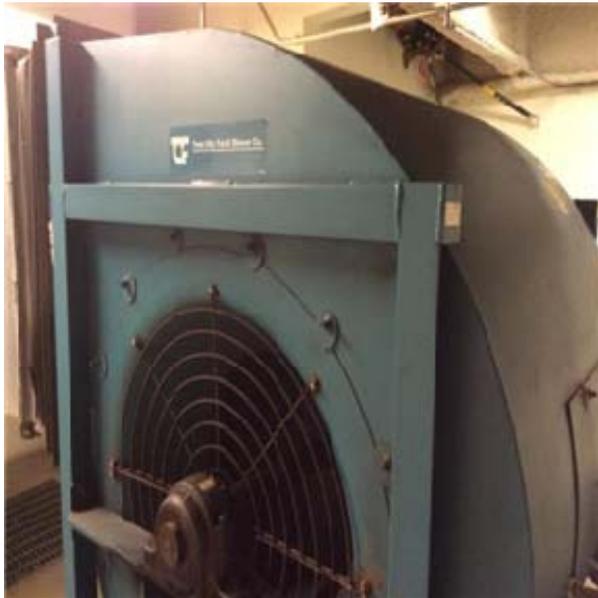
D3042 Exhaust Fan, Under 15,000 CFM

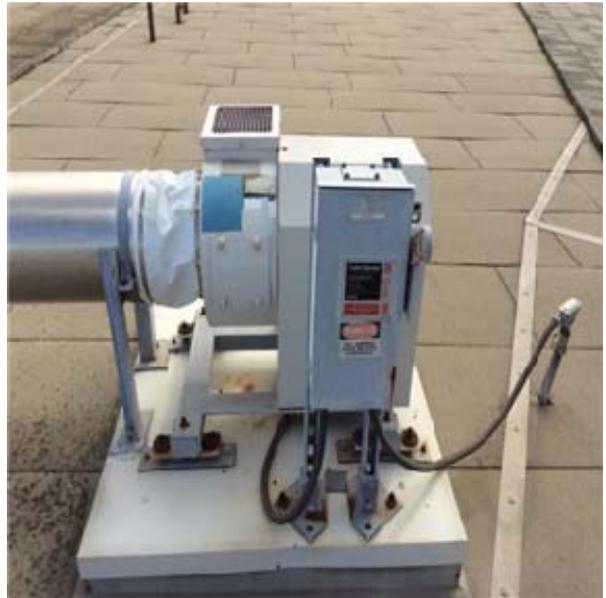
D3042 Exhaust Fan 26,000 CFM

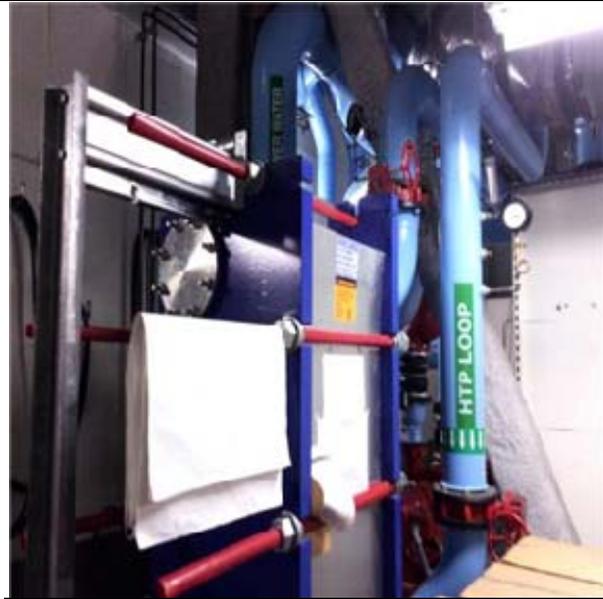
D3043 Heat Exchanger For Telco - Stainless

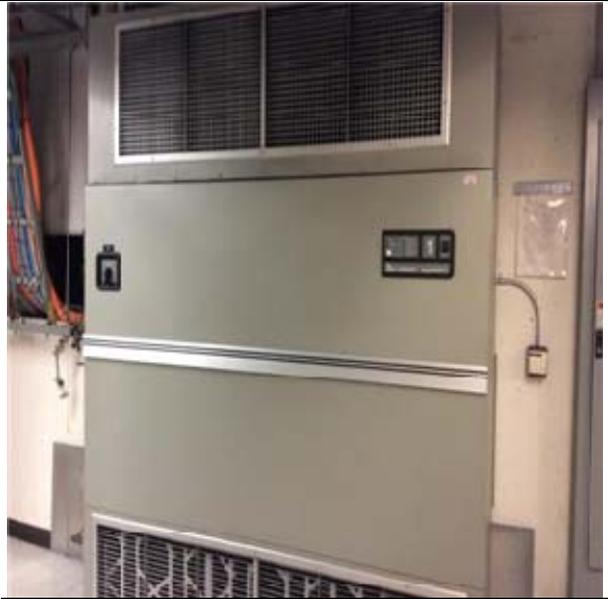
D3052 Computer/Server Room Air Condition

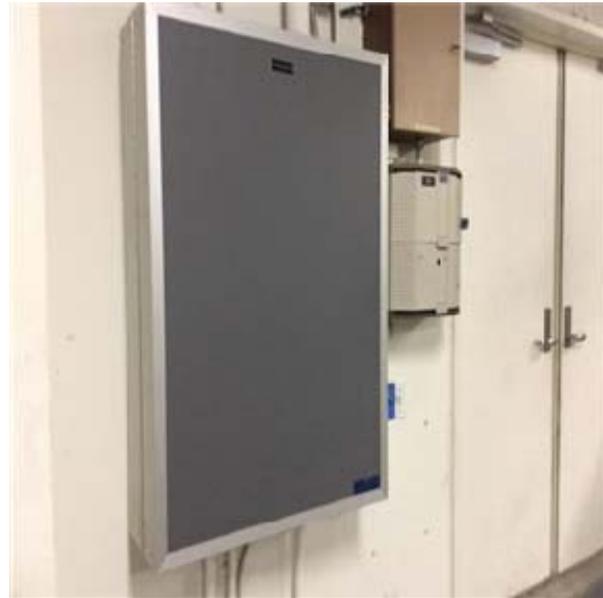
D3068 Direct Digital Controls

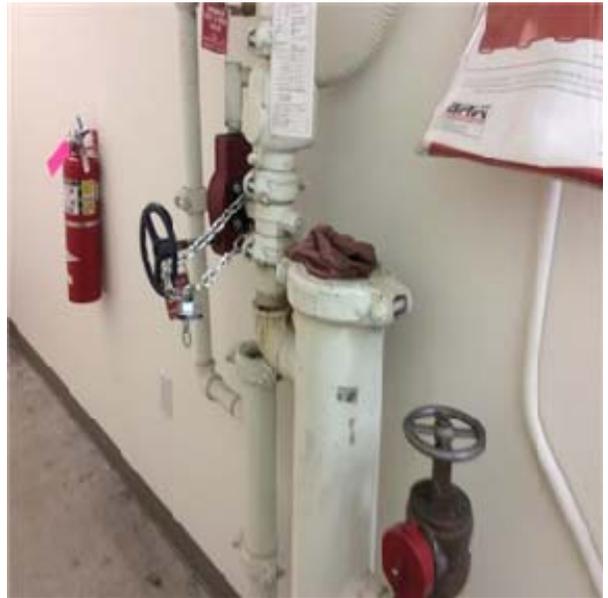
D401 I Wet-Pipe Sprinkler System

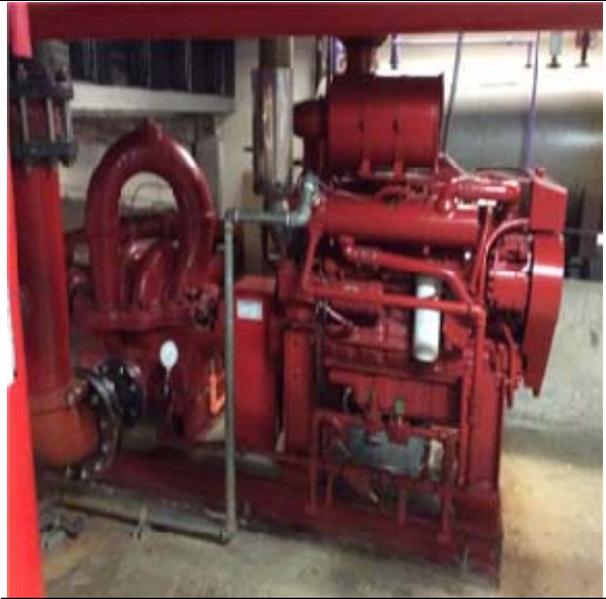
D4012 Fire Pump Diesel 750 Gpm 280 HP

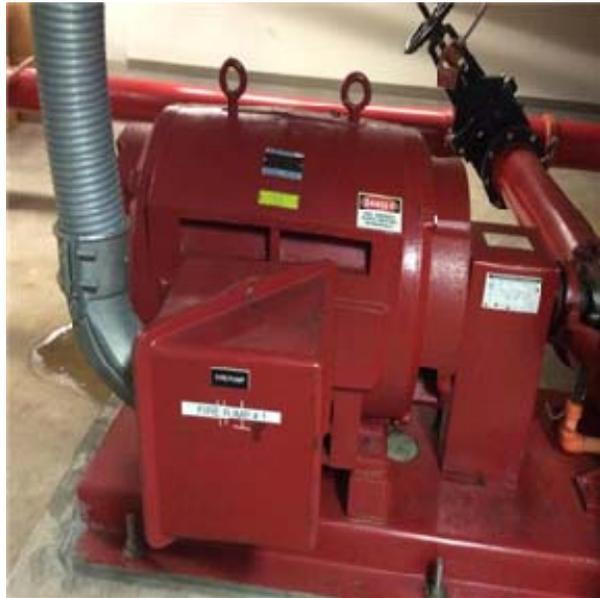
D4012 Fire Pump Electric 1250 Gpm 200 HP

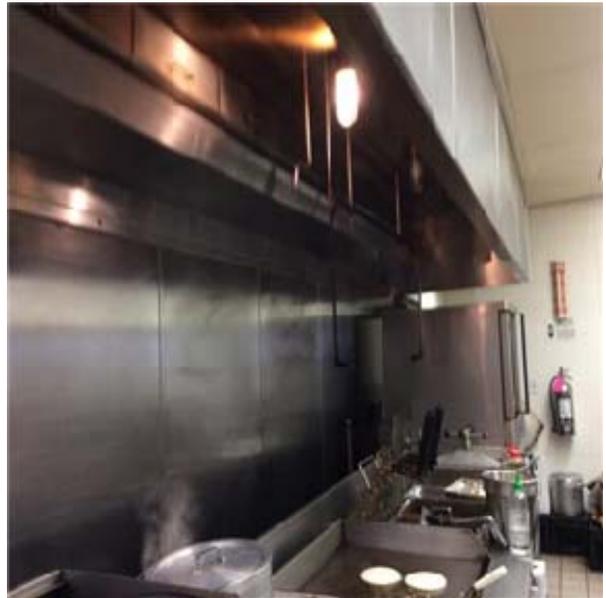
D4031 Ansul System at Kitchen Hood

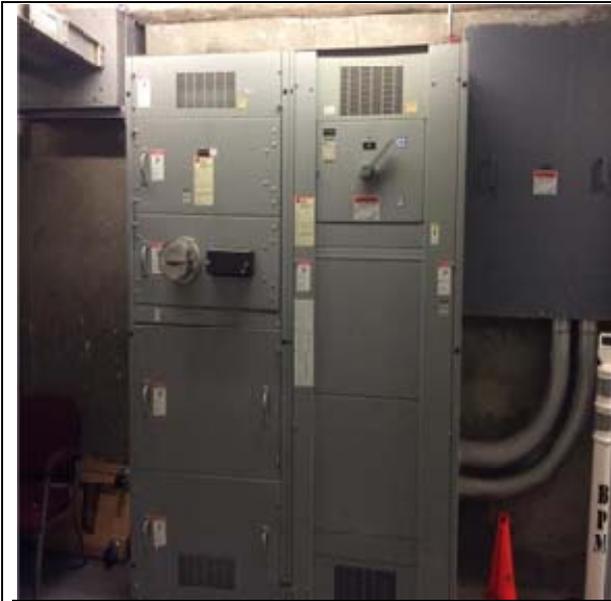
D5010 Switchgear, Mainframe, 800 Amps

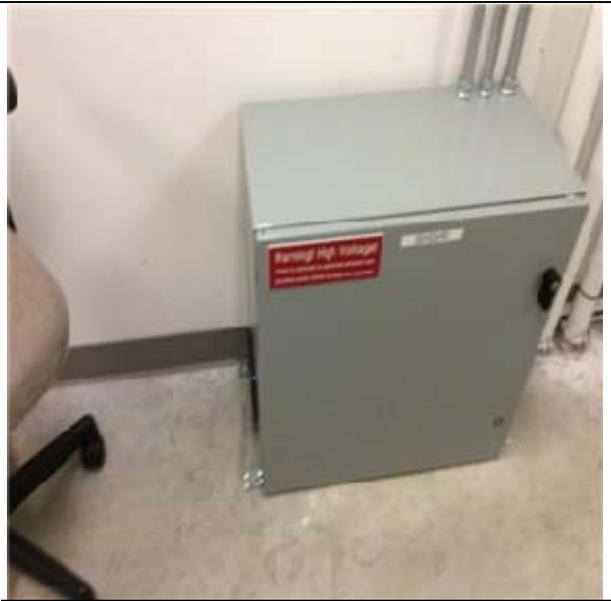
D5012 Secondary Dry Transformer 35 kVA

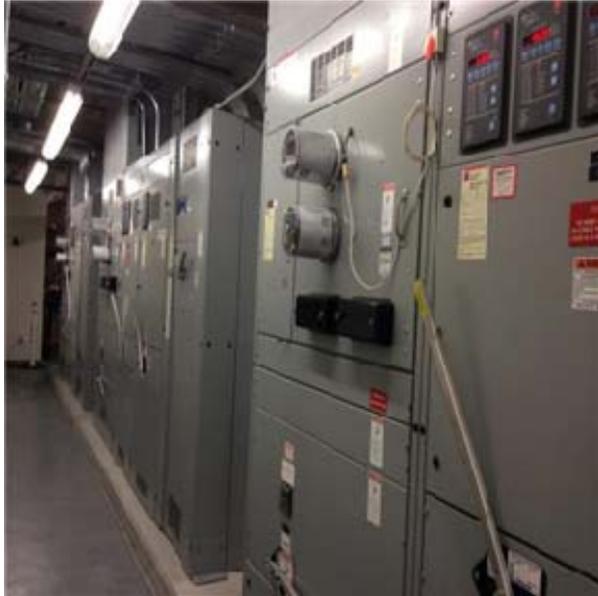
D5010 Switchgear, Mainframe, 4000 Amps

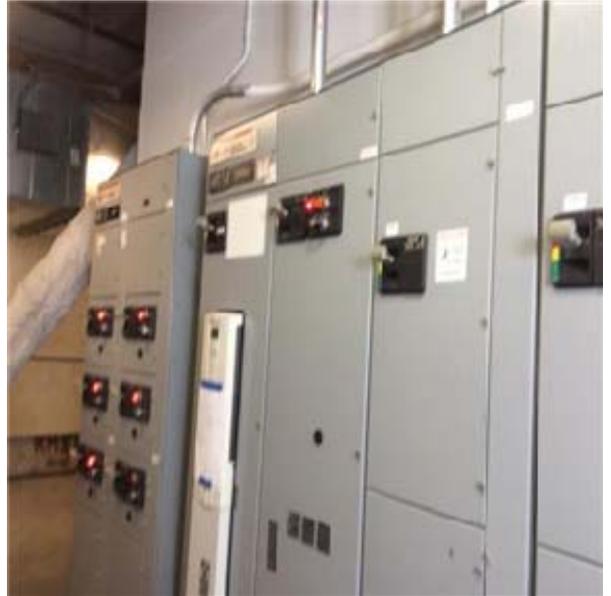
D5010 Switchgear, Mainframe, 1200 Amps

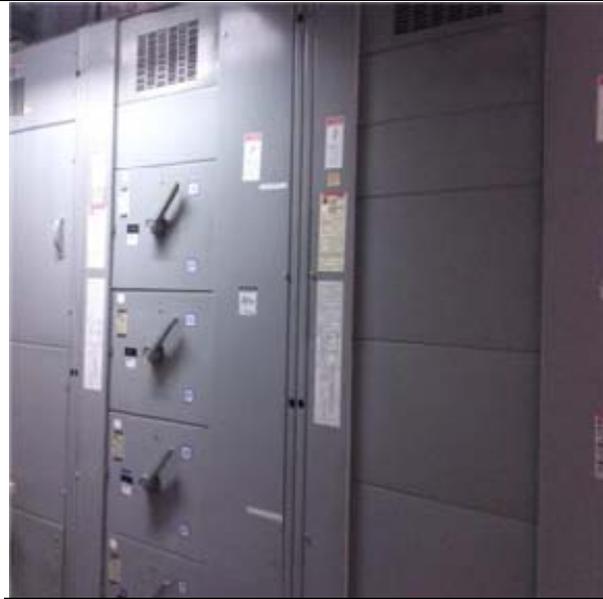
D5010 Switchgear, Mainframe, 2500 Amps

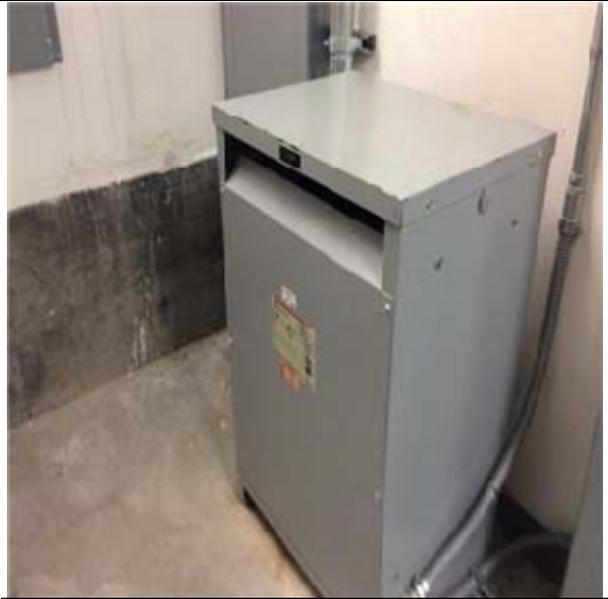
D5012 Secondary Dry Transformer 400 kVA

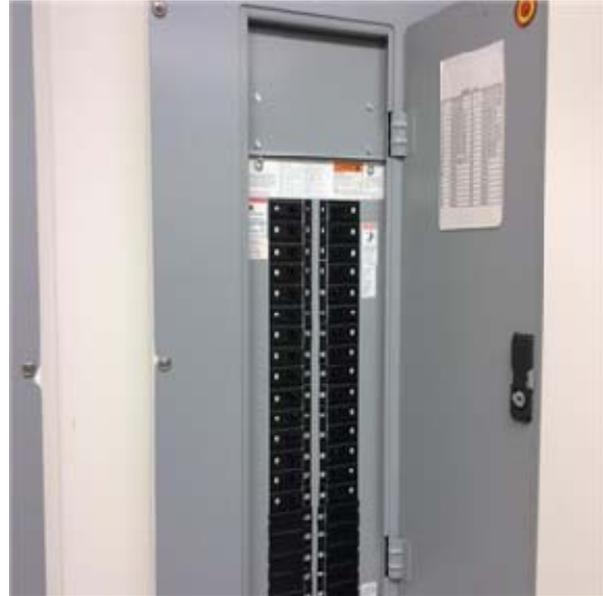
D5012 Breaker Panel 225 Amps, 30 Circuits

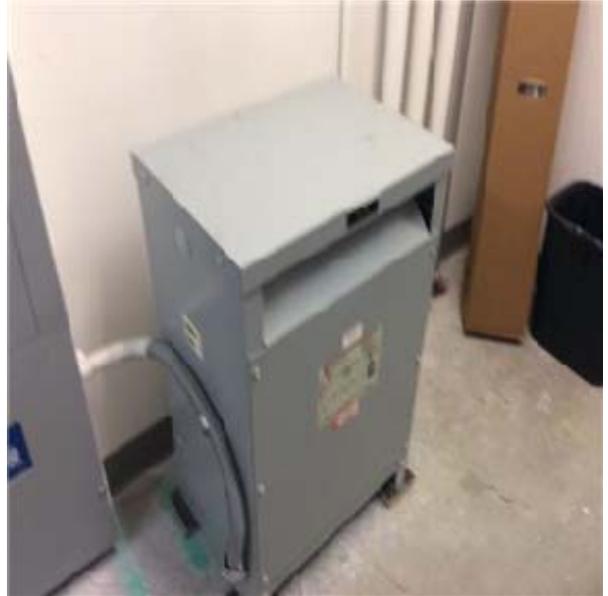
D5012 Secondary Dry Transformer 45 kVA

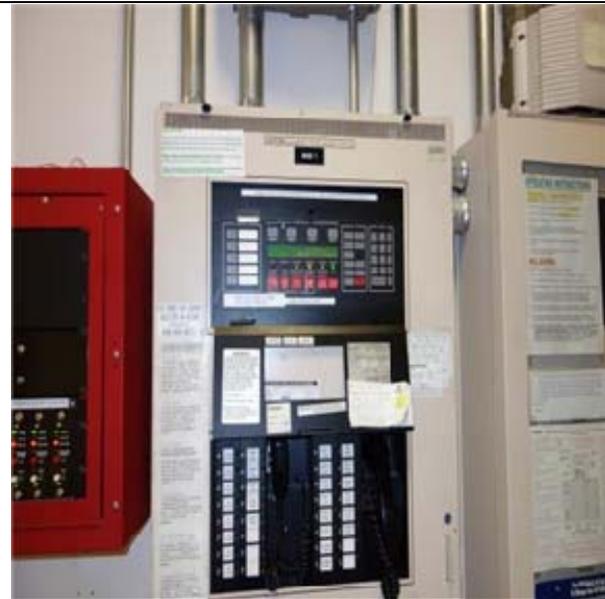
D5037 Fire Alarm Panel

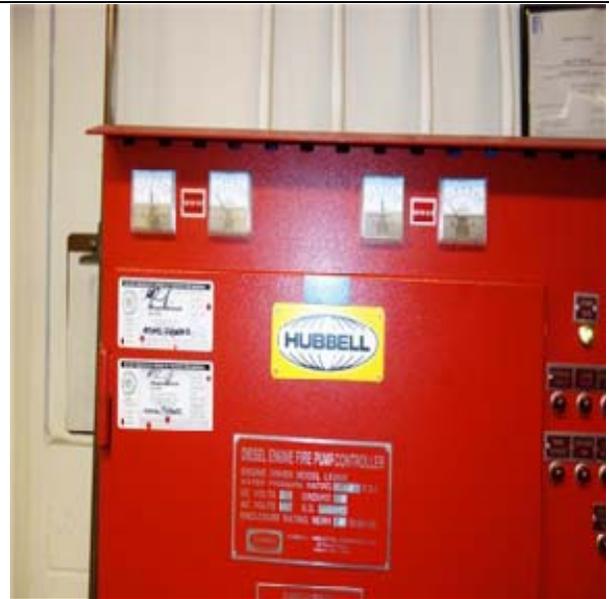
D5037 Fire Alarm System

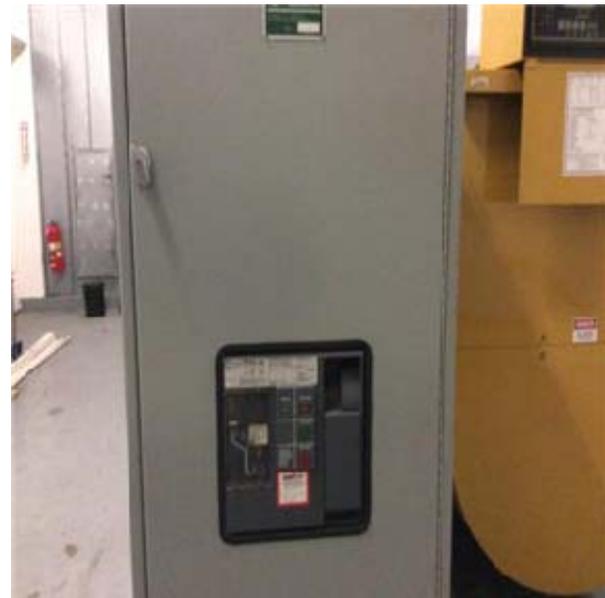
D5092 Emergency Transfer Switch - 2500 KW

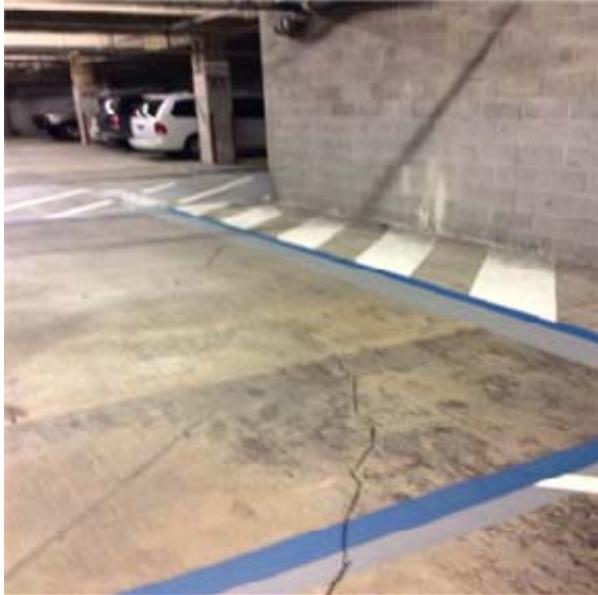
G2020 Restripe Parking Lot

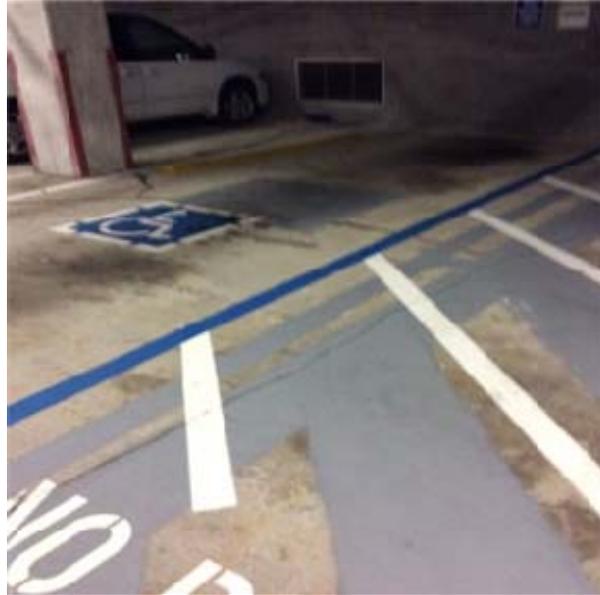
G2020 Restripe Parking Lot

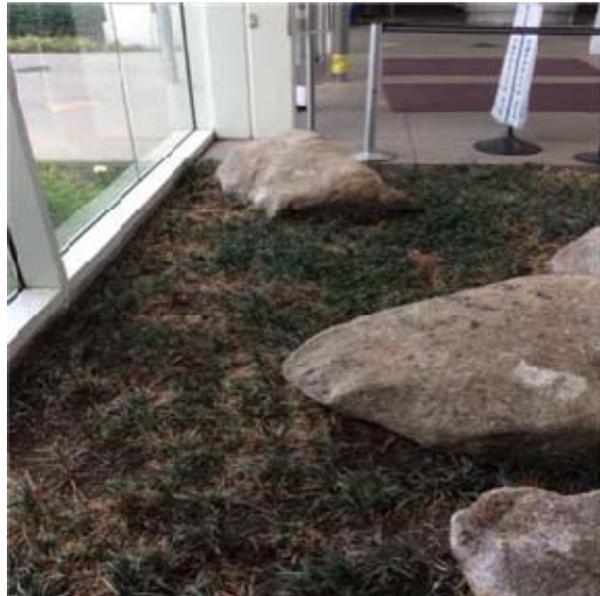
G2056 Interior Lobby Area Planters

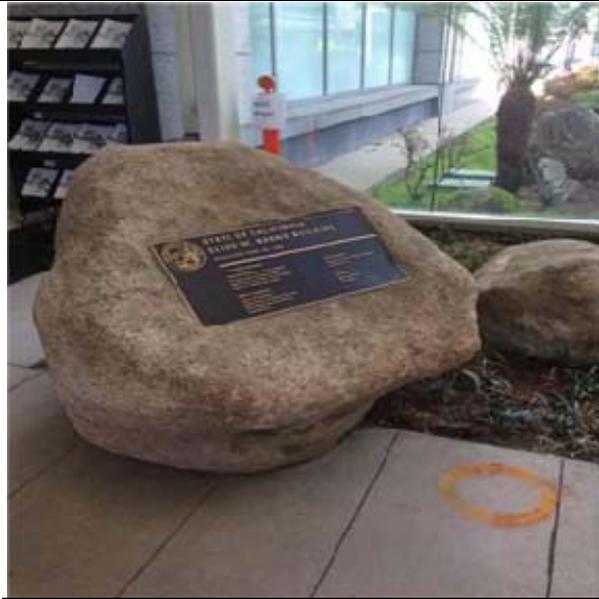
G2056 Interior Lobby Area Planters

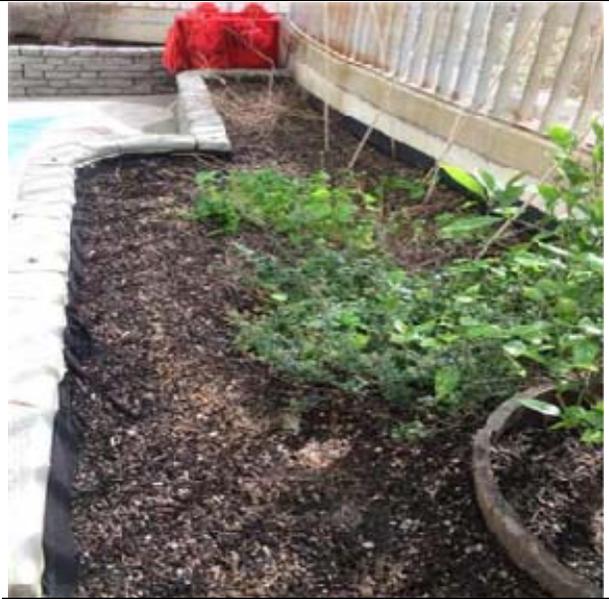
G2056 Exterior Planters
