Governor Edmund G. "Pat" Brown Building (418)

505 Van Ness Avenue, San Francisco, CA 94102

Facility Condition Assessment

September 2015

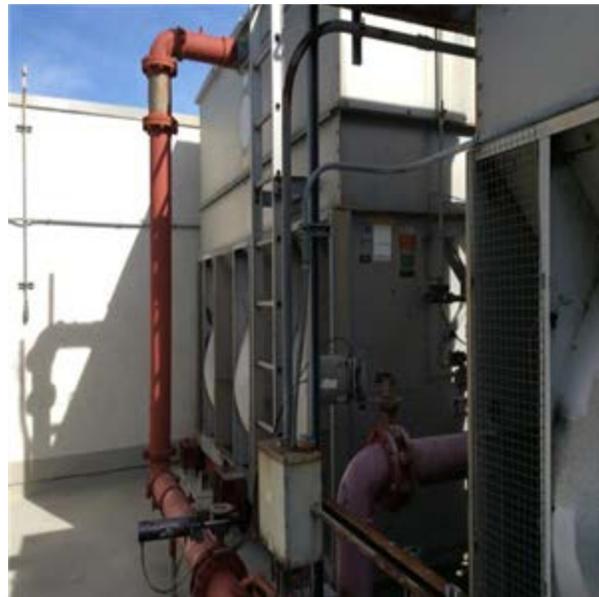
D3031 Cooling Tower, Galvanized Steel, 220 Ton

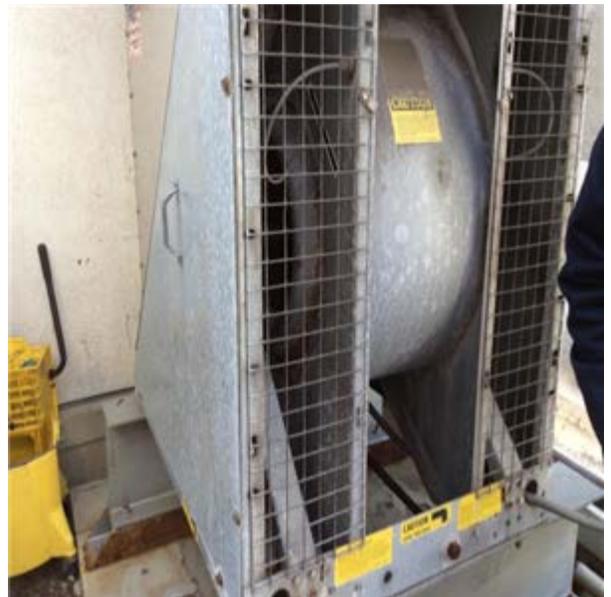
D3031 Cooling Tower, Galvanized Steel, 30Ton

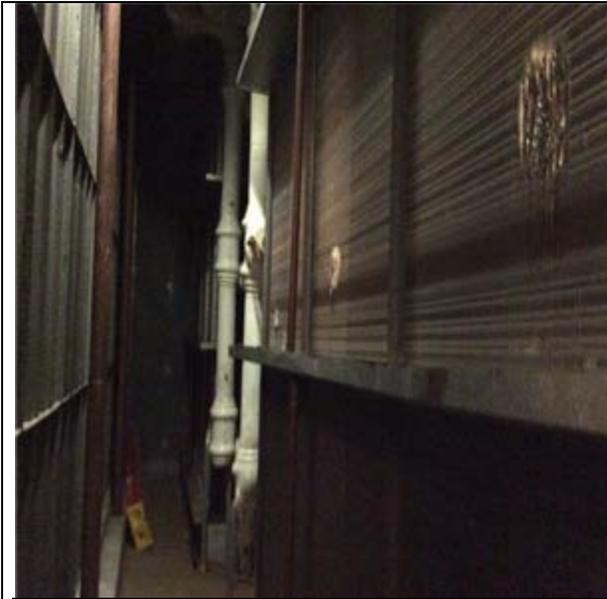
D3032 Condenser Coils 100 Ton

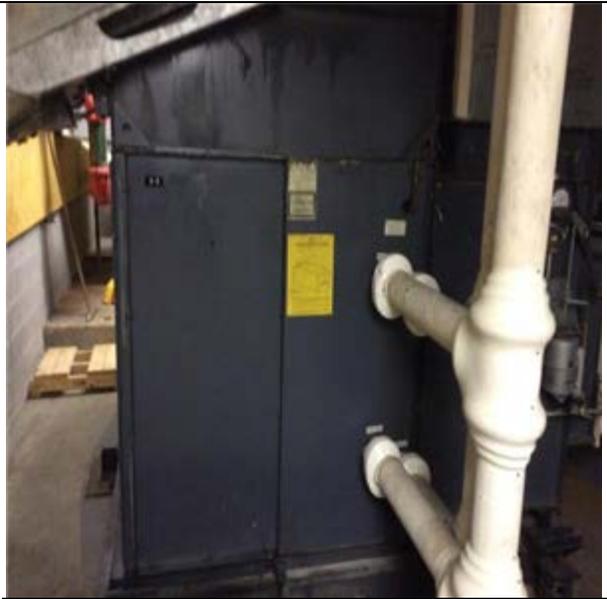
D3032 Pad-Mounted Condenser 20-Ton

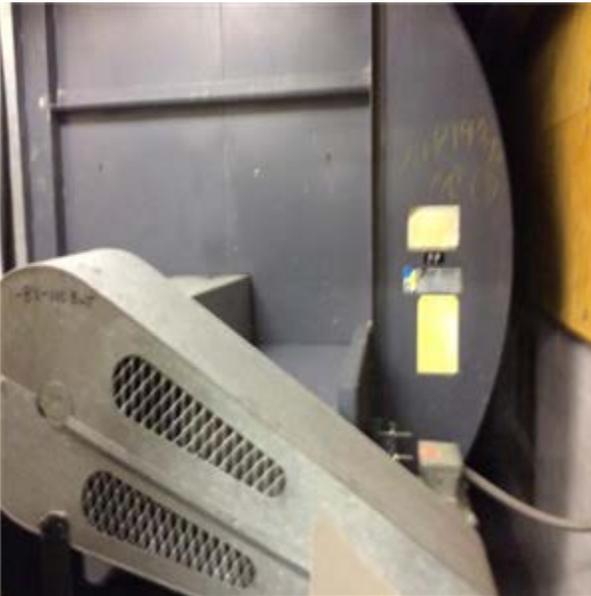
D3041 Return Air - 34,000 CFM - 15 Hp

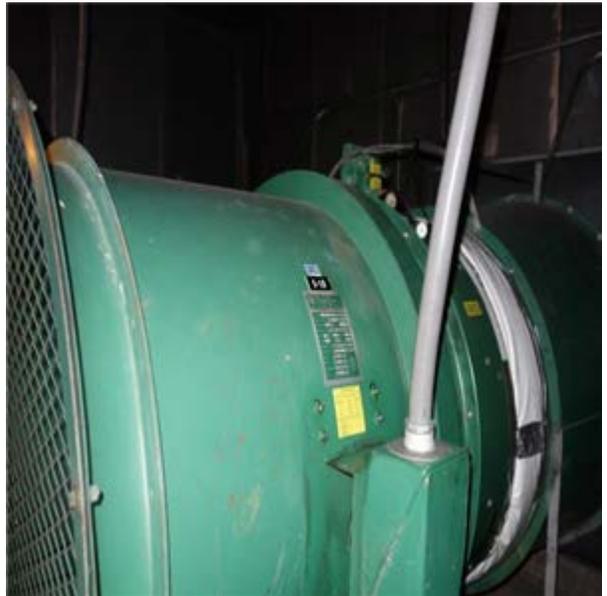
D3041 Supply Air Fans - 1A,B,C - 54,000 CFM - 75 HP Motors

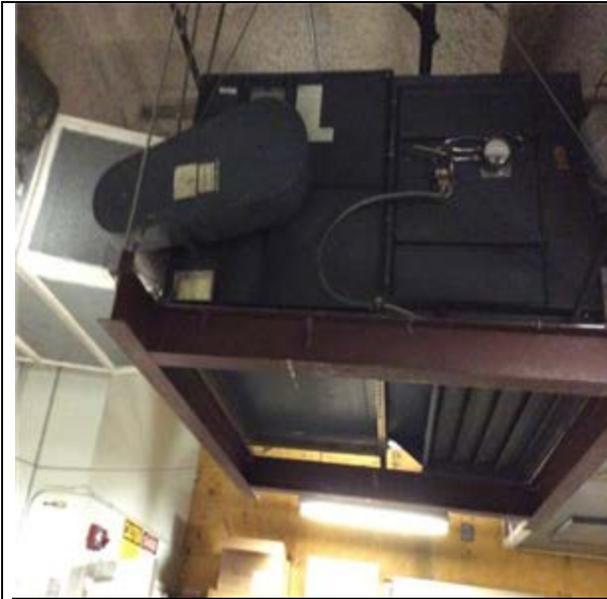
D3042 Exhaust Fan 20,000 CFM

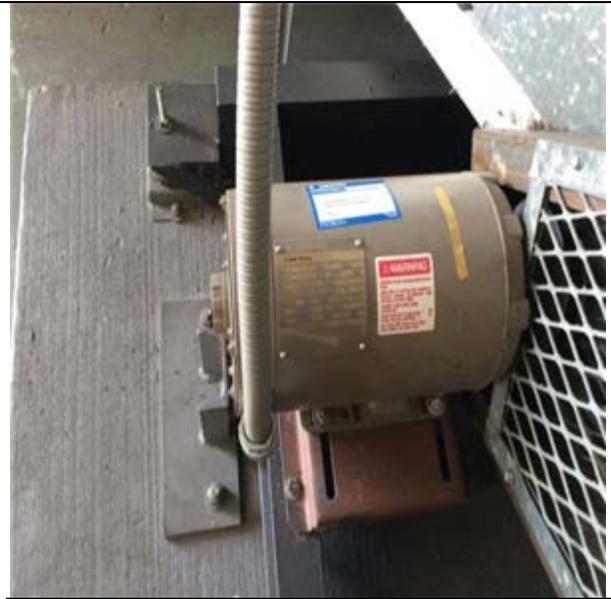
D3042 Exhaust Fan < 15,000 CFM

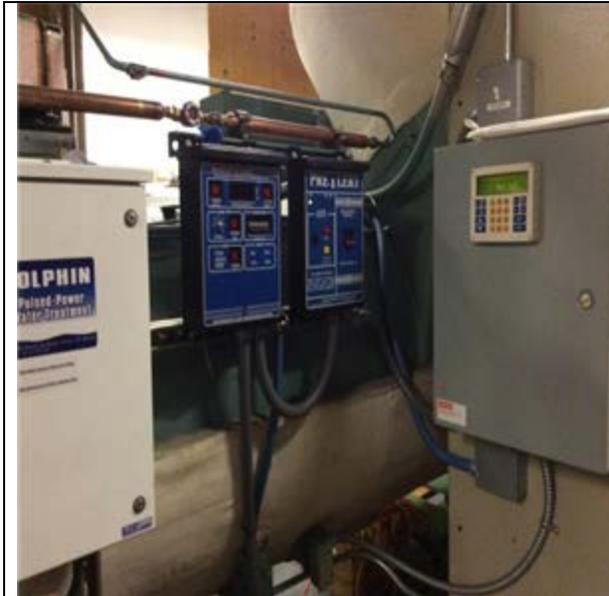
D3068 DDC Controls

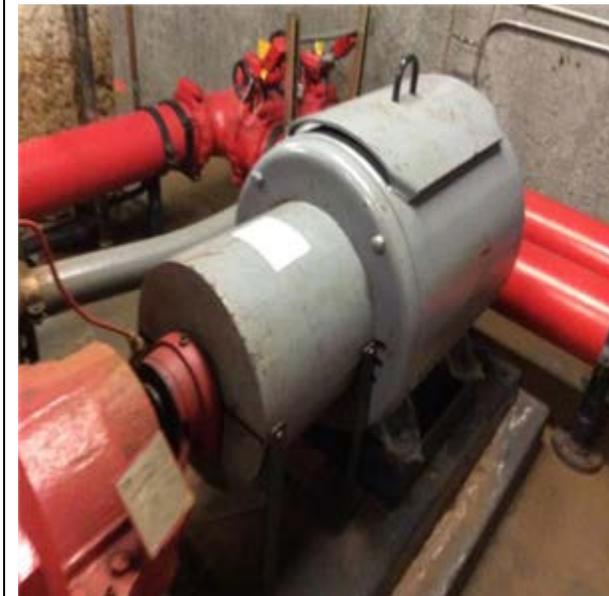
D4012 Fire Pump Electrical 150 HP

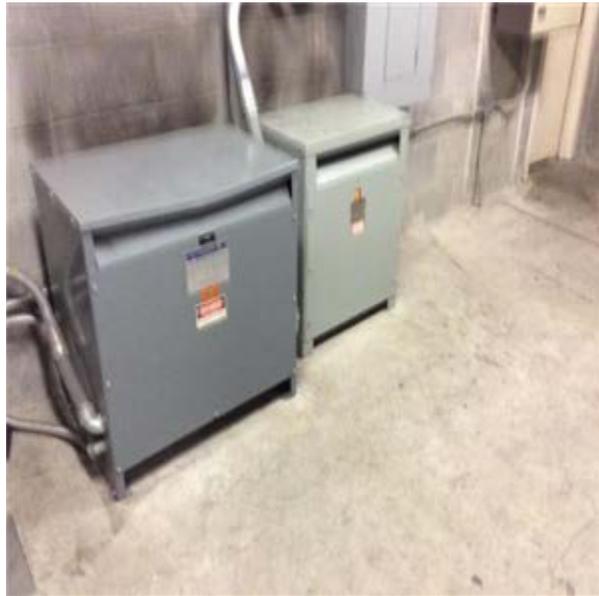
D5012 Secondary Dry Transformer 75 kVA

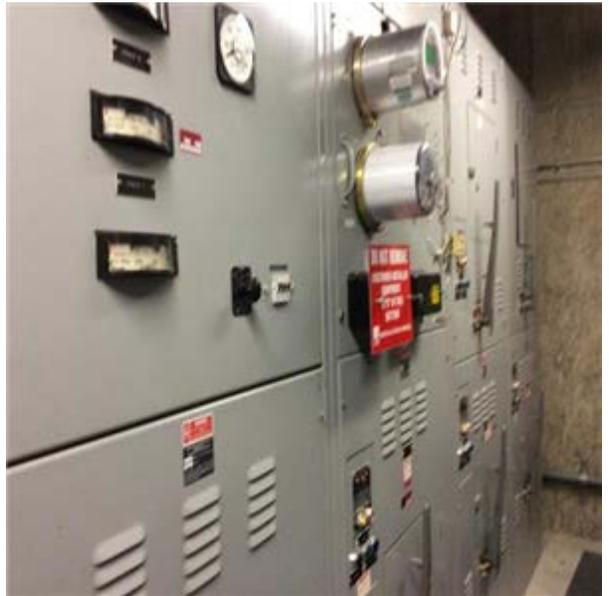
D5010 Switchgear, Mainframe, 800 Amps

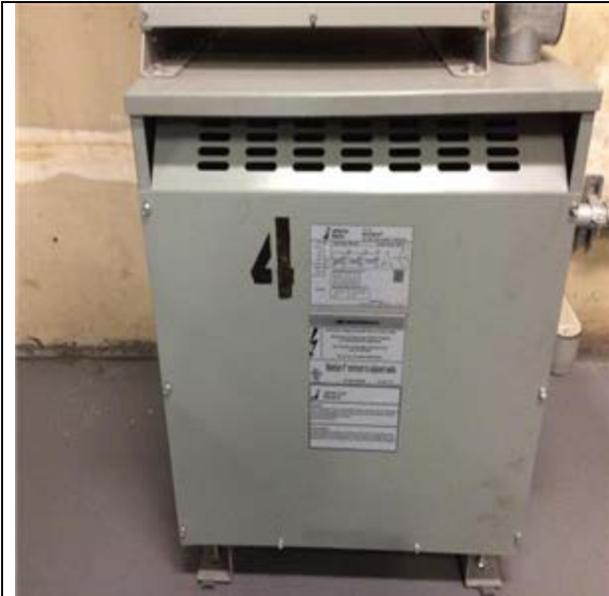
D5012 Secondary Dry Transformer 45 kVA

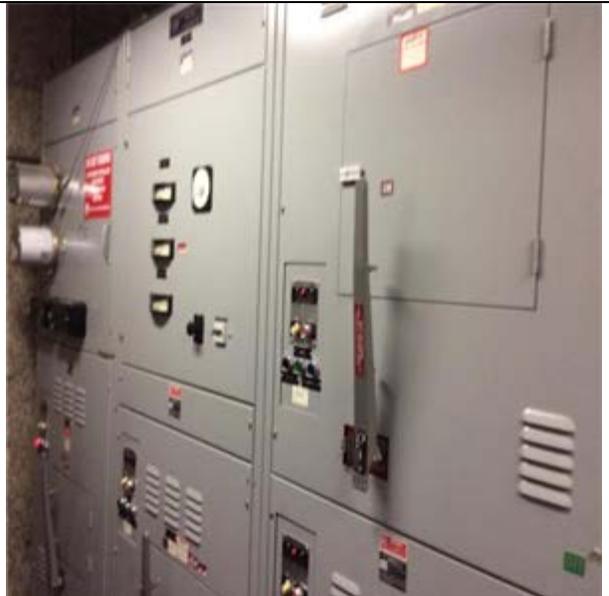
D5010 Switchgear, Mainframe, 2500 Amps

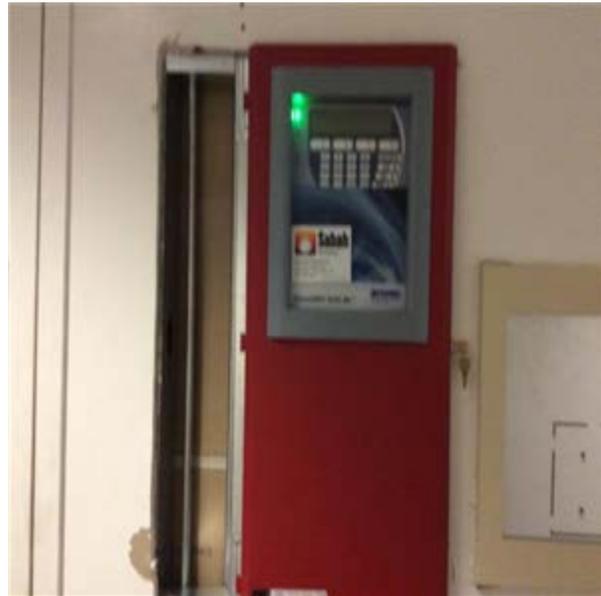
D5037 Fire Alarm Panel

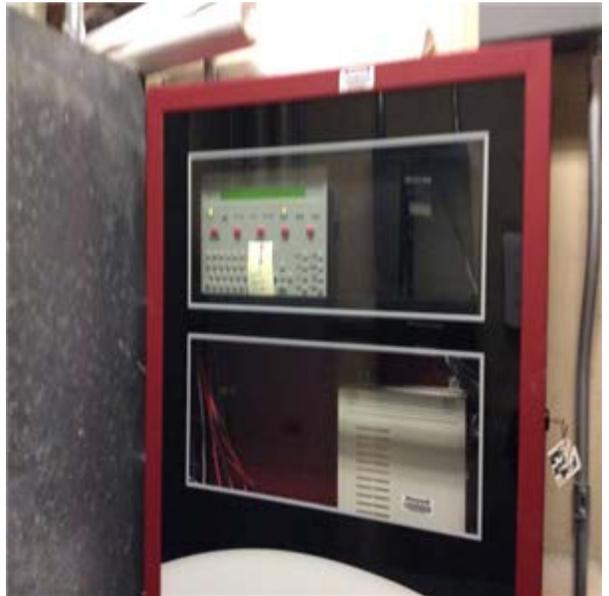
D5037 Fire Alarm Panel

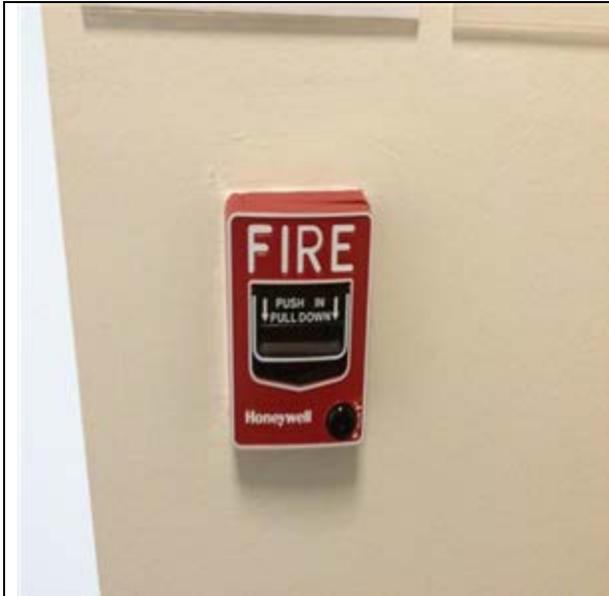
D5037 Fire Alarm System

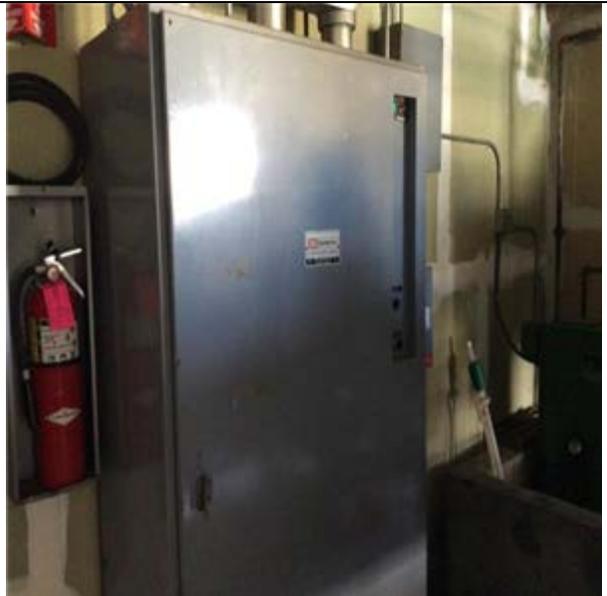
D5092 Emergency Transfer Switch - 750 KW

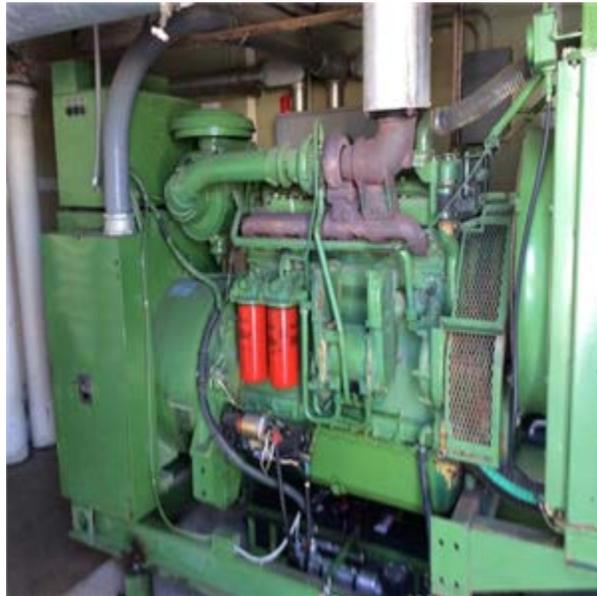
D5092 Emergency Generator 750 kW

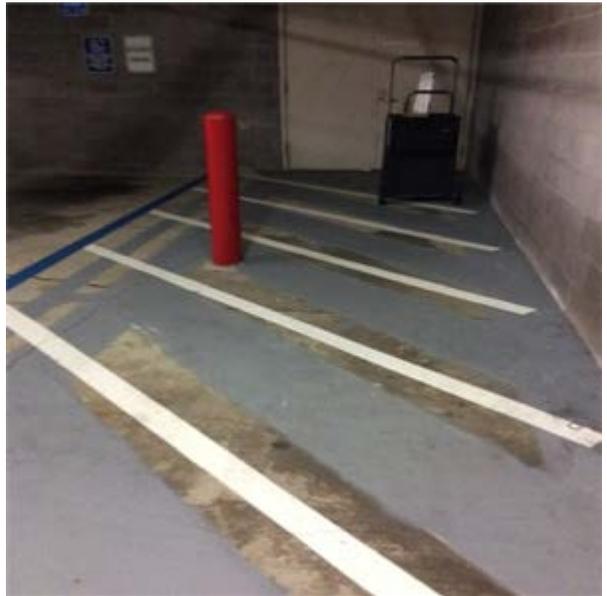
G2020 Parking Lots
