Alfred E. Alquist Building (470)

100 Paseo de San Antonio, San Jose, CA 95113

Facility Condition Assessment

September 2015

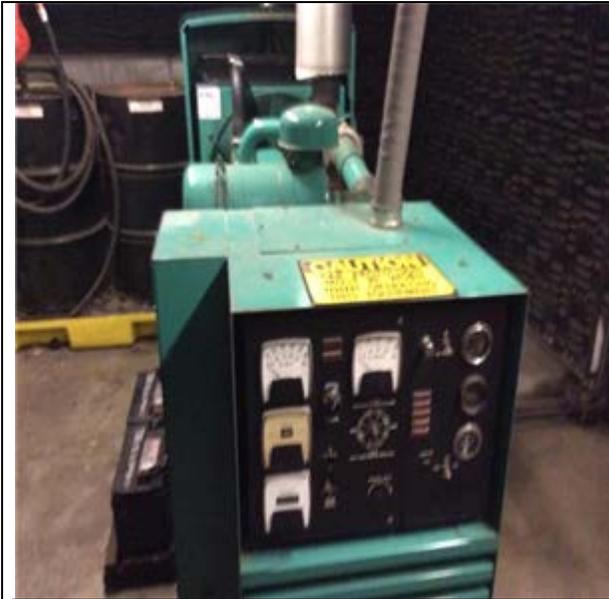
D5092 Emergency Transfer Switch

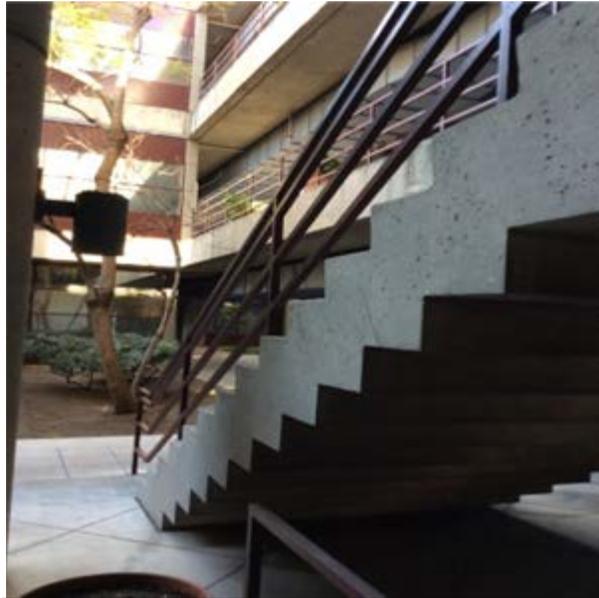
G2031 Concrete Walk, Small Areas

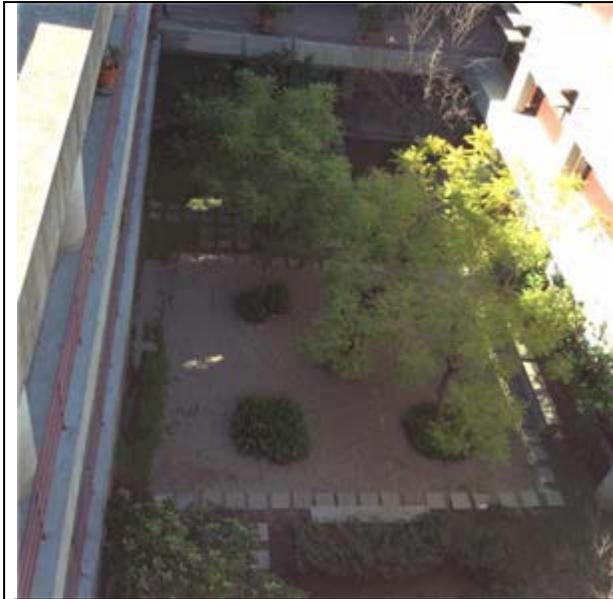
G2053 Landscaping Allowance, Large Area

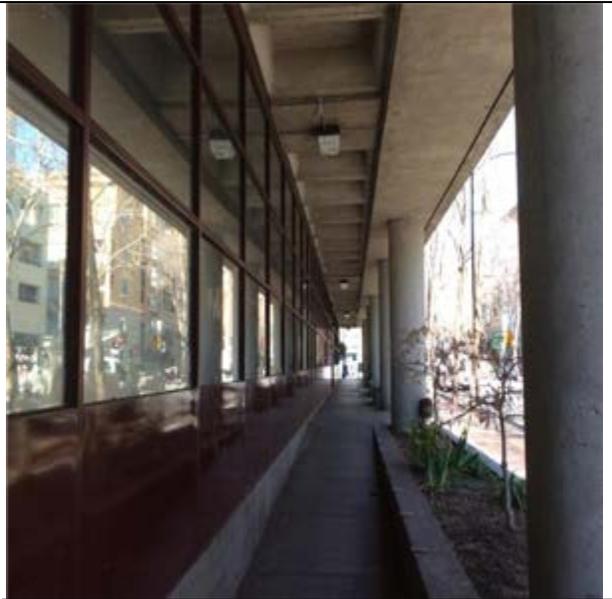
G2053 Landscaping Allowance, Large Area
