Van Nuys State Building (530)

6150 Van Nuys Boulevard, Van Nuys, CA 91401

Facility Condition Assessment

September 2015

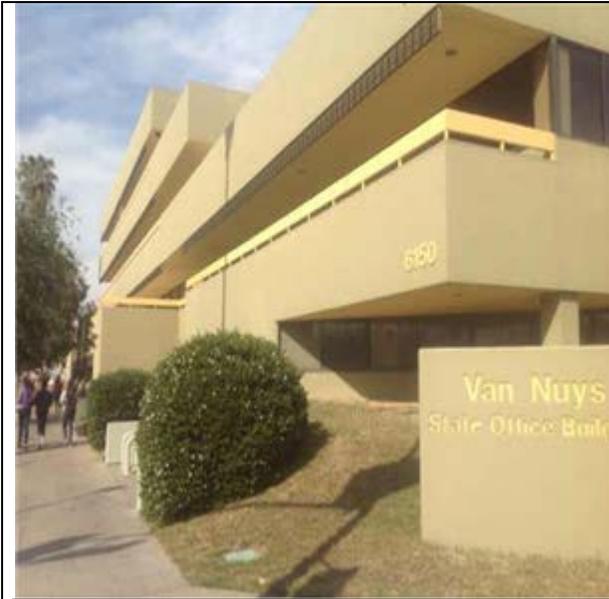
:- Typical elevation

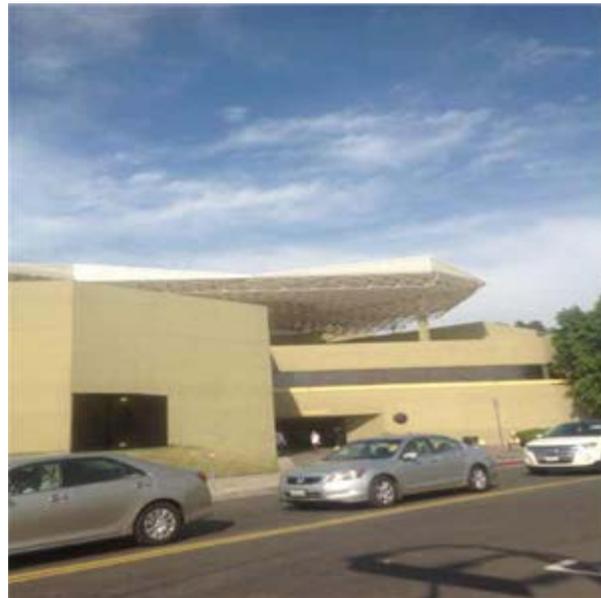
:- Typical elevation

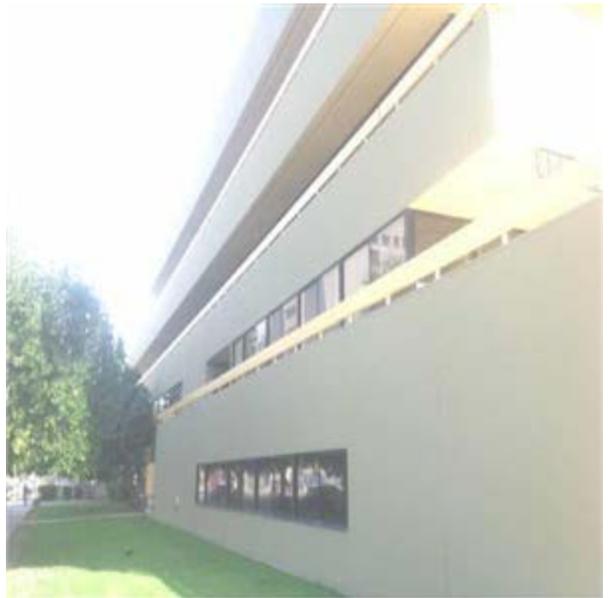
:- Typical elevation

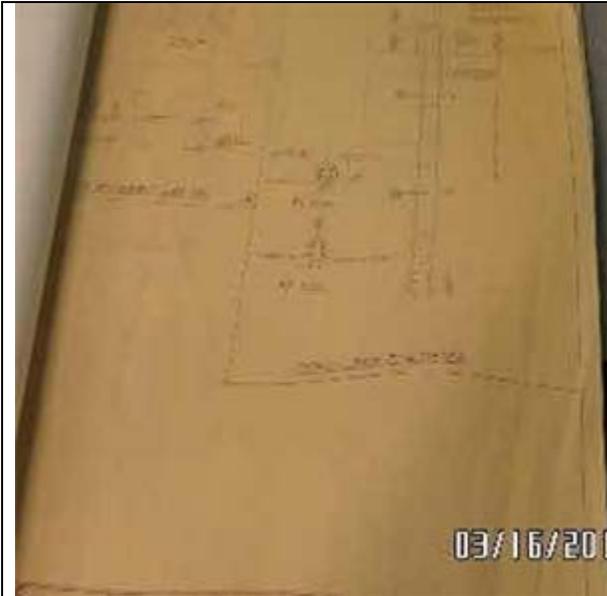
A1012 Structural concrete,in place, pile cap over 10 CY

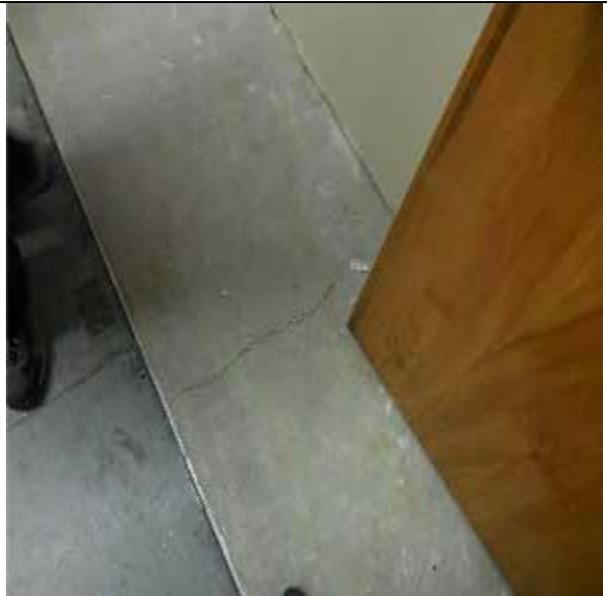
A1012 Structural concrete,in place, pile cap over 10 CY

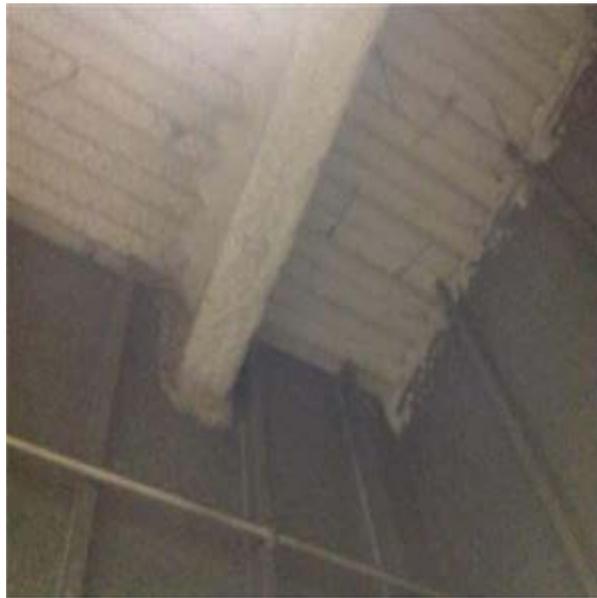
B1031 Structural Steel Columns and Beams Frame

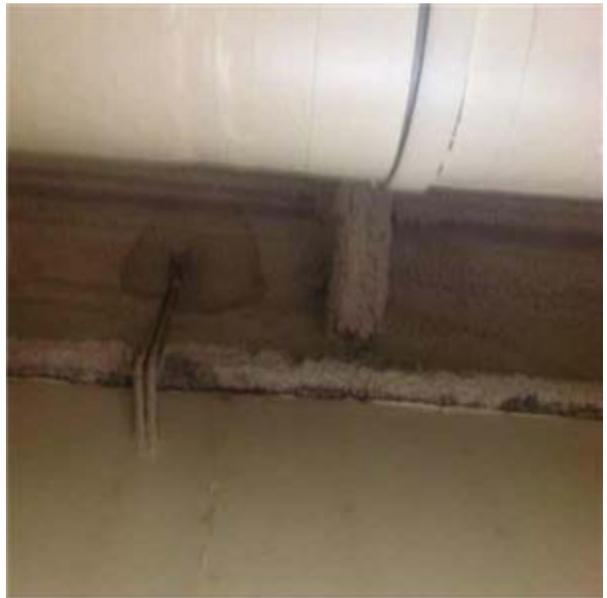
B1031 Structural Steel Columns and Beams Frame

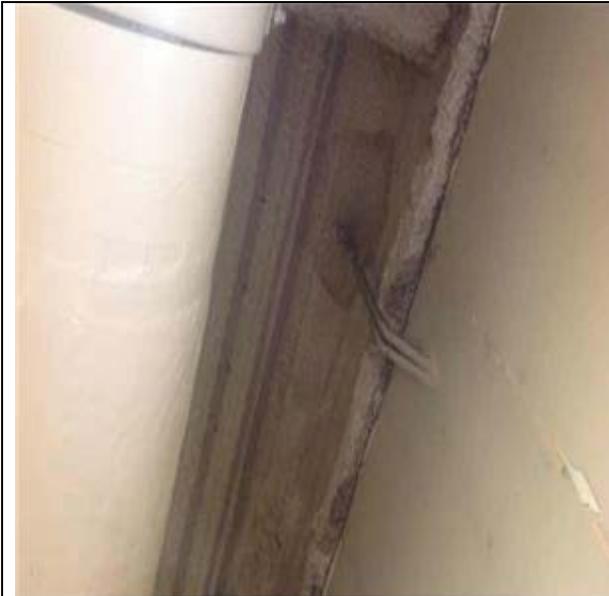
B1031 Structural Steel Columns and Beams Frame

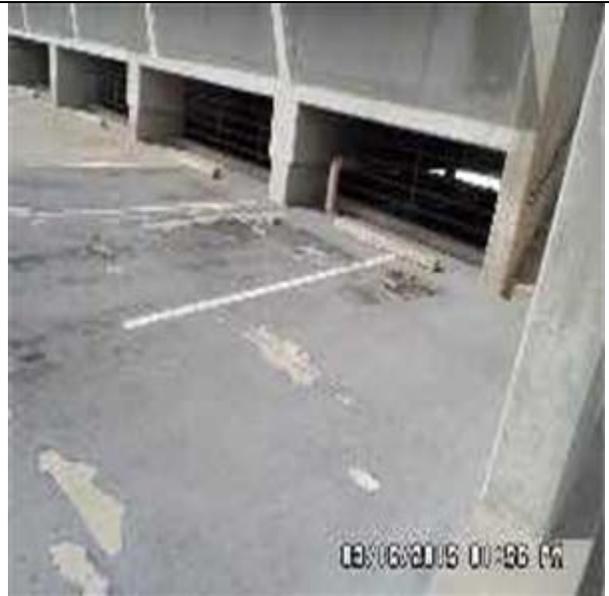
B2031 Cast-in-Place Reinforced Concrete Structural Frame

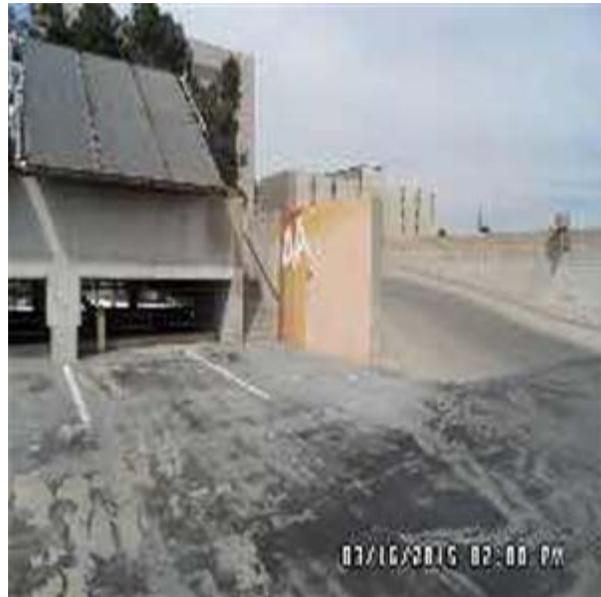
B2031 Cast-in-Place Reinforced Concrete Structural Frame

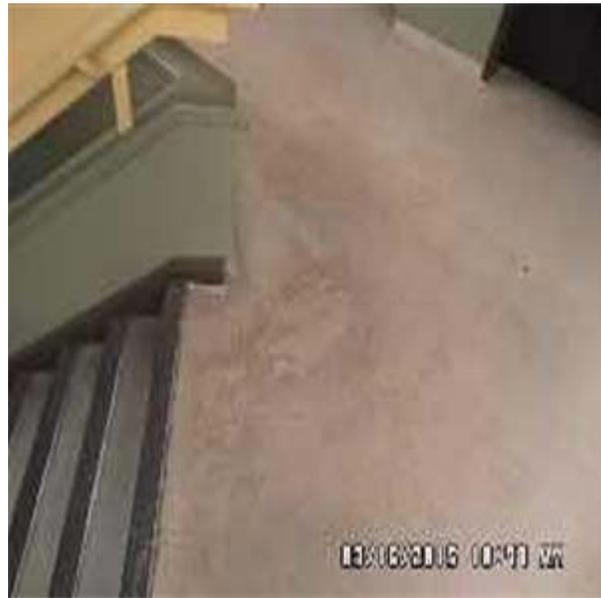
B3011 Balcony - White Liquid-Applied Elastomeric Coating

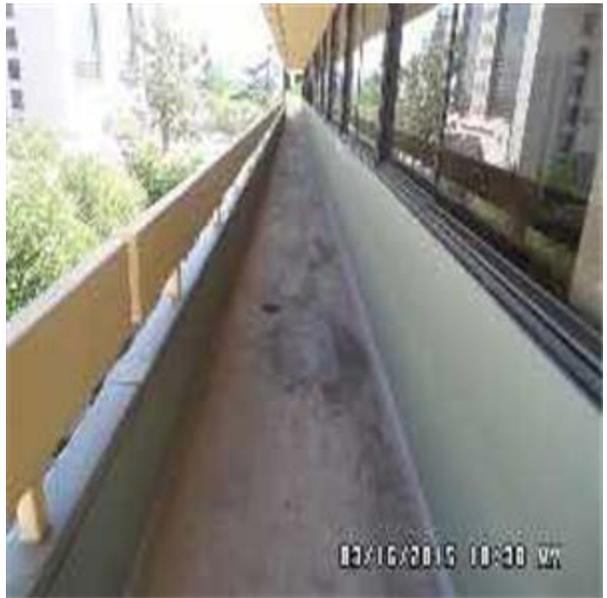
B3011 Balcony - White Liquid-Applied Elastomeric Coating

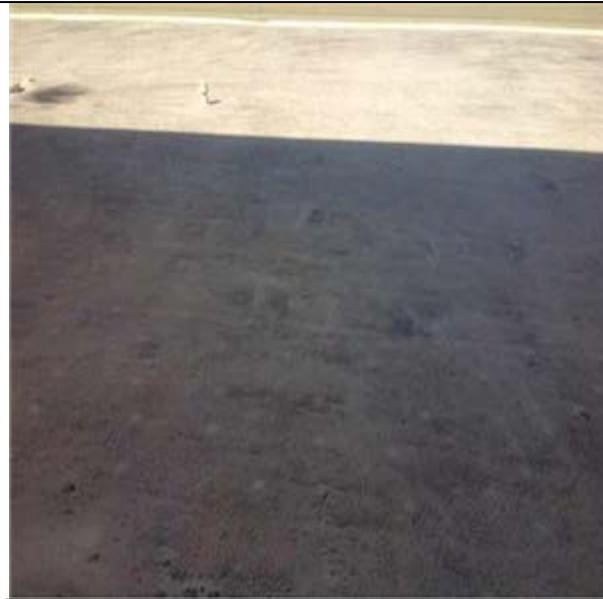
B3011 Built-Up Roofing

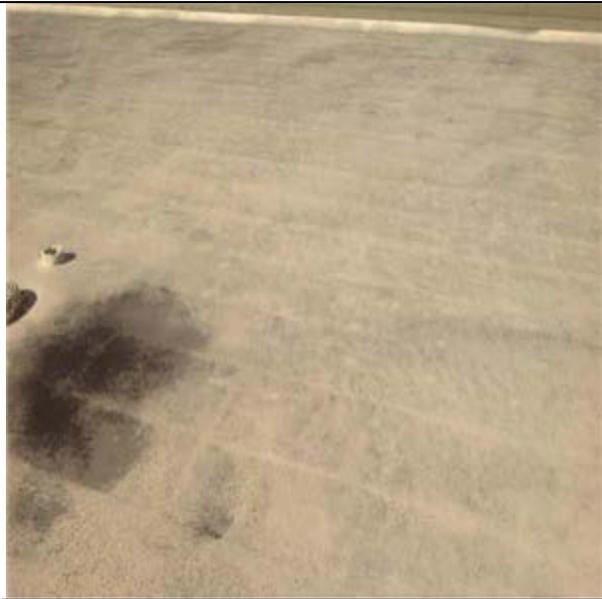
B3011 Built-Up Roofing

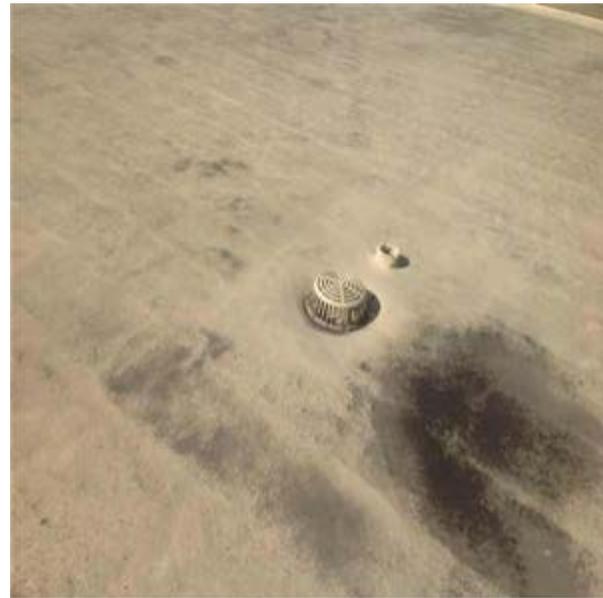
B3011 Built-Up Roofing

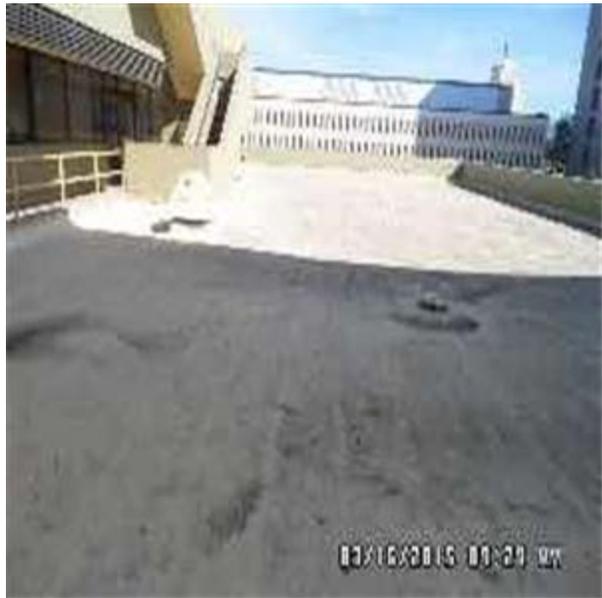
B3011 Built-Up Roofing

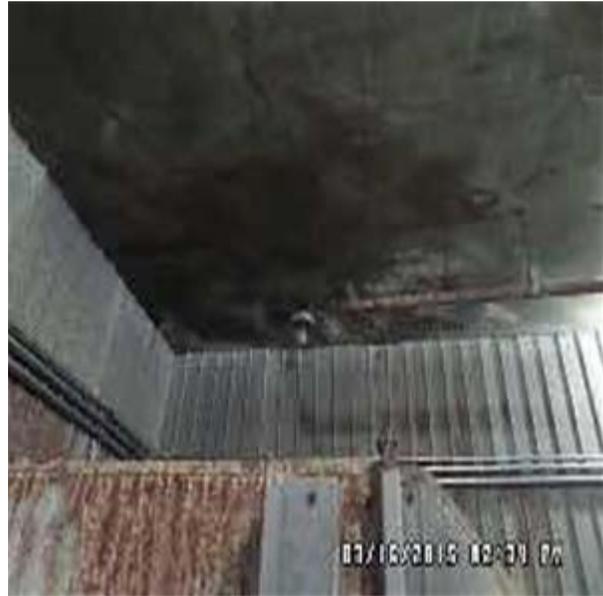
B3011 White Liquid-Applied Coating

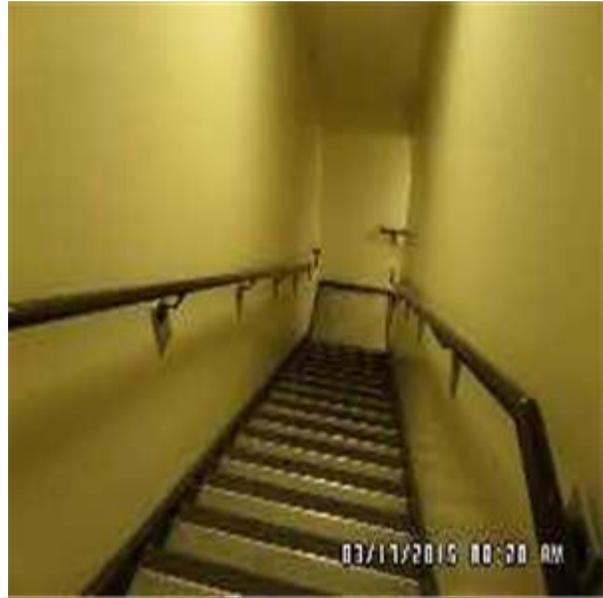
C2011 Concrete filled metal pan stairs Stairs

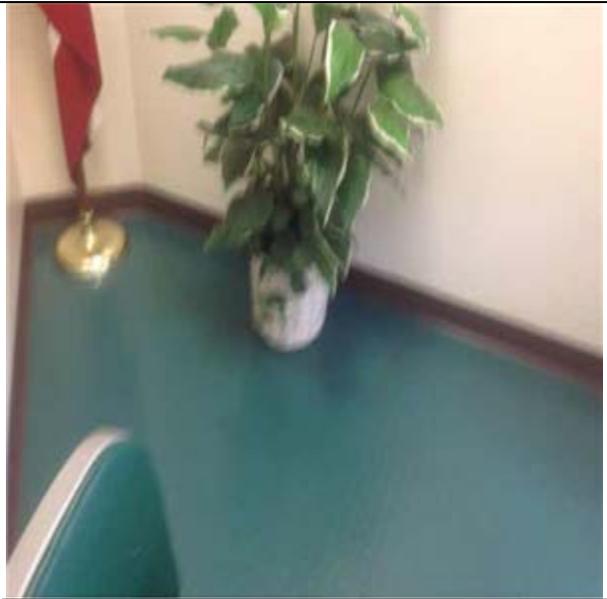
C3024 Vinyl Tile

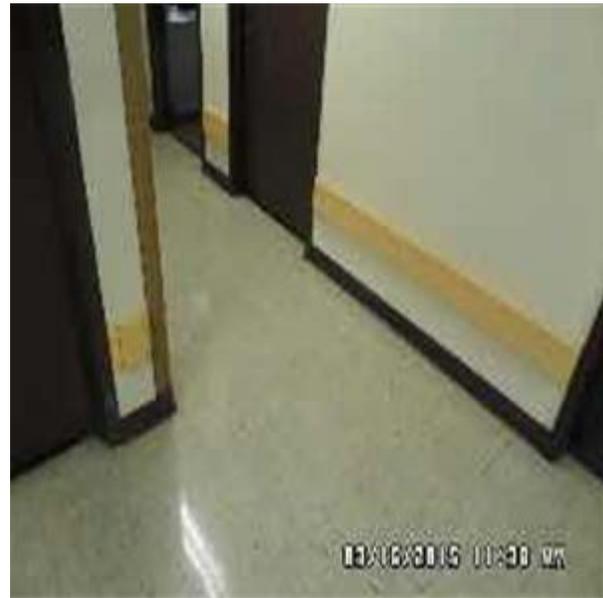
C3024 Vinyl Tile

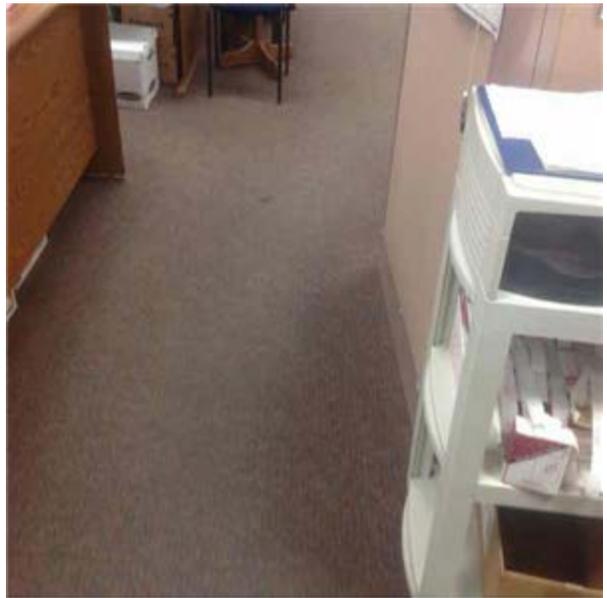
C3025 Carpet Tiles - Standard

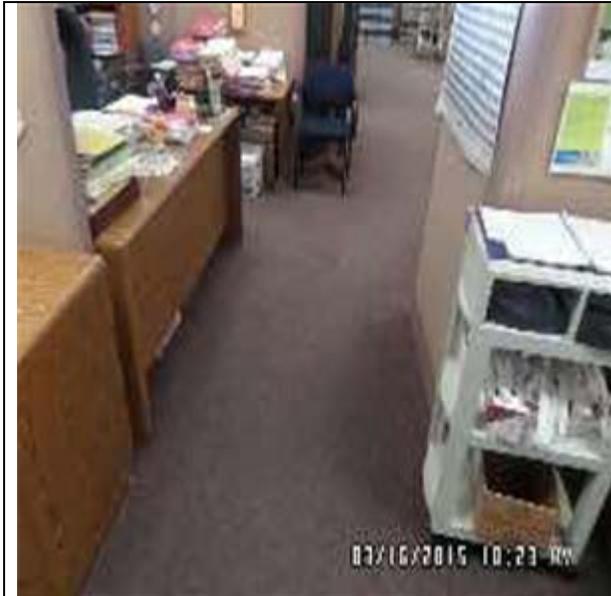
C3025 Carpet Tiles - Standard

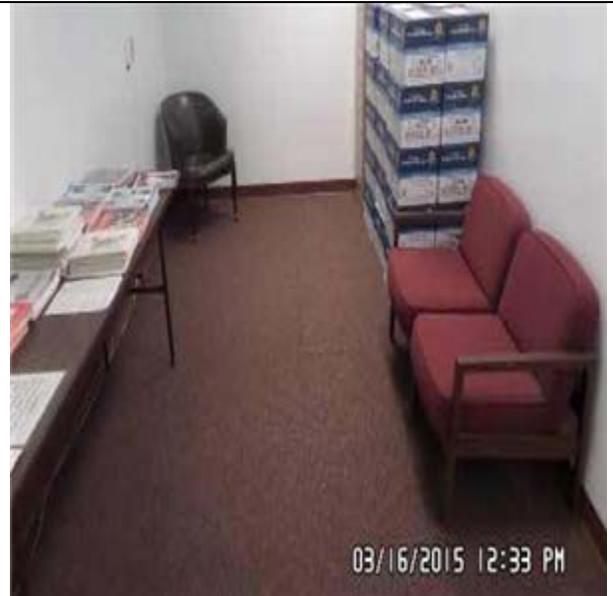
C3025 Carpet Tiles - Standard

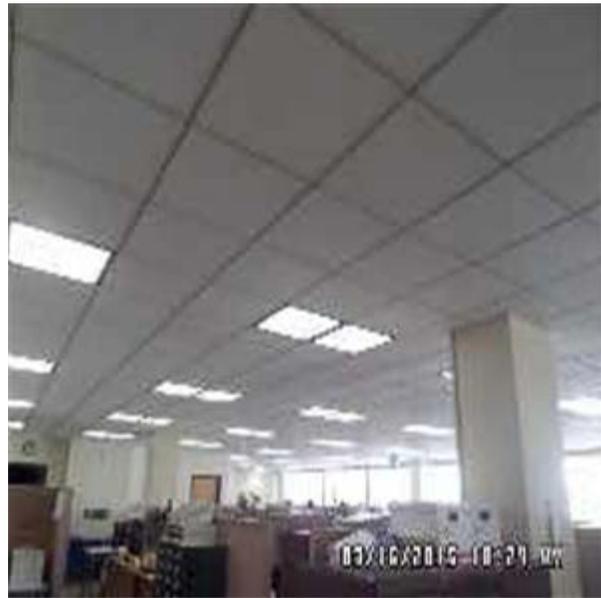
C3032 Acoustical Ceiling Tile

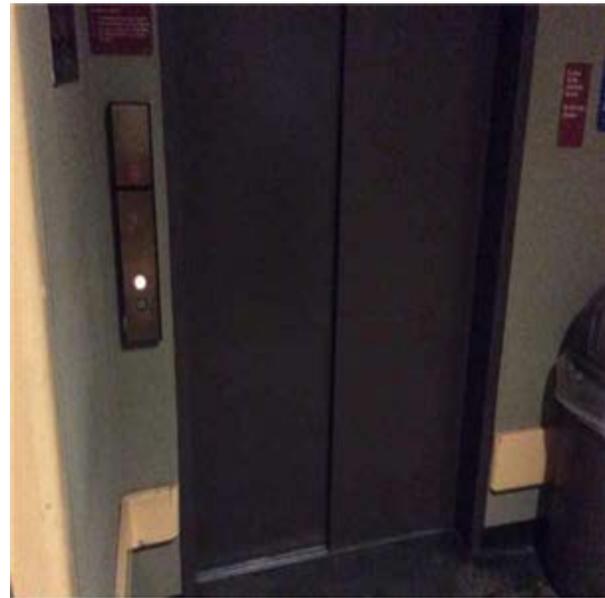
D1011 Hydraulic Service Elevator 4000 lbs

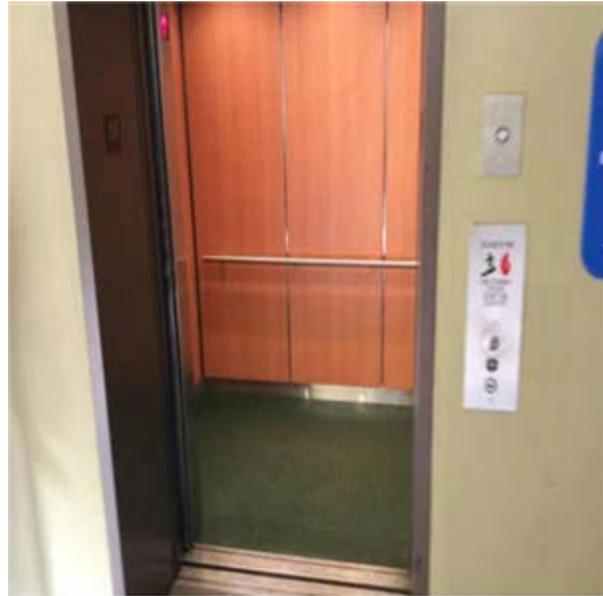
D1011 Hydraulic Passenger Elevator 2500 lbs

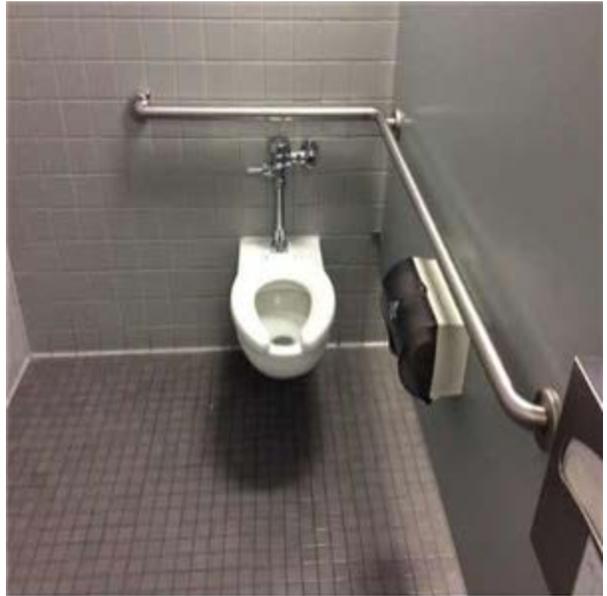
D2011 Water Closet, 1.6 GPF Unit

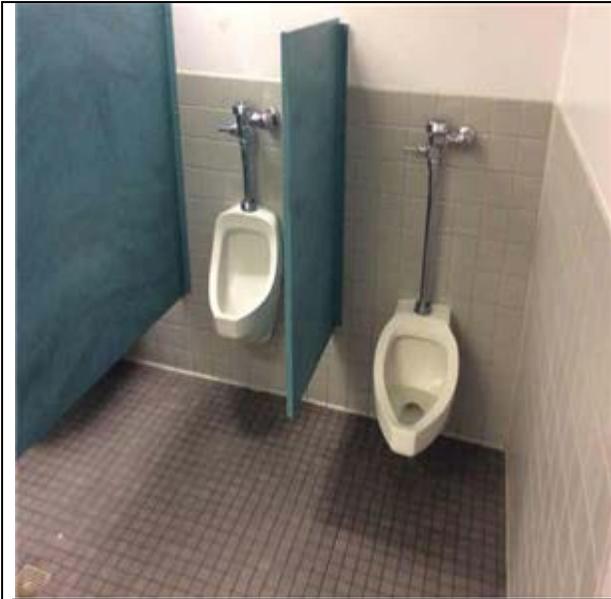
D2012 Urinals

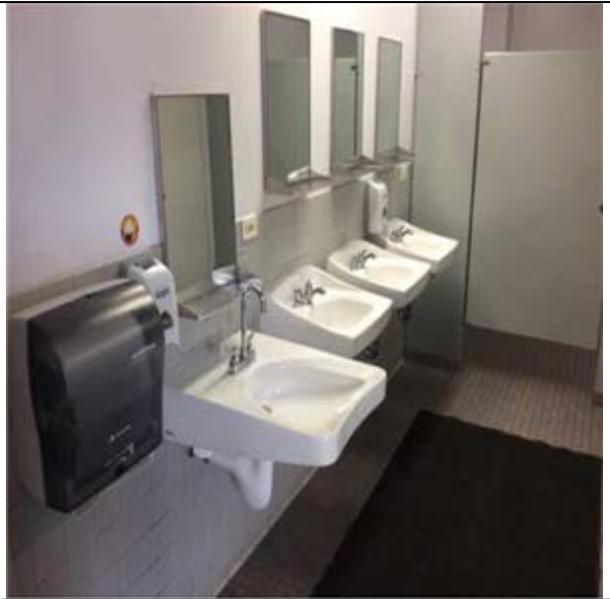
D2013 Lavatory sink

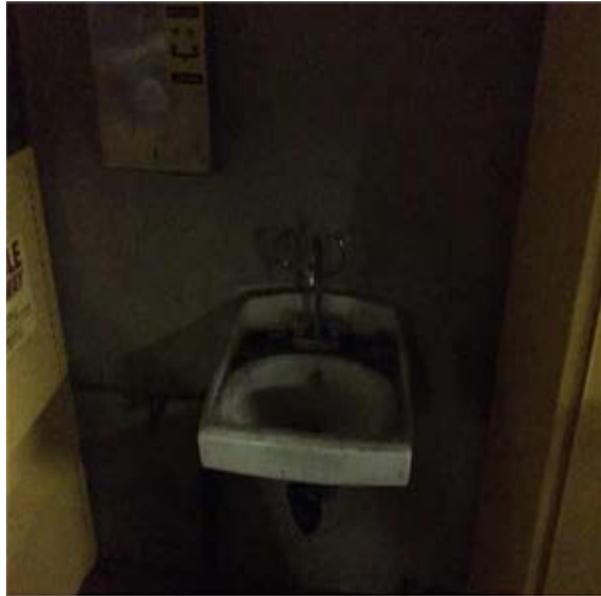
D2014 Sink and Faucet

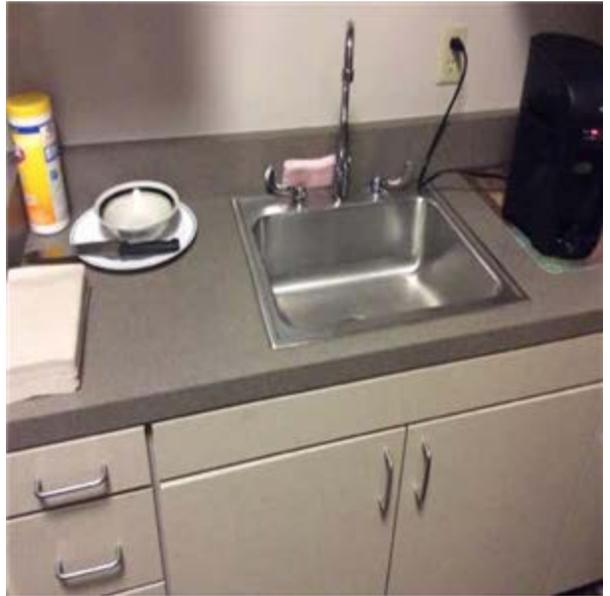
D2014 Sink and Faucet

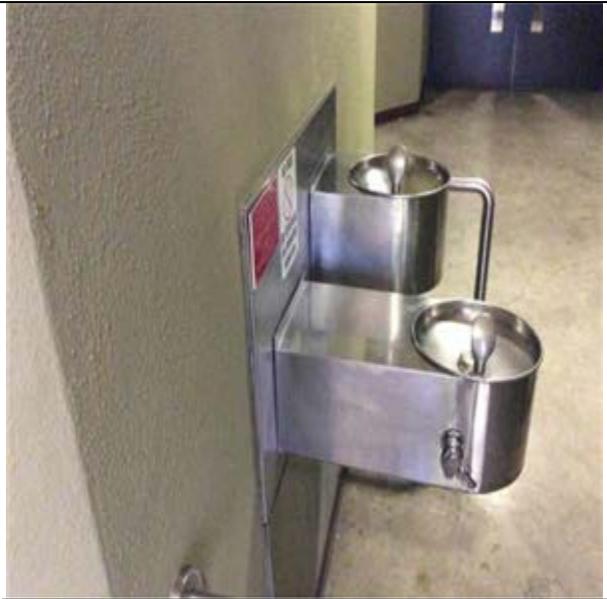
D2018 Drinking Fountain

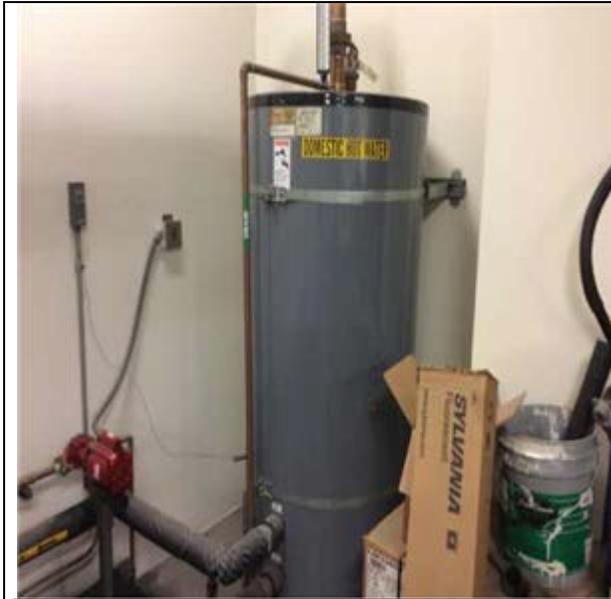
D2022 Electric water heater 50 Gal

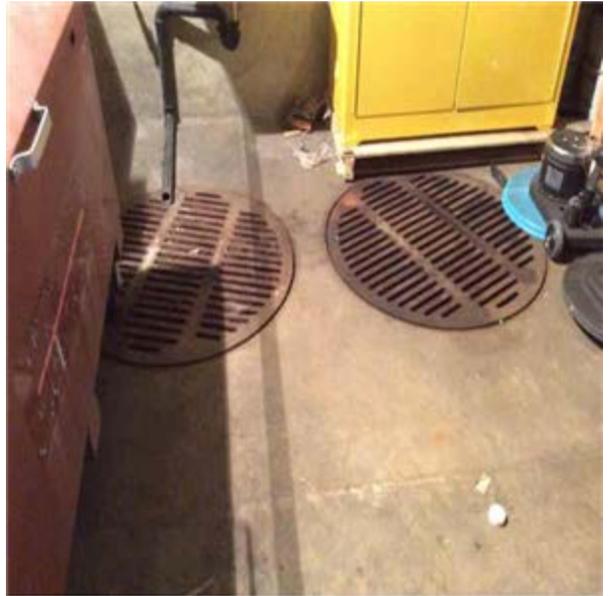
D2034 Sump Pump, Large, 7 HP

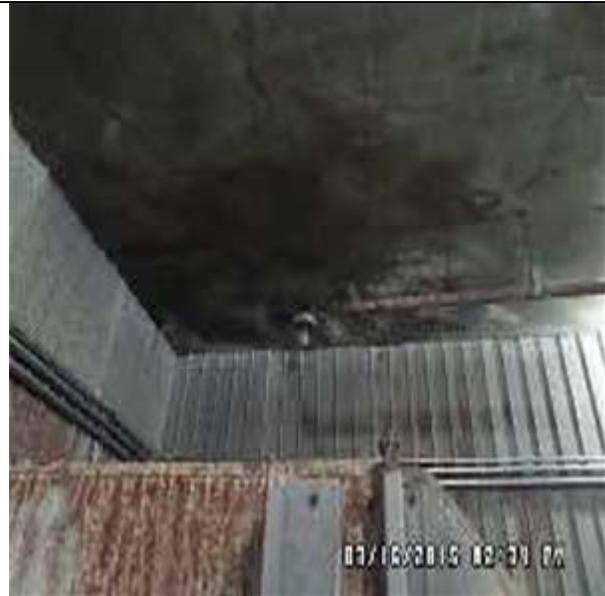
D2034 Sump Pump, Large, 7 HP

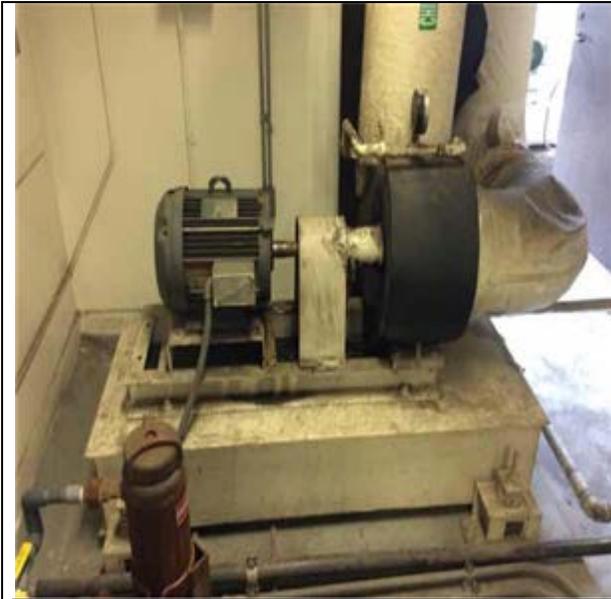
D3022.1 Heating Primary Water Circulation Pumps 3 HP

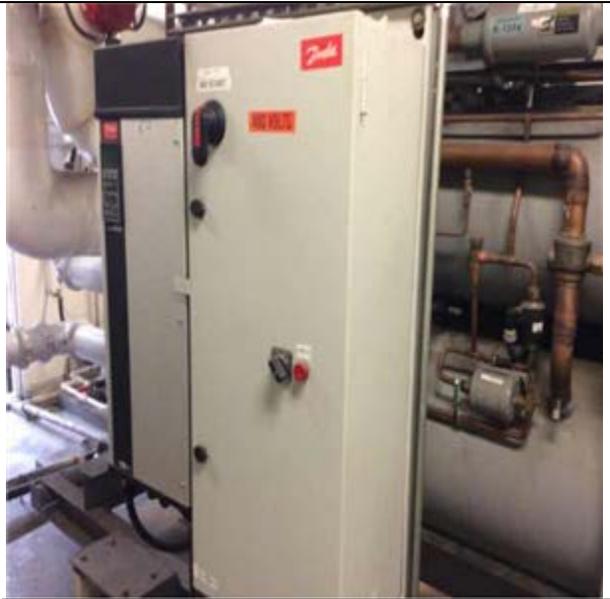
D3022.1 Chiller Distribution Pump 15 hp

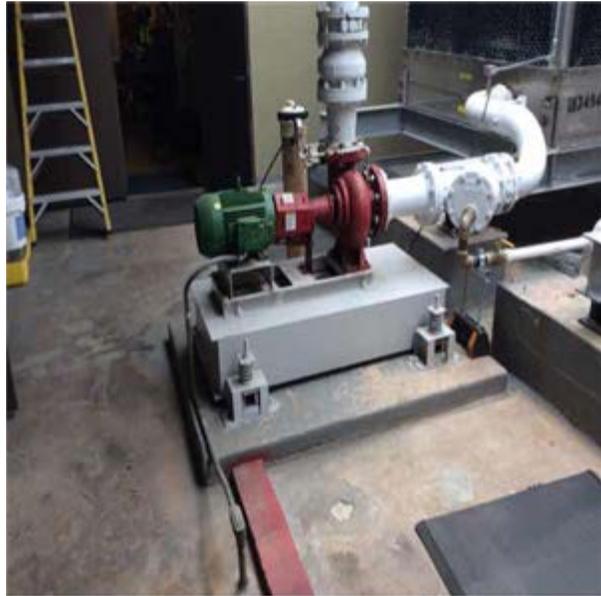
D3022.1 Chiller Distribution Pump 15 hp

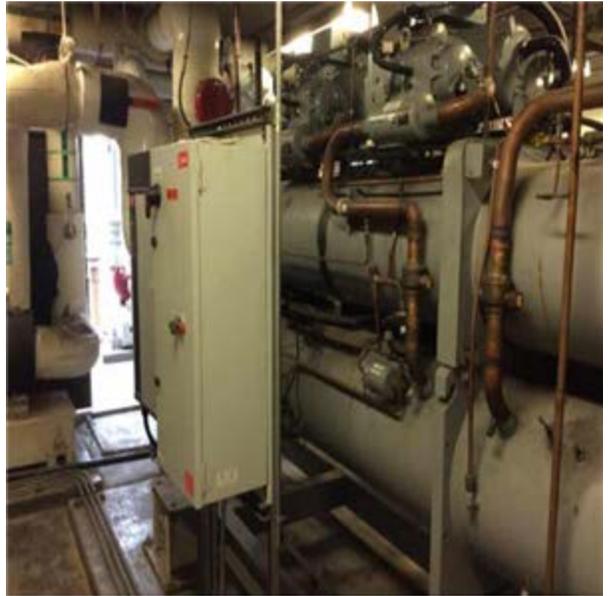
D3022.1 Chiller Condenser Pump 10 hp

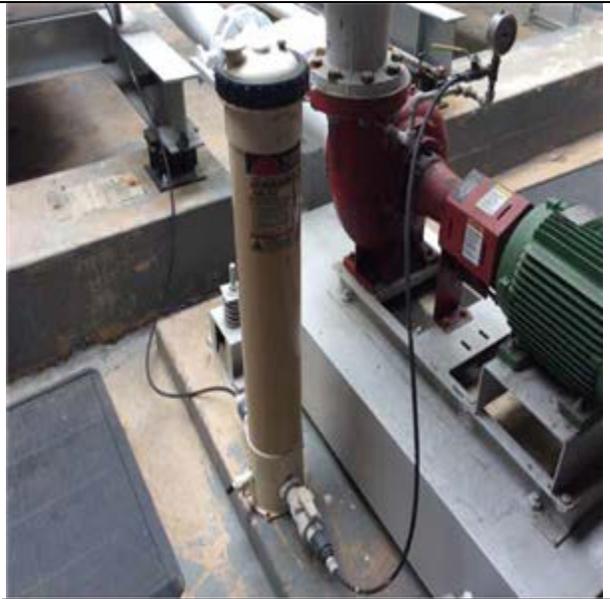
D3031.2 Cooling Towers

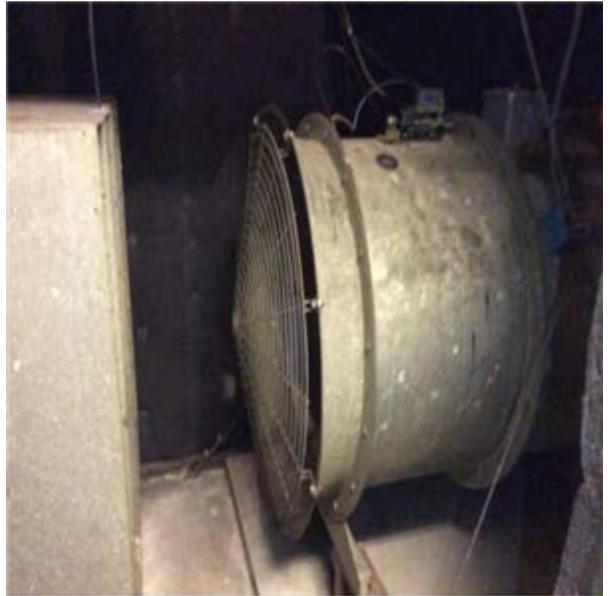
D3041.1 AHU2 31190 CFM

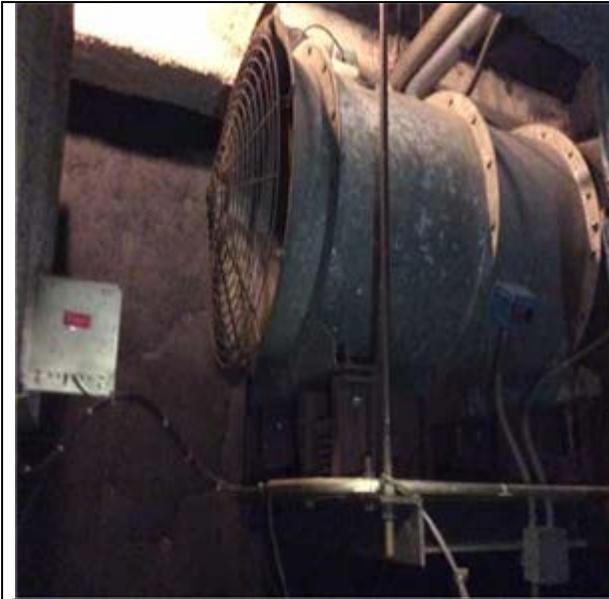
D3041.1 AHU3A 19500 CFM

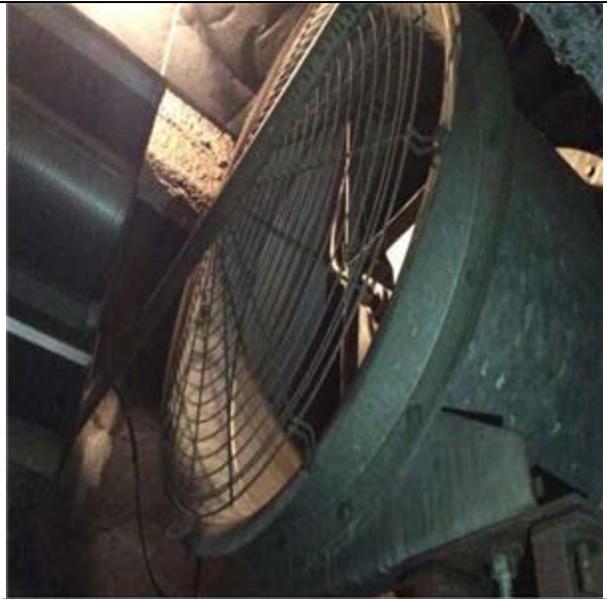
D3041.1 AHU3B 13,460 CFM

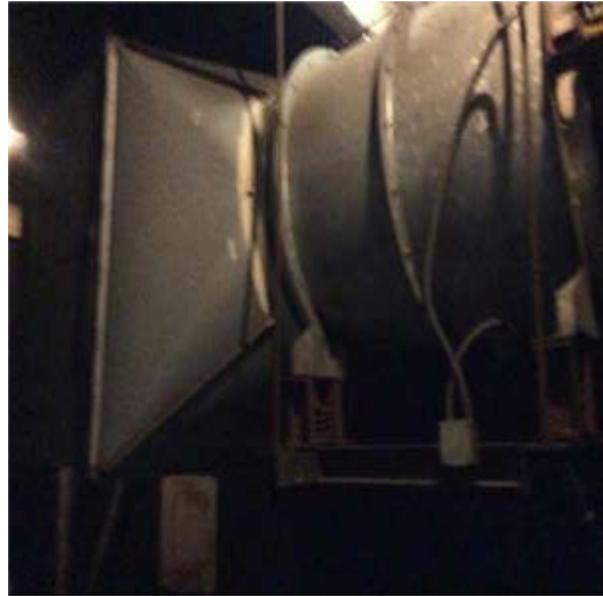
D3041.1 AHU4 15150 CFM

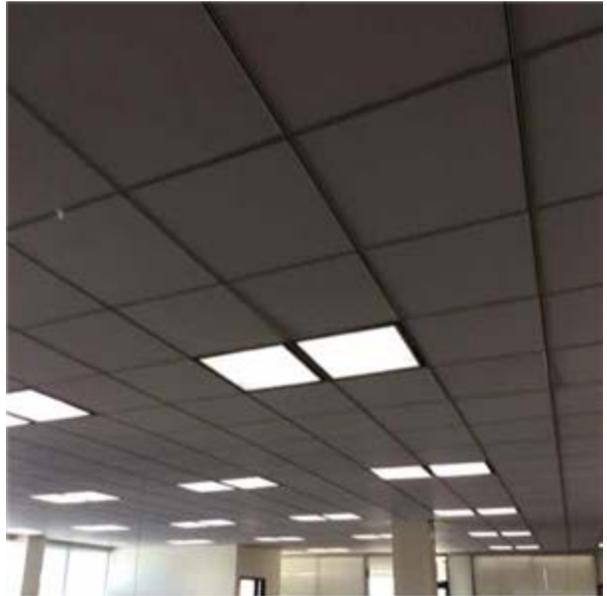
D3041.1 AHU 48130 CFM

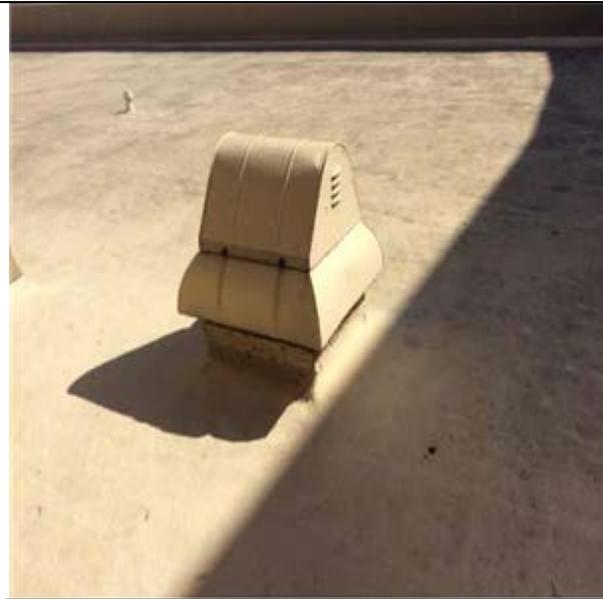
D3041 VAV Boxes

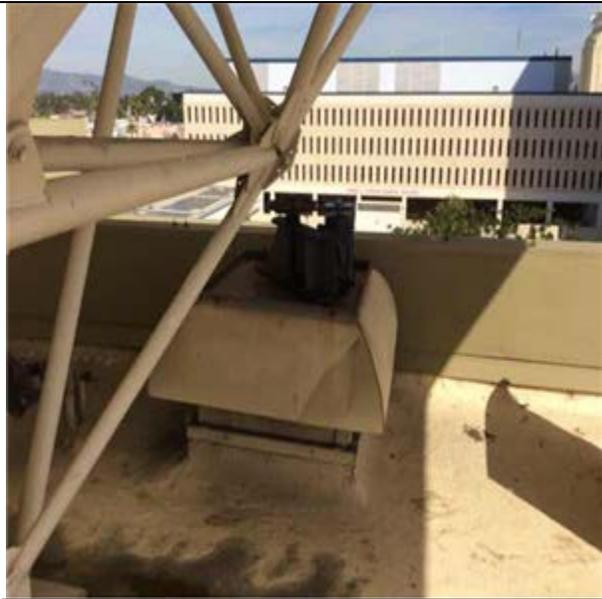
D3042 Exhaust fan 1/6 hp

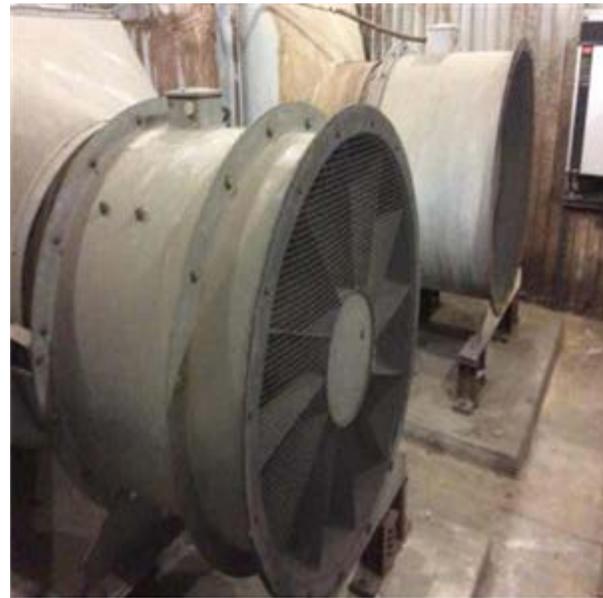
D3042 Exhaust fan 2 hp

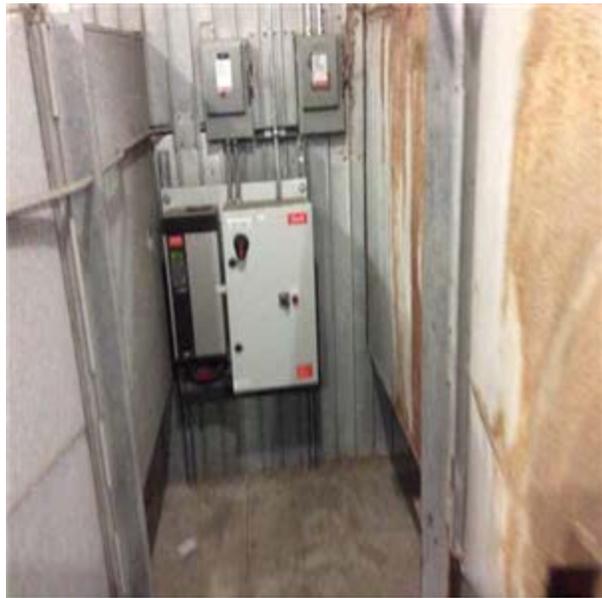
D3042 Exhaust Fan, Sidewall 35360 CFM

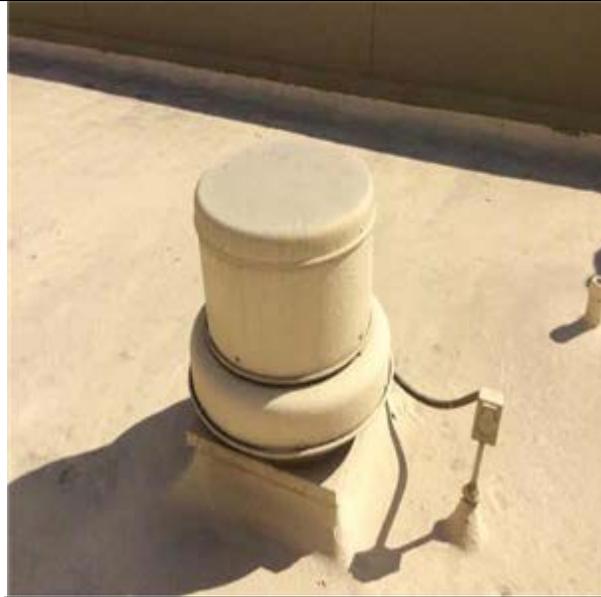
D3042 Exhaust Fan, Sidewall 35360 CFM

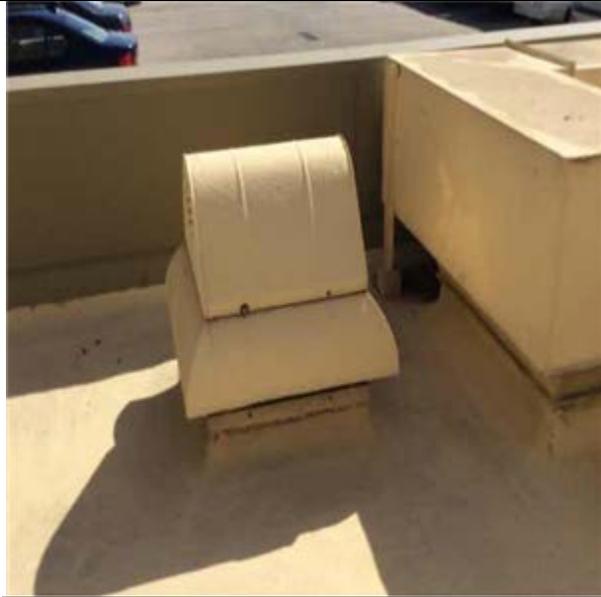
D3042 Exhaust fan 1/6 hp - Locker room

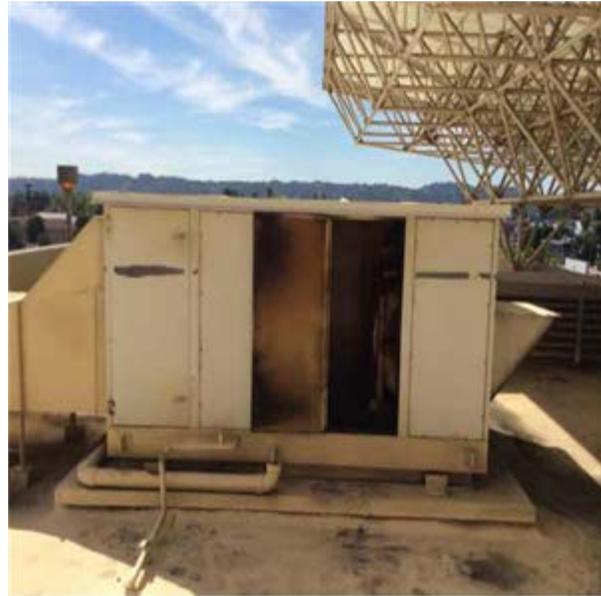
D3042 Exhaust fan 1/6 hp - Kitchen

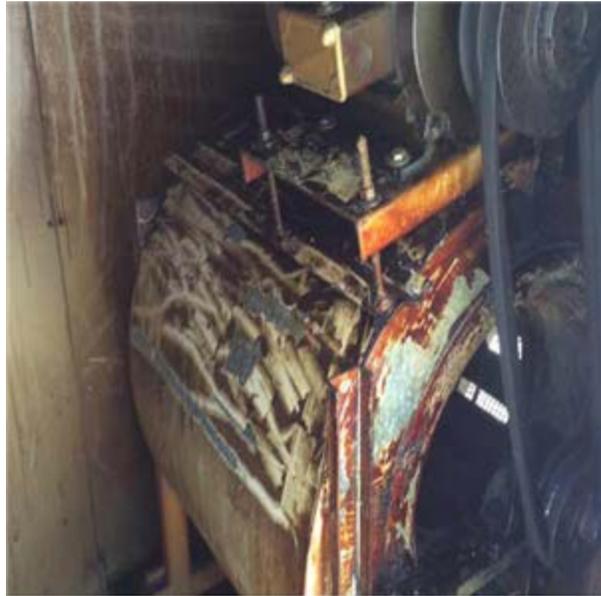
D3042 Exhaust Fan 5500 CFM

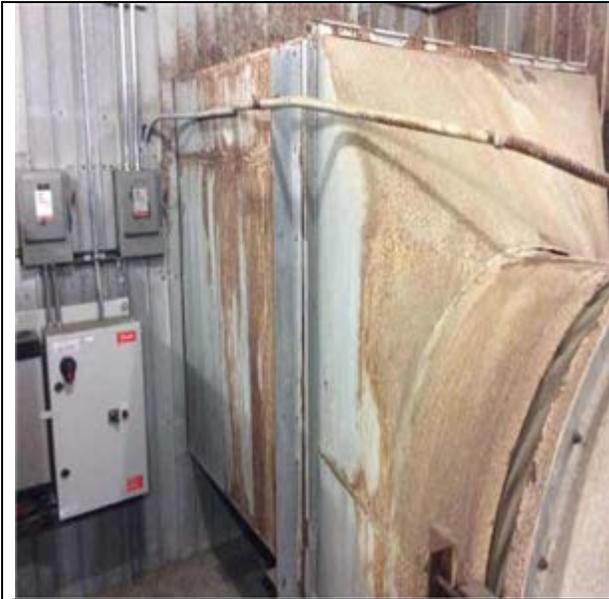
D3042 Exhaust Fan 5500 CFM

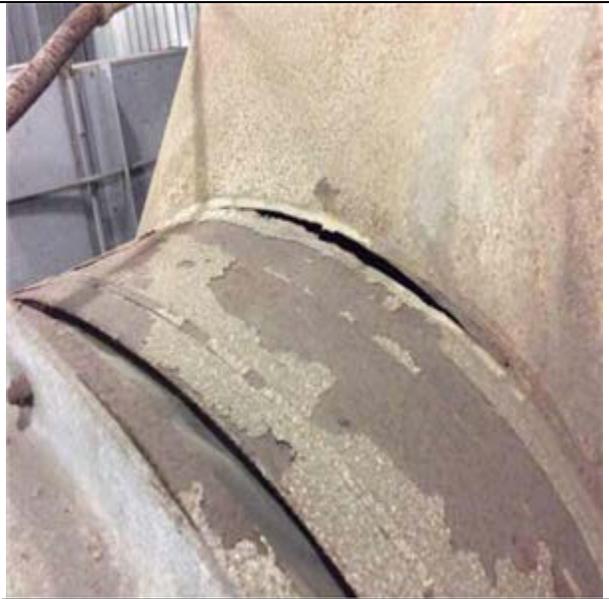
D3042 Exhaust Fan, Sidewall 18840 CFM

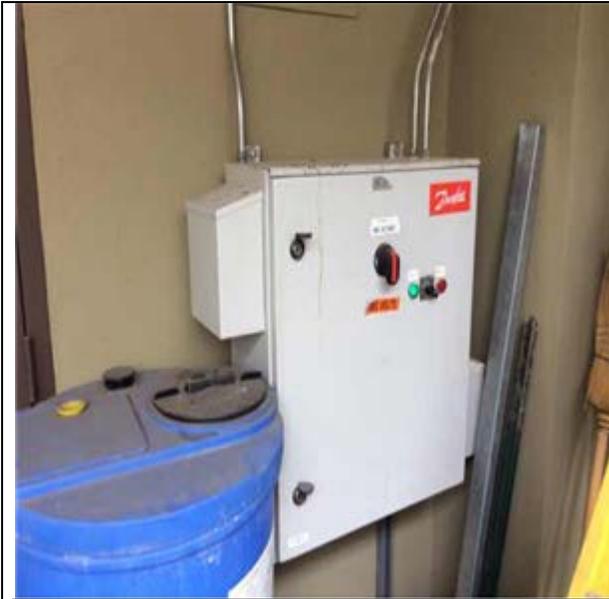
D3063 Variable Frequency Drive, 15 HP Motor, Pneumatic

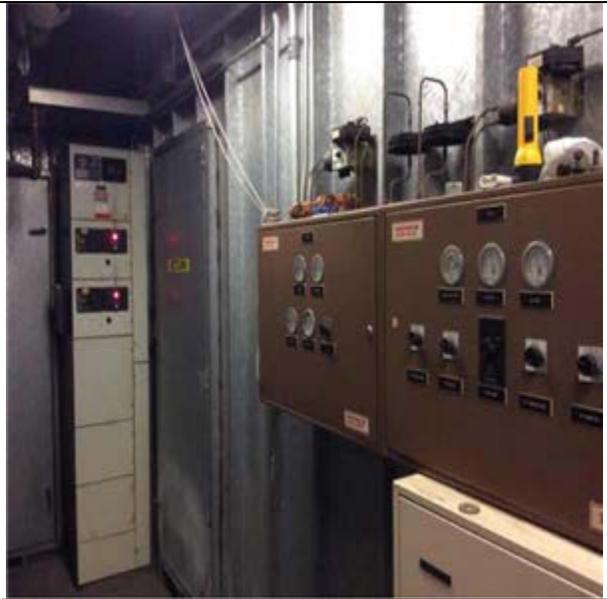
D3041.1 Cooling Tower Fan motor VFD 7.5 hp

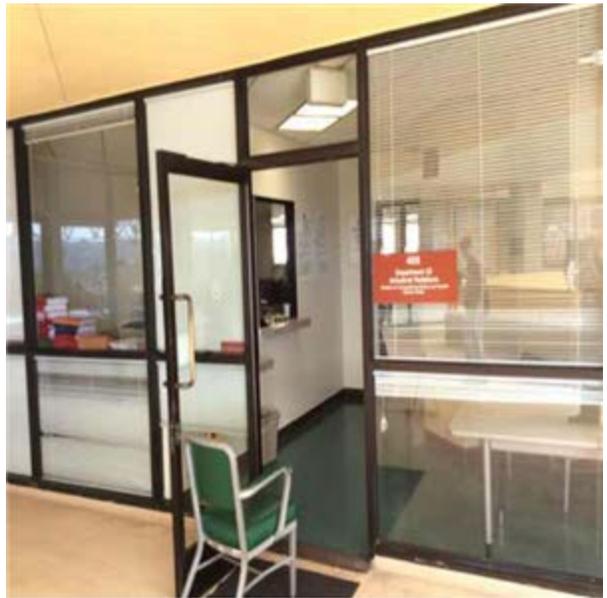
D3068 DDC Controls

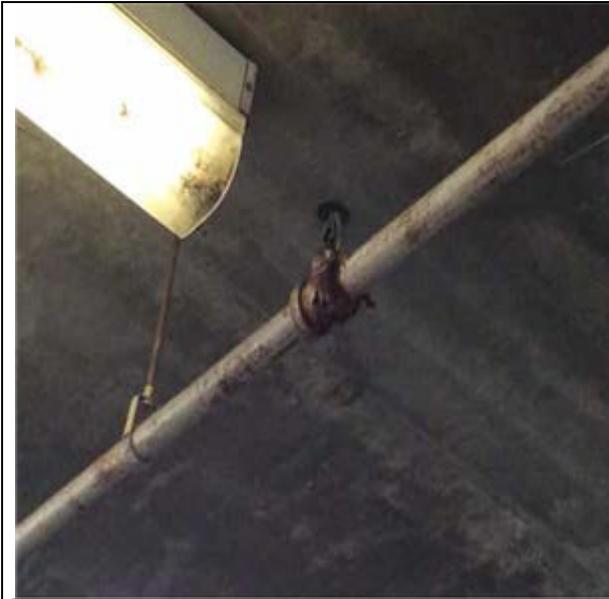
D3072 Air Systems Testing & Balancing

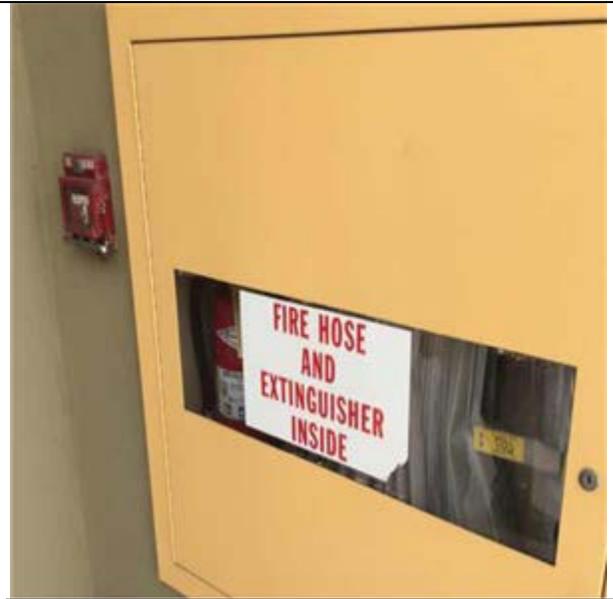
D4011 Wet-Pipe Sprinkler System

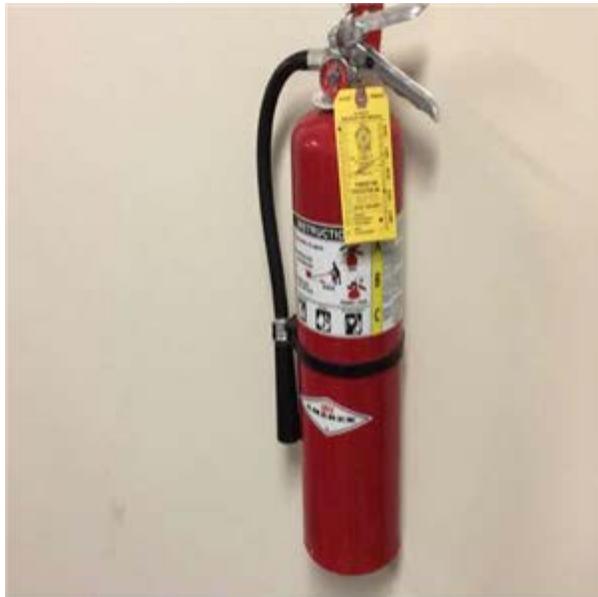
D4031 Fire Extinguishers 5 Lb, Install

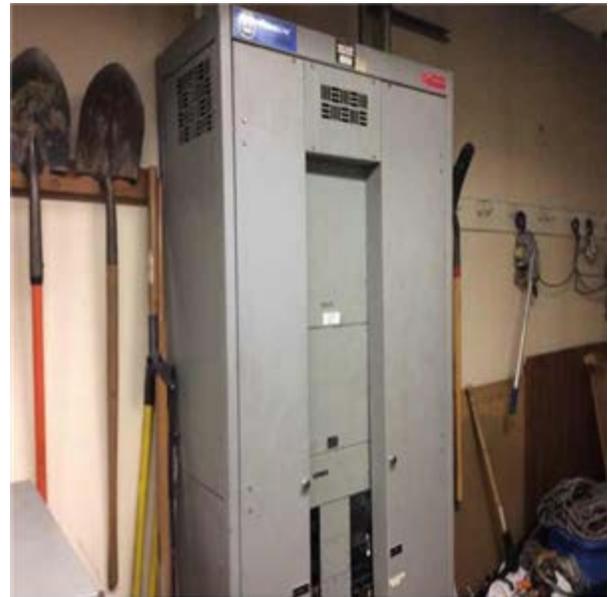
D5012 Switchgear 1000 Amps
