Van Nuys State Building (530)

6150 Van Nuys Boulevard, Van Nuys, CA 91401

Facility Condition Assessment

September 2015

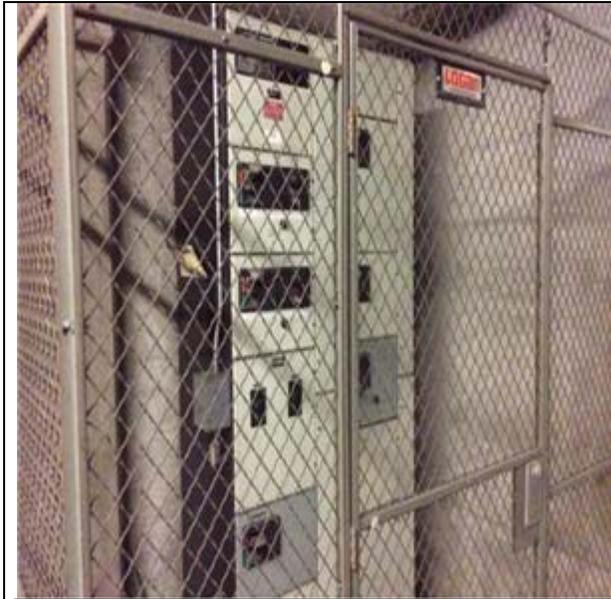
D5012 Distribution Panel 1200 Amps

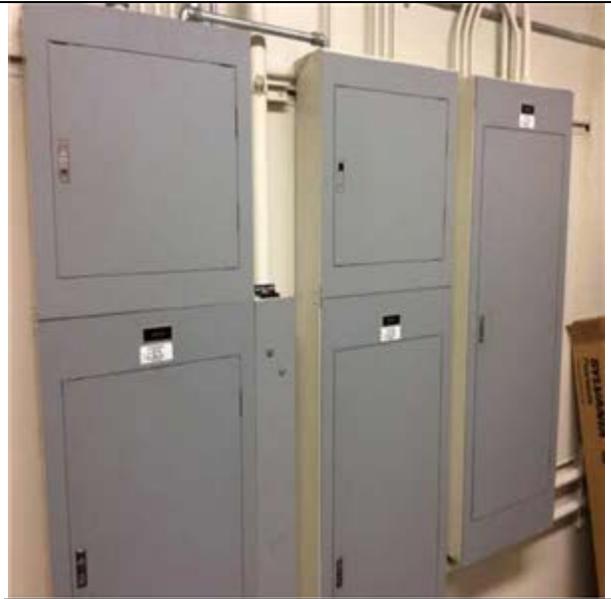
D5012 Breaker Panel 50-400 Amps

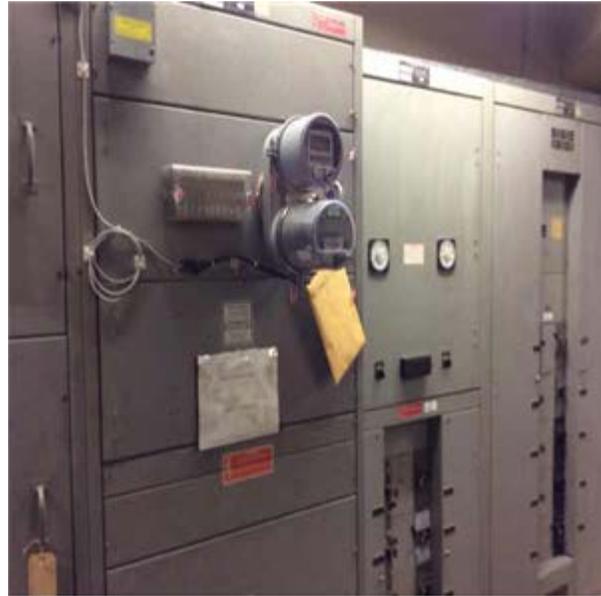
D5012 Main Switchgear 3000 Amps

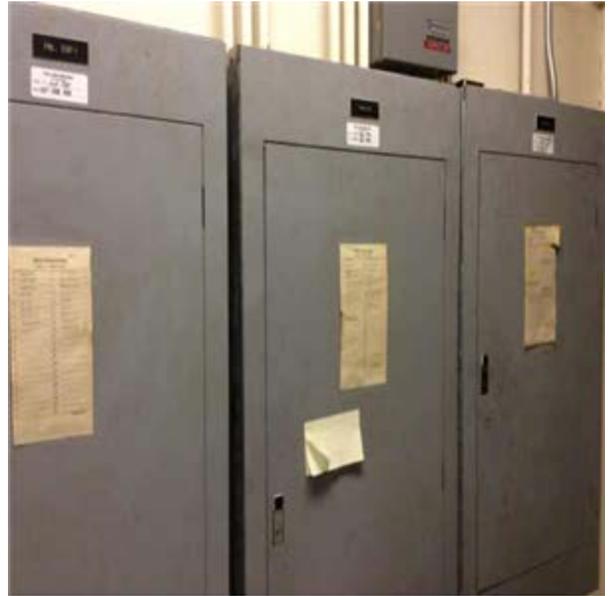
D5012 Breaker Panel 200 Amps

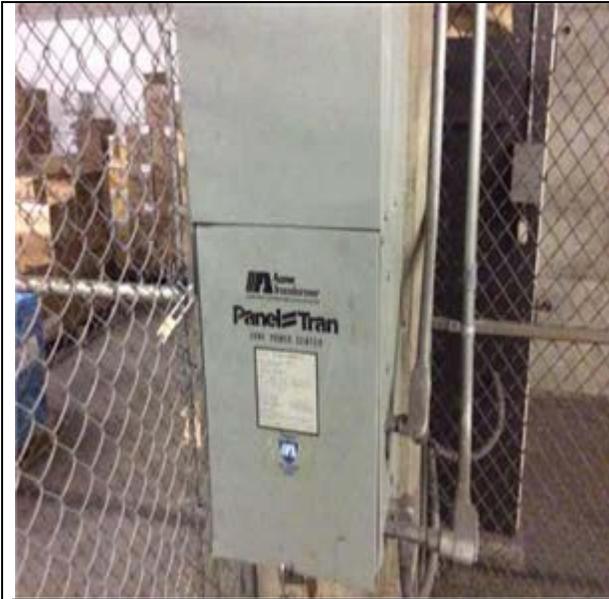
D5012 Dry Transformer 25 kVA

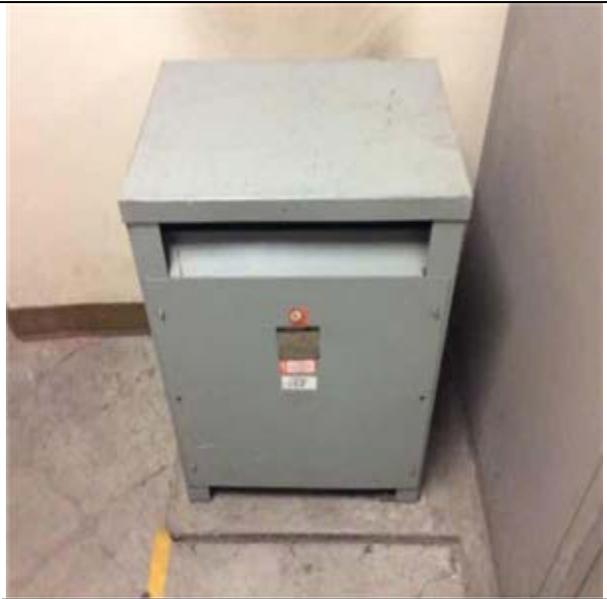
D5012 Dry Transformer 30 kVA

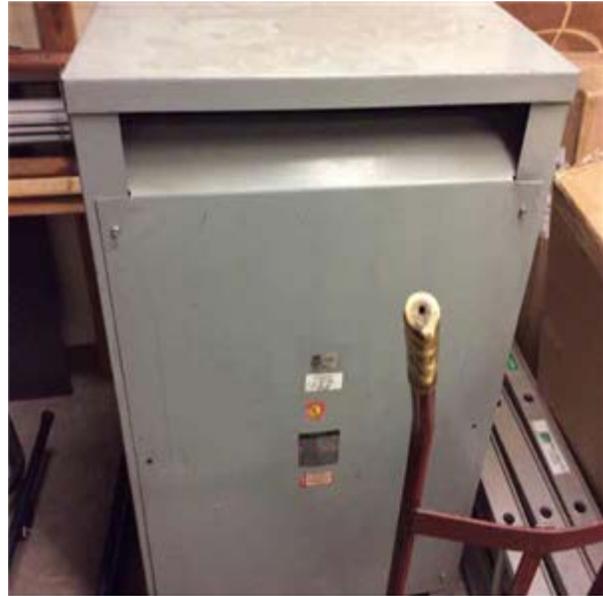
D5012 Dry Transformer 150 kVA

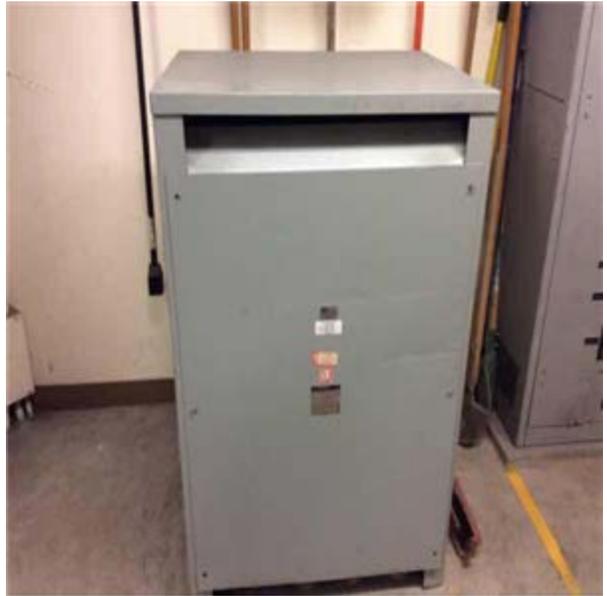
D5012 Dry Transformer 300 kVA

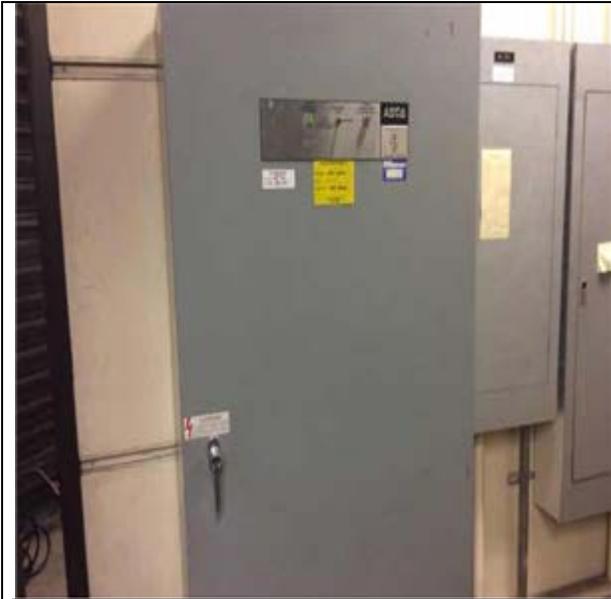
D5012 Emergency Switchgear 200 Amps

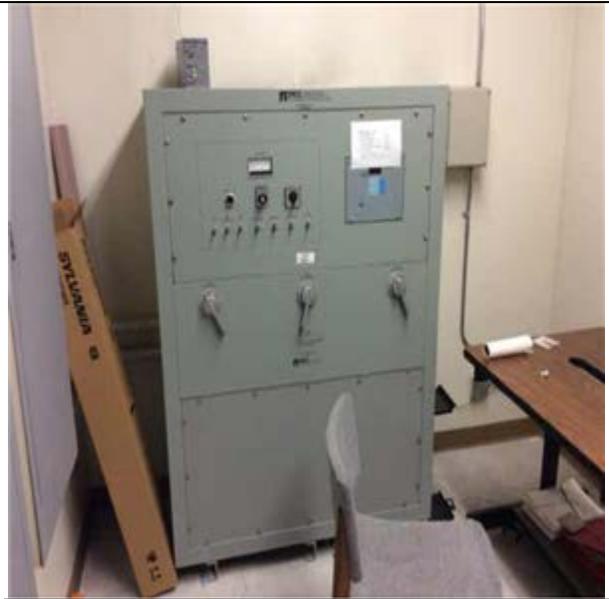
D5021 Lighting control unit

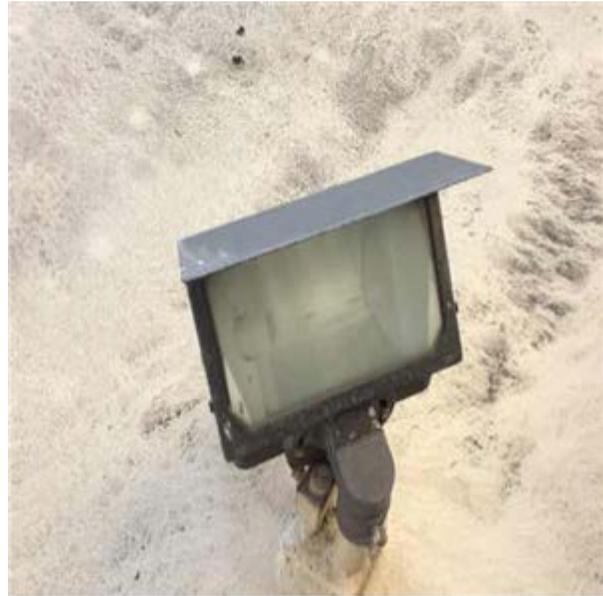
D5022 Uplighting 150 W HPS

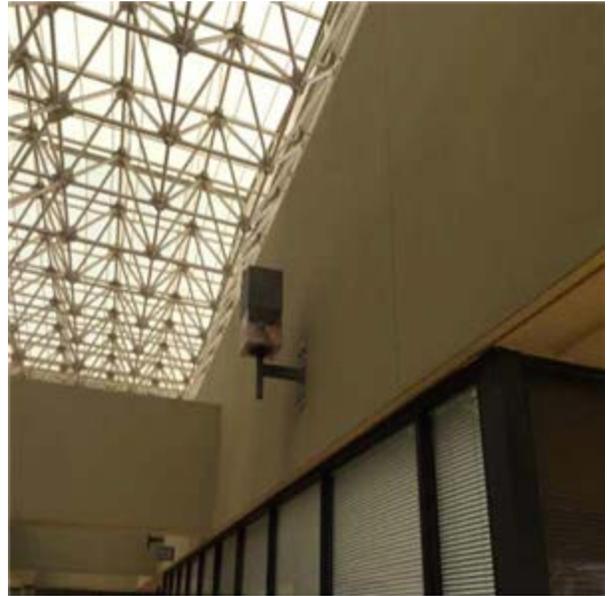
D5022 Wallpacks 150 W HPS

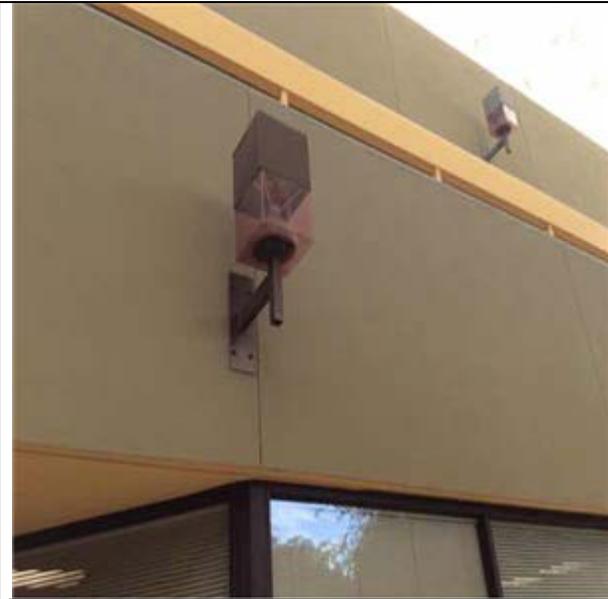
D5022 Wallpacks 150 W HPS

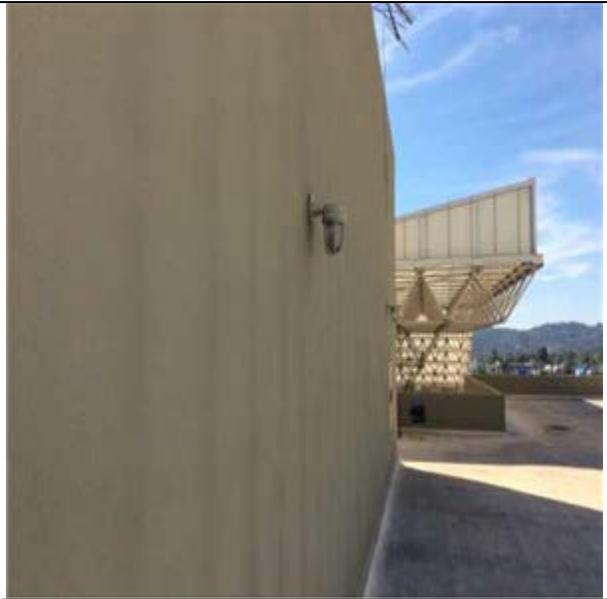
D5022 Wall Pack 23W CFL

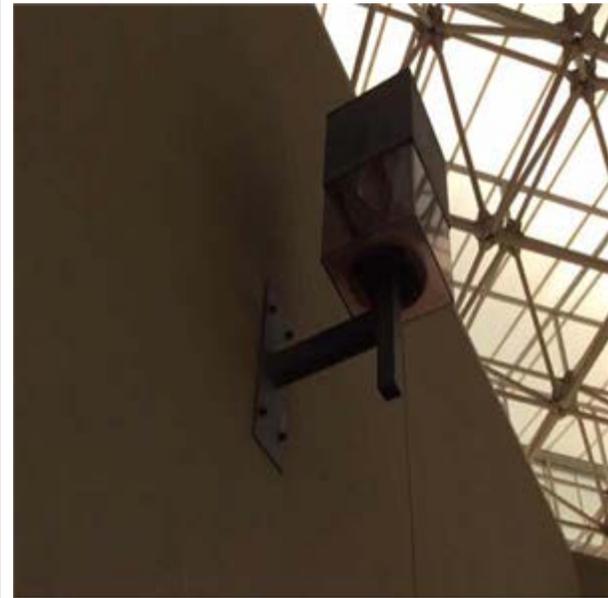
D5022 Wallpacks 150 W HPS

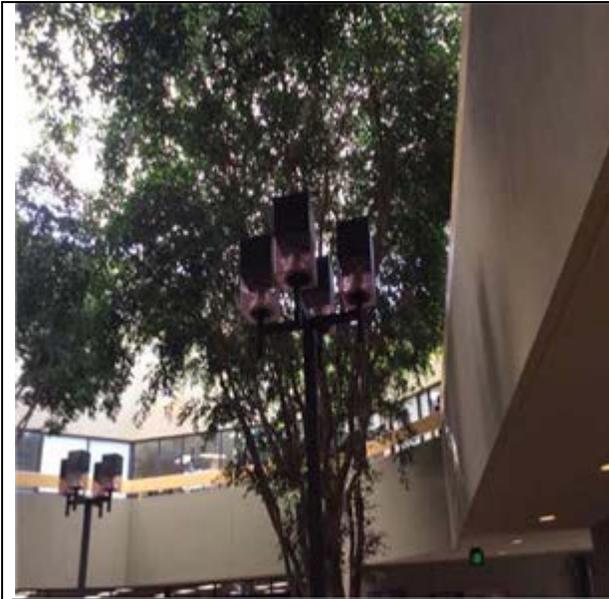
D5022 Pole lamps 150 W HPS

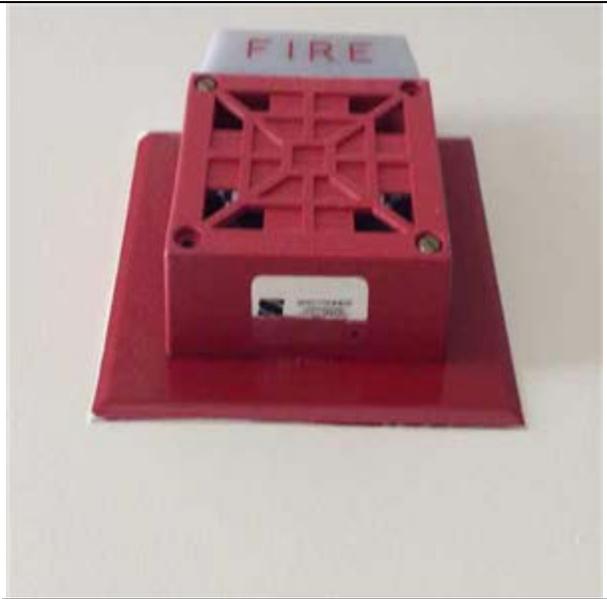
D5037 Strobe and Horn

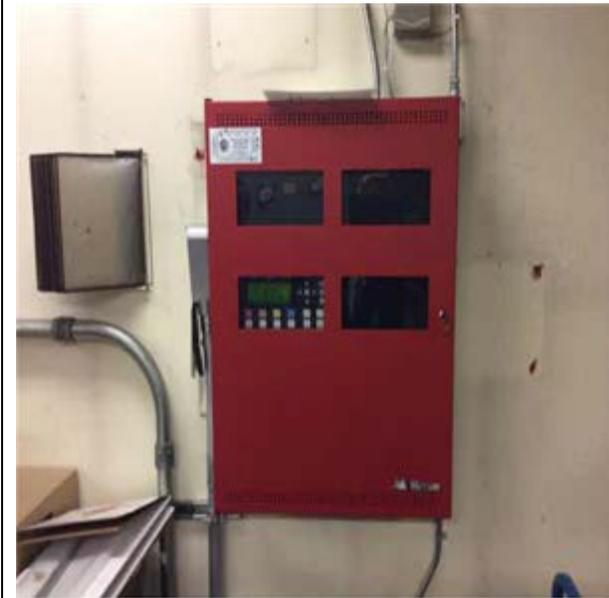
D5037 Fire Alarm Panel

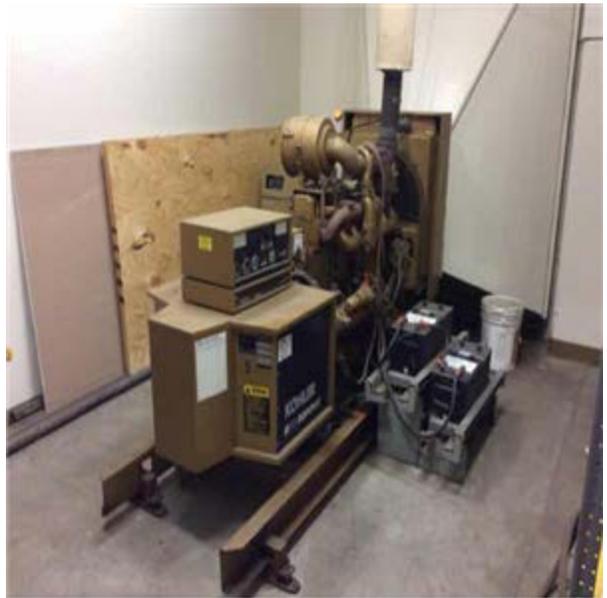
D5092 Diesel Generator 100 kW

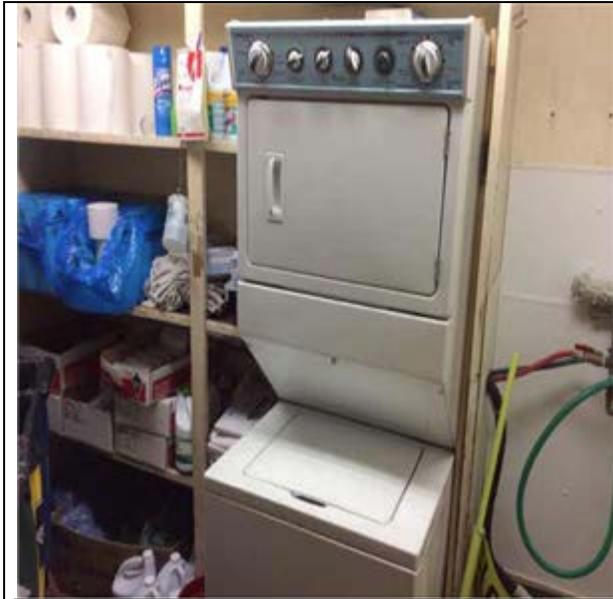
E1016 Commercial Washers 30 Lb

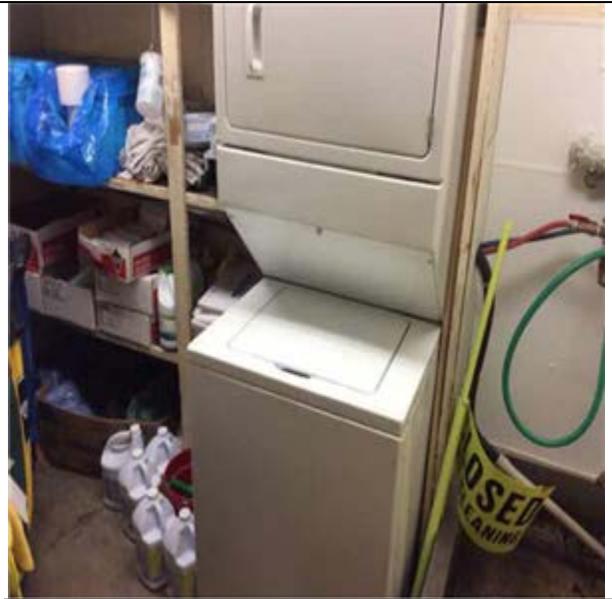
E1016 Commercial Dryers Electric 50Lb

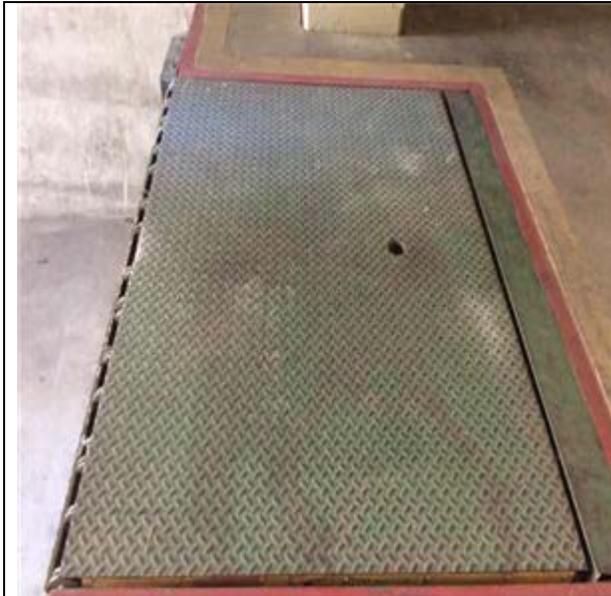
E1033 Loading Platforms

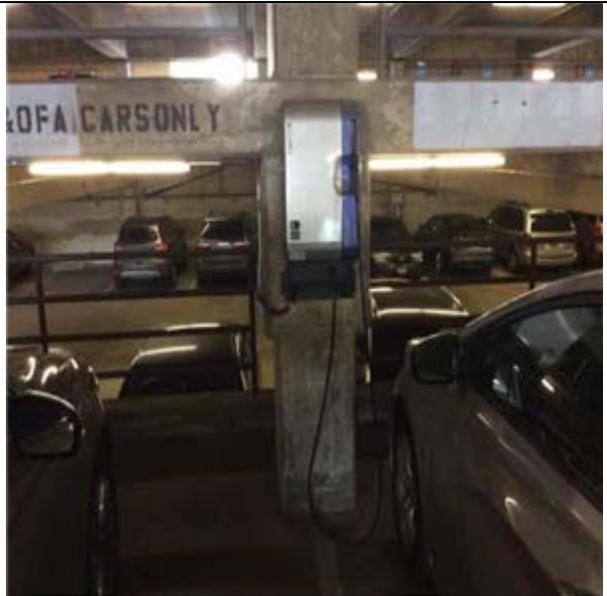
E1039 Electric charging station

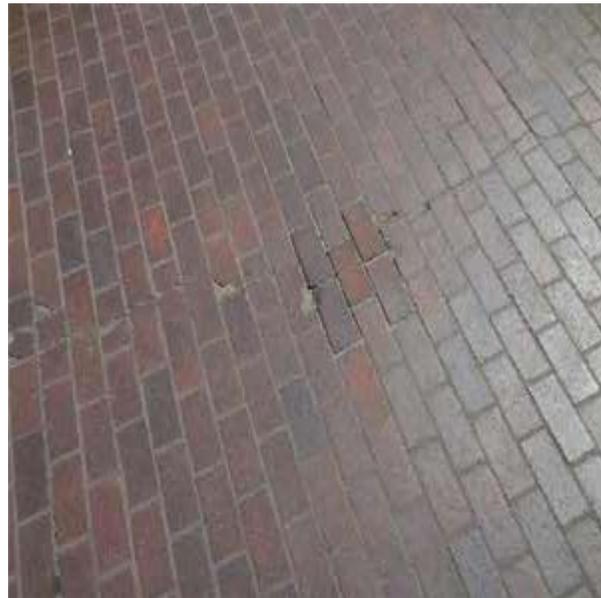
G2031 Brick Pavers, Grouted

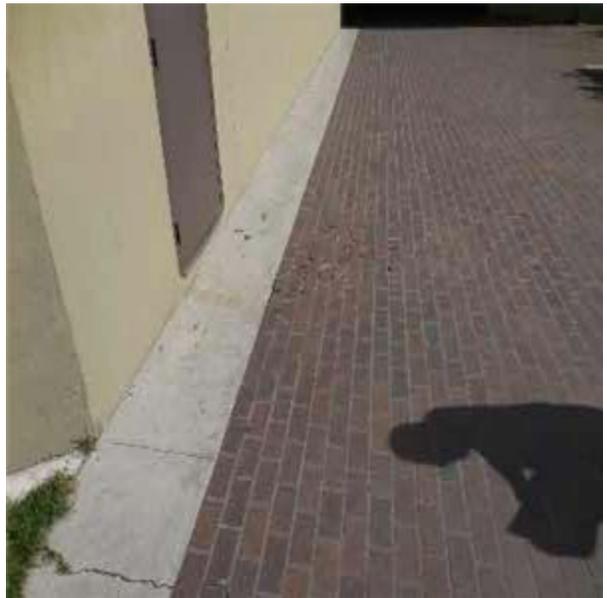
G2031 Brick Pavers, Grouted

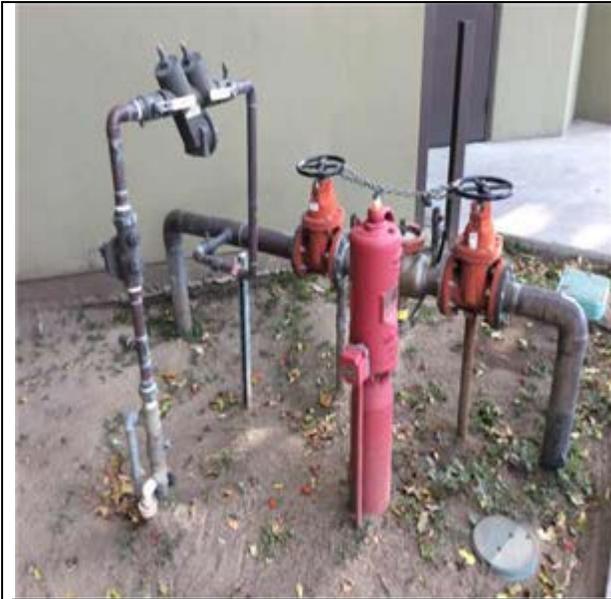
G2050 Sprinkler System, Backflow Preventer, 2"

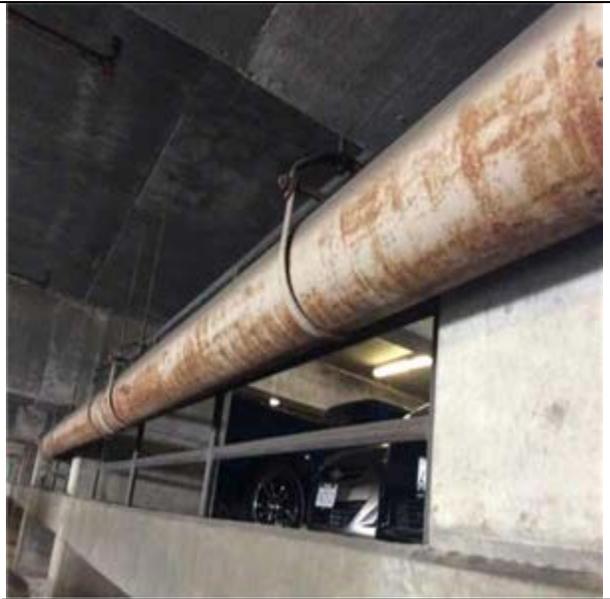
G3021 Drain pipe 5"

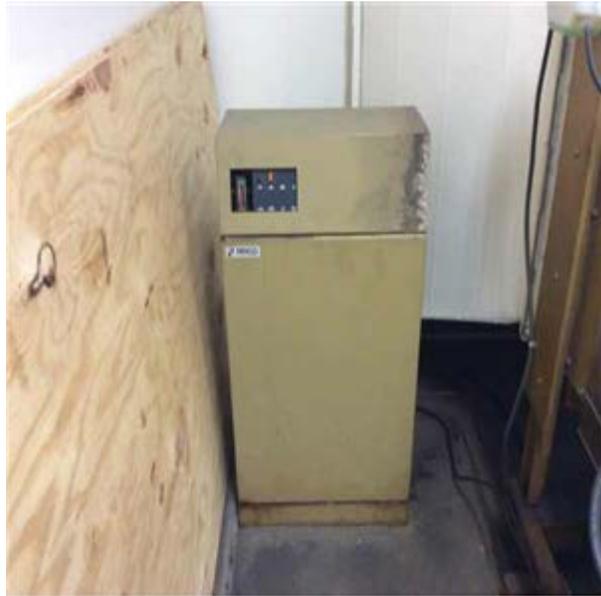
G3063 Diesel Tank, 50 Gallon

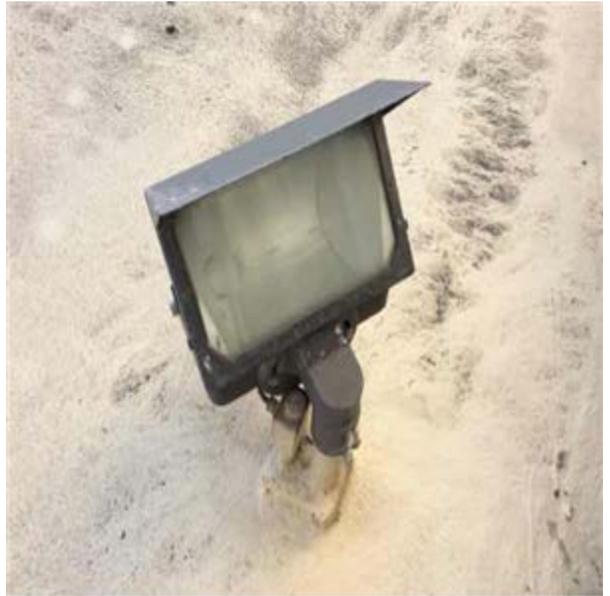
G4021 Landscape Ground Mounted Uplight Fixture
250w

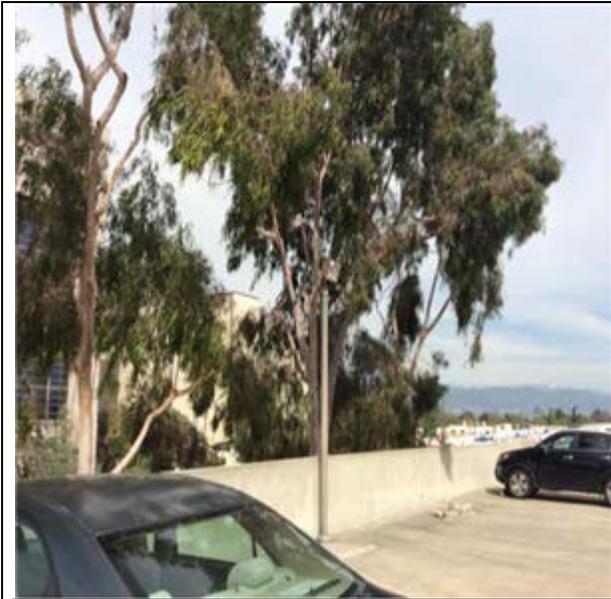
G4021 Pole Lamps 150 W
