East End Complex Block 225 (049)

1430 "N" Street, Sacramento, CA 95814

Facility Condition Assessment

June 2015

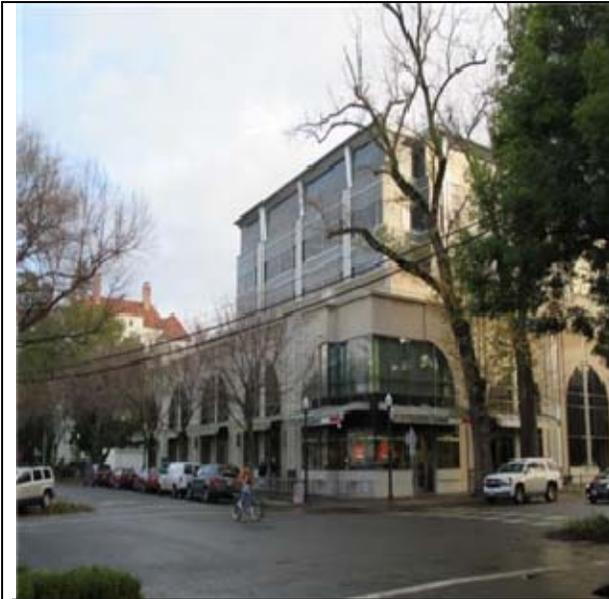
:- Partial side elevation along 14th Street

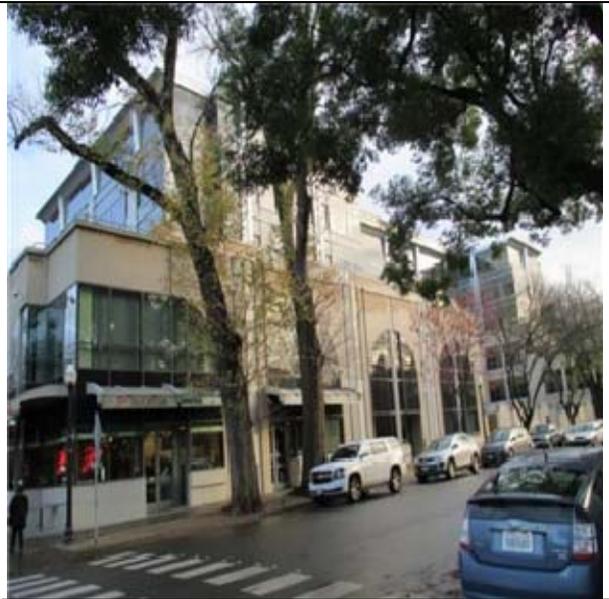
:- Partial side elevation along O Street

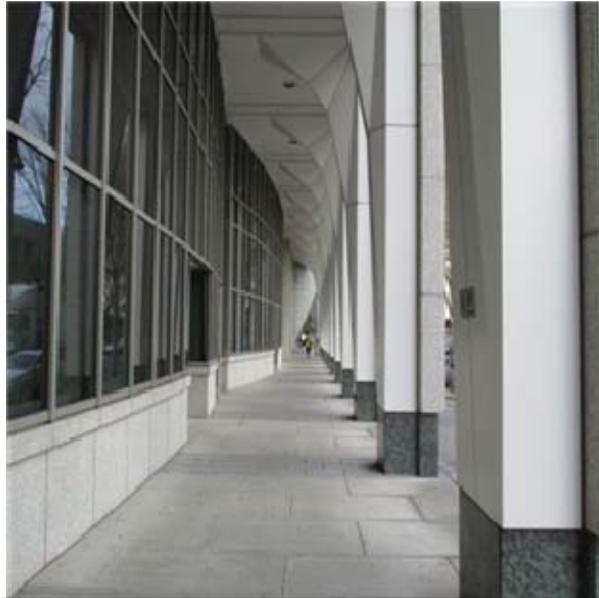
:- Pedestrian elevation along 15th Street

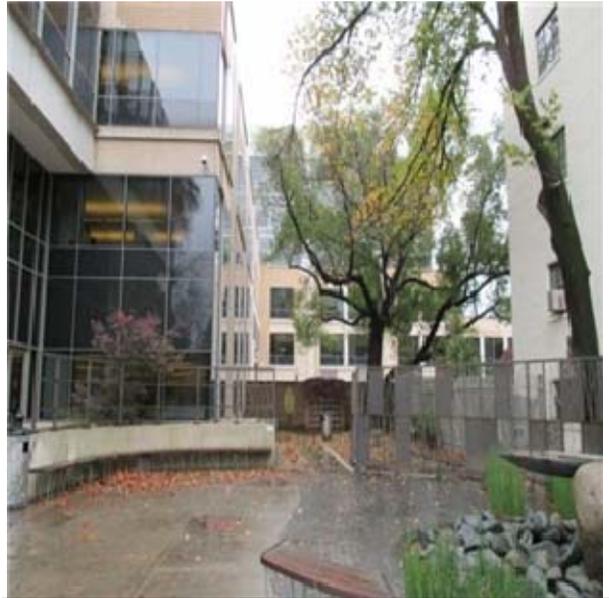
:- Pocket Park

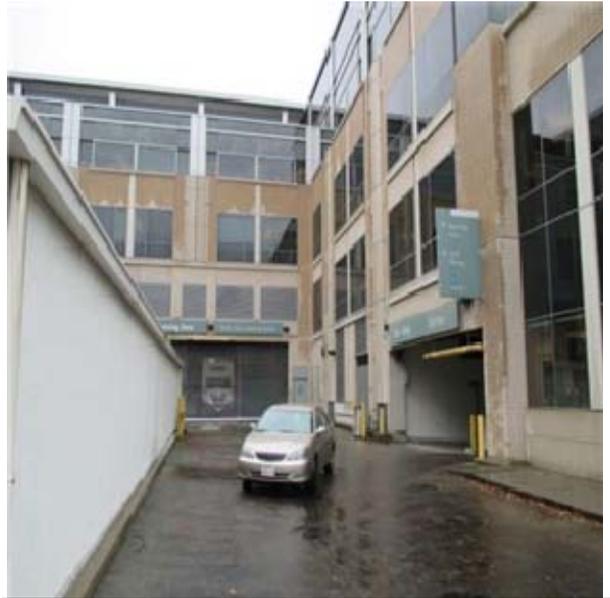
B2034 Steel Mesh Rolling Overhead Door, Electric - 12' to 20':- loading dock and at entry to garage

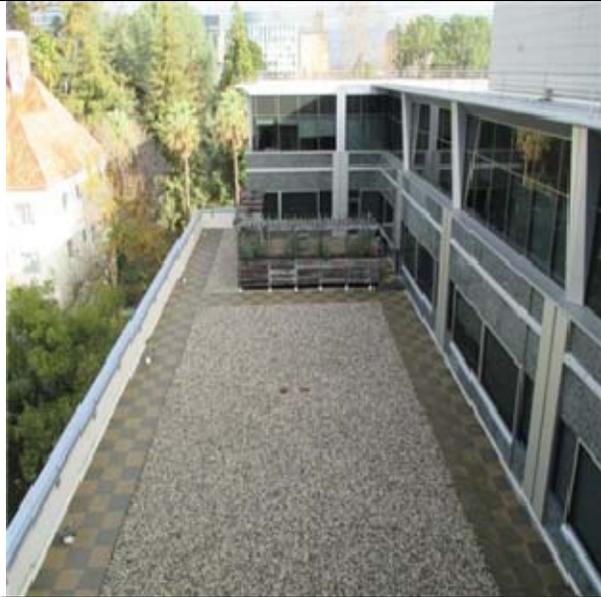
B3011 TPO Roof 45 Mills, Full Adhered:- fourth floor rooftop terrace

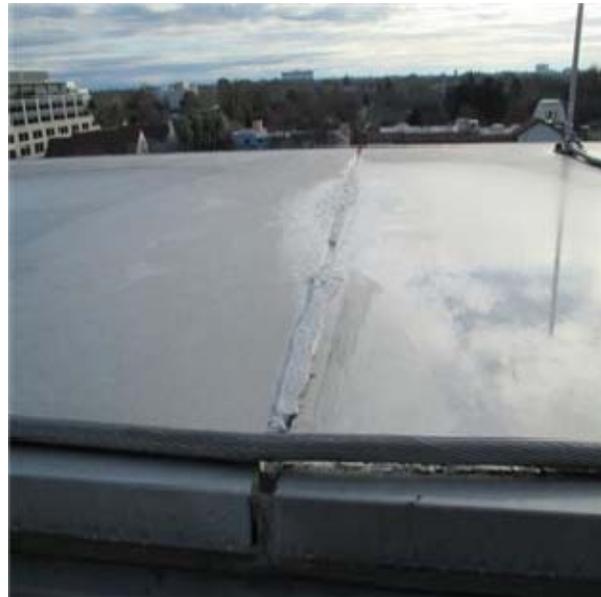
B3014 Coping :- Patched sealant

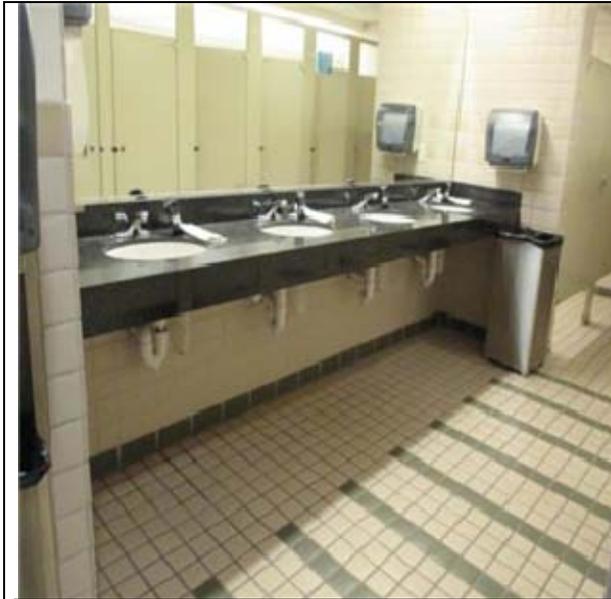
C3024 4X4 Ceramic Tile :- restroom floors

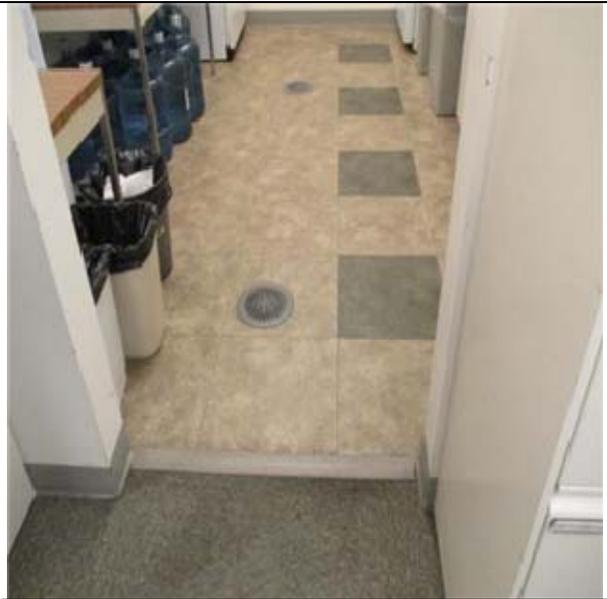
C3024 Vinyl Tile:- Flooring in the break rooms

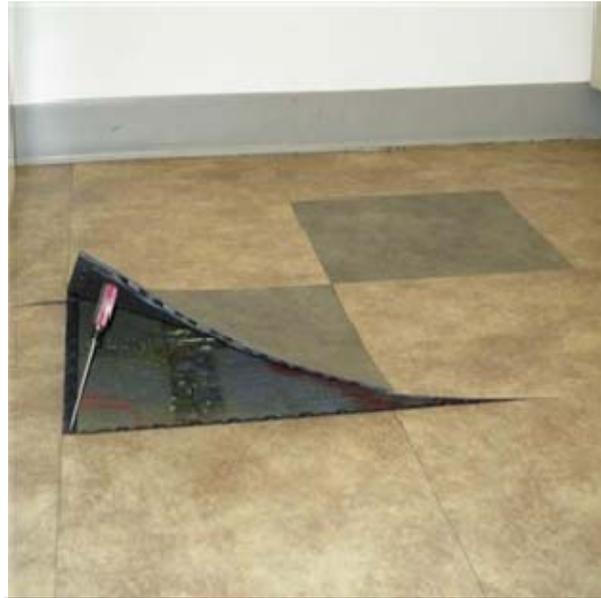
C3024 Vinyl Tile :- Interlocking tile

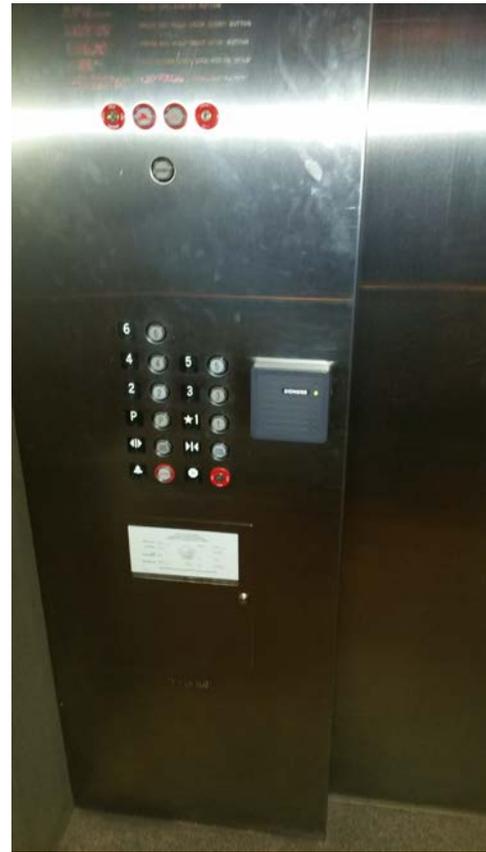
Car Operating Panels:

All the Car Operating Panels (COP's) are original, and The panels are in good condition and meet all ADA and T24. No work is anticipated on the car operating panels in the near term.

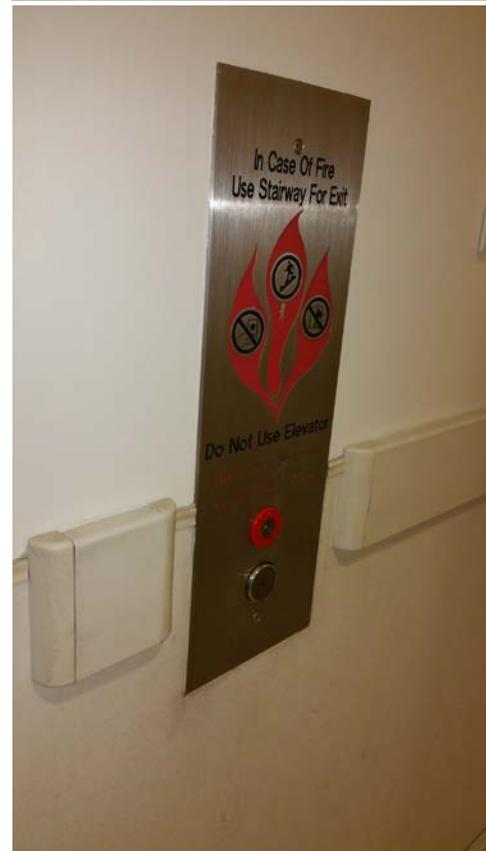
Hall Call Pushbuttons:

At each floor hall call push buttons are located so that users can call the elevator. The hall call stations have raised operation buttons which meet ADA and California Title 24. They also have the code required fire exit signs in station.
