Wadie P. Deddeh State Office Building (860)

4050 Taylor Street, San Diego, CA 92110

Facility Condition Assessment

September 2015

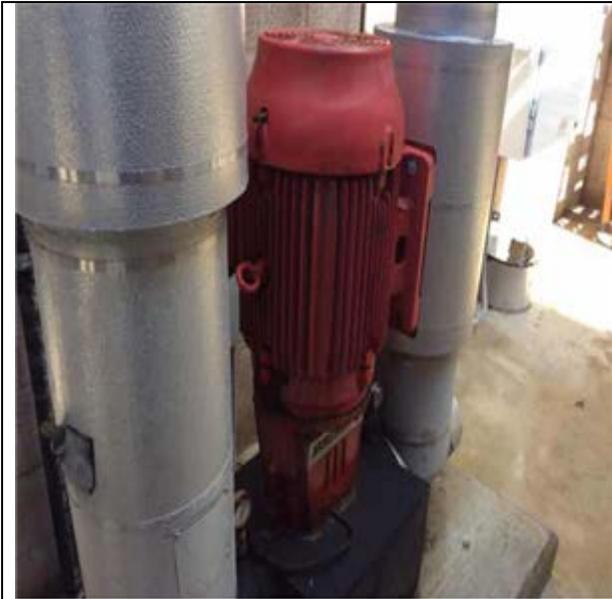
D3022.1 Chiller Condenser Pump 50 hp

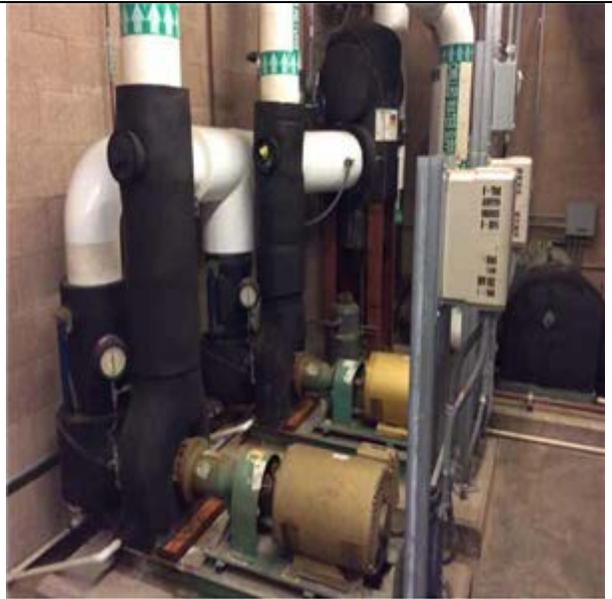
D3022.1 Chiller Primary Pump 30 hp

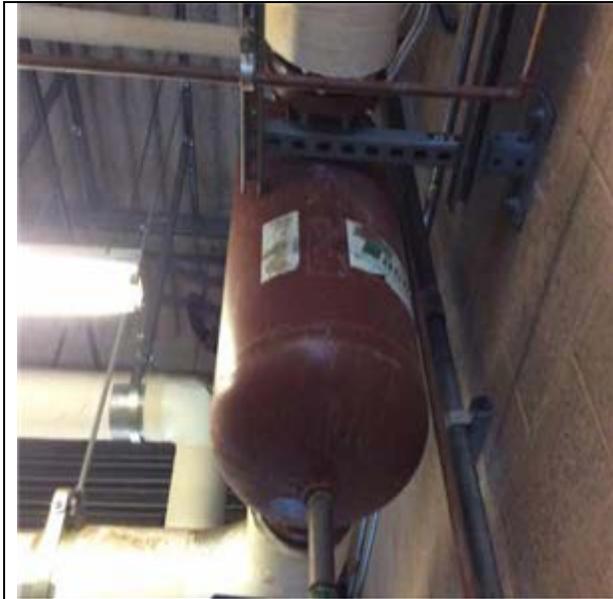
D3023 Expansion Tank (370 Gal)

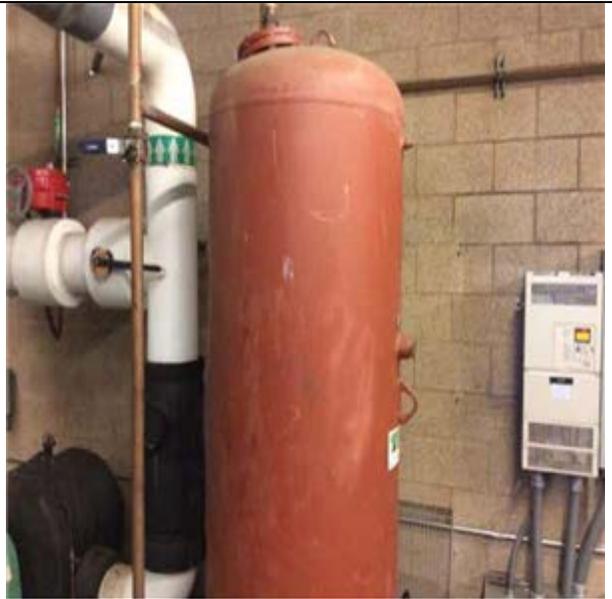
D3023 Air separator

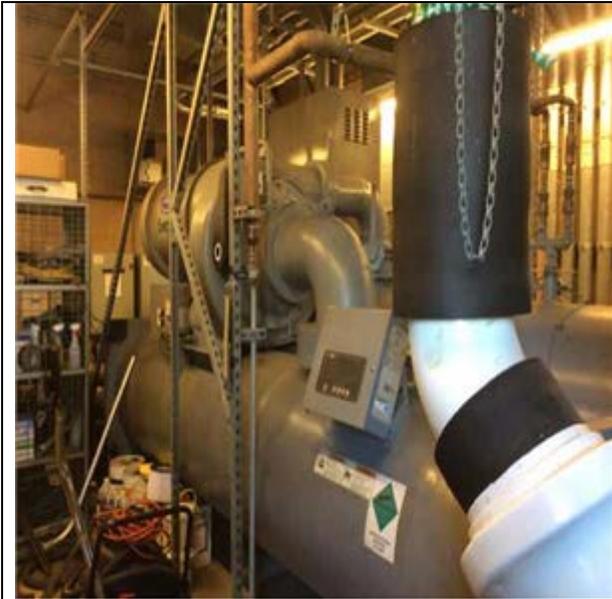
D3031.1 Water cooled chiller 210 ton

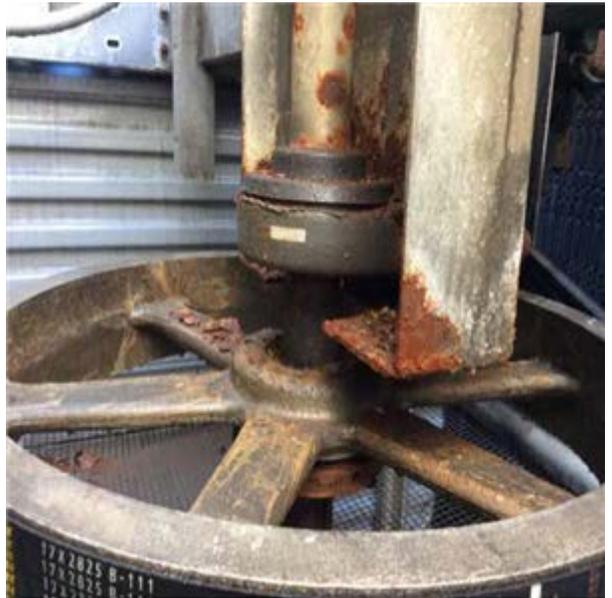
D3031.2 Cooling Towers

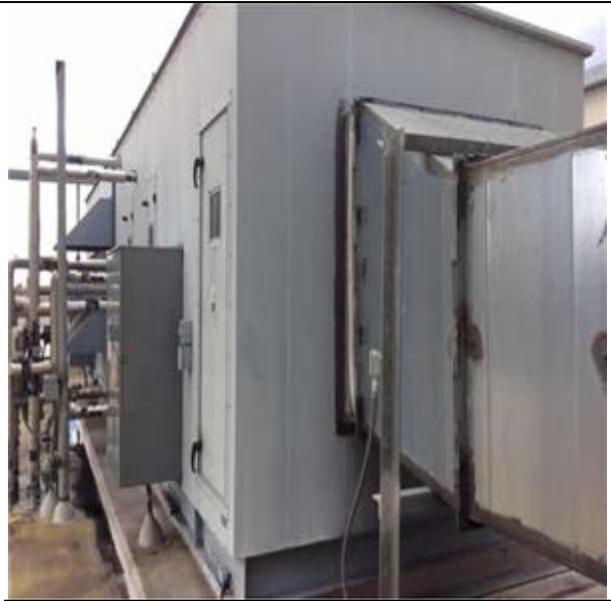
D3041 Supply fan for kitchen 3840 CFM

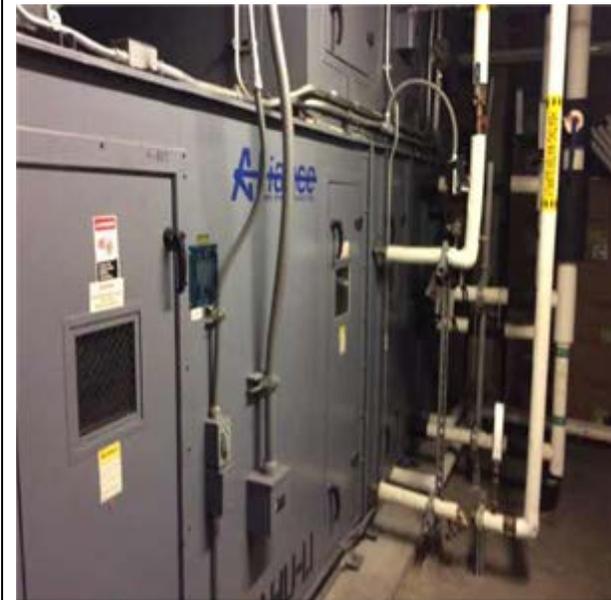
D3041.1 AHU 22000 CFM

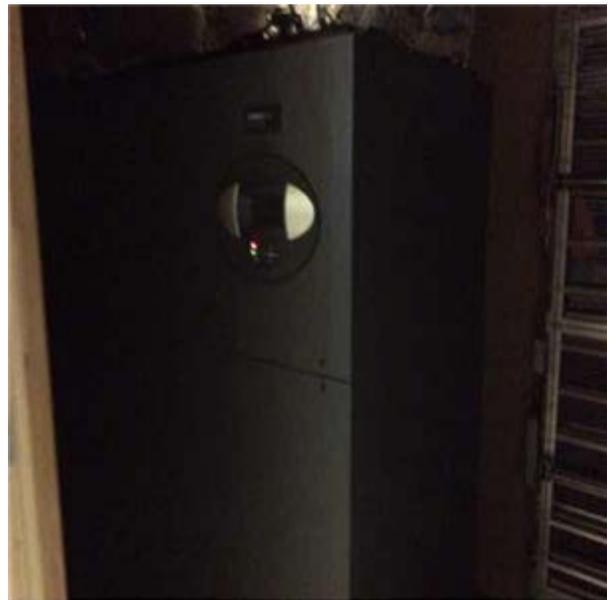
D3041.1 AHU 23000 -23500 CFM

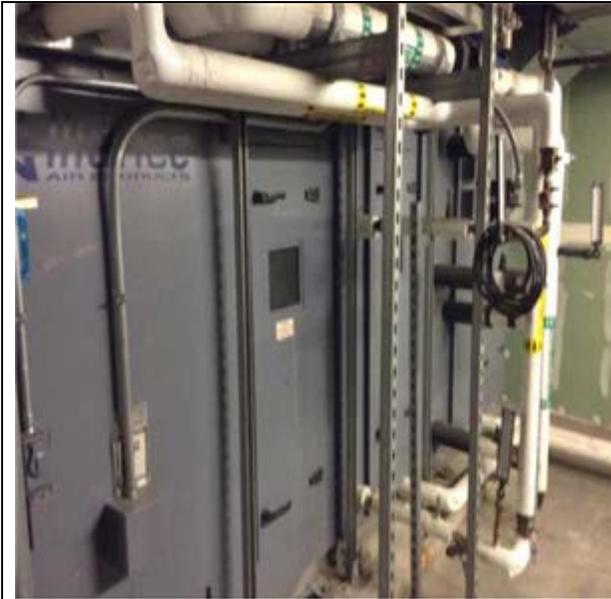
D3041.1 FCU with chilled water 22 ton

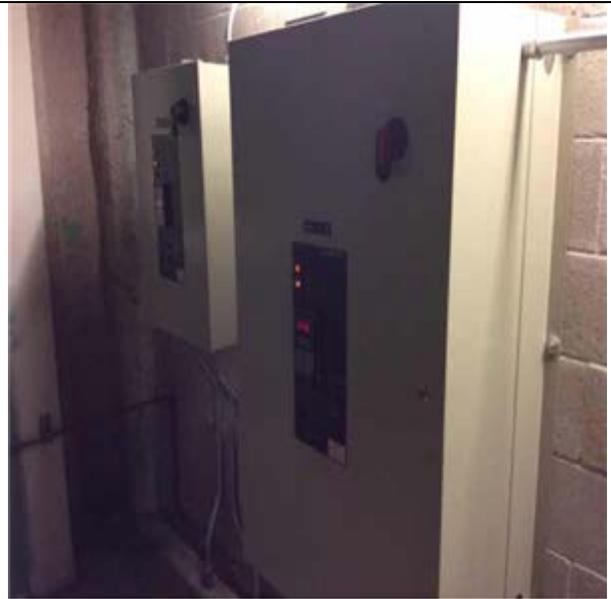
D3041.1 AHU 22000 -29000 CFM

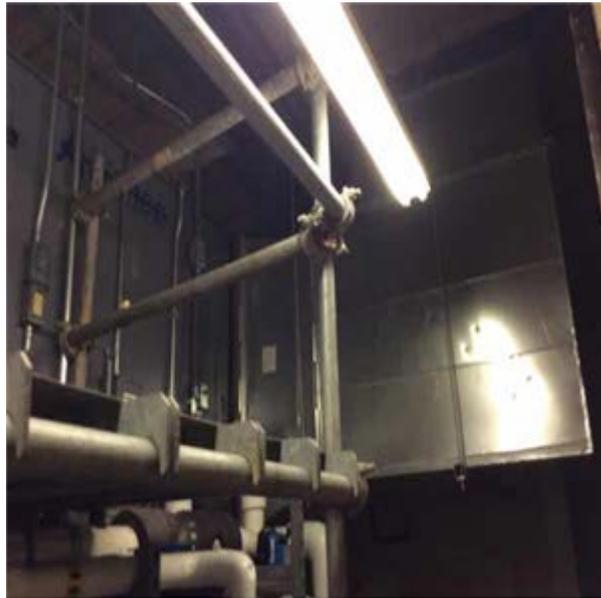
D3041.1 AHU 22000 -29000 CFM

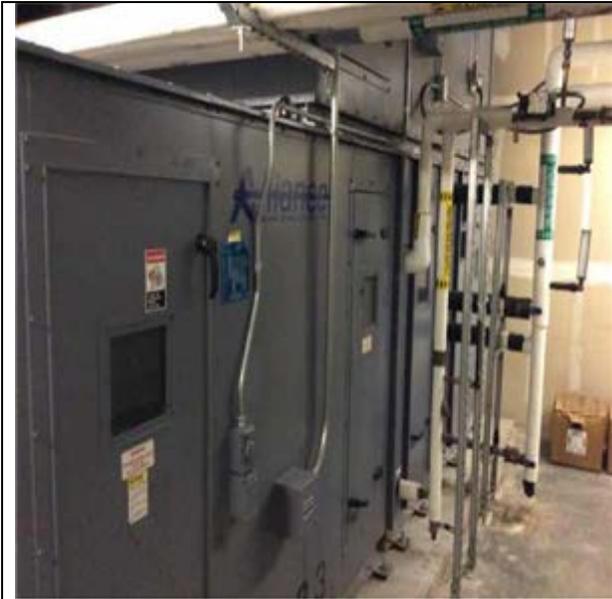
D3041.1 AHU 17500 CFM

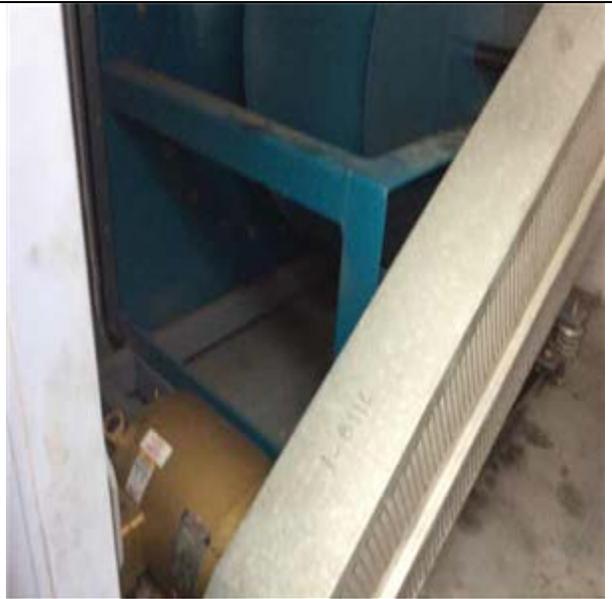
D3041.1 AHU 22000 -29000 CFM

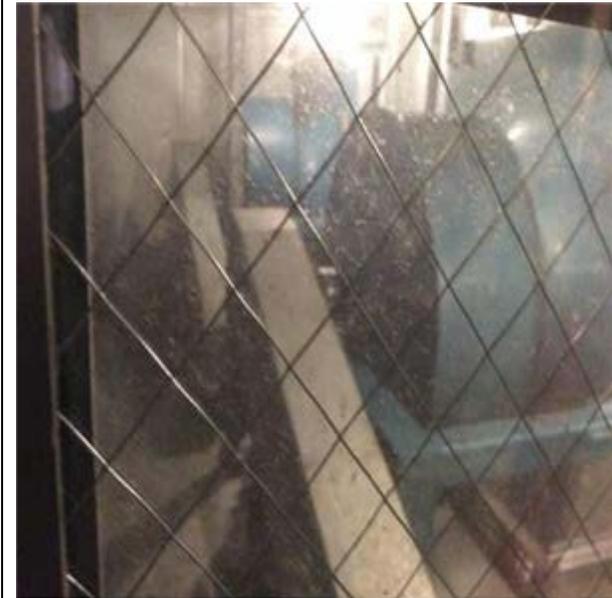
D3041.1 AHU Fan supply motor 30 hp

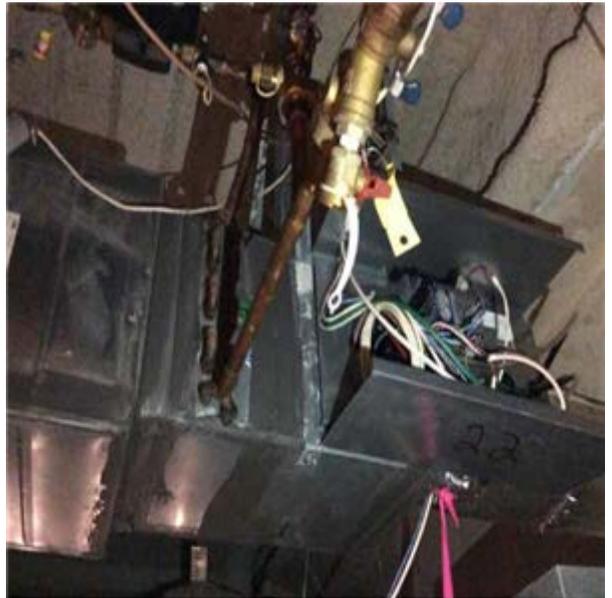
D3041.1 AHU Fan supply motor 20 hp

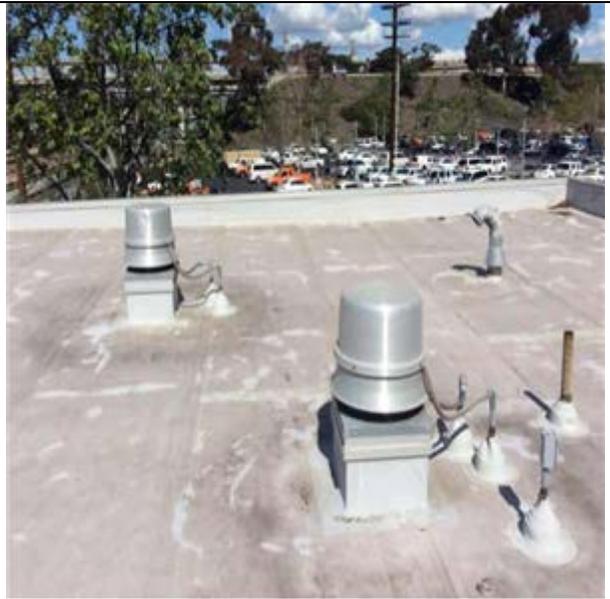
D3042 Exhaust Fan 6440 CFM

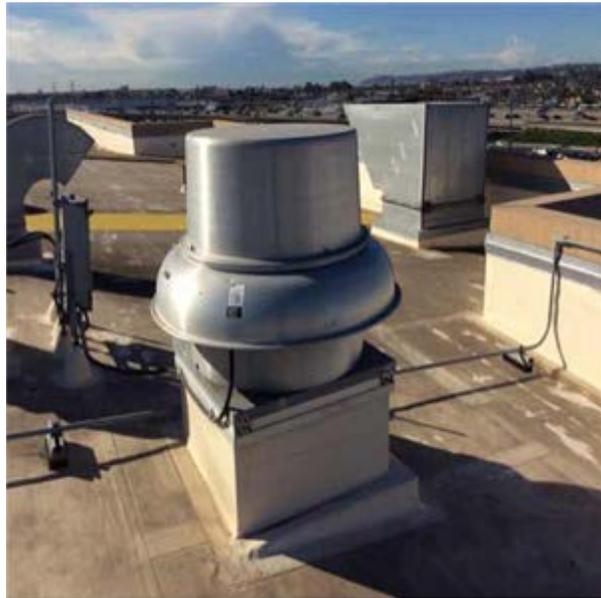
D3042 Exhaust Fan 100- 1500 CFM

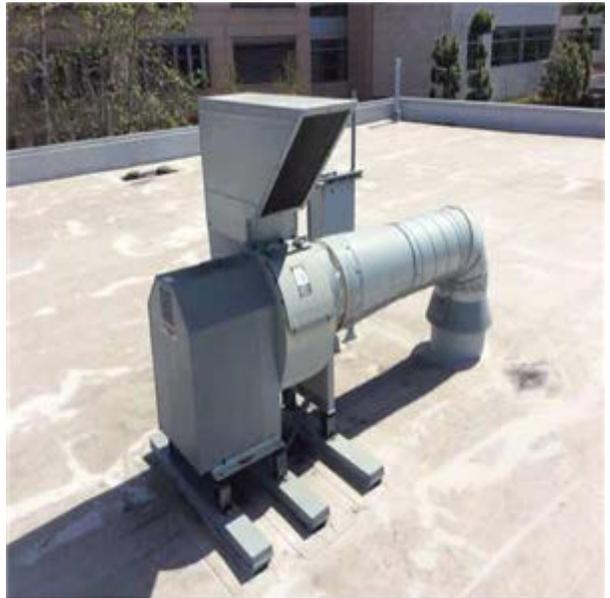
D3042 Exhaust Fan 7465 CFM

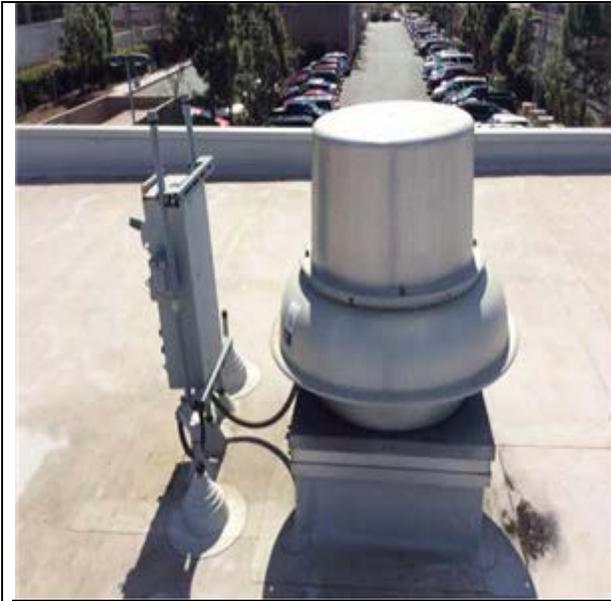
D3042 Exhaust Fan 2000 - 3500 CFM

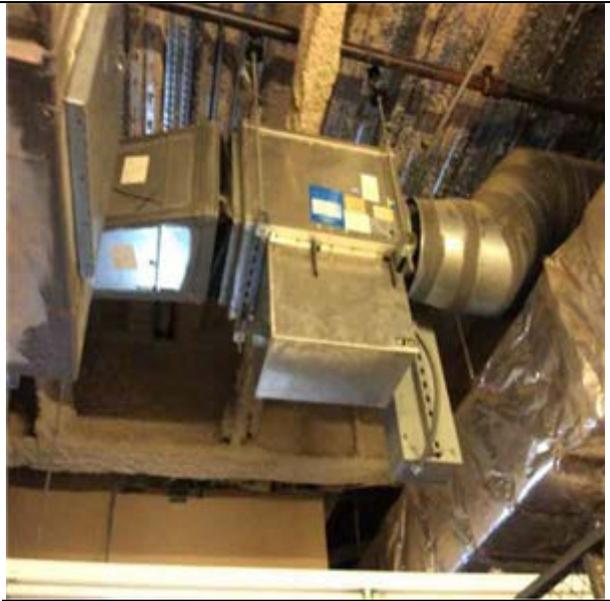
D3042 Exhaust Fan 2000 - 3500 CFM

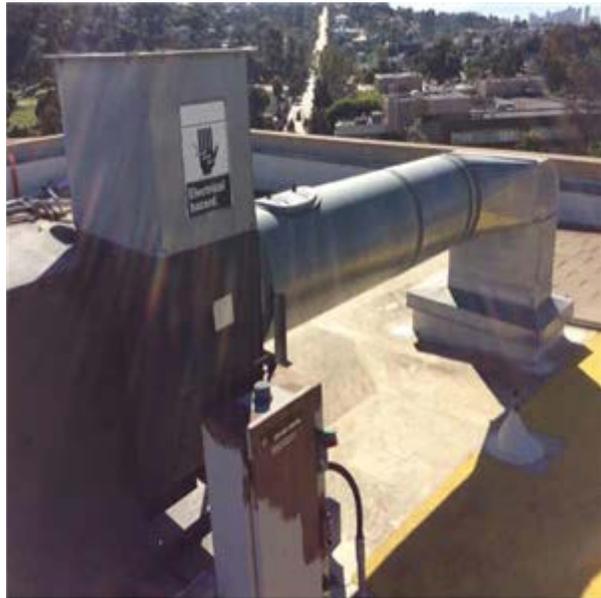
D3042 Exhaust Fan 700-2000 CFM

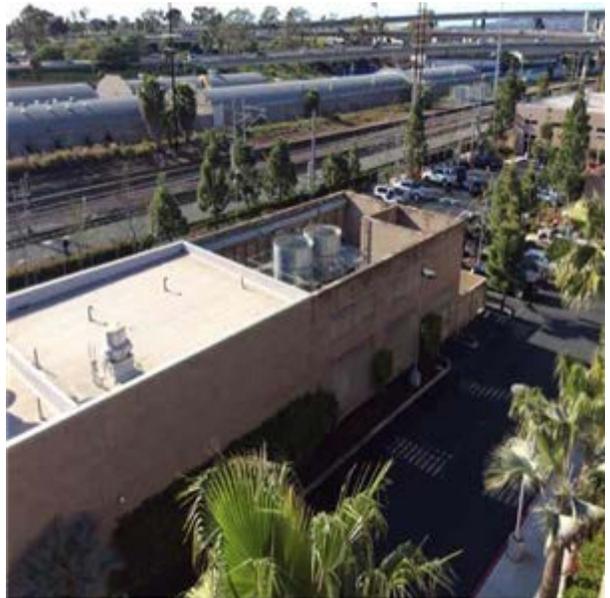
D3042 Exhaust Fan 4800 CFM

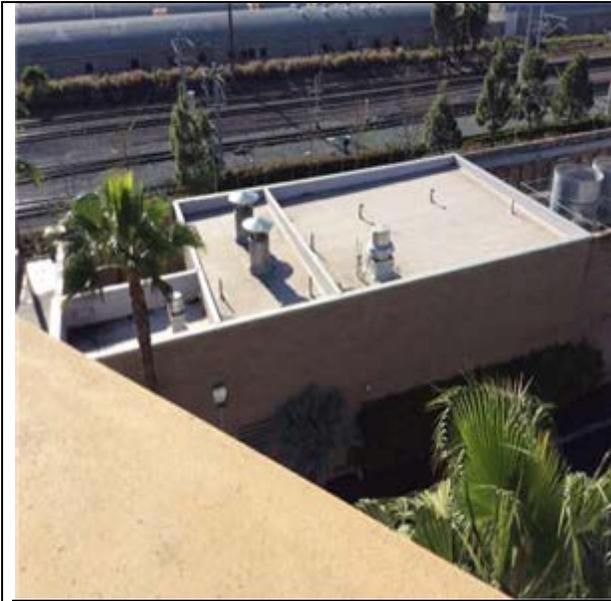
D3042 Exhaust fan 3 hp

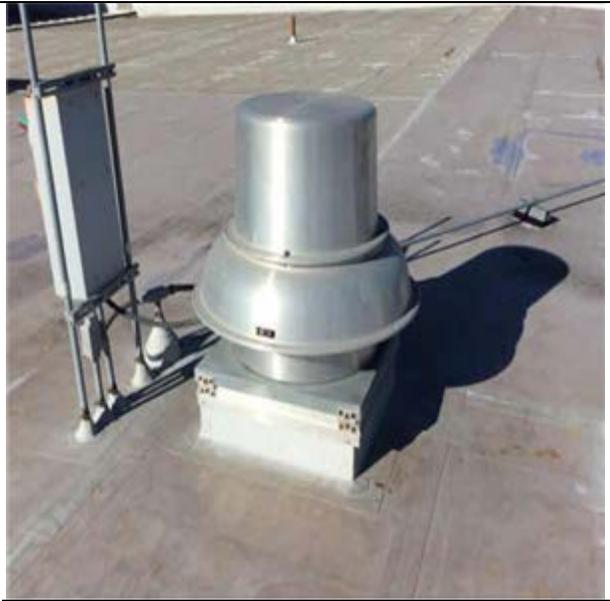
D3042 Exhaust fan 1/6 hp

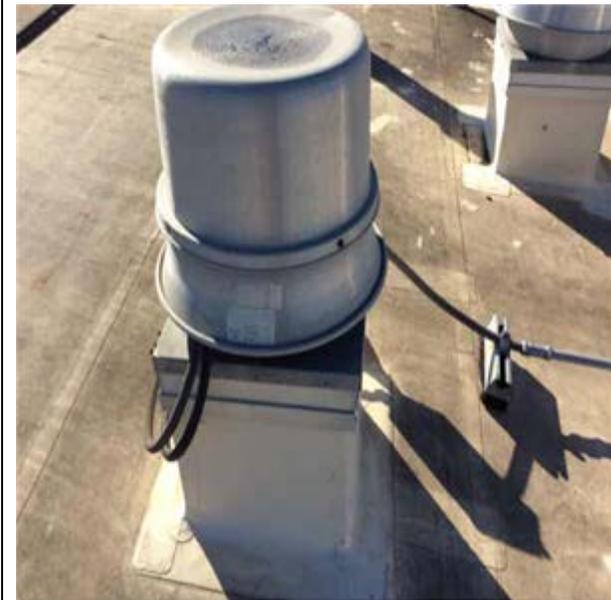
D3042 Exhaust Fan 2800 CFM

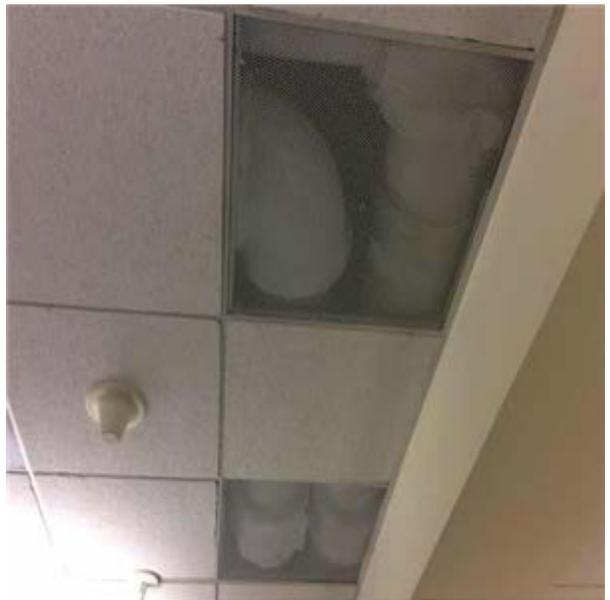
D3042 Exhaust Fan 485 CFM

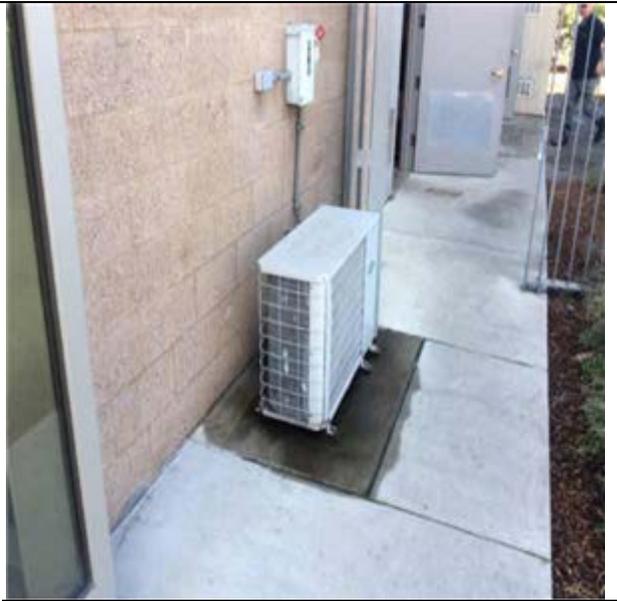
D3051 Fan Coil 1-6 ton cooling

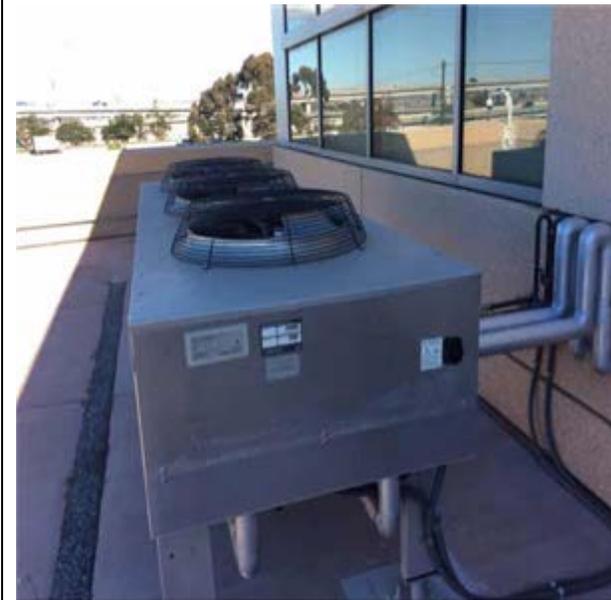
D3051.1 Split system heat pump 2 ton

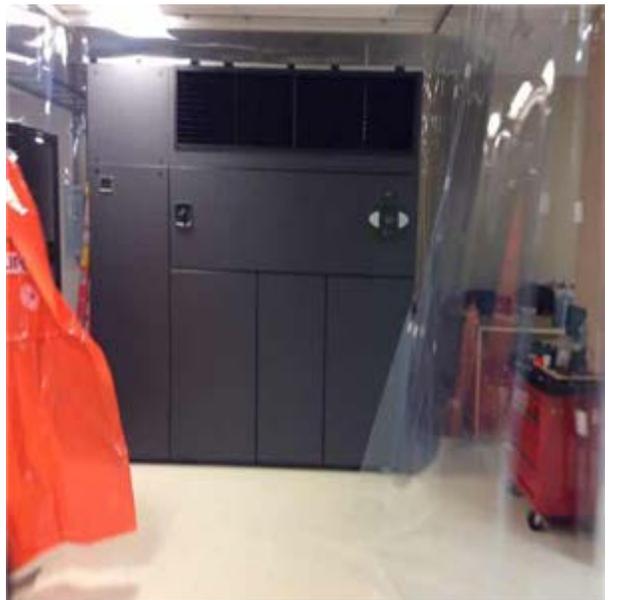
D3052 Air Conditioner, Dx Package (Liebert) 18-Ton

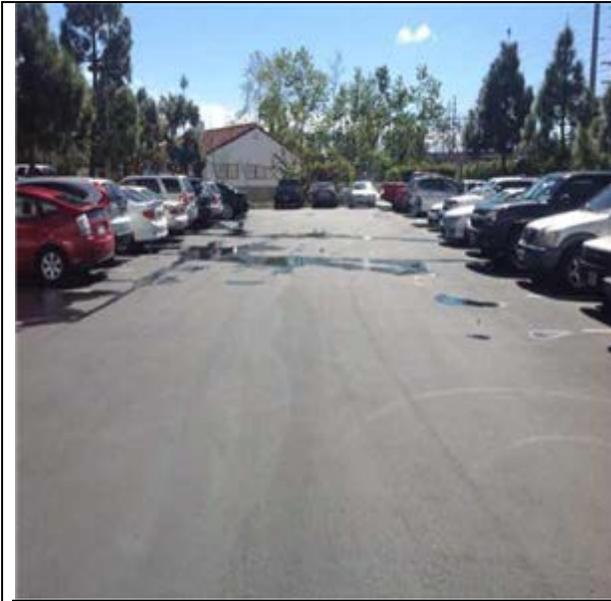
G2012 Asphalt Seal Coat

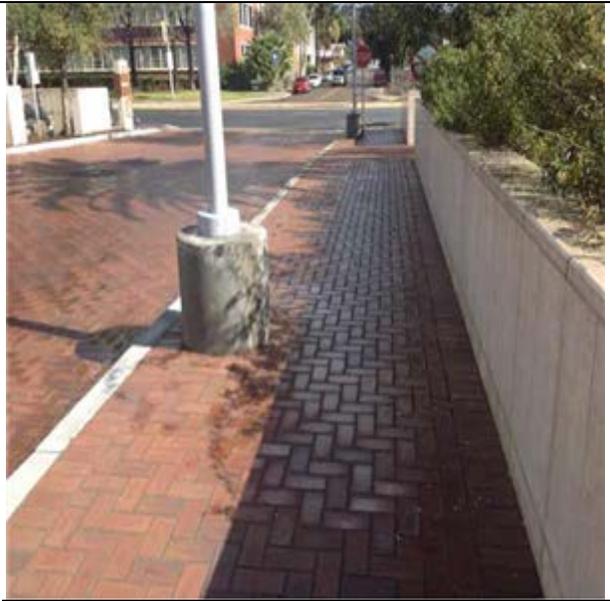
G2031 Brick Pavers, Grouted

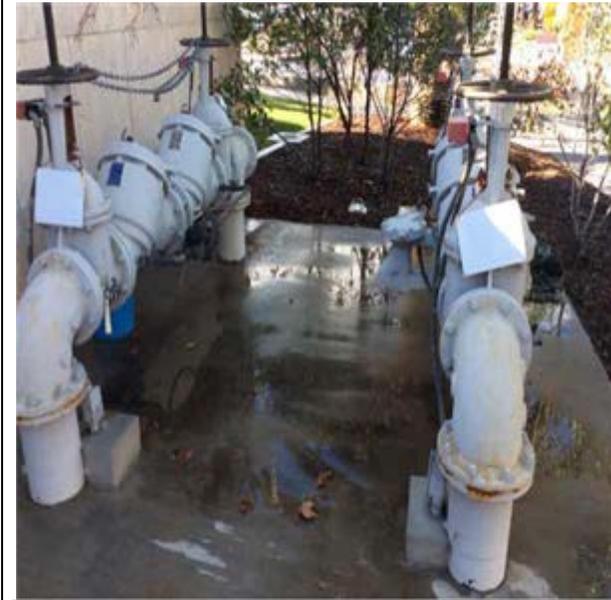
G2050 Sprinkler System, Backflow Preventer, 4"

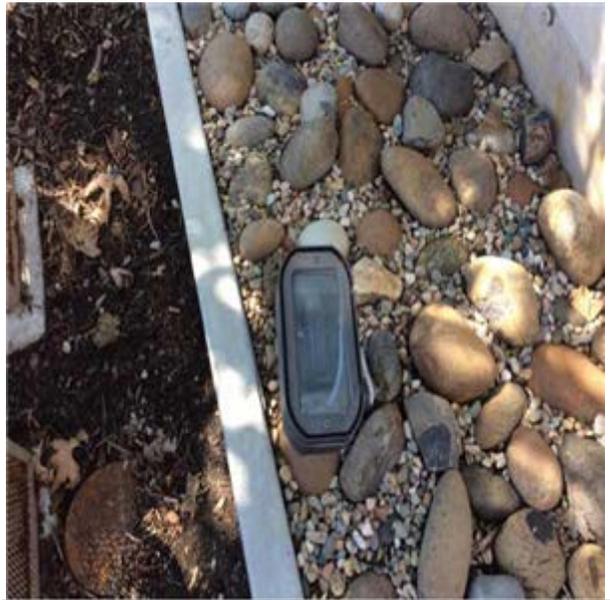
G4021 Landscape Ground Mounted Uplight Fixture 26 W CFL

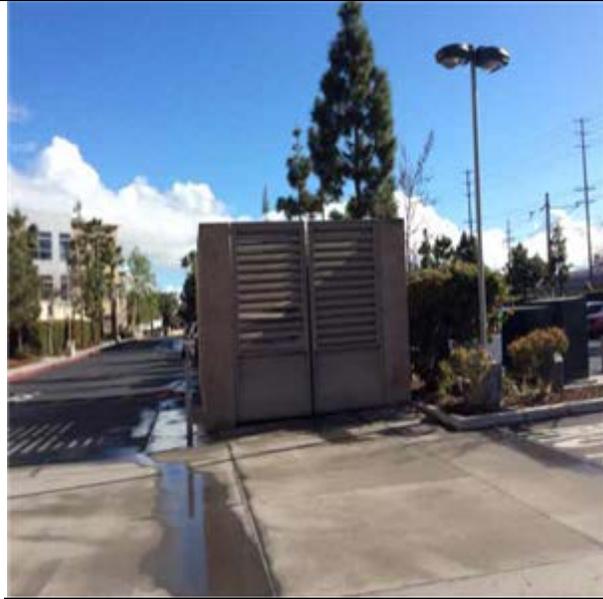
G4021 Pole Lamps 400 W
