Ronald Reagan State Building (509)

Facility Condition Assessment

September 2015

Prepared for the State of California Department of General Services

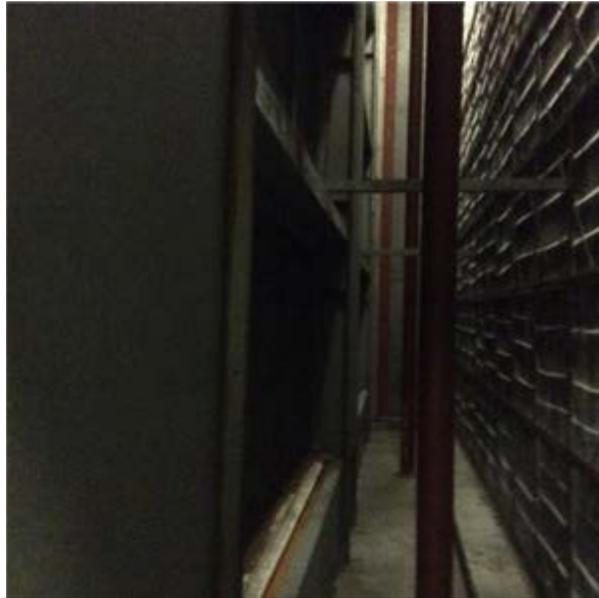
D3032 Condenser Coils

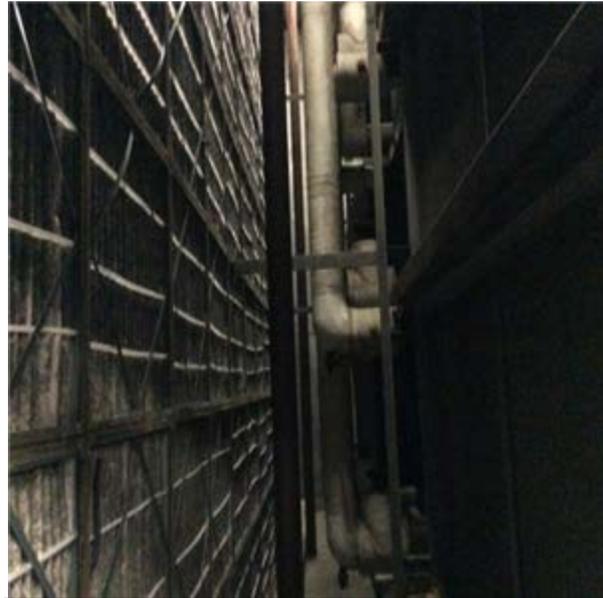
D3032 Condenser Coils

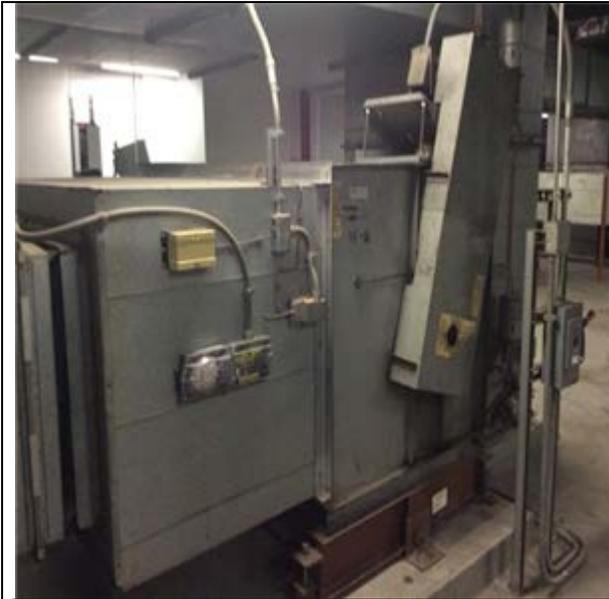
D3041 AHU Fan Motor, 15 HP with AC

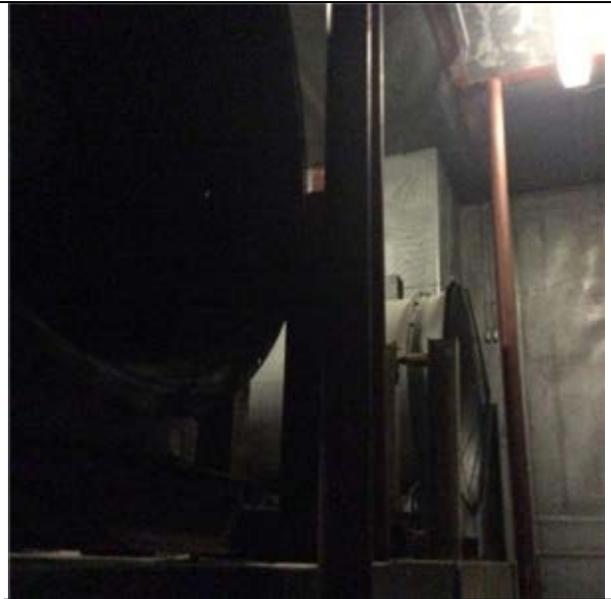
D3041 Supply Air Fans - AH 1,2 -50K CFM -150 HP Motors

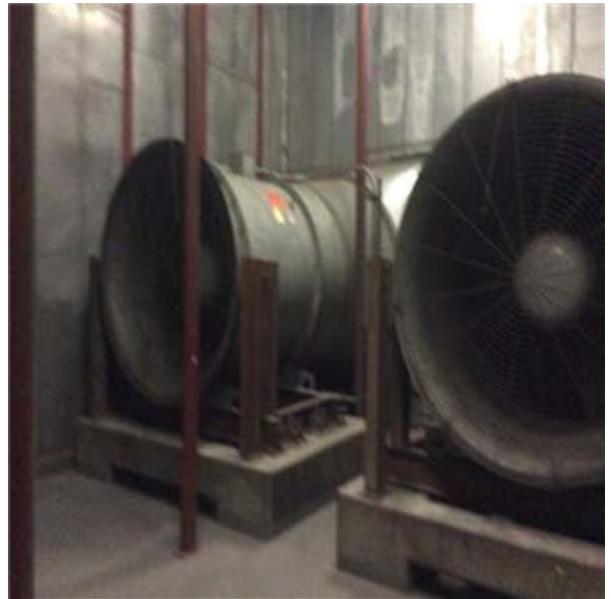
D3041 Supply Air Fans - AH 3,4 -77K CFM -150 HP Motors

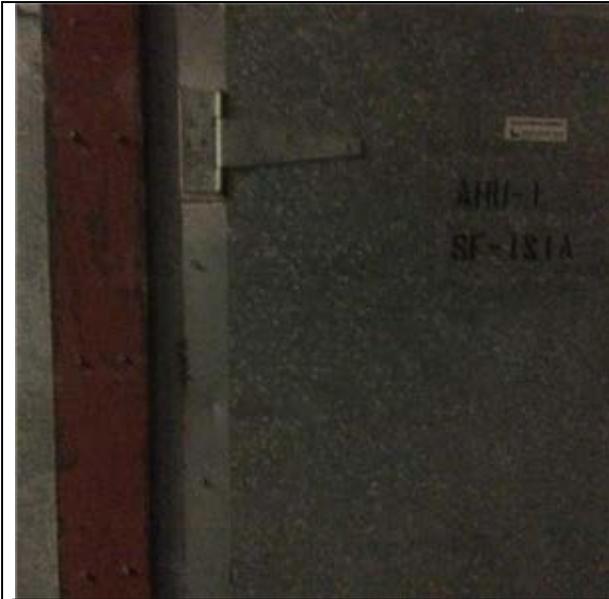
D3041 Return Air Fans - 68k CFM - 40 HP Motors

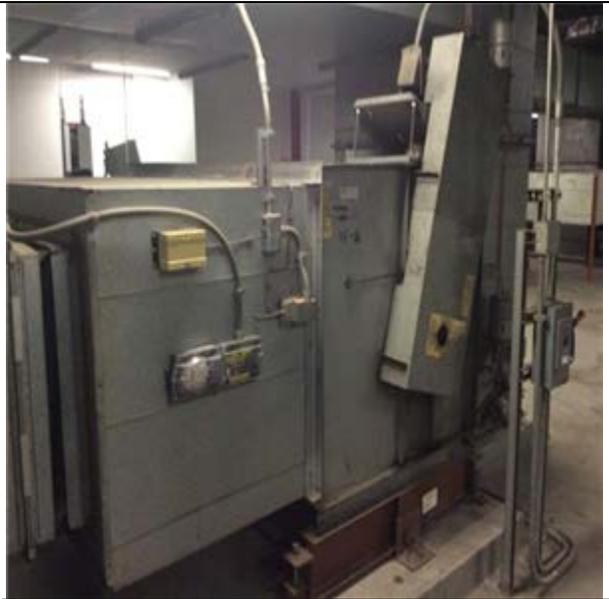
D3041 AHU Fan Motor, 7/ 1/2 HP

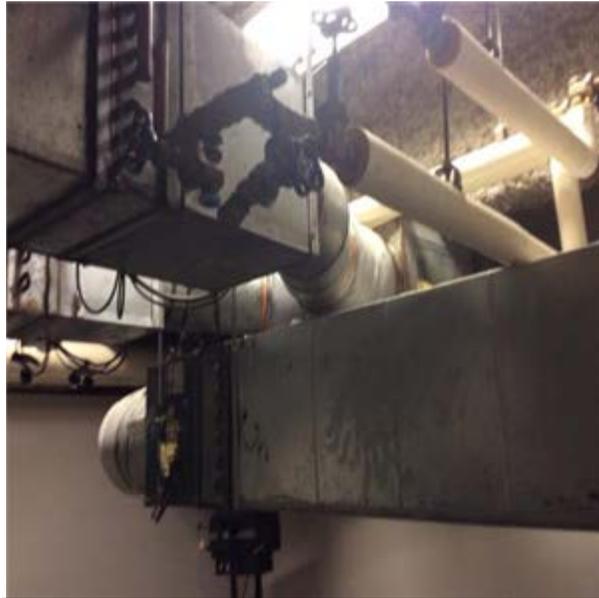
D3041 VAV Boxes w Coil Towers

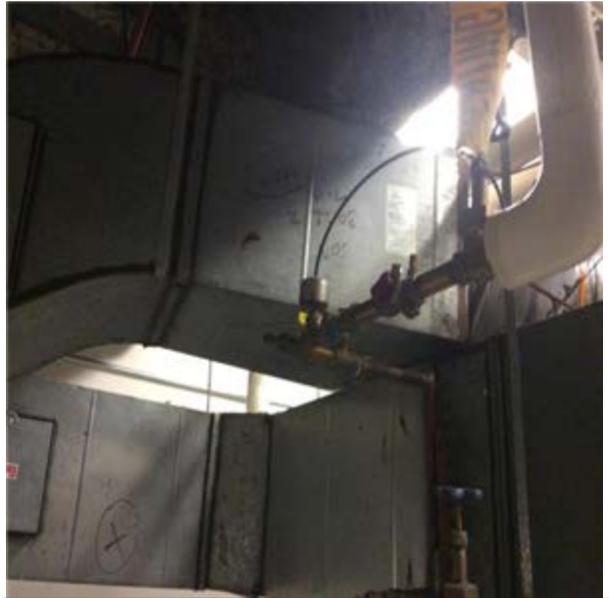
D3041 VAV Boxes Towers

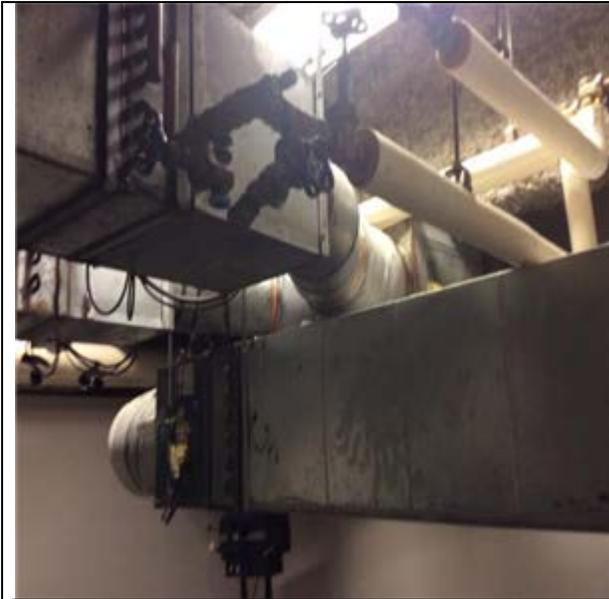
D3041 VAV Boxes w Coil Flrs 1-4

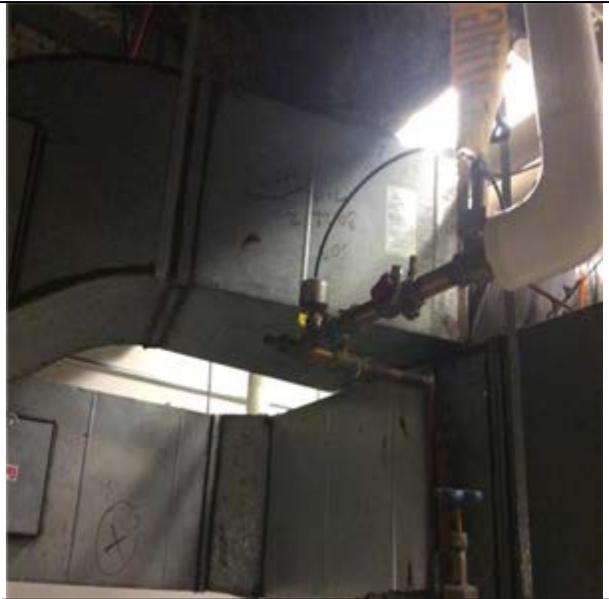
D3041 VAV Boxes Flrs 1-4

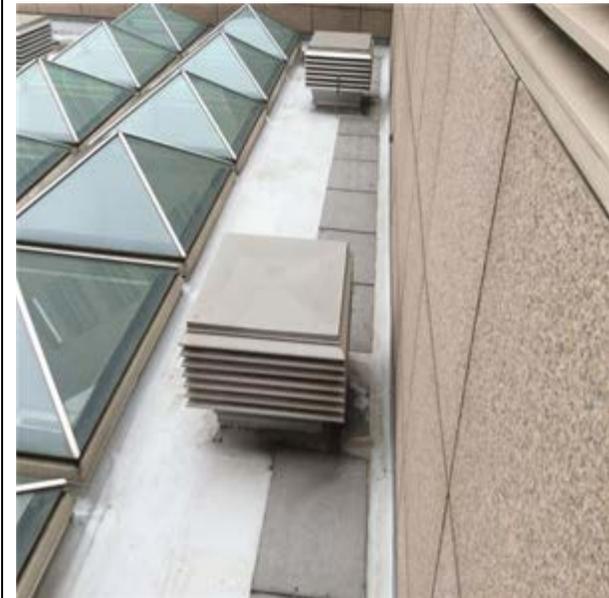
D3042 Smoke Evacuation Fans (4.8 to 7.2 MCFM)

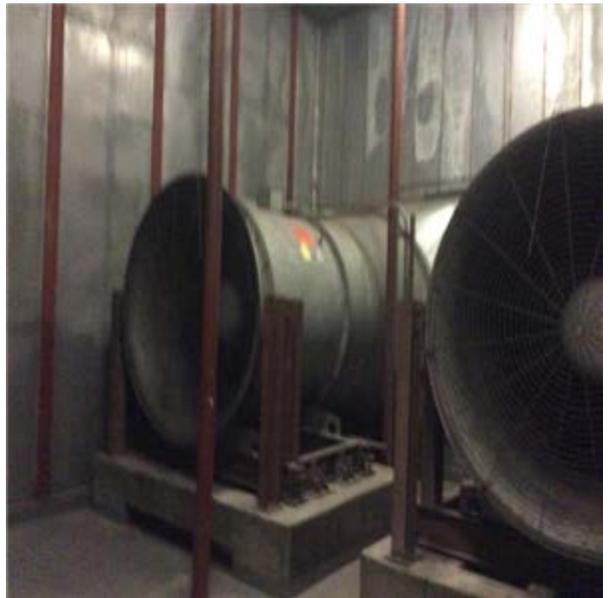
D3042 Supply Fan 77000 CFM

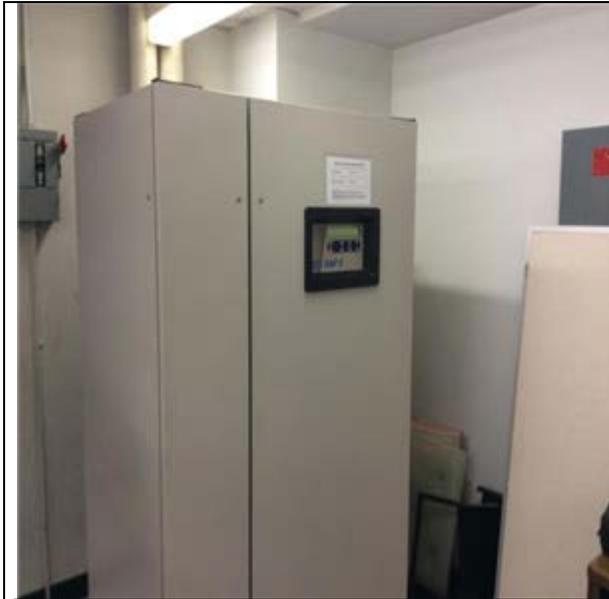
D3052 Computer/Sever Room AC, 5 Tons

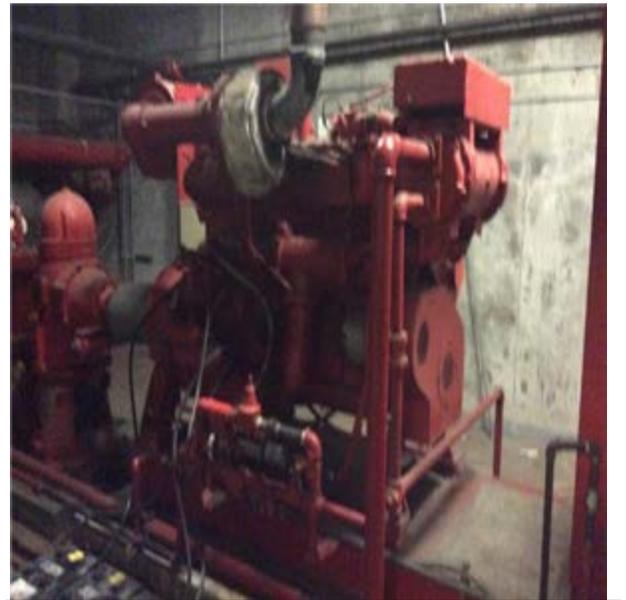
D4012 Fire Pump Diesel 1500 Gpm 279 HP

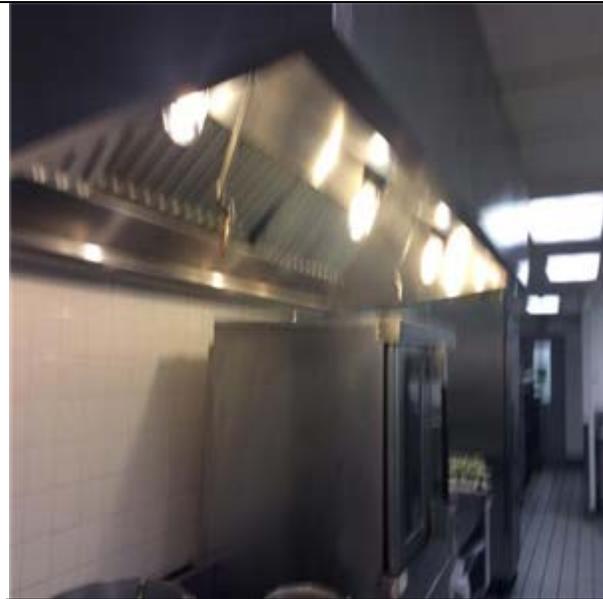
D4031 Ansul System at Kitchen Hood

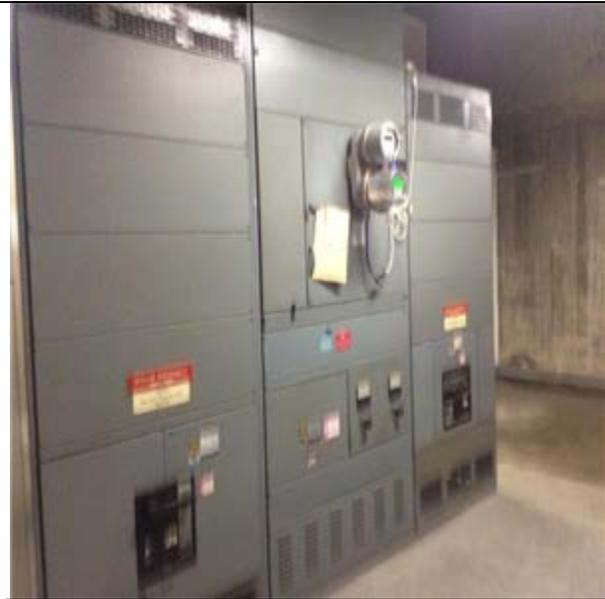
D5010 Switchgear, Mainframe, 3000 Amps

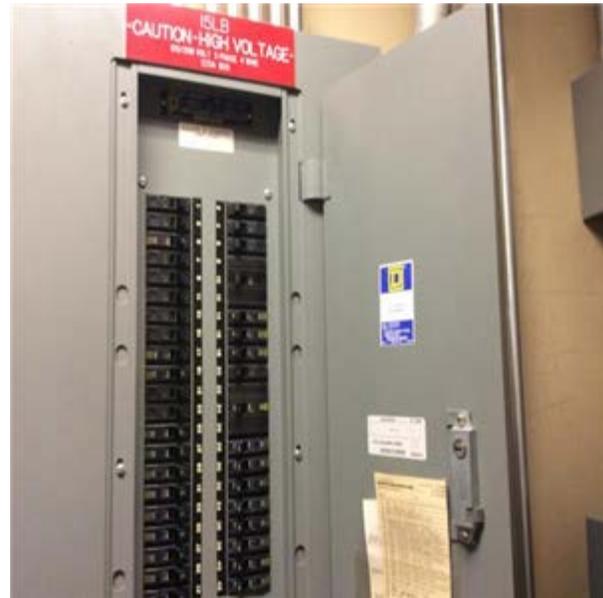
D5012 Breaker Panel 225 Amps, 30 Circuits

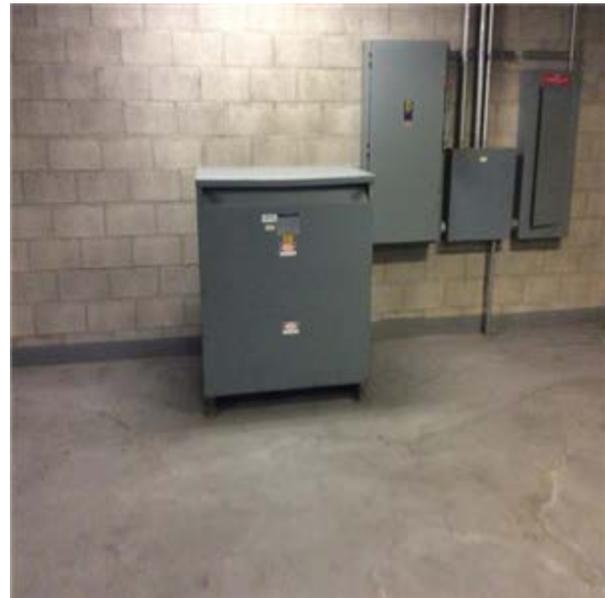
D5012 Secondary Dry Transformer 75 kVA

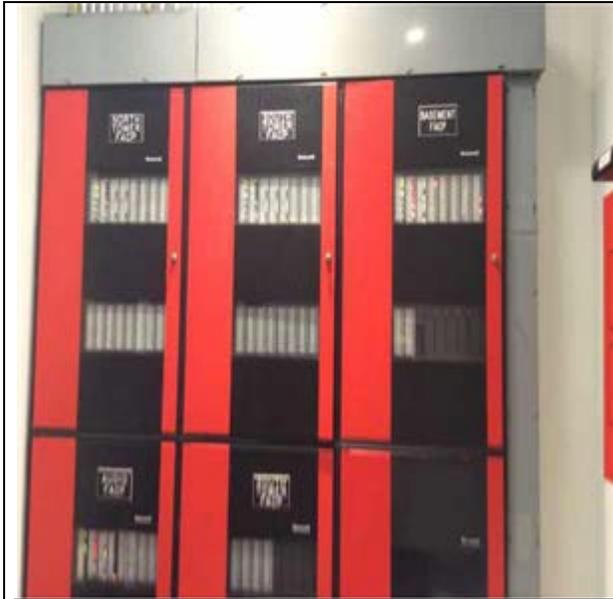
D5037 Fire Alarm Panel

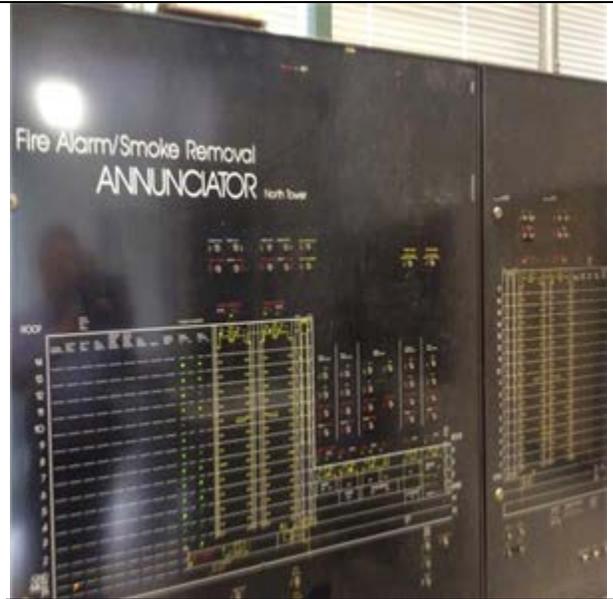
D5037 Fire Alarm System

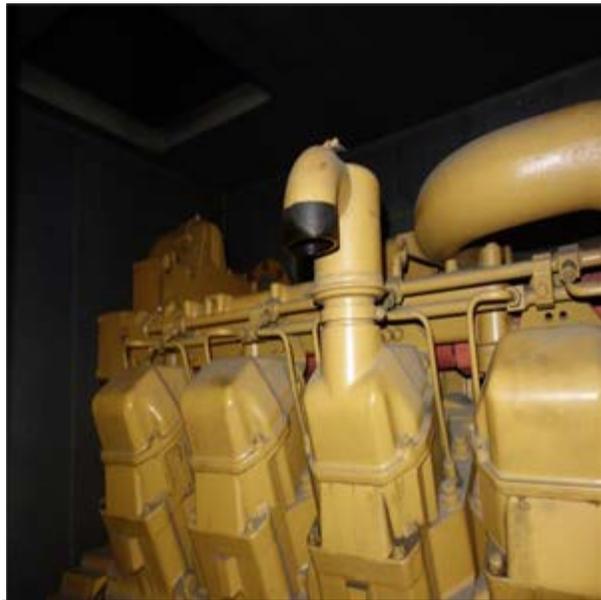
D5092 Emergency Generator 800 KW

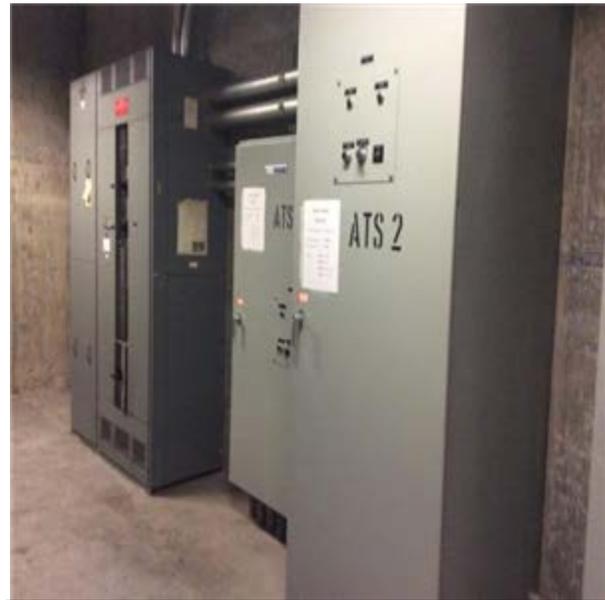
D5092 Emergency Transfer Switch

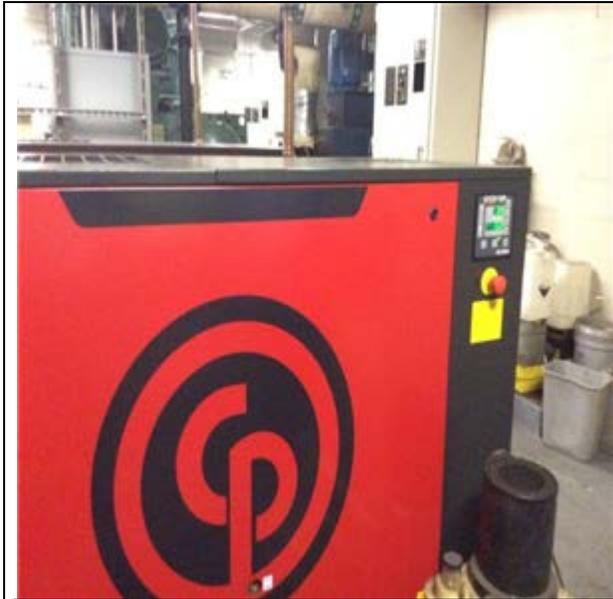
E1019 Compressor for Pneumatic Controls - 30 HP

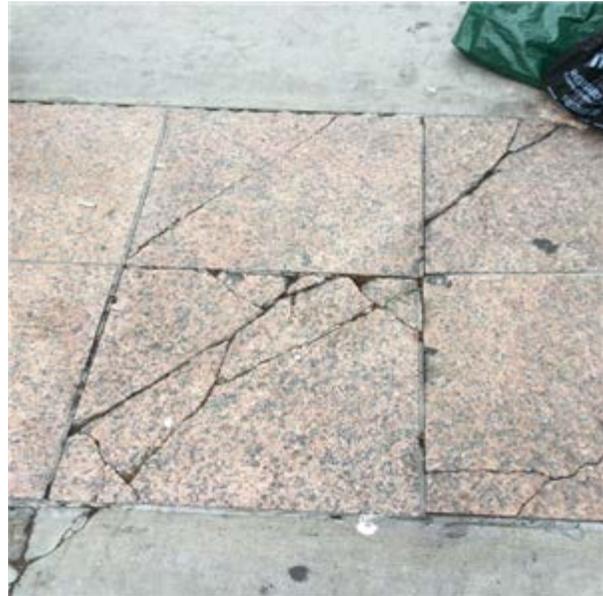
G2022 Granite Pavers
